STATE COMMISSION ON RAILWAY ACCIDENT INVESTIGATION
Ministry of the Interior and Administration

REPORT No. PKBWK 3/2025

**on the investigation of a serious railway accident
that occurred on 3 December 2023 at 10:06 hrs at Jaszczów station
at turnout no. 1 on track 1, at km 201.000 of railway line no. 7
Warszawa Wschodnia Osobowa - Dorohusk,
the area of infrastructure manager PKP PLK S.A. Railway Line Plant in Lublin**

WARSAW, 15 April 2025

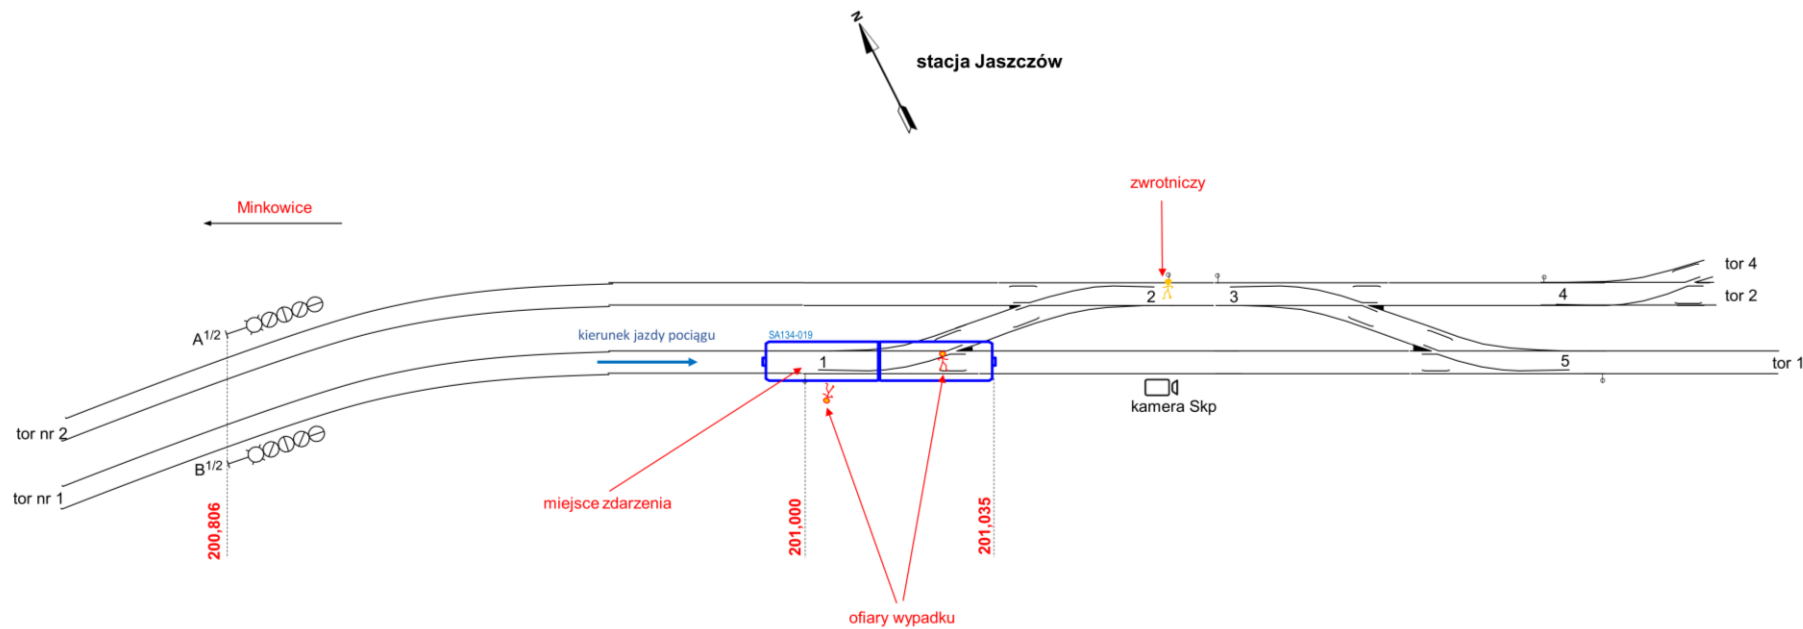
Figure 2 - A sketch plan of the occurrence scene

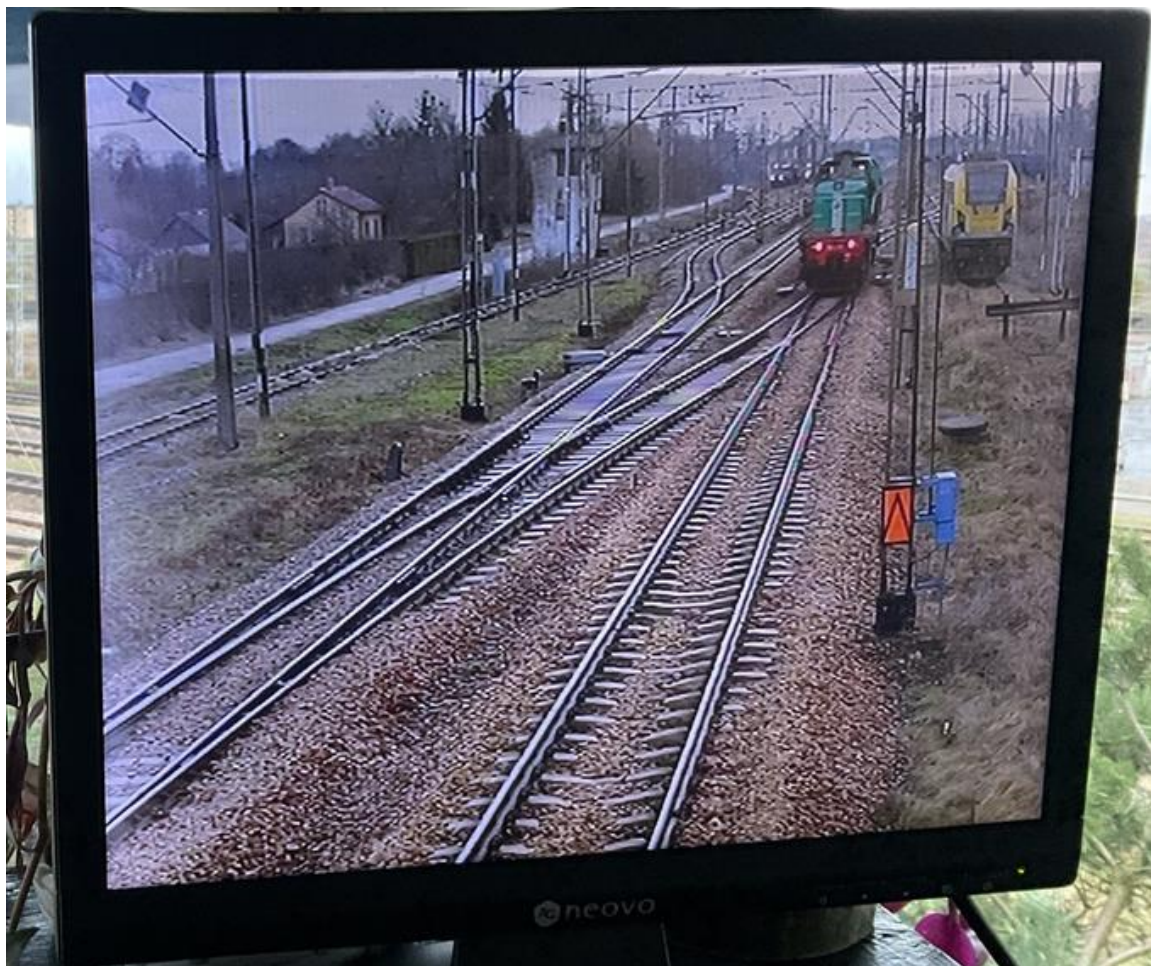
The turnout switch is fitted with an EEA-5 type switch drive. The switch has switch blade control and track occupancy detection, and is electrically heated. A camera is installed at the station at km 201.040 at track 1, and the command box "Jw" has a CCTV monitor for determining the end of trains entering the station from the direction of Minkowice station. The camera does not monitor turnouts no. 1 and 2, where the workers were performing snow clearance.

Photograph 1 - The signaller's view of turnouts no. 3, 4 and 5.

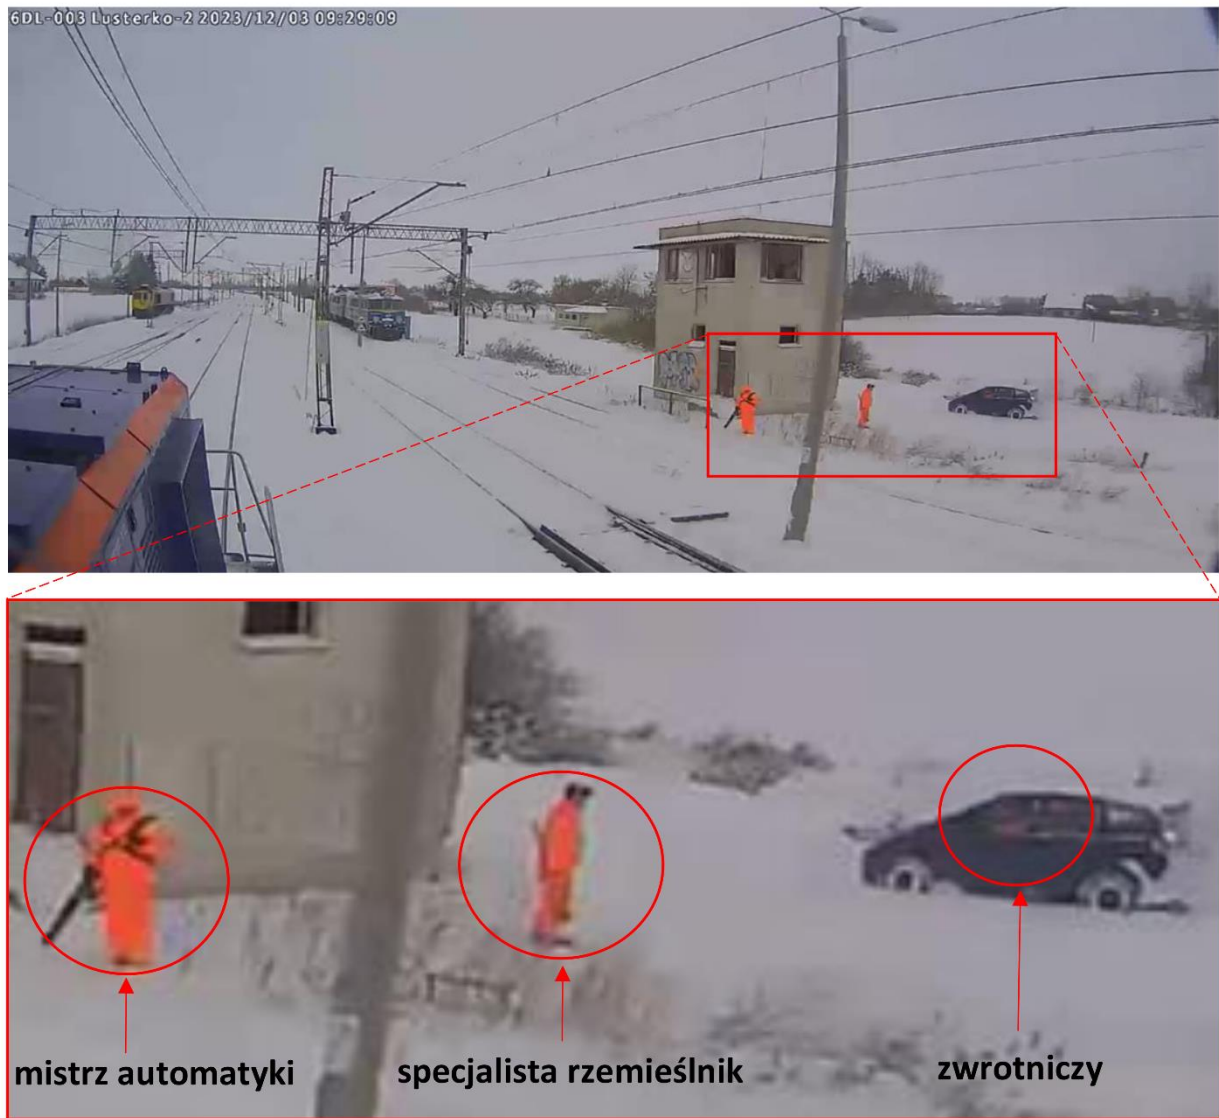
Photograph 2 - An image recorded by the camera on passing train no. 28104 (source: PKP INTERCITY S.A.)

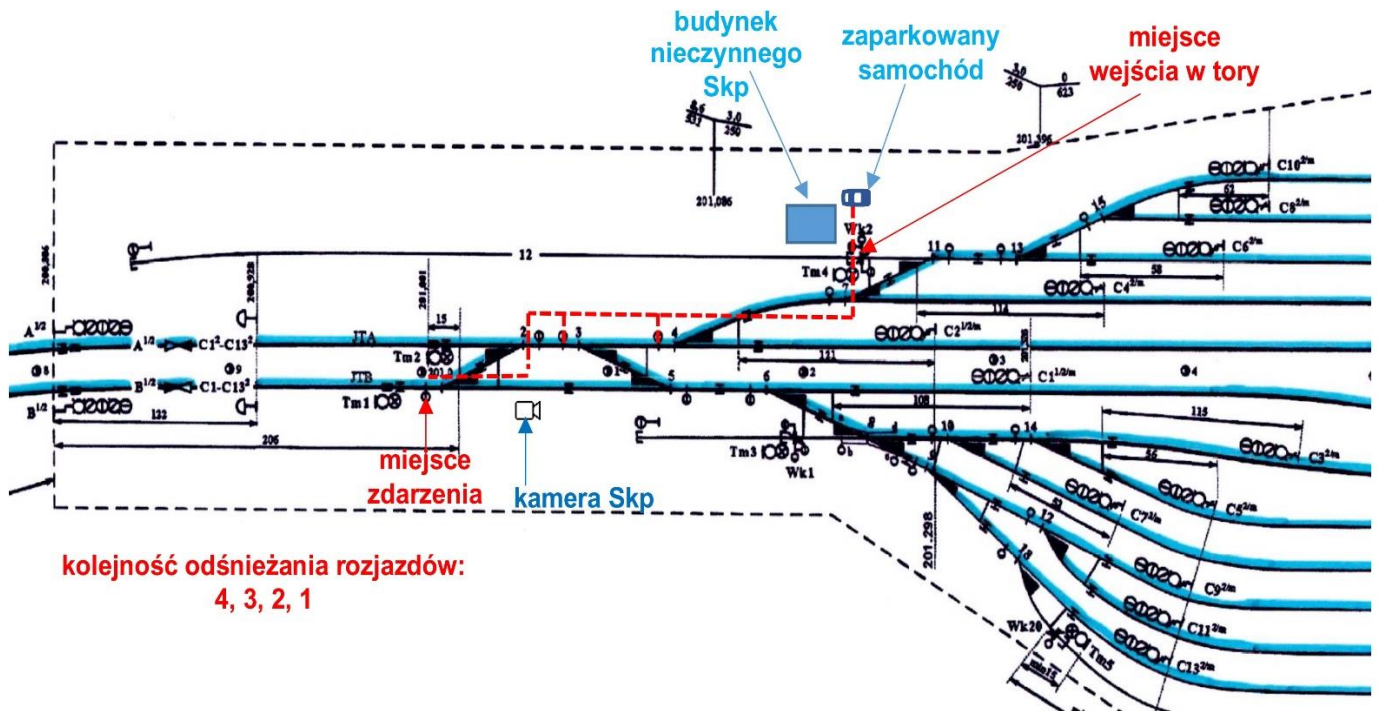
After starting the blower, all three workers made for turnout no. 4 on the intertrack space of tracks 2 and 12. The blower was operated by the specialist craftsman who was blowing snow from the switch section of the turnout, while the switchman was brushing off the channel and setting-up closure. The automation foreman was standing on the side and watching the works at the turnout. Not satisfied with the results, he personally took over the operation of the blower and proceeded to clearing turnouts no. 3 and 2 on track two of snow. Then the automation master with the blower and the specialist craftsman made for turnout no. 1 on track one, and the switchman remained at turnout no. 2 on track two, continuing the cleaning.

Figure 3 - The point of entry onto the tracks and marked locations of snow clearance work

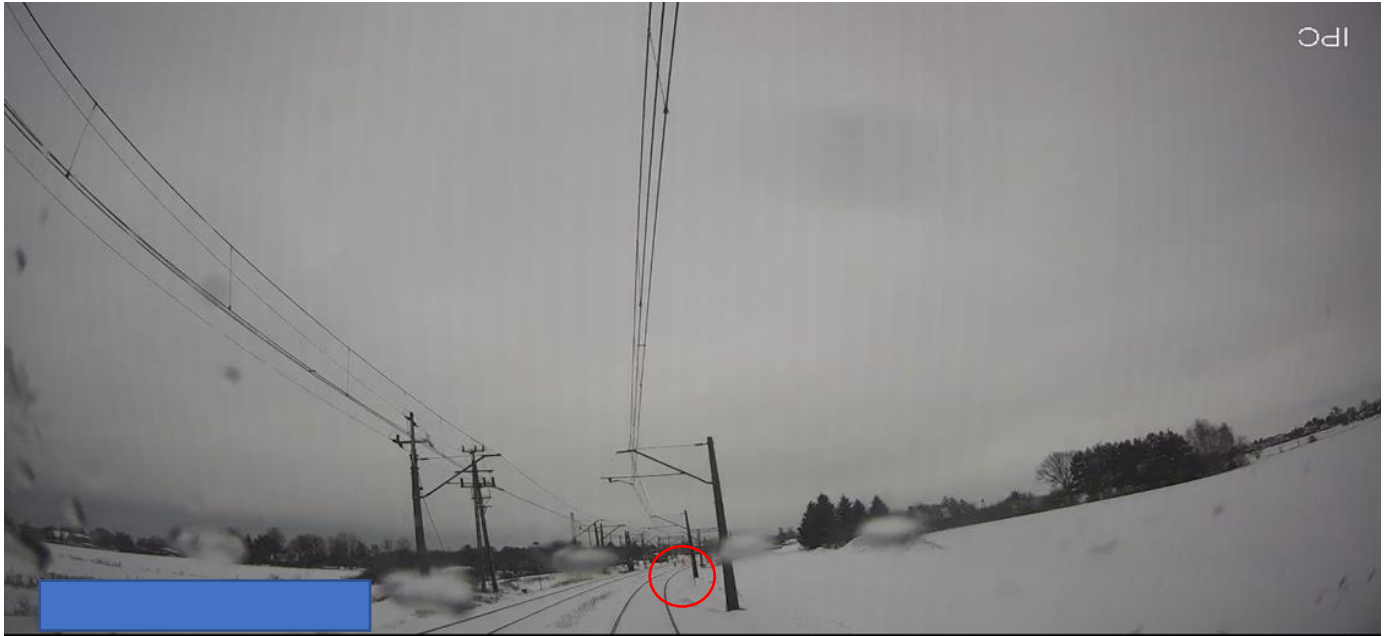
Seeing no reaction from the workers at turnout no. 1, the train driver continued the Rp1 "Attention" signal and implemented emergency braking at 10:05:46 hrs at the speed of 86.75 km/h.

Photograph 3 - A view of the working group captured by the front camera of SA134-019 (source: POLREGIO S.A.)

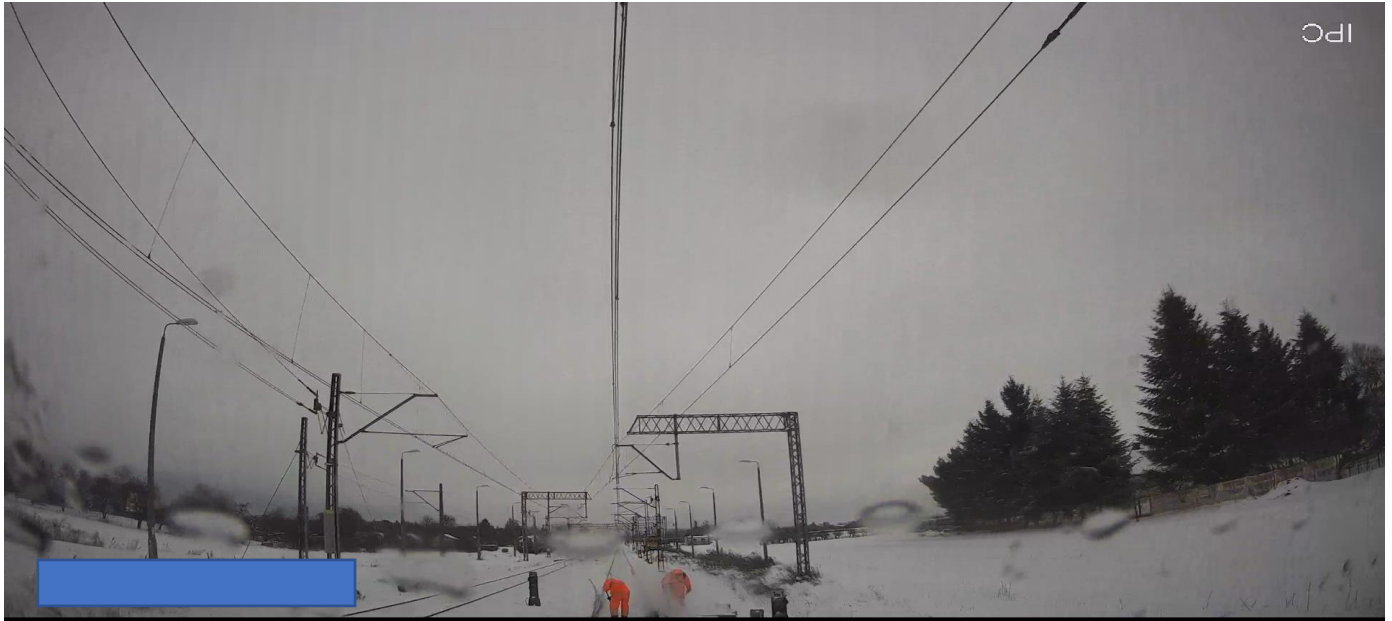
As a result of the impact, the worker with the blower was thrown some 5 m in the direction of the train's travel onto the right side of the right track rail, where he remained lying on his back with his head against the electric turnout heating (EOR) transformer box and his left leg at the right track rail. The other worker, who was between the track rails, was hit, knocked over and dragged under the train.

Photograph 4-A a view from the front camera of SA134-019 on the working group just before the accident (source: POLREGIO S.A.)

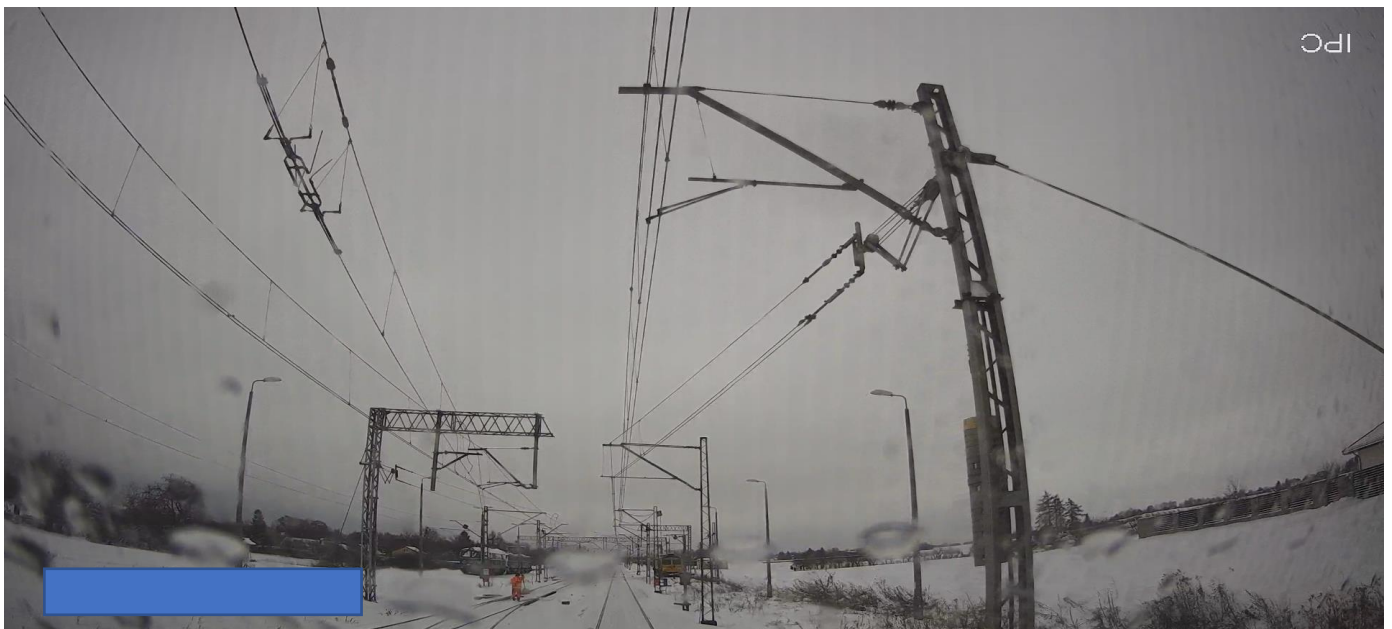
Photograph 5 - A view from the front camera of SA134-019 on the third worker, shortly after the occurrence and train stop (source: POLREGIO S.A.)

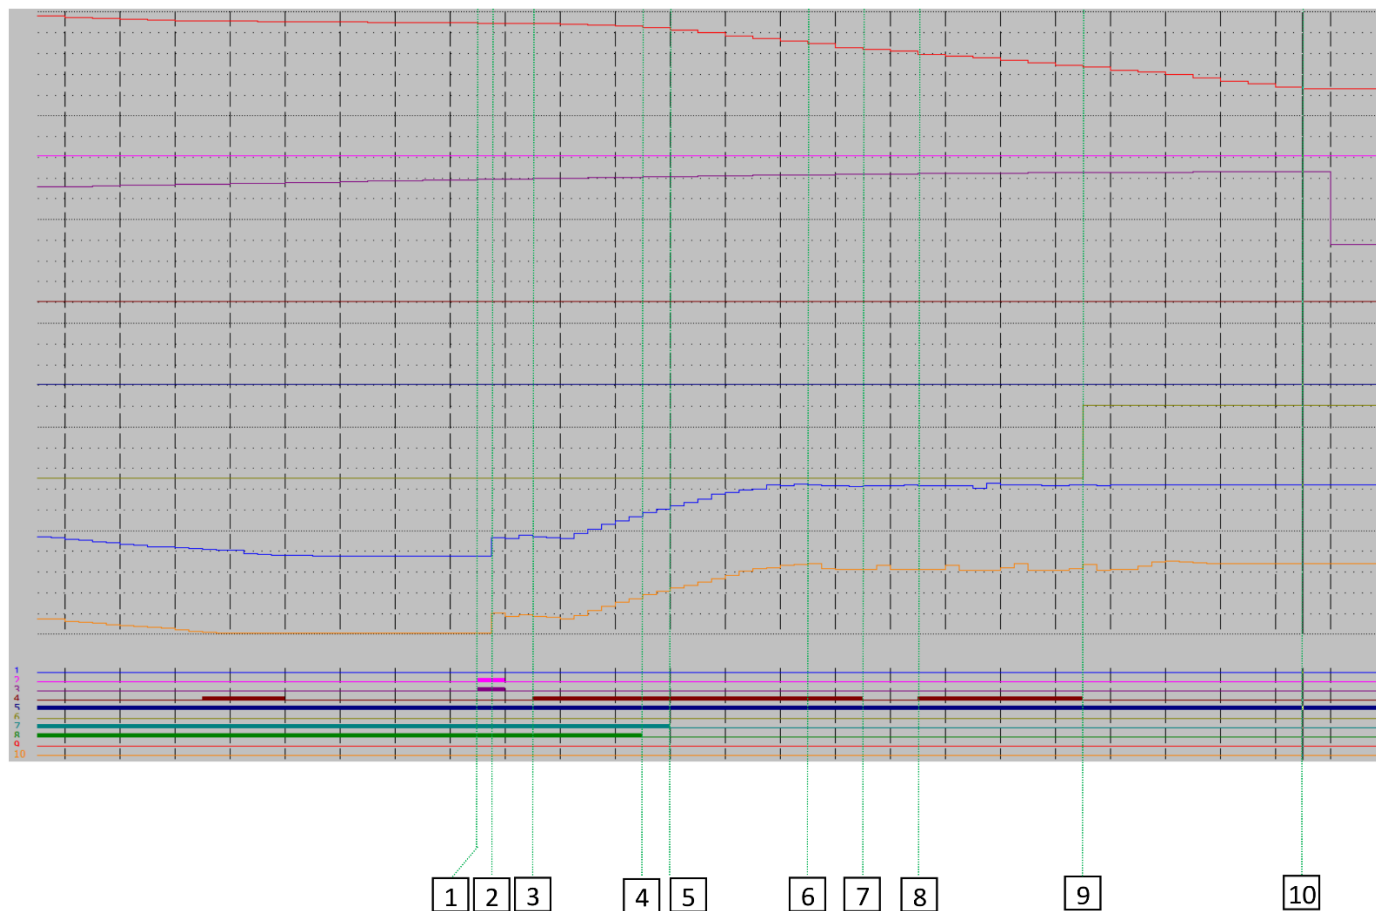
Figure 4 - Diagram of the SA134-019 driving parameters

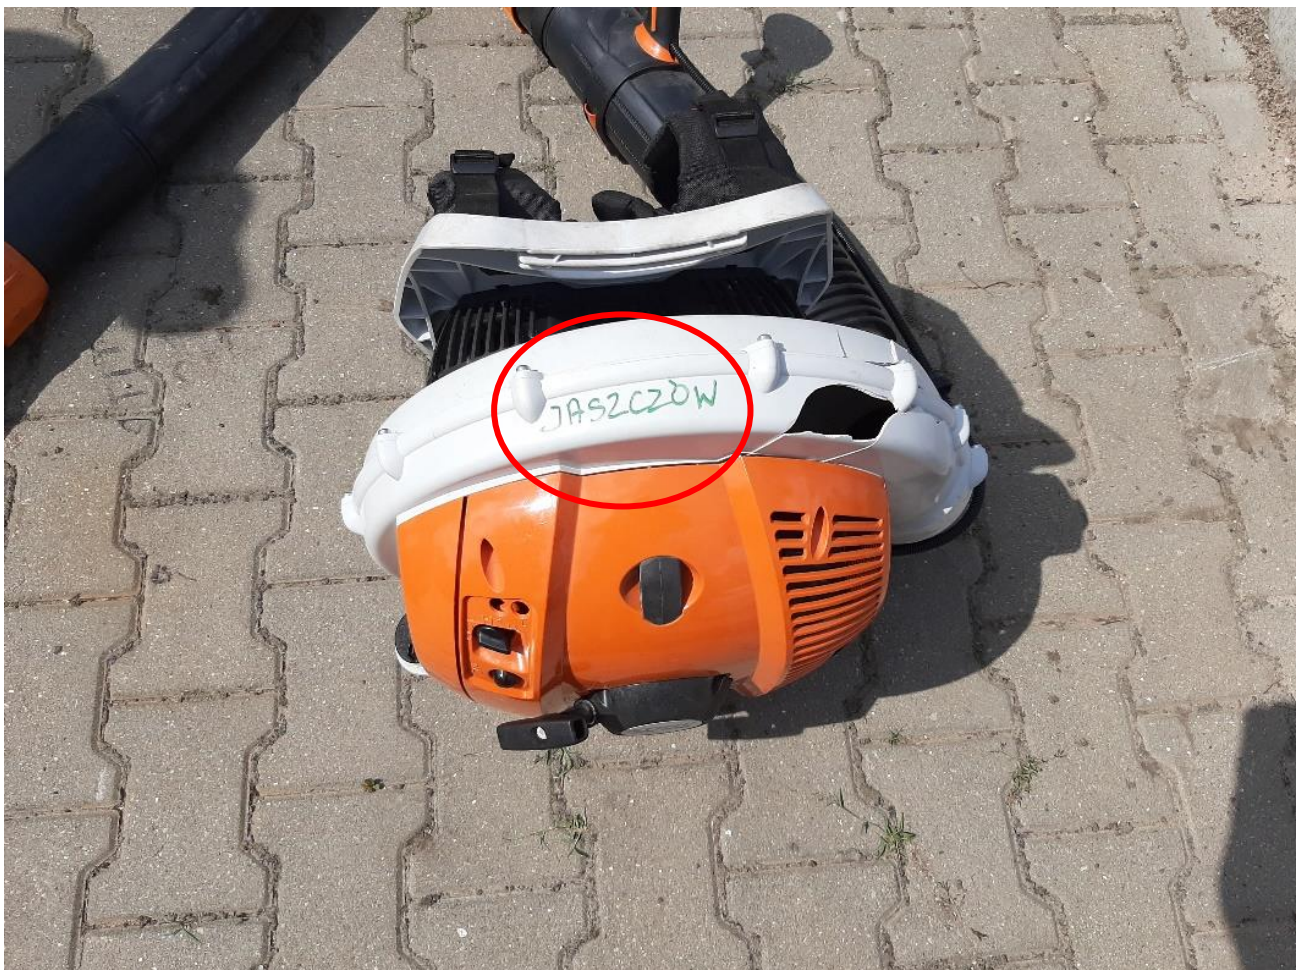
Photograph 6 - The diesel blower on the equipped list for the Jaszczów station shelter which was in use on the day of the occurrence (source: PKBWK).

The failure to develop an effective system of mutual communication during snow clearance from turnouts with a backpack diesel blower that produced high-intensity noise was also identified by the Investigation Team as a systemic factor contributing to the occurrence.

1. PKP PLK S.A. shall carry out a risk assessment regarding the use of backpack blowers for snow clearing work.
2. PKP PLK S.A. shall promptly develop and communicate to its subordinate organisational units that use backpack blowers for works on or at railway tracks, a set of requirements concerning safety conditions at work with this type of equipment, and shall enhance supervision of compliance with those requirements.
