STATE COMMISSION ON RAILWAY ACCIDENT INVESTIGATION
Ministry of the Interior and Administration

REPORT No. PKBWK 05/2025

**on the investigation of a serious railway accident that occurred on 1 July 2024 at 09:19 hrs
on the Ożarów Mazowiecki - Błonie route, track no. 2, category B level crossing at km
17.211 of railway line no. 3 Warszawa Zachodnia - Kunowice,
area of infrastructure operator PKP PLK S.A. Railway Line Plant
in Warsaw**

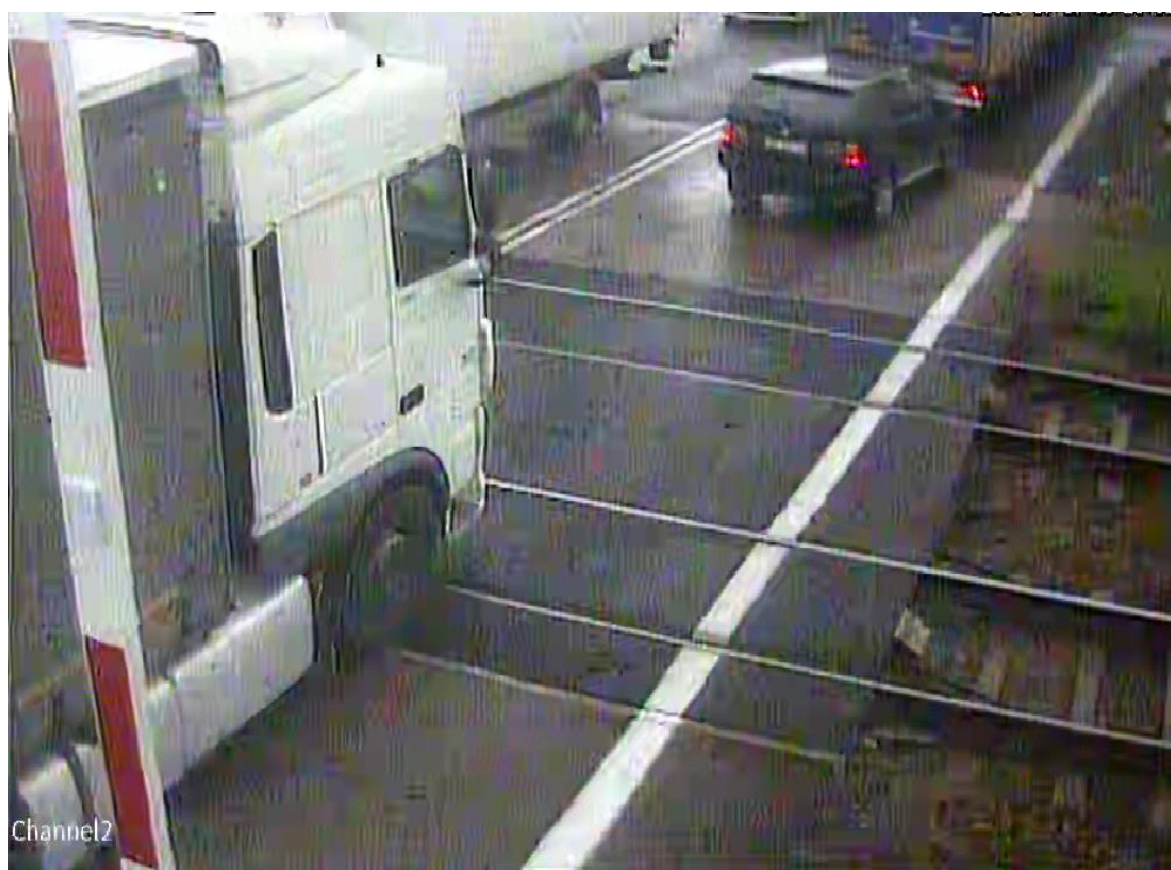
Photograph 1 - View of the lorry which stopped in the crossing zone behind the cars stationary on the other side of the crossing (source: PKP PLK S.A.)

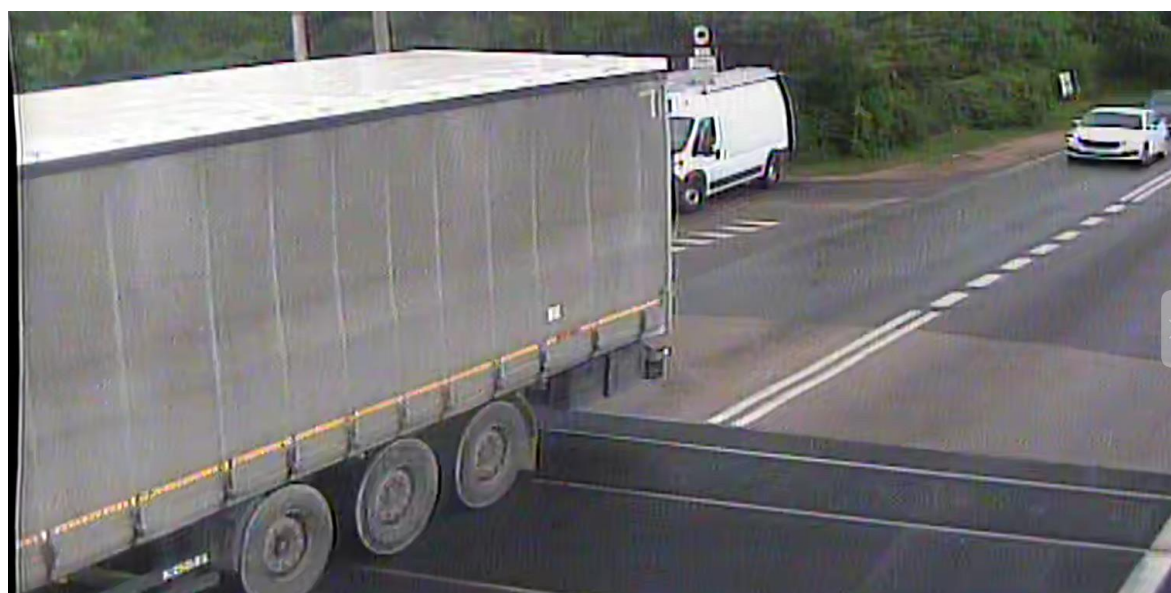
Photograph 2- View of the lorry semi-trailer on the crossing at approximately 0.5 s before the occurrence (source: PKP PLK S.A.)

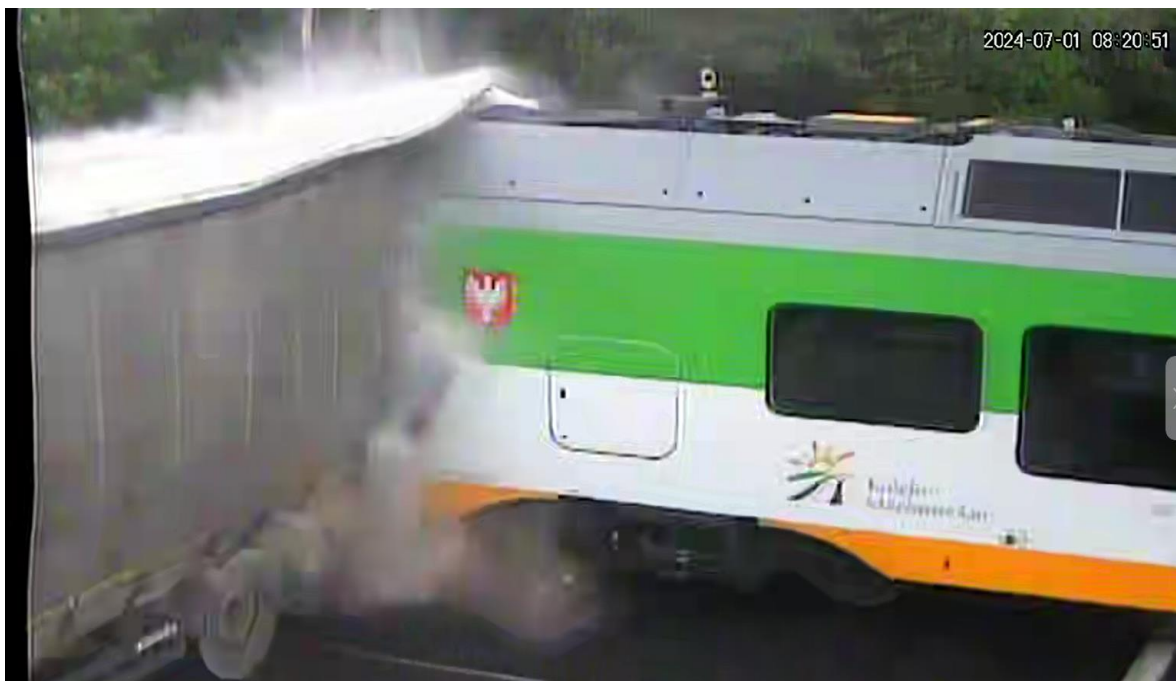
Photograph 3 - View of KM's passenger train colliding with the lorry semi-trailer (source: PKP PLK S.A.)

The Investigation Team found as the causal factor the lorry entering and remaining on the Cat. B level crossing on tracks 1 and 2 as the vehicles ahead of it stopped unexpectedly, as a result of which the passenger train travelling on track no. 2 collided with the semi-trailer of the lorry.

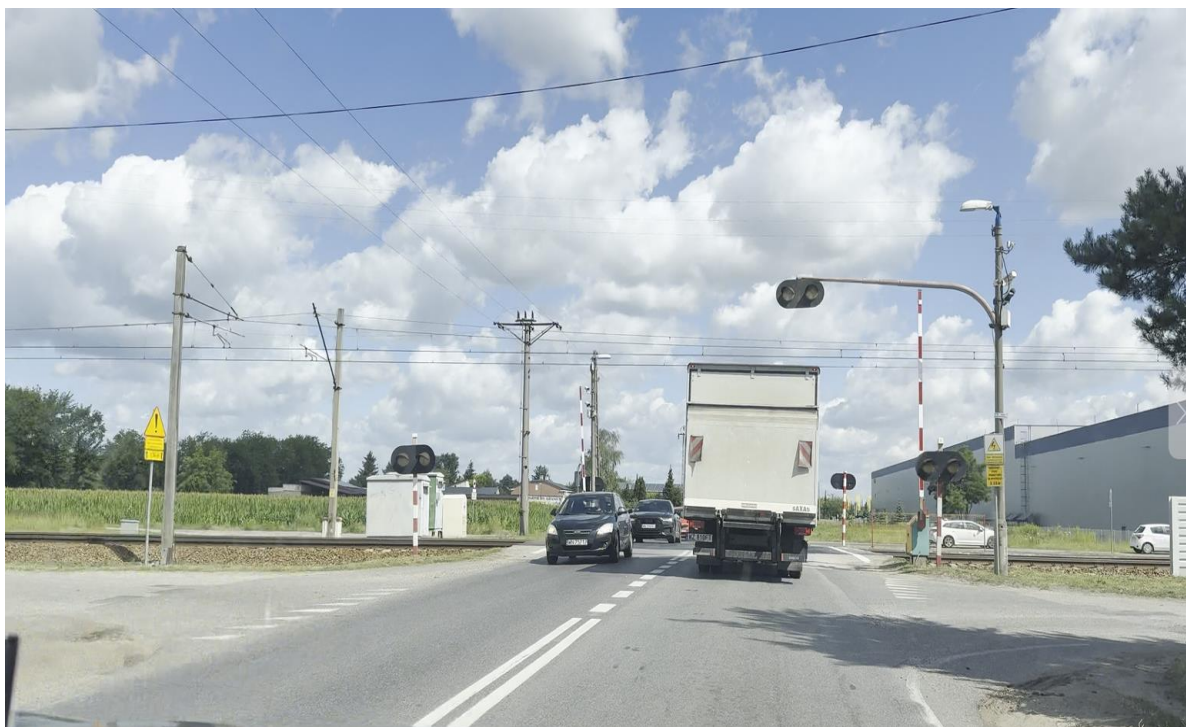
Photograph 5- View of the crossing from the lorry's direction of travel (source: PKBWK)

8. Check, complete or make legible the signage from the internal roads parallel to the railway line within the crossing area informing of the crossing (refers to the situation of turning right into the crossing) by adding F6a signs - currently, the signs are missing on one of the aforementioned roads, whereas on the other two roads they are rotated and not legible to road users.

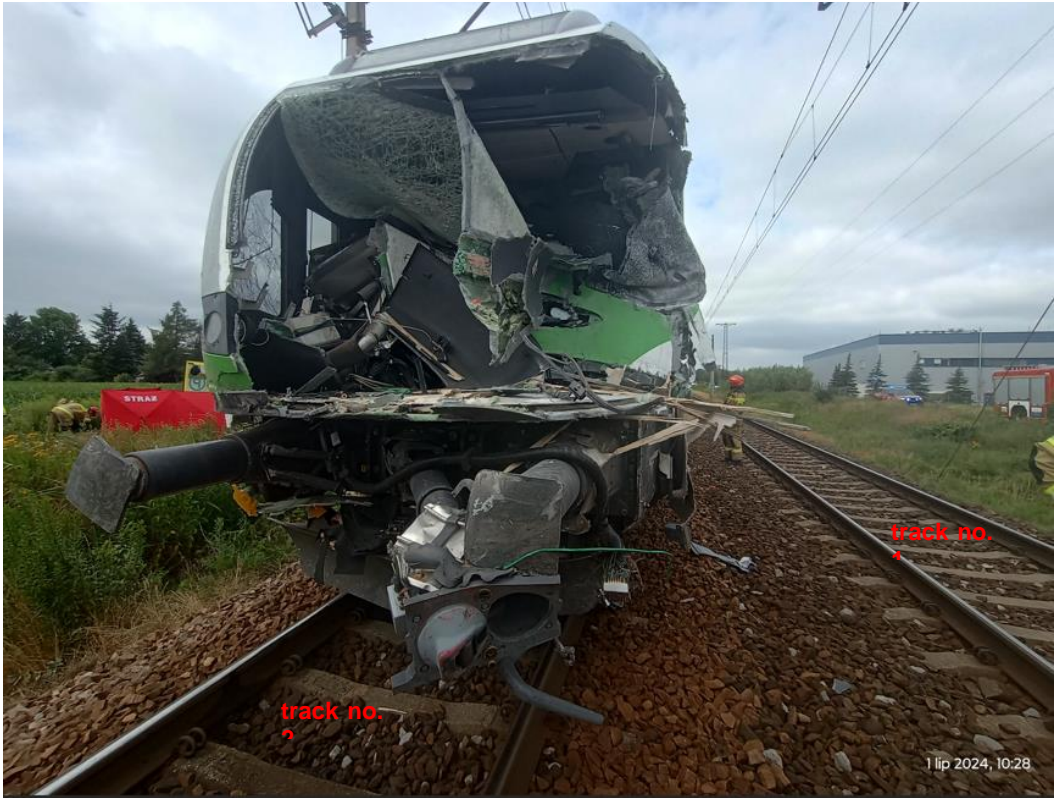
Train 91448 was not derailed. The collision resulted in very significant damage to rail vehicle ER75-001, namely:

- completely destroyed front cabin of the A section, including skin and windscreen,
- destroyed automatic coupling,
- destroyed front information display,
- destroyed two front bumpers,
- damaged side body of the vehicle,
- damaged bogies of the A section,
- damaged recorders,
- damage to the A section body frame.

Photograph 6 - View of the damaged front wall of railway vehicle ER75-001 (source: KM)

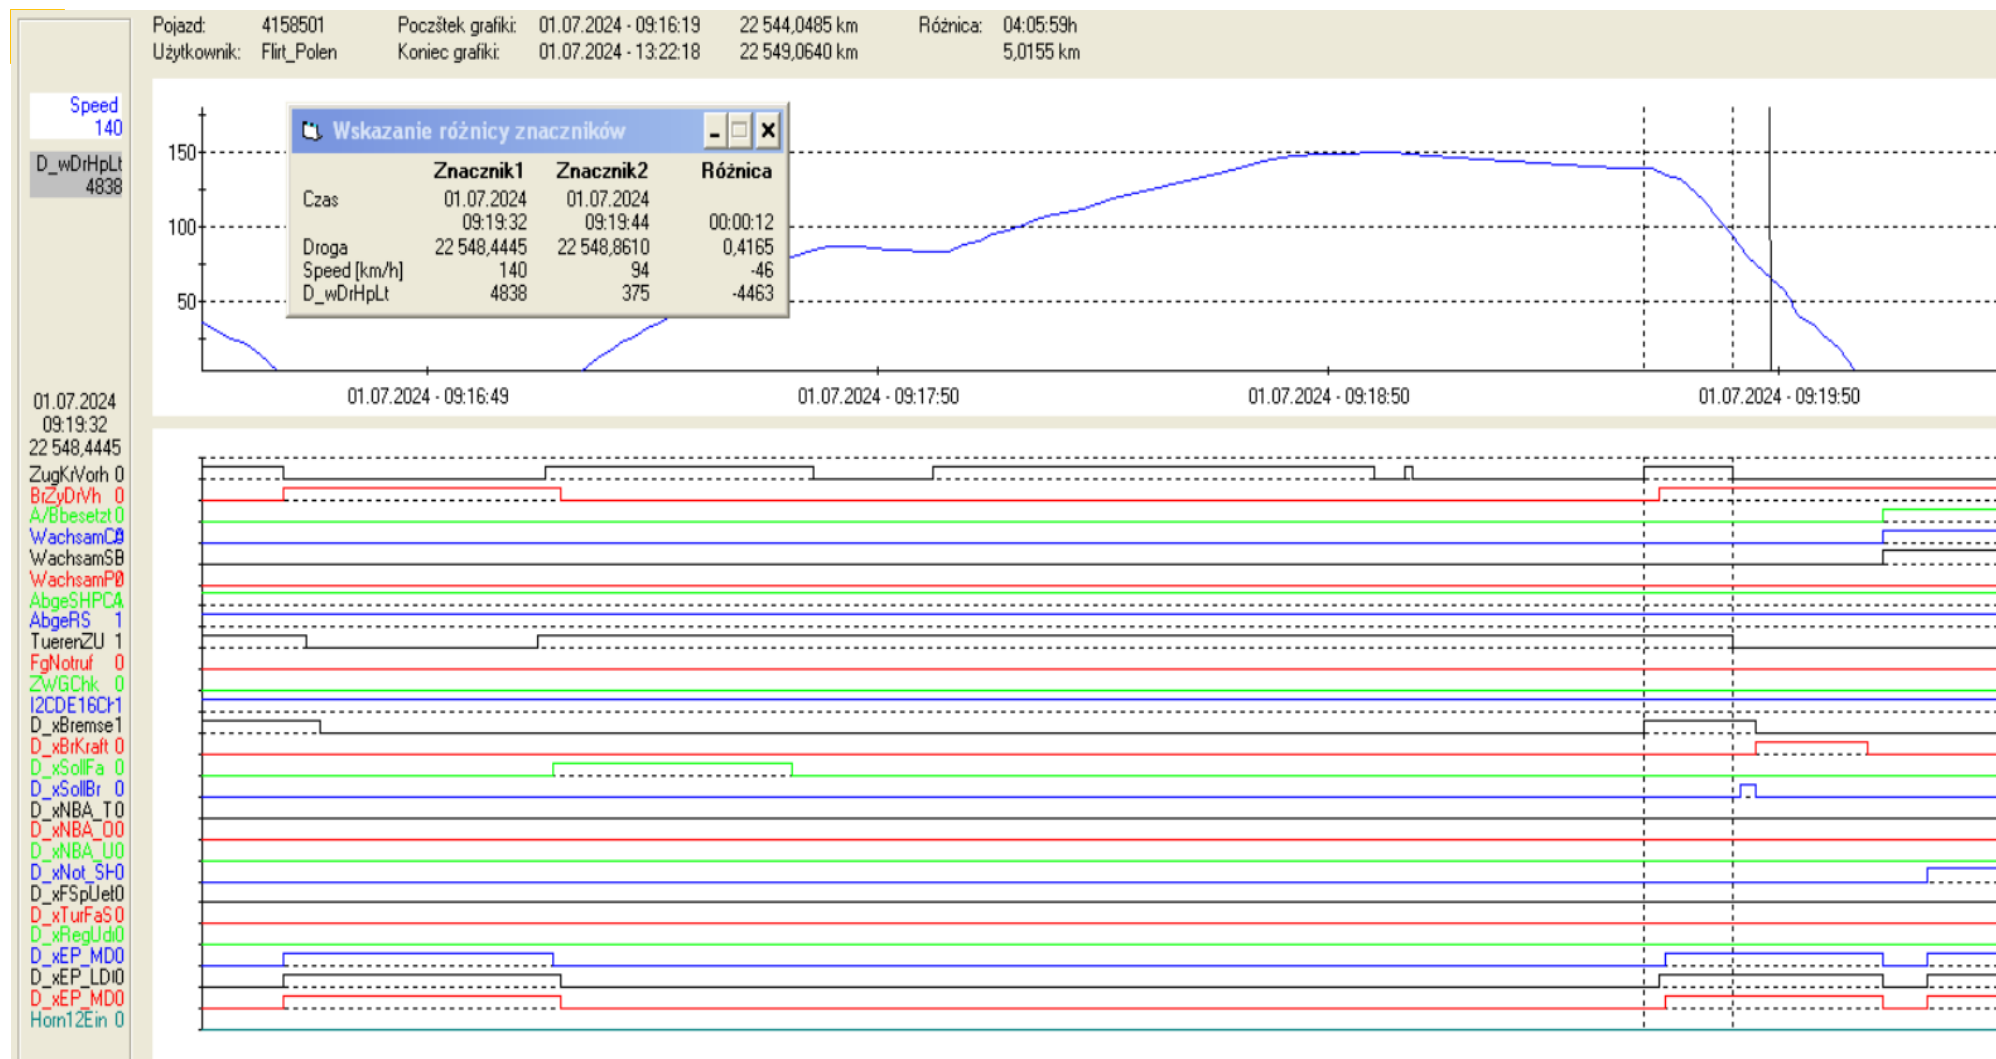
Figure 4 - Diagram of the train parameters from the Plochocin passenger stop

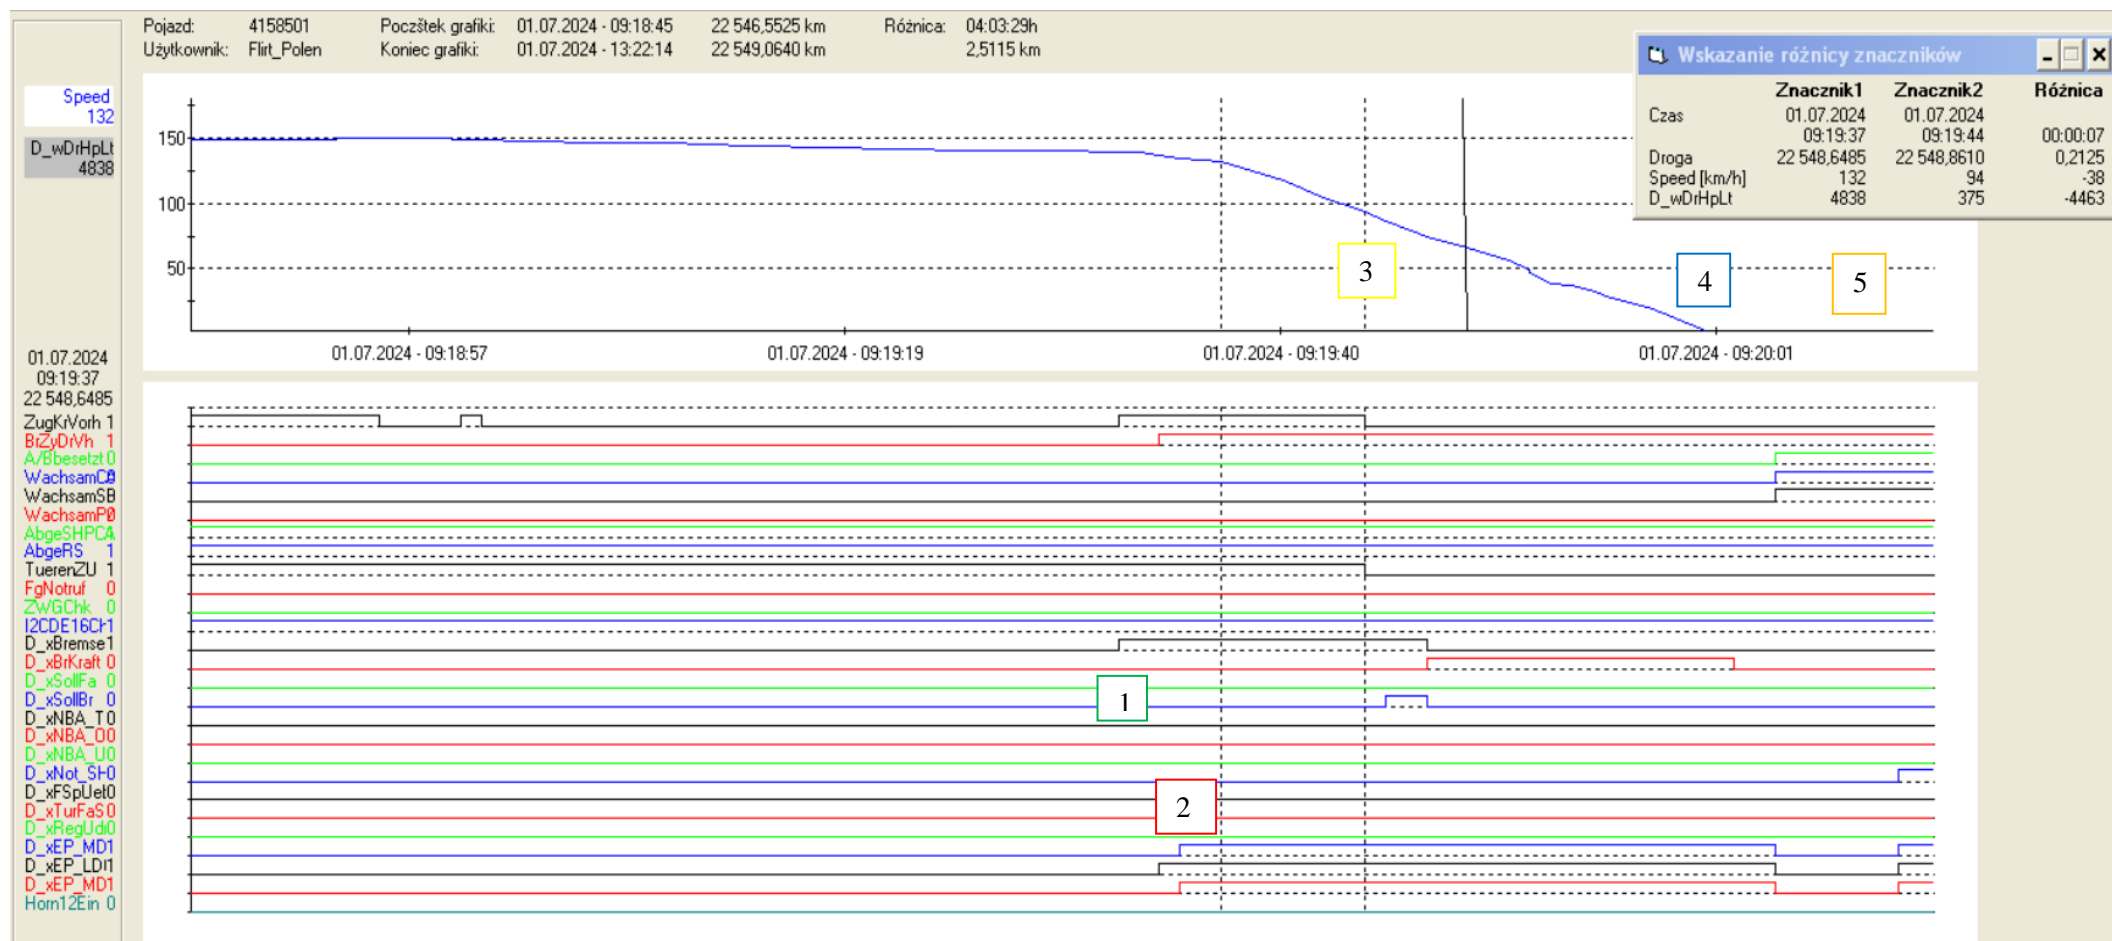
Figure 5 -Diagram of the train parameters - the last phase prior to the occurrence
