REPUBLIC OF SERBIA  
CENTER FOR INVESTIGATION OF ACCIDENTS IN TRANSPORT  
SECTOR FOR INVESTIGATION OF ACCIDENTS IN RAILWAY TRAFFIC  
Nemanjina 11, 11000 Belgrade

## FINAL REPORT ON ACCIDENT INVESTIGATION

Accident type: Train collision

Location: Belgrade, Vračar tunnel, between the station Vukov Spomenik and Pančevački Most junction and halt.

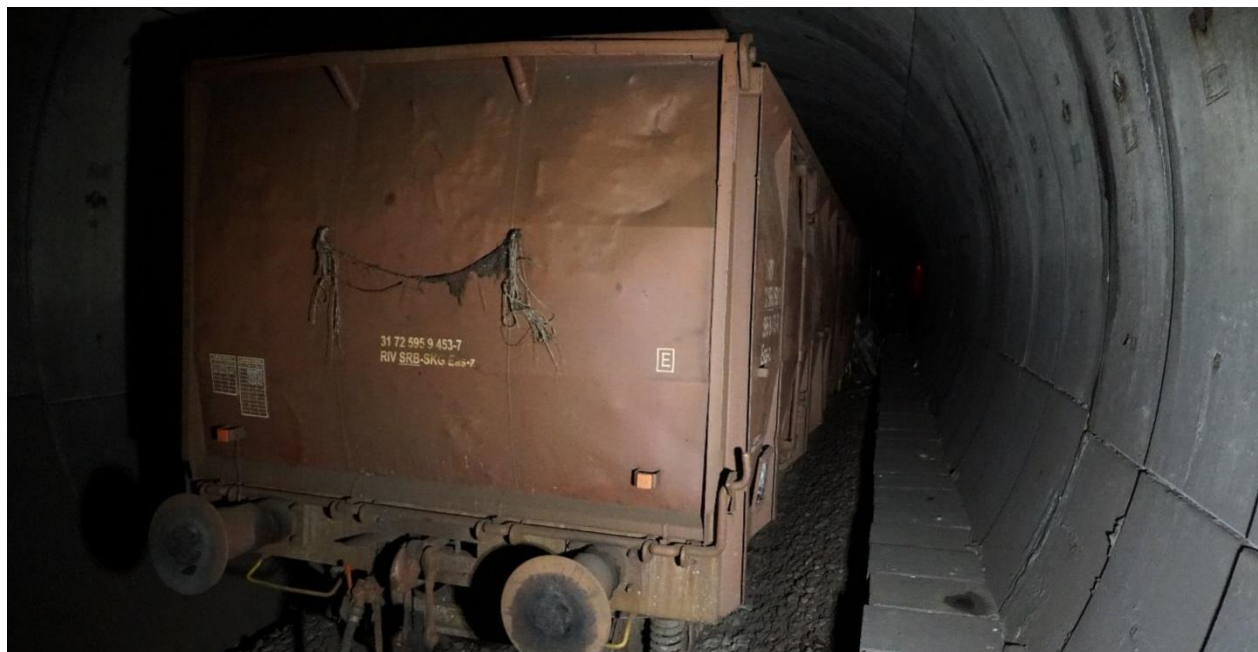
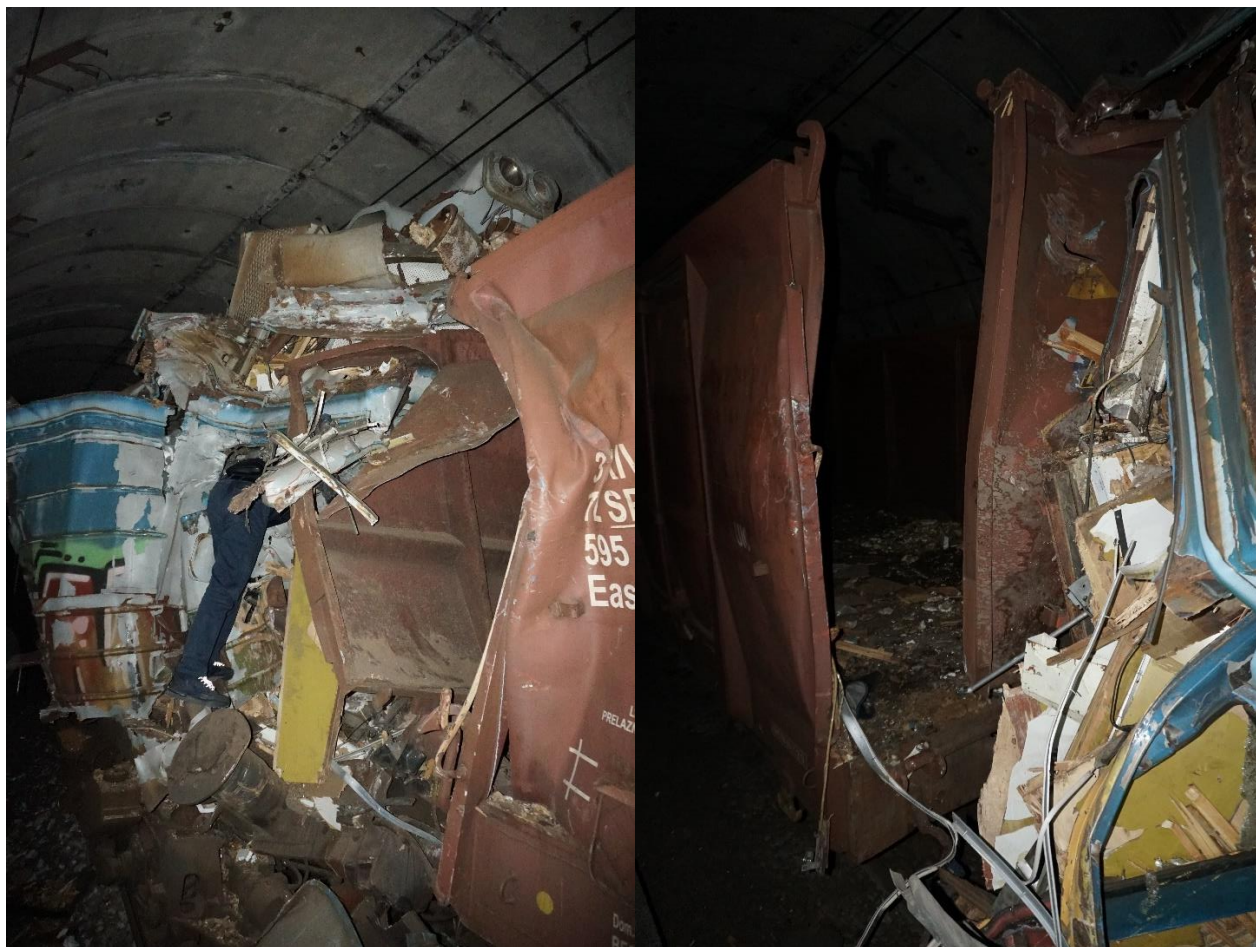
**Figure 3.4.4.1:** Appearance of the wagon No. 31 72 5959 453-7 in the train No. 52601 after the accident

**Figure 3.4.4.2:** Appearance of the wagon No. 31 72 5959 453-7 in the train No. 52601 after the accident

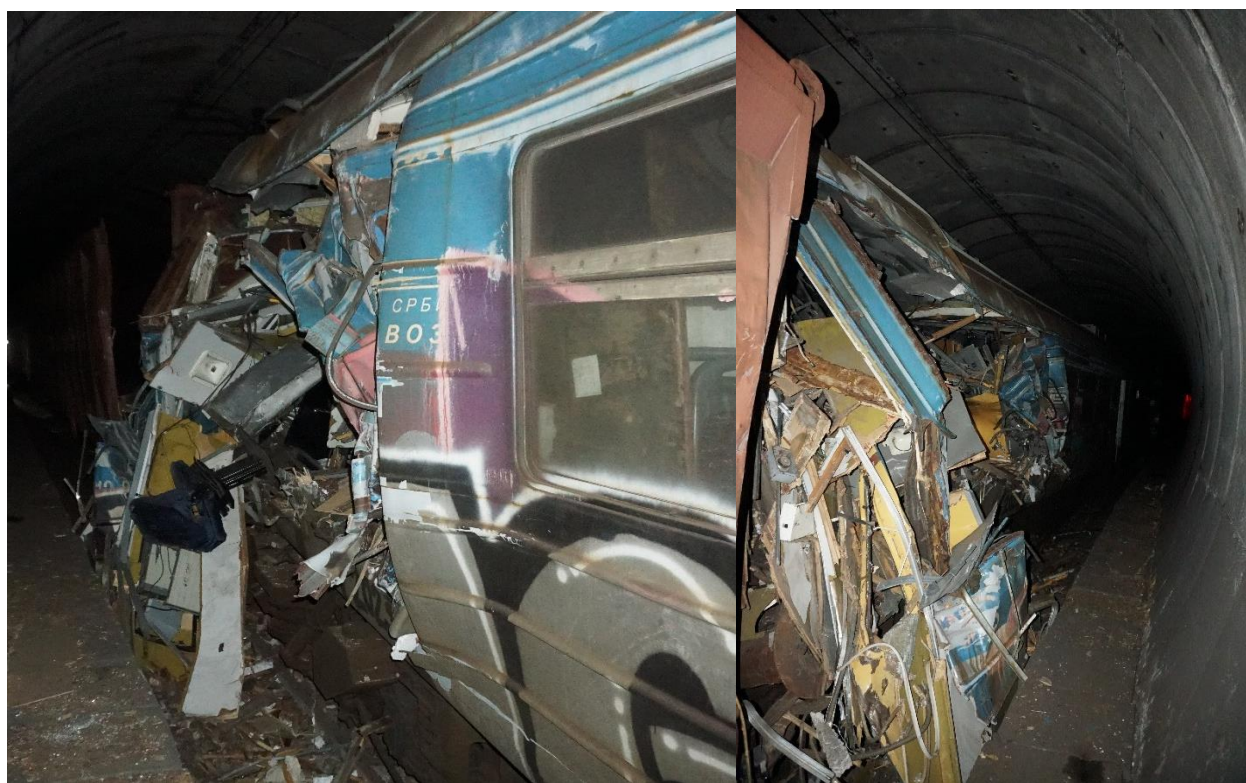
**Figure 3.4.4.3:** Exterior view of the motor coach 412-005 of the train No. 7112 after the accident.

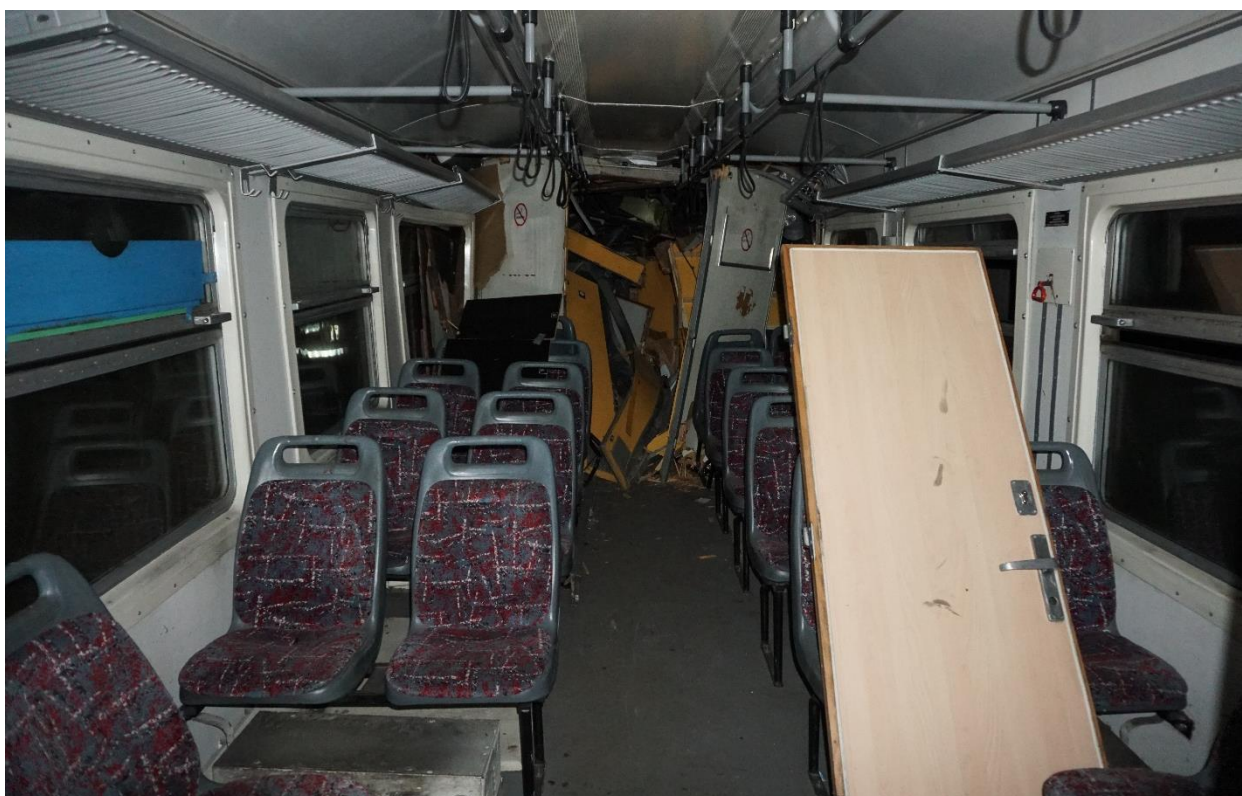
**Figure 3.4.4.4:** View of the passenger compartment of the motor coach 412-005 of the train No 7112 after the accident

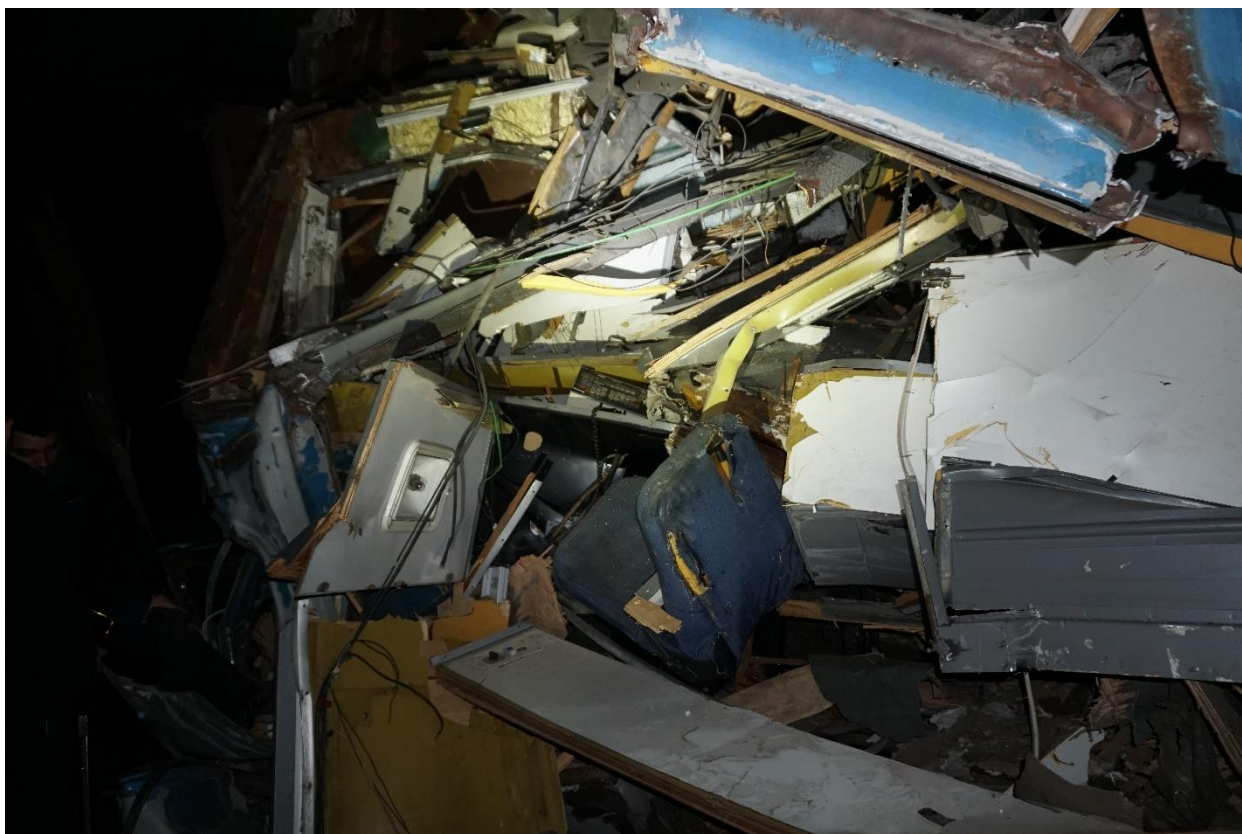
**Figure 3.4.4.5:** View of the driver's cab of the motor coach 412-005 of the train No. 7112 after the accident

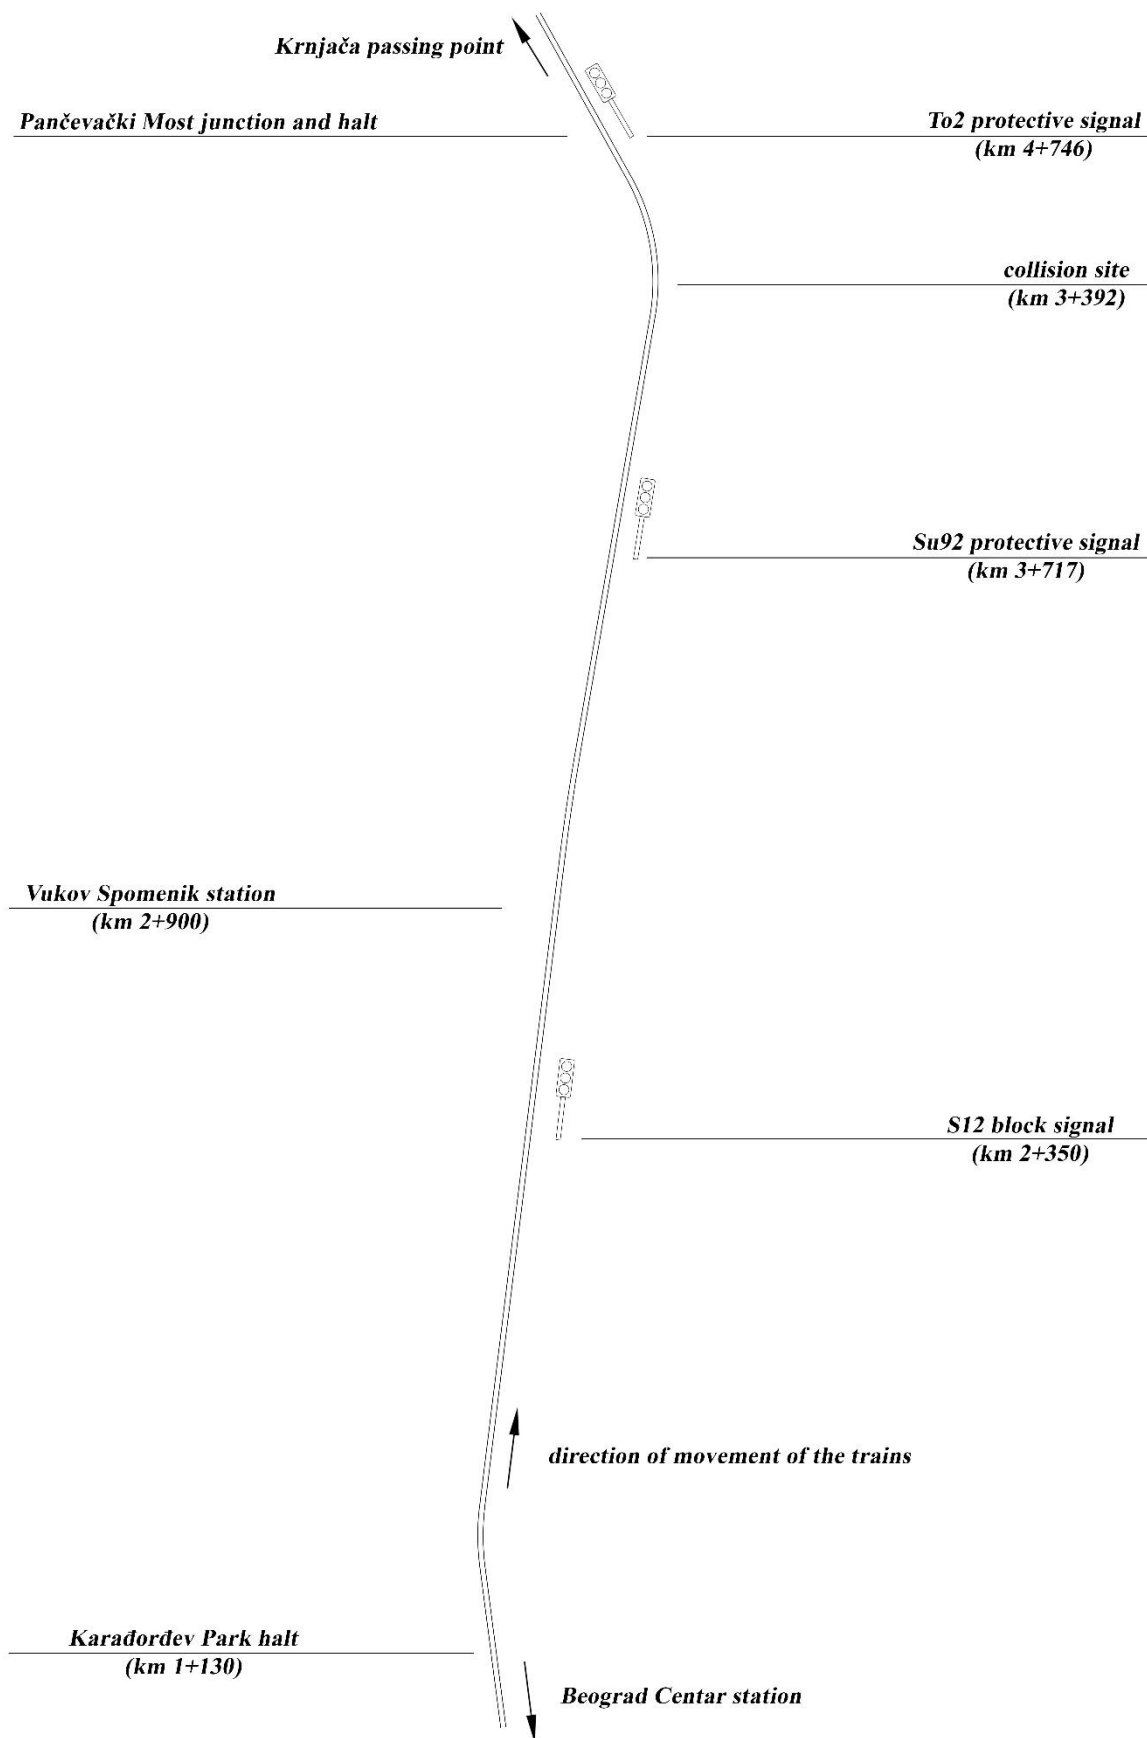
Figure 4.1.1: sketch of the accident

After the collision, due to the action of the kinetic energy of the train No. 7112 (which was moving), the train No. 52601 (which was stationary) moved from its place and continued moving for a length of approximately 10 m. On this occasion, the front part of the body of the motor coach 412-005 was deformed in the area of the driver's cab and passenger compartment, and the deformation of the wagon No. 31 72 5959 453-7 occurred. Motor coach 412-005 derailed with both bogies.

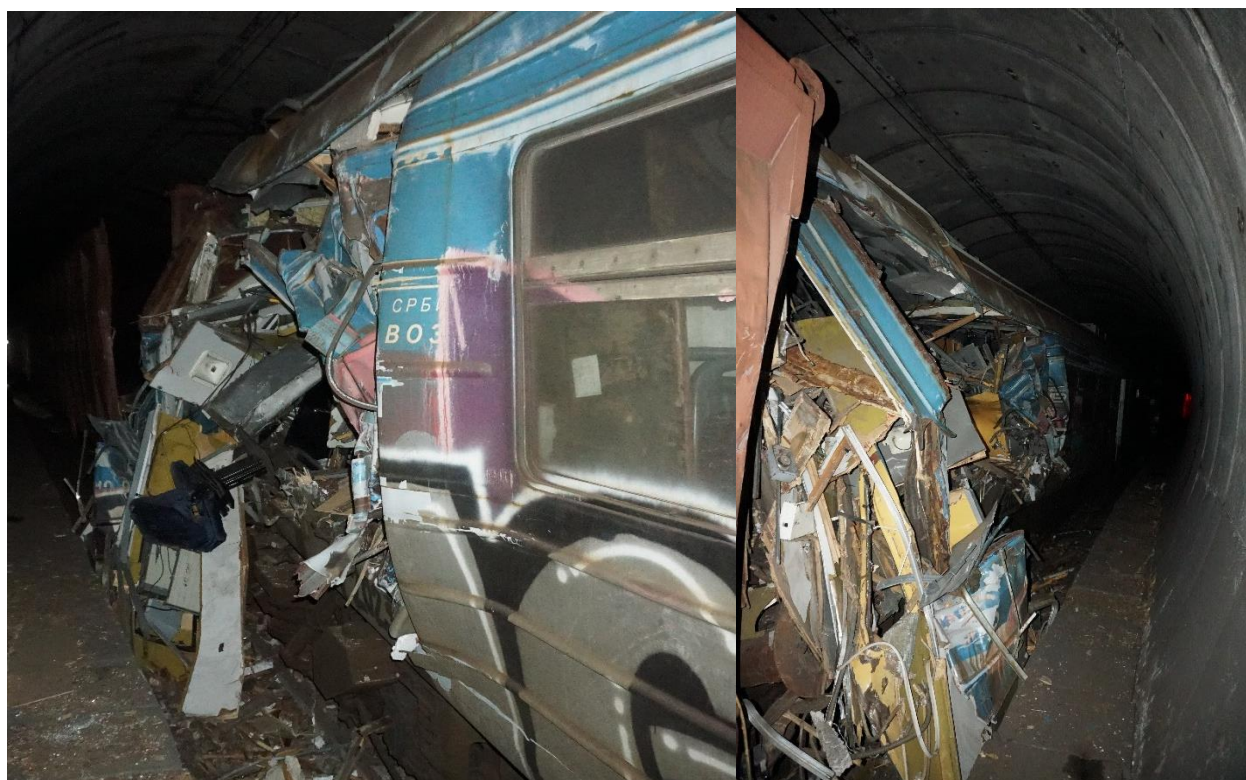
**Figure 4.1.2:** Appearance of damage to the front of the motor coach 412-005 of the train No. 7112 after the accident

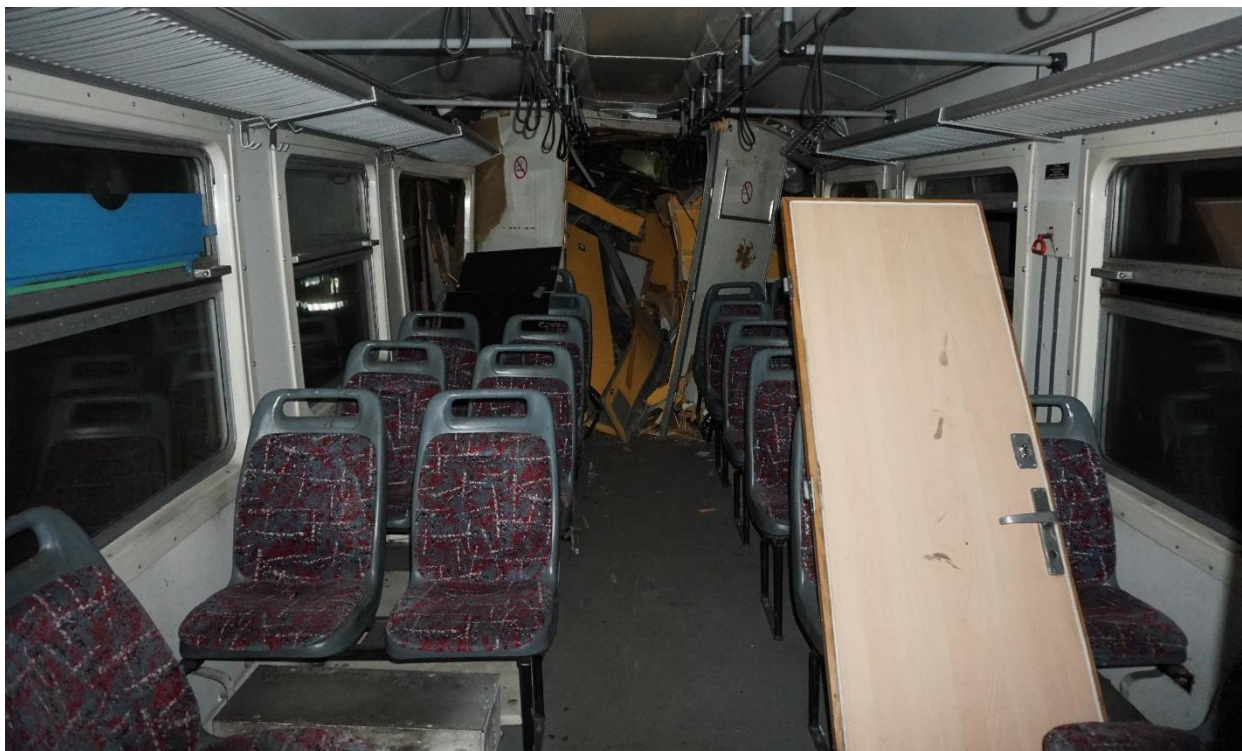
**Figure 4.1.3:** Appearance of deformations in the passenger compartment of the motor coach 412-005 of the train No. 7112 after the accident

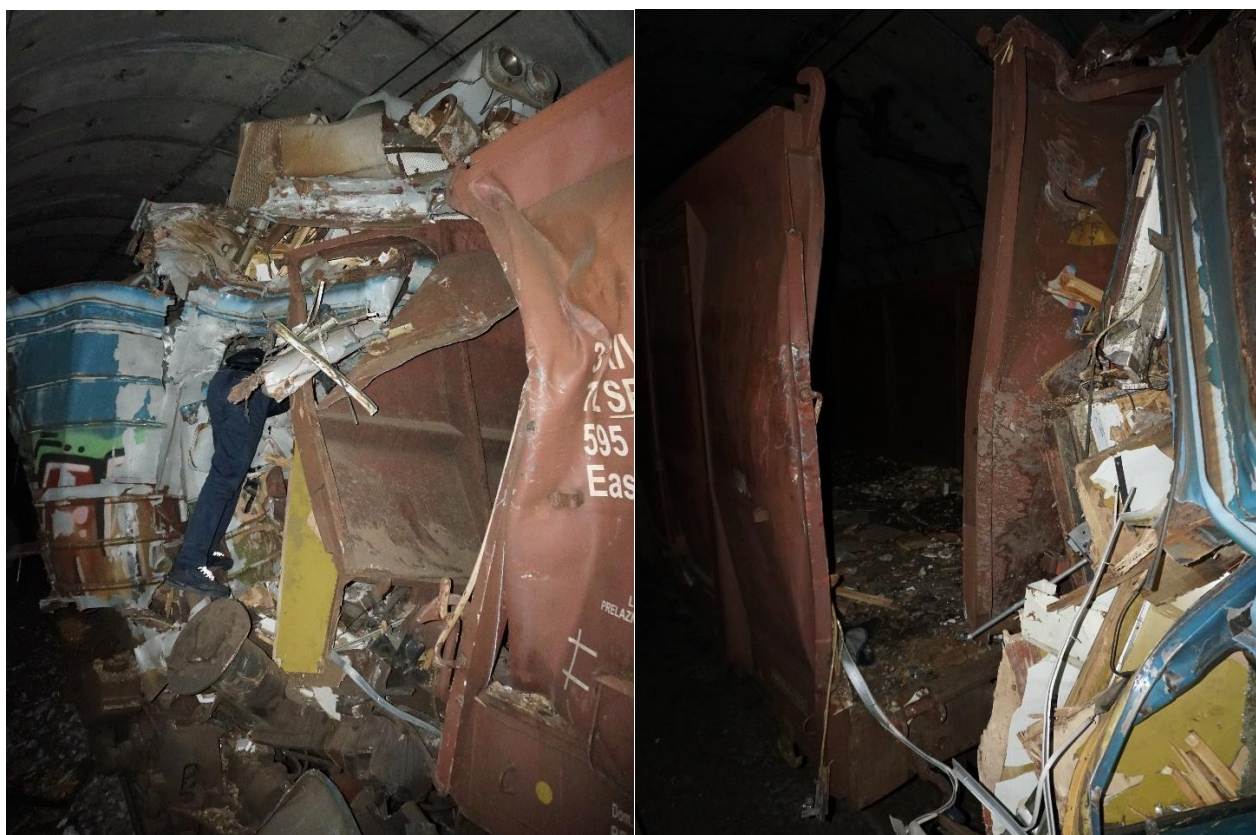
**Figure 4.1.4:** Appearance of deformation of the wagon No. 31 72 5959 453-7 of the train No. 52601 after the accident

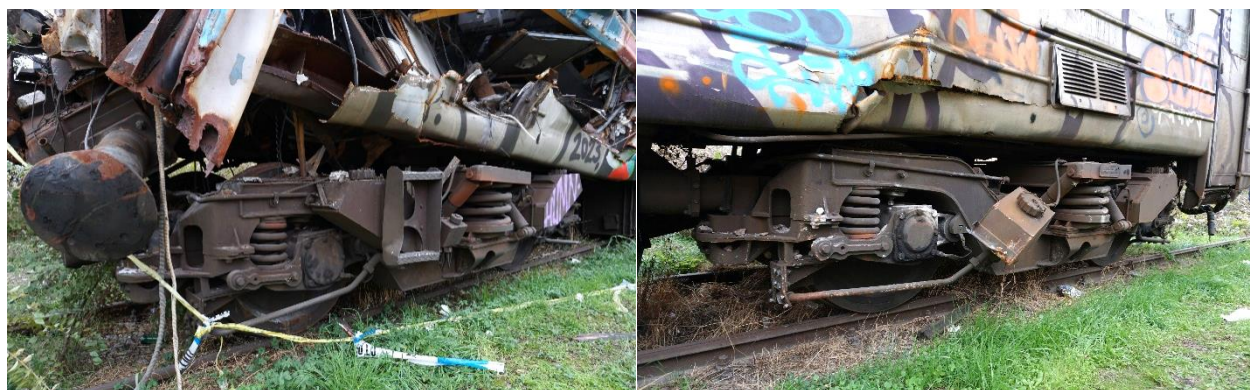
**Figure 4.2.5.2:** Appearance of damage to the bogies of of the motor coach 412-005

A visual inspection revealed that all vital subassemblies under the coach body were in place. Significant damage was observed on the subassemblies (front bogie, electrical and air equipment, front traction and buffer equipment), which occurred as a result of the accident. Vital brake parts (direct and indirect brake, aerial conductors, block cylinders with and without parking brake and compressed air reservoirs) are present and significantly damaged.

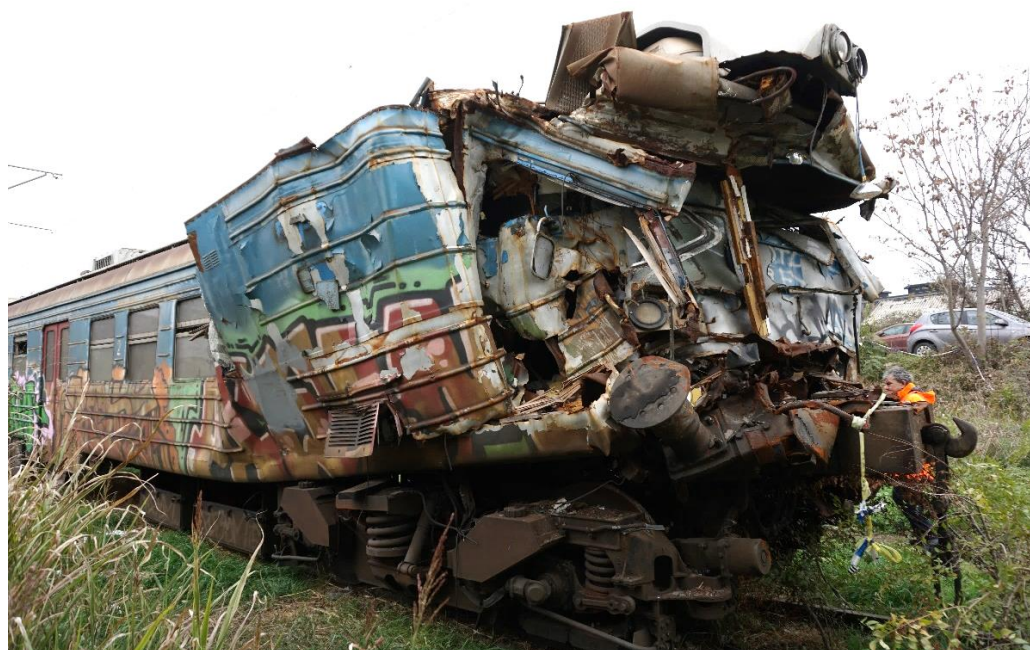
**Figure 4.2.5.3:** Appearance of damage to the front of the motor coach 412-005

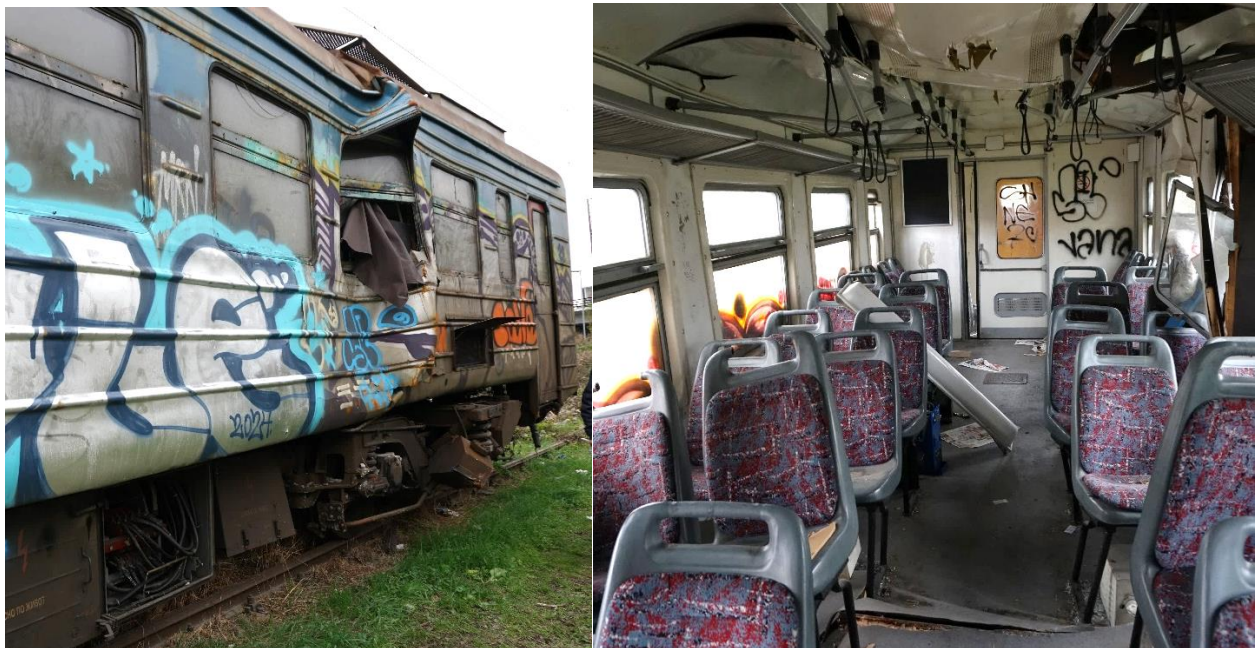
**Figure 4.2.5.4:** Appearance of damage to the body of the motor coach 412-005

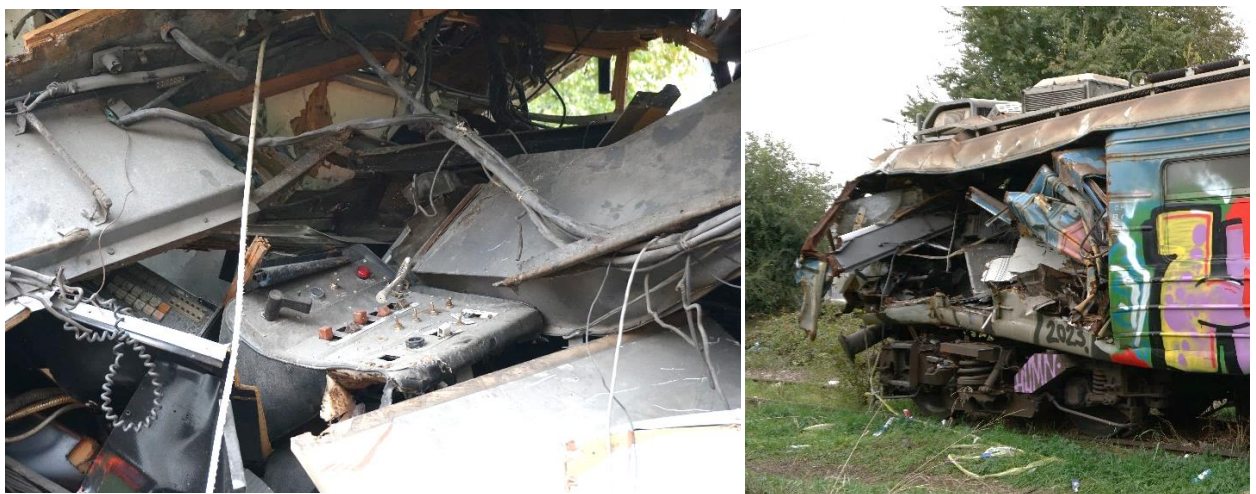
Significant damage was observed on the motor coach body and the front of the motor coach in the drivers cab area (see Figure 4.2.5.5.). Light and sound signaling devices, interior drivers cab, vigilance control, radio dispatch device, locomotive part of the autostop device and controller (direction of travel and traction/electric braking) are present and significantly damaged.

**Figure 4.2.5.5:** Appearance of the driver's cab of the motor coach 412-005

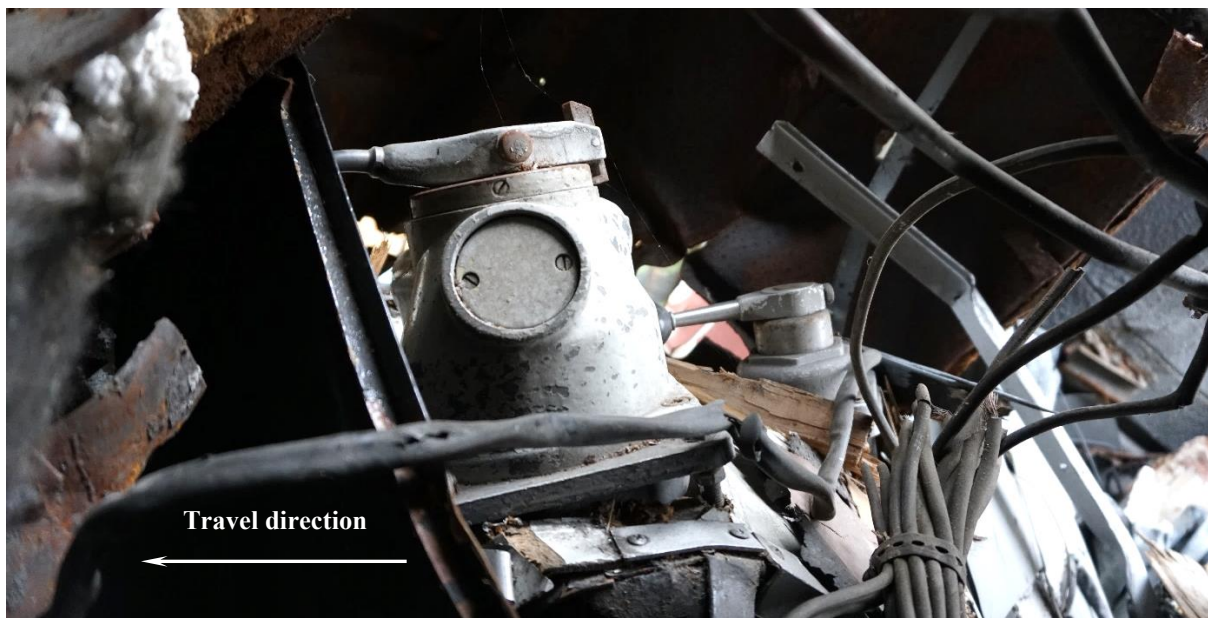
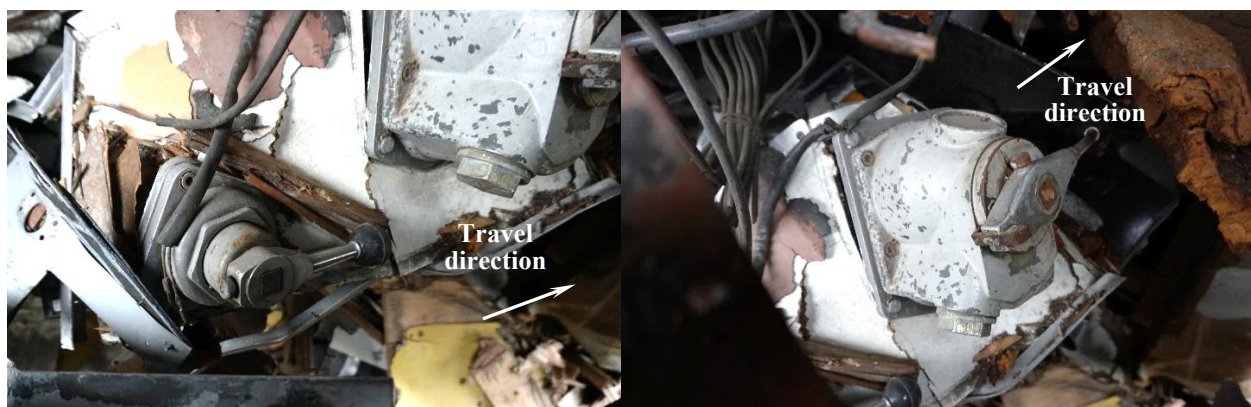
Also, upon inspection on site, the handles of both driver's automatic brake valves (direct and indirect) were found in the "release" position (see figures 4.2.5.6. and 4.2.5.7.), and the direction controller was in the forward position.

**Figure 4.2.5.6:** Appearance of the driver's automatic brake valve in the driver's cab of the motor coach 412-005

**Figure 4.2.5.7:** Appearance of the driver's automatic brake valve of the direct brake (left) and of the indirect brake (right) in the driver's cab of the motor coach 412-005

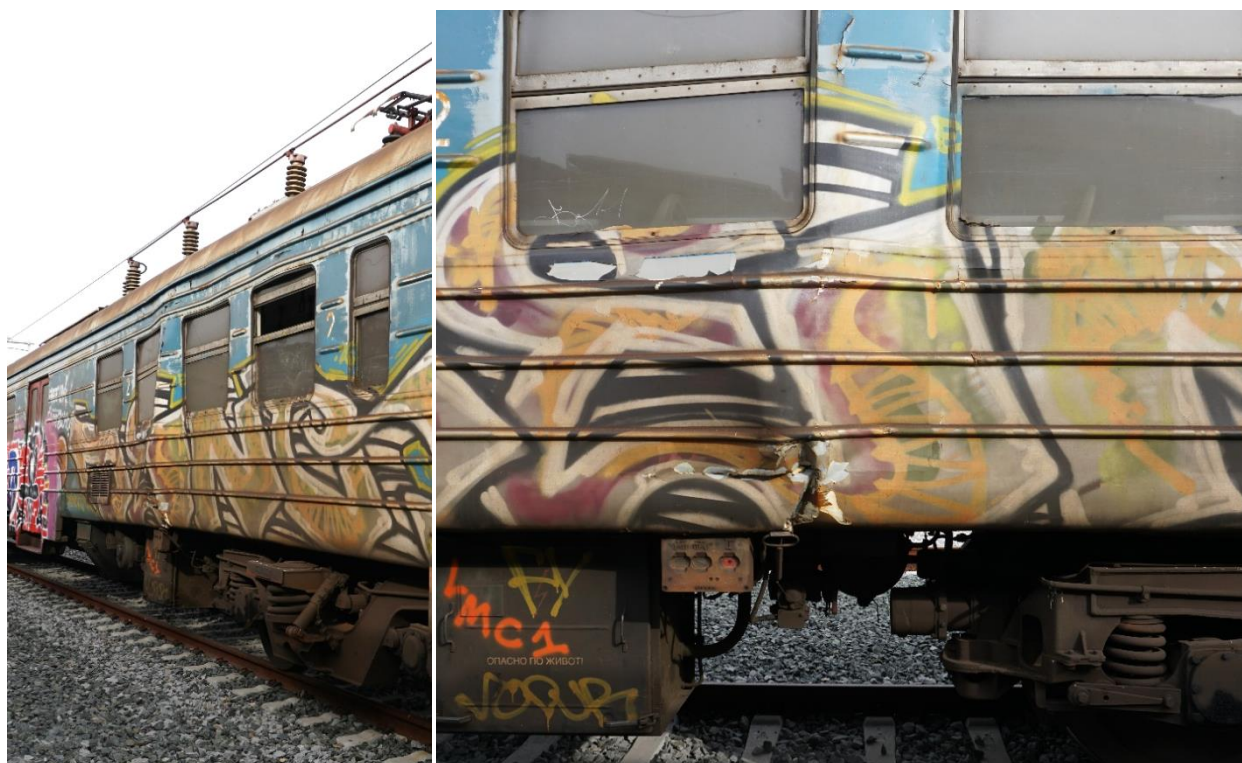
A visual inspection of the trailer vehicles 416-013 and 416-095 and motor coach 412-032 found that the two trailer vehicles and the motor coach are complete. All parts of the subassemblies are present in their places. The bogies are in good condition with the presence of deformations resulting from the accident (on the motor coach 412-032, the shunter's poles are bent and damage was observed on the body of the trailer vehicles 416-013, see pictures 4.2.5.11, 4.2.5.12. and 4.2.5.13.).

**Figure 4.2.5.13:** Appearance of the damage on the body of the trailer vehicle 416-013
