**REPUBLIC OF BULGARIA**  
**NATIONAL AIR, MARITIME AND RAILWAY TRANSPORT,**  
**ACCIDENTS INVESTIGATION BOARD**  
**(NAMRTAIB)**

**FINAL REPORT**

**investigation of significant accident – front collision of shunting train № 30802 with direct freight train № 30595 along Kremikovtsi- Svetovrachane interstation on 15.01.2025**

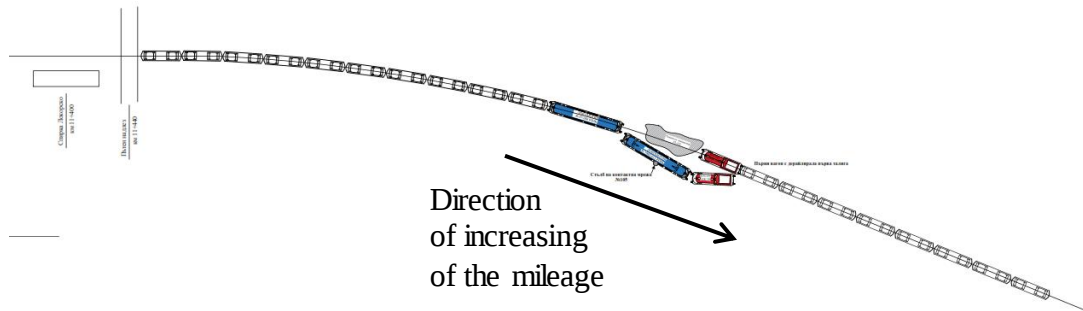
- As a result of the collision, the two leading locomotives No. 91521080013-1 of DFT No. 30595 and 98520055155-6 of ST No. 30802 rose into the air, then tilted to the right (as viewed in the direction of the mileage, i.e. the movement of DFT No. 30595) and fell to the ground outside the gauge of the railway track (Fig. 4.9);

**Fig. 4.9. Scheme of the place of the accident – collision of DFT № 30595 with ST № 30802 at km 11+949 along Svetovrachane-Kremikovtsi interstation.**

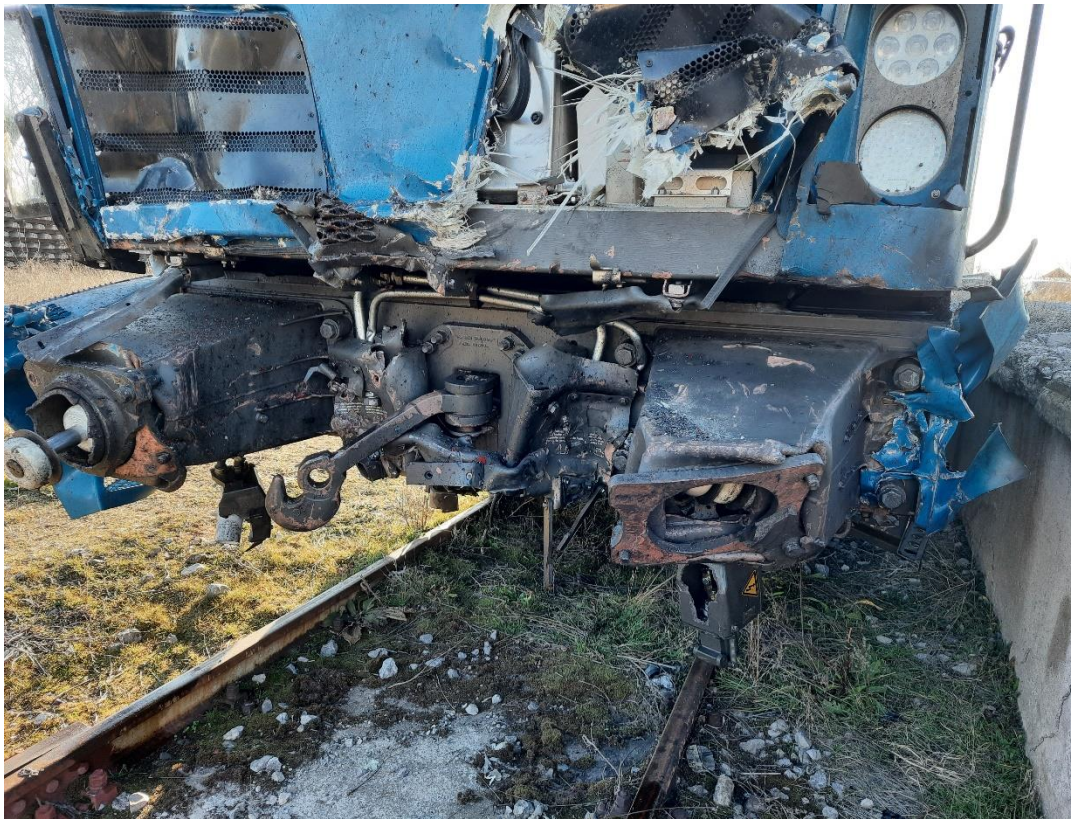
**Fig. 4.10.**

Locomotive No.91521080013-1 was deformed in the front in the area of the buffers, which were completely destroyed, absorbing a large part of the collision energy (Fig. 4.10). The cladding of the front wall of the front cabin was deformed and torn in places, as were the broken but intact windshields of the cabin (Fig. 4.11).

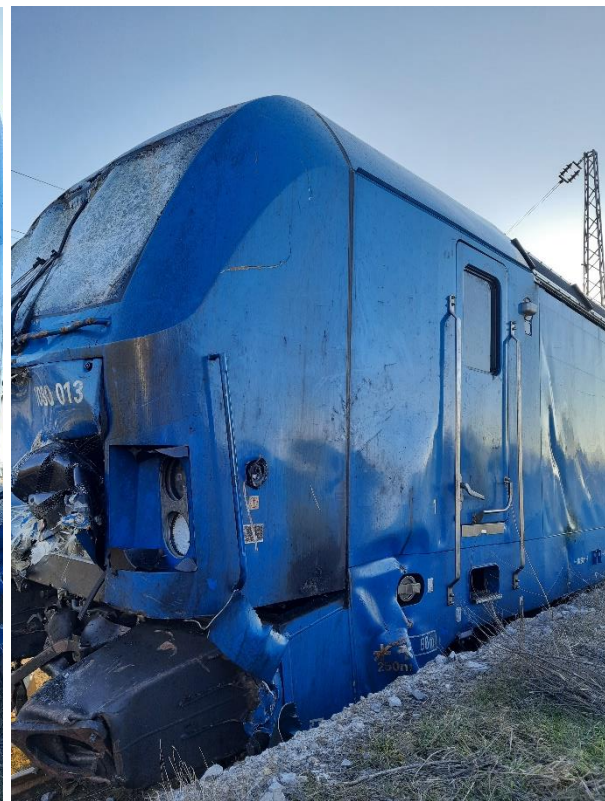
**Fig. 4.12.**

- There are observed slight deformations on the sidewalls of the locomotive bodysell behind the front (first) cabin (fig. 4.12).

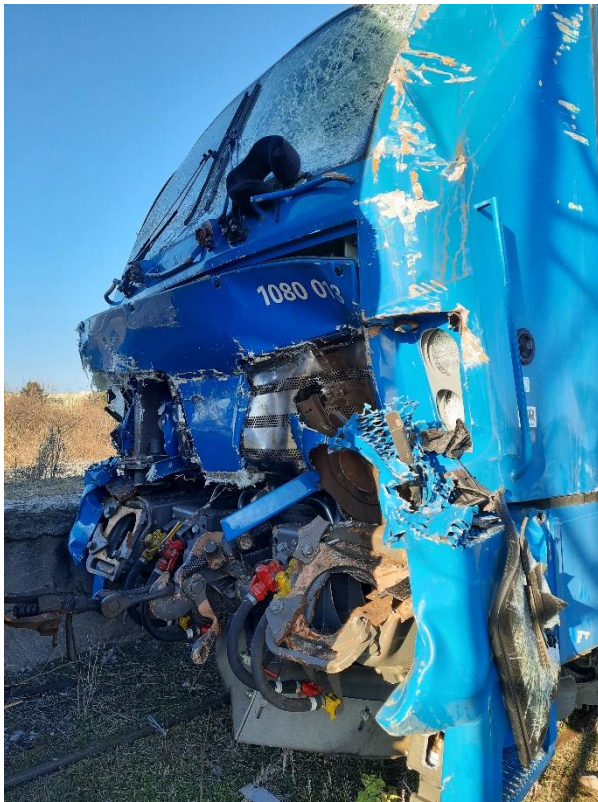
**Fig. 4.13.**

- The damages from the rear part of the cabin of locomotive № 91521080013-1 are almost identical (fig. 4.13).

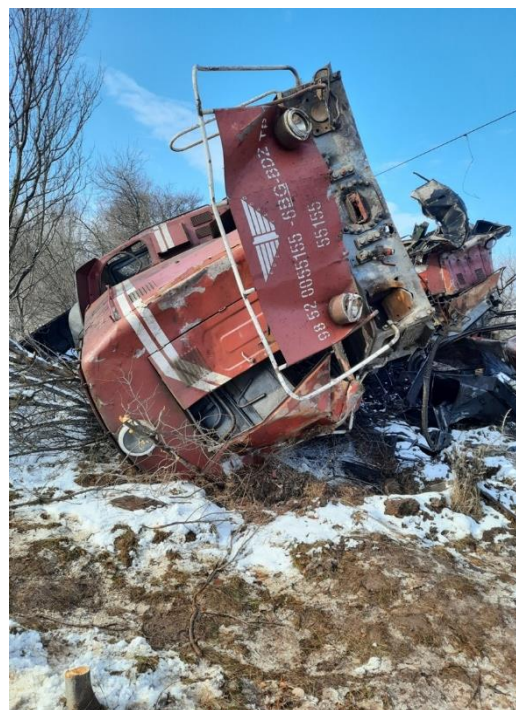
**Fig. 4.16.**

- Locomotive № 98520055155-6 fell on its left side in the movement direction after the clearance of the rail track with totally deformed bodyshell (fig. 4.16). The bodyshell is totally separated from the bogies and together with the locomotive № 91521080013-1 fell aside from the rail track (fig. 4.17), while the bogies, nevertheless the damages remained on the track (fig. 4.18). The bogies are with deformed frames, wheelset together with wheelset reducers, and the cardan shafts are separated from them, as the corpuses of the reducers are broken. Elements of the spring hanging and the lever brake system are missing and deformed (fig. 4.19).

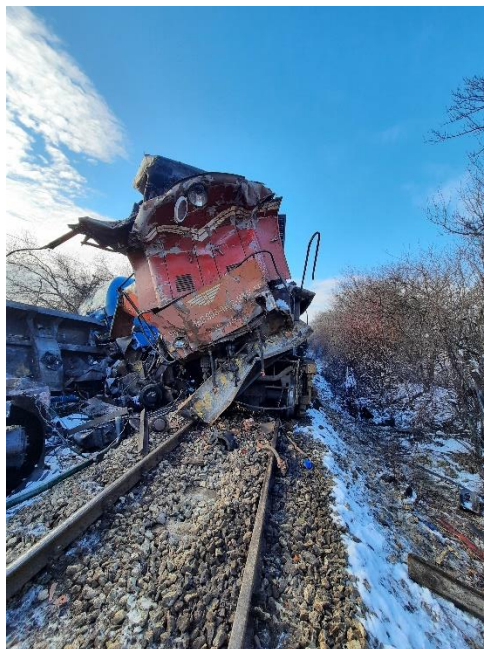
**Fig. 4.20.**

- Locomotive № 98520055093-9 is with a totally deformed bodyshell (fig. 4.20). The bodyshell is separated from the bogies, but continues to lay on them (fig. 4.21). The bogies are on the rail track. The frames of the bogies are deformed with missing and damaged elements of the traction driving, spring hanging and the lever brake system (fig. 4.22). Some of the wheelset redactors and cardan shafts are dismantled and broken (fig. 4.23). Deformed and punctured is the main fuel tank (fig. 4.24). Fire occurred in the locomotive encompassed the area of the control cabin, which is almost totally burnt outside and inside (fig. 4.25). The fire did not encompass the engine compartment where is located the diesel engine, the fuel and the oil system of the locomotive, neither the air compressor (fig. 4.26).

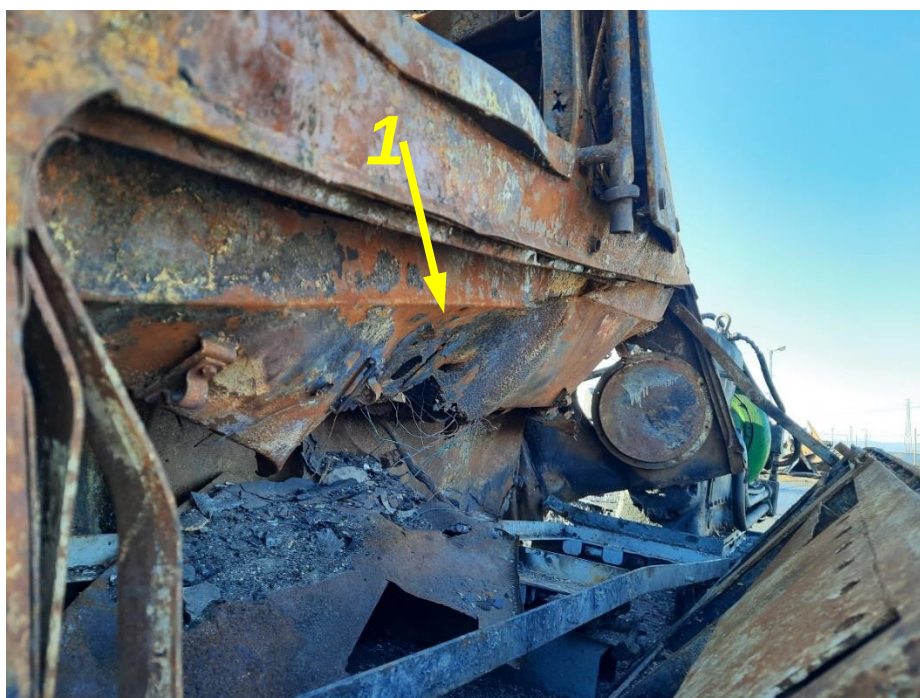
**Fig. 4.29.**

The traces of combustion indicate that the ignition started from the cavity under the control cabin, to the right in the direction of travel of ST No. 30802, where the locomotive's batteries are located (Fig. 4.29).

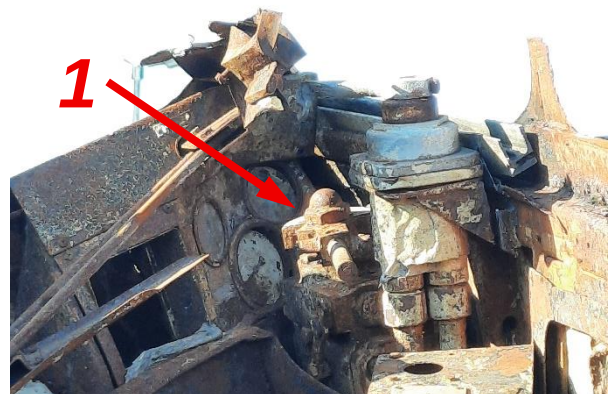
**Fig. 4.31.**

Within the inspections of the diesel locomotives, it was found that during movement, the brake valve at console No. 2 of locomotive No. 98520055093-9 (rear in the direction of movement) was set to the third insulated position, but the key was in the lock, which indicated that the brake valve was not locked in this position (Fig. 4.30, pos. 1). The locomotive driver controlled the locomotive from console

No. 1 (front in the direction of movement) and activated the automatic train brake of ST № 30802 by that brake valve (fig. 4.31, pos. 1).

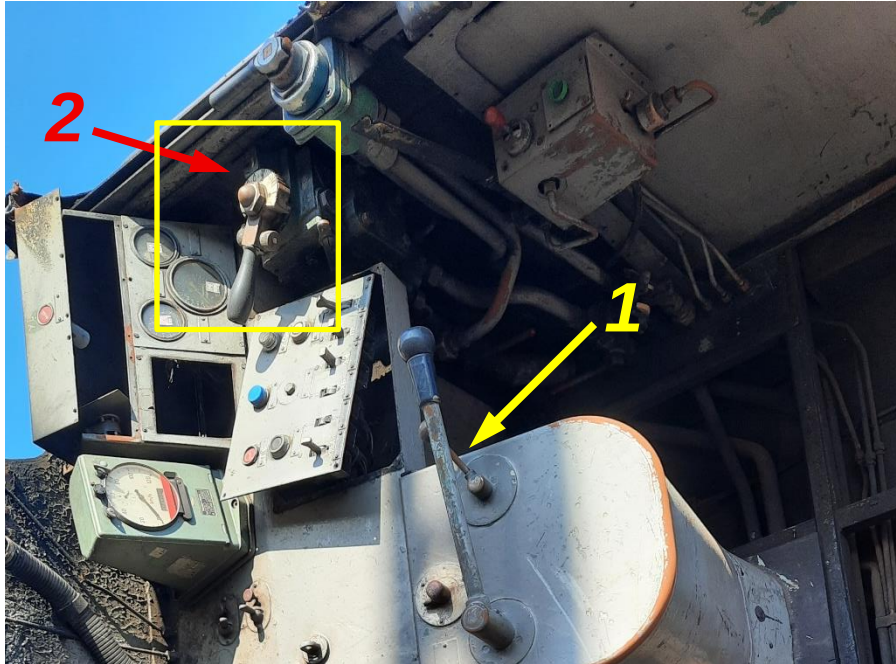
**Fig. 4.32.**

Locomotive No. 98520055155-6 has a severely deformed cab and other parts described above. During the inspection, it was found that the locomotive was controlled by console No. 1 (front in the direction of travel), evident from the position of the turn signal handle, set to the forward position (Fig. 4.32, pos. 1). At the same time, the brake valve was set to the insulated position, but the key in the lock was missing, which means that the brake valve was unlocked without a key and cannot be locked (Fig. 4.32, pos. 2), and also that the other brake valve was also unlocked and manipulations could be performed with it.

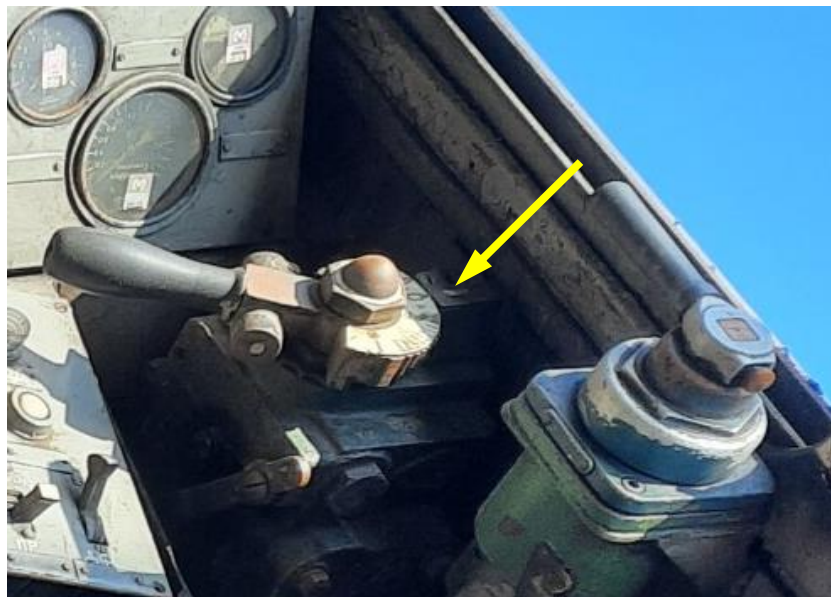
**Fig. 4.32, pos. 2. The switch shows that the brake valve for the automatic brake is on an *insulated position*.**

The observations, inspections and analyses conducted clearly show that the locomotive driver of the leading locomotive No. 98520055155-6 of ST No. 30802 did not activate the automatic train brake,
