STATE COMMISSION ON RAILWAY ACCIDENT INVESTIGATION
Ministry of Interior and Administration

REPORT No. PKBWK 7/2025

**on the investigation of a serious railway accident
that occurred on 26 November 2024 at 12:30 hrs
on the Sochaczew - Bednary route,
track no. 1, km 61.941 of railway line no. 3 Warszawa Zachodnia - Kunowice,
a Category B level crossing
the area of the infrastructure operator PKP PLK S.A., Railway Line Plant in Warsaw**

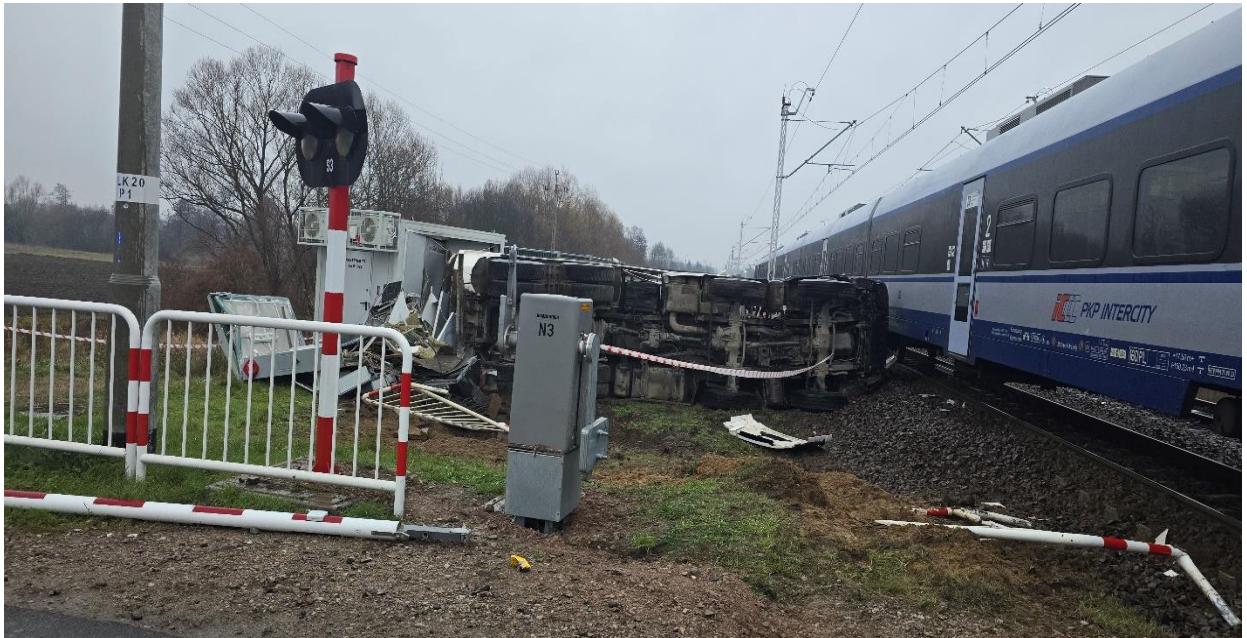
Photograph 1 – The consequences of the occurrence in the area of the crossing – damage to the infrastructure and equipment prohibiting entry to the crossing (photo by the railway commission)

- a damaged apparatus and power supply cabinet for the Automatic Crossing System equipment,
- a damaged technical container (ruptured side wall),
- broken barrier rods, 2 pcs,
- damaged prestressed concrete sleepers, 186 pcs. with attachments,
- damaged "Mirosław Ujski" type crossing slabs, 2 pcs.

During the reconstruction of the damaged crossing safety equipment, a project was developed and executed taking into account the implementation of Recommendation 2, *point 4.2 from the 2018 PKWK Annual Report*. The level crossing has been fitted with entrance barriers and the exit barriers were removed.

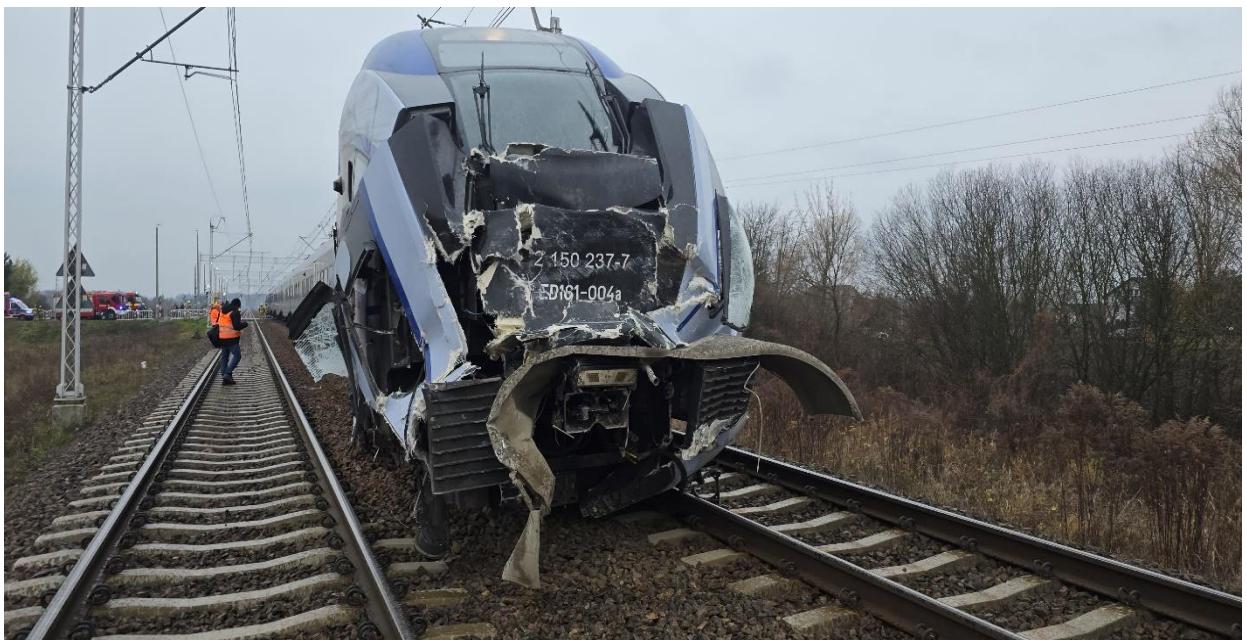
Photograph 2 – The consequences of the occurrence to the railway vehicle – damage to the cab and head of ED161- 004a (photo by the railway commission)

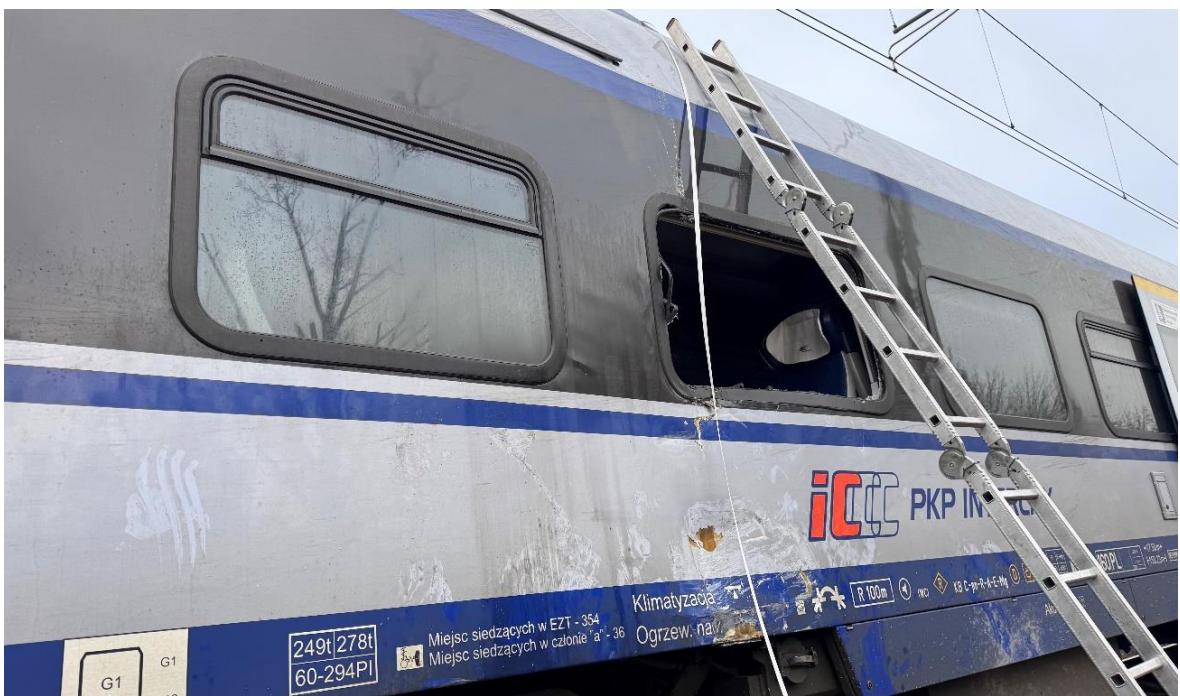
Photograph 3 – The consequences of the occurrence to the railway vehicle (photo by PKBWK)

A broken glass pane in the passenger section of the carriage on the left side of the train in the second window behind the driver's cab (photographs 3 and 4), and damaged carriage skin (photograph 3).

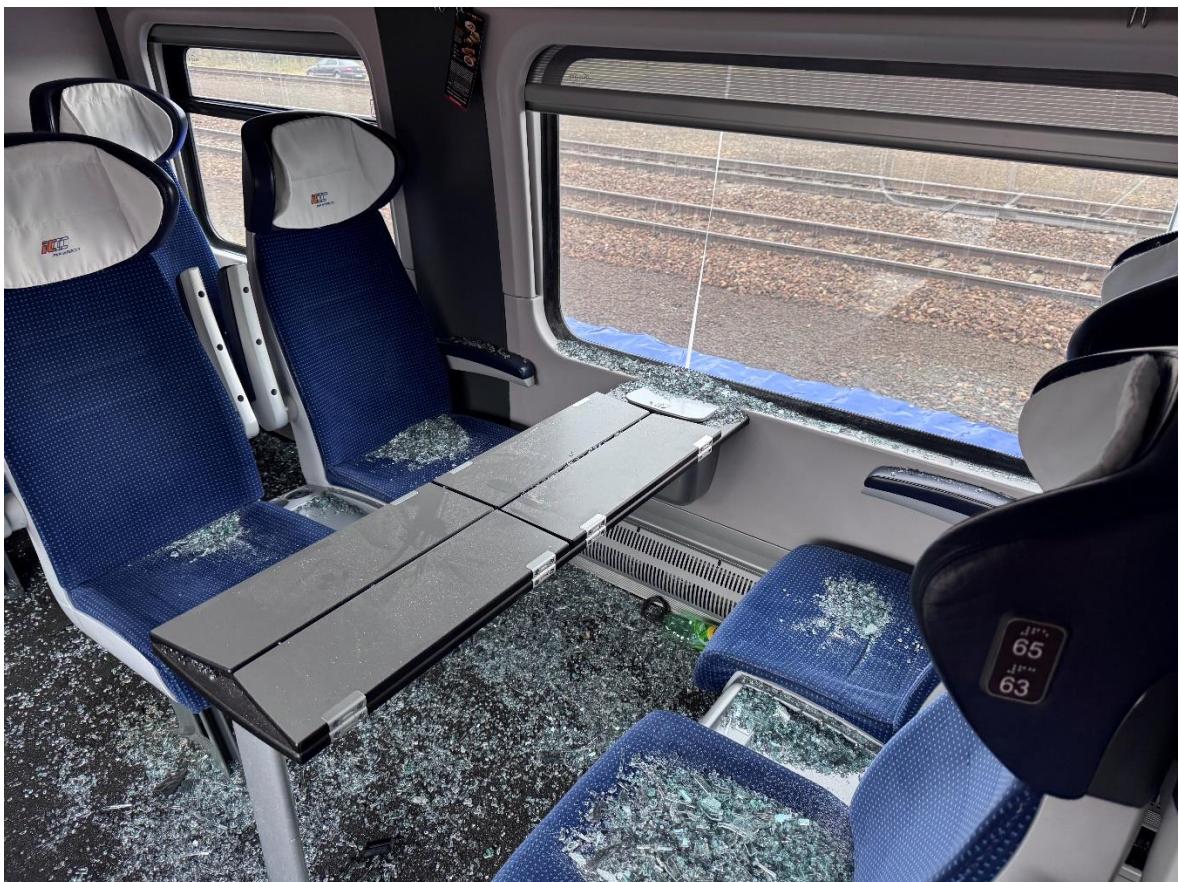
Photograph 4 – The consequences of the occurrence to the railway vehicle (photo by PKBWK)

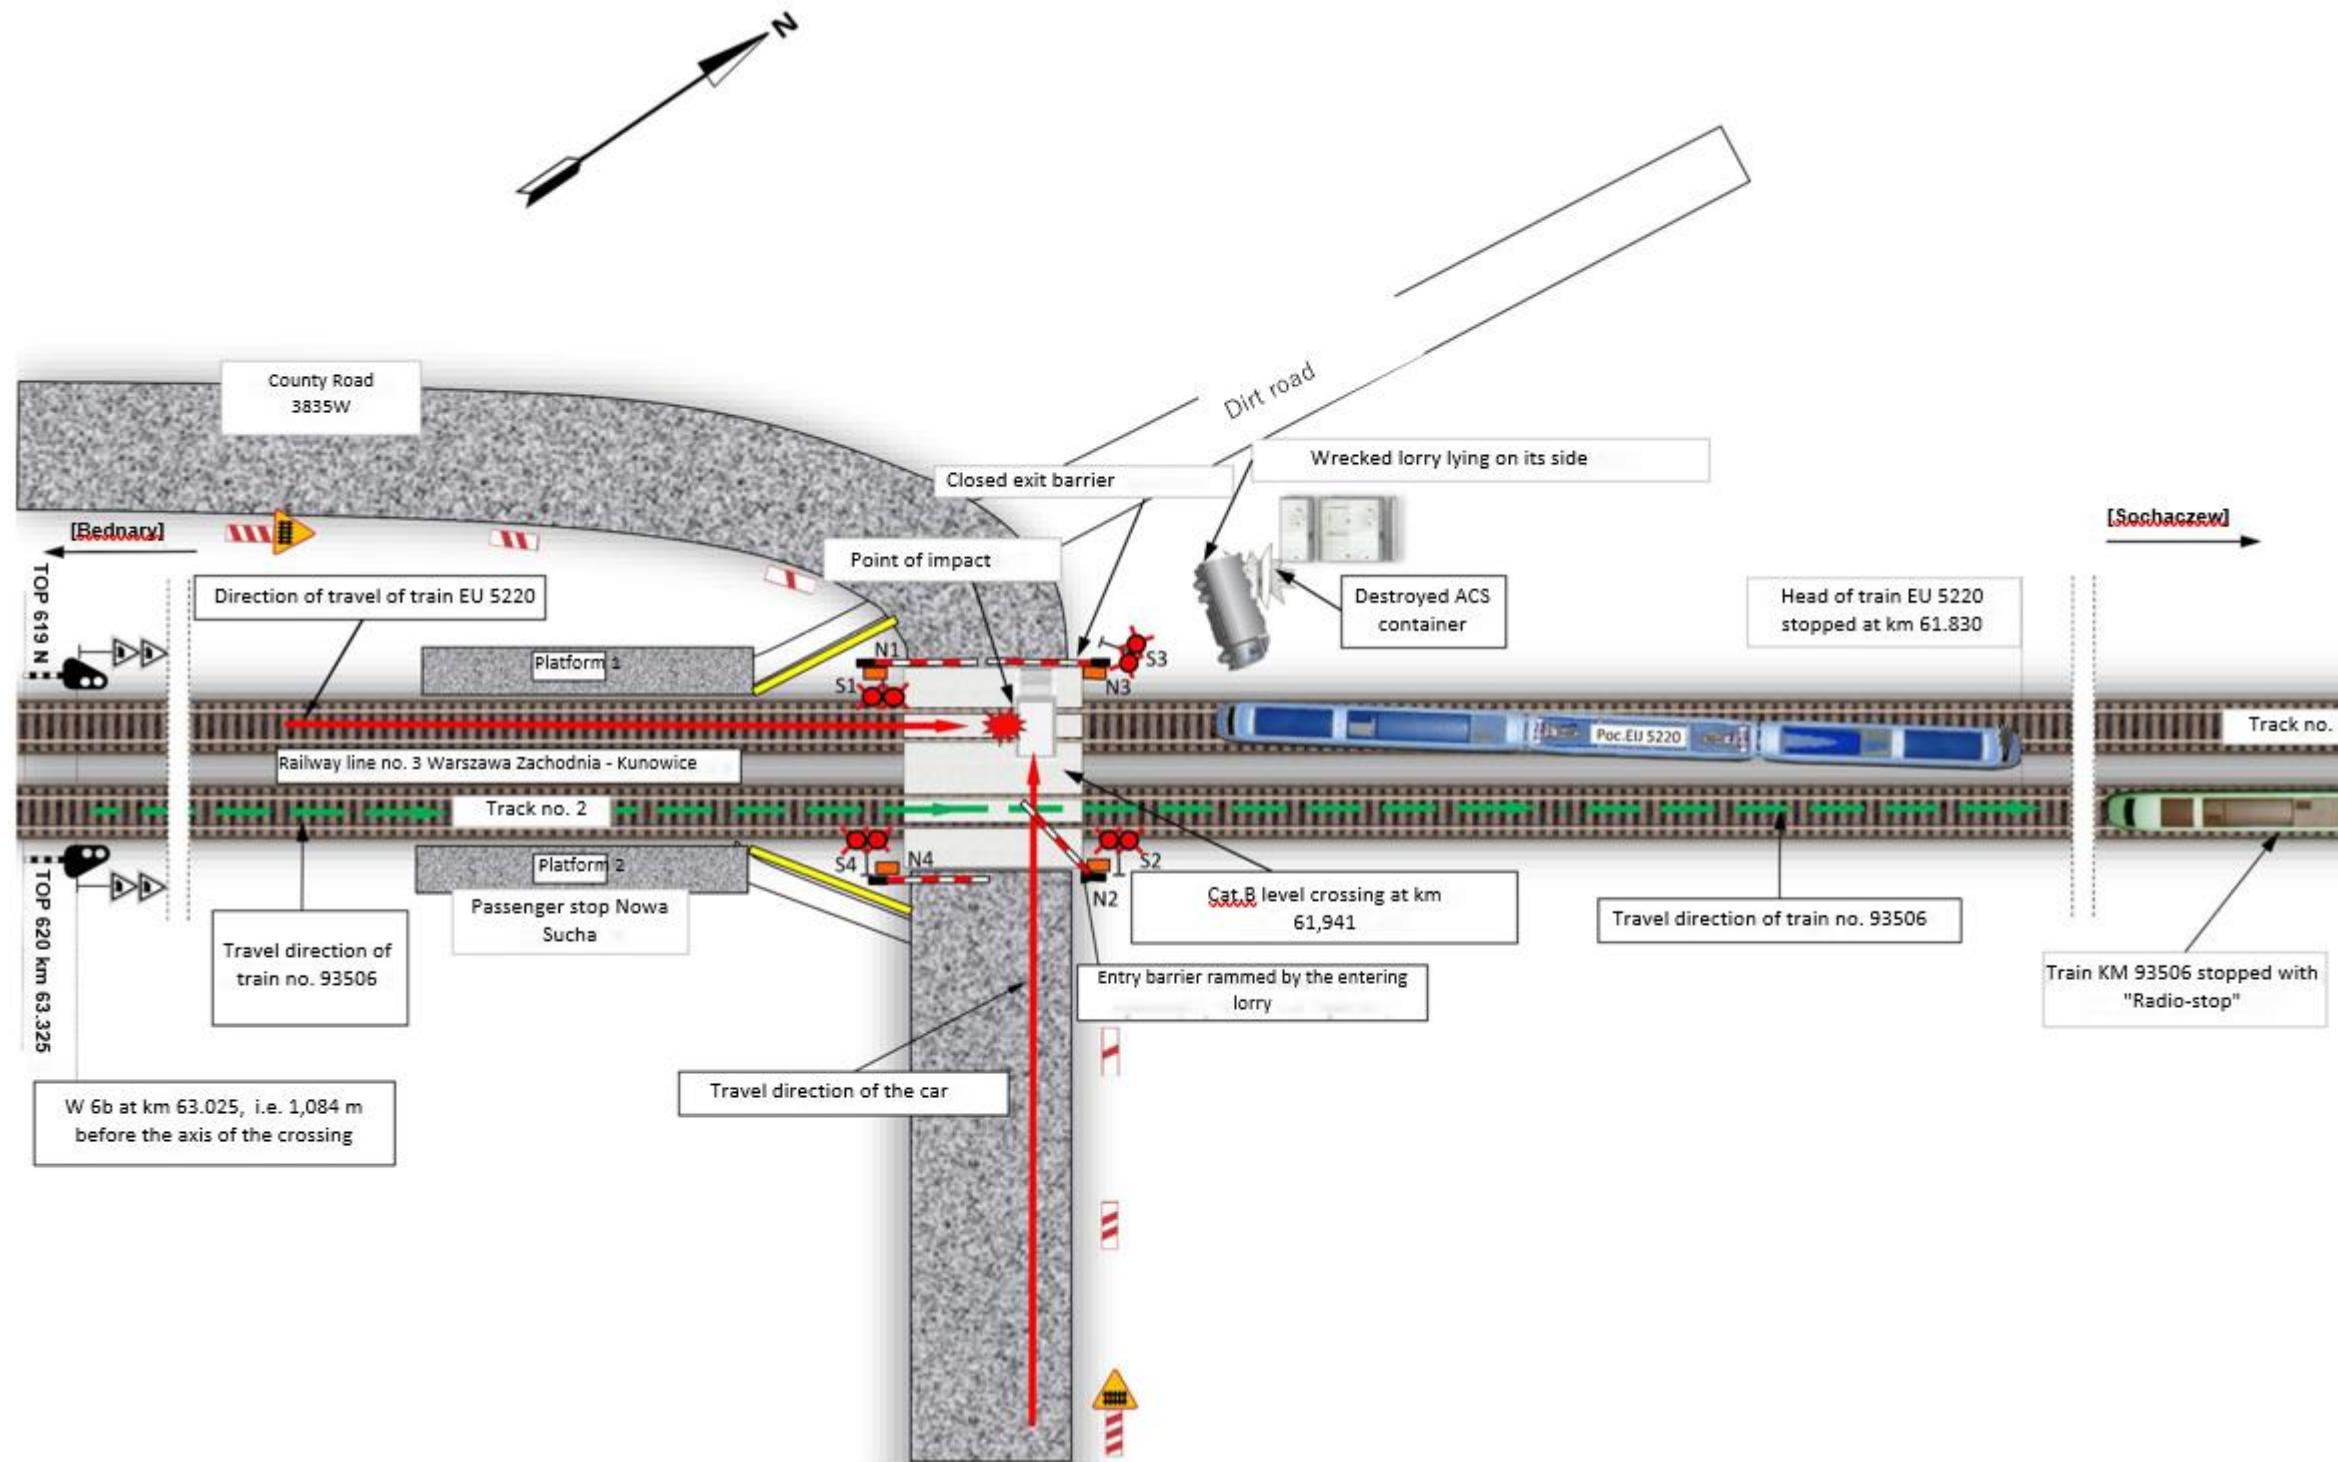
Figure 1 – A sketch of the serious accident (prepared by PKBWK)

The Cat. B level crossing where the occurrence took place is located in the town of Nowa Sucha on County Road No. 3835W. The car entered the crossing from the right side looking from the direction of the moving train. The surface of the road is mineral bitumen. The width of the roadway on the approach to the level crossing is: left side 6.5 m, right side 5.8 m. The inclination in advance of the crossing over 20 metres is: left side 1.8%, right side 1.77%. The permitted speed of road vehicles on the road in the area of the level crossing is 50 km/h. The road intersects with the railway track at a 73° angle. The area where the road intersects with the railway line is located in an urban area. The level crossing for road users has signage on both sides: warning signs A-9, indication posts on the right-hand side, G-1a, G-1b, G-1c and G-2 "Electrified overhead line" plates. Following the accident, the crossing was additionally marked with a B-20 "Stop" sign with the plate "Traffic lights out of order" due to the damage to the signalling equipment at the crossing. The lanes are separated by the double continuous line P-4, with the conditional stop line P-14 drawn on the roadway before the traffic lights. The geographical coordinates of the level crossing are as follows: 52°09'44,1"N 20°10'24,7"E. The occurrence took place in daylight with no precipitations or fog, in good visibility, ambient temperature of +6° C. No works were being carried out in the area of the crossing. The Cat. B level crossing was equipped with four traffic lights and four half-barriers (two entrance barriers and two exit barriers).

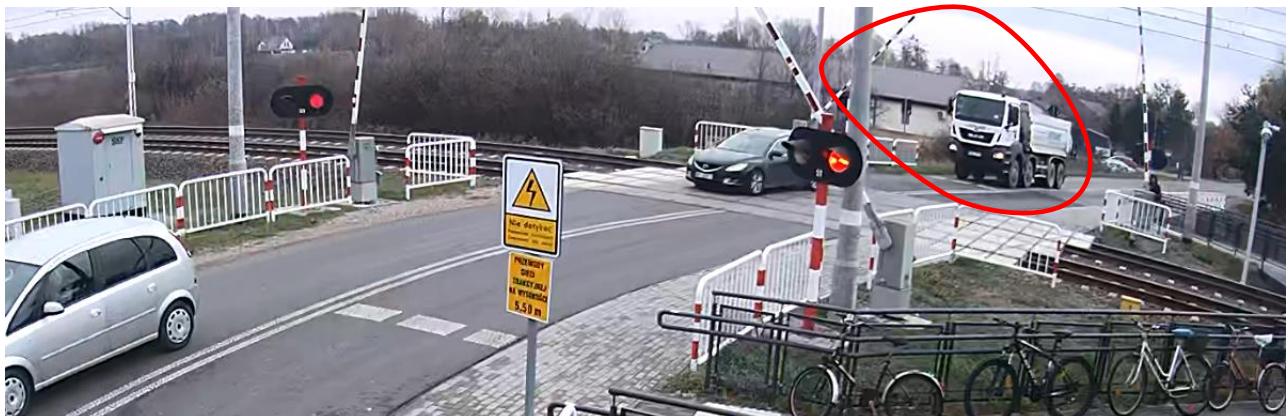
When the lorry was at the conditional stop line P-14, the entry half-barriers had been already closing to secure the passage of train EIJ 5220 and their angle of inclination relative to the horizontal was approximately 45° (photographs 5 and 6).

Photograph 5 – A view from the camera from the side of the N1 drive showing the crossing at the moment when the lorry is in front of the P-14 line (source: PKP PLK S.A.).

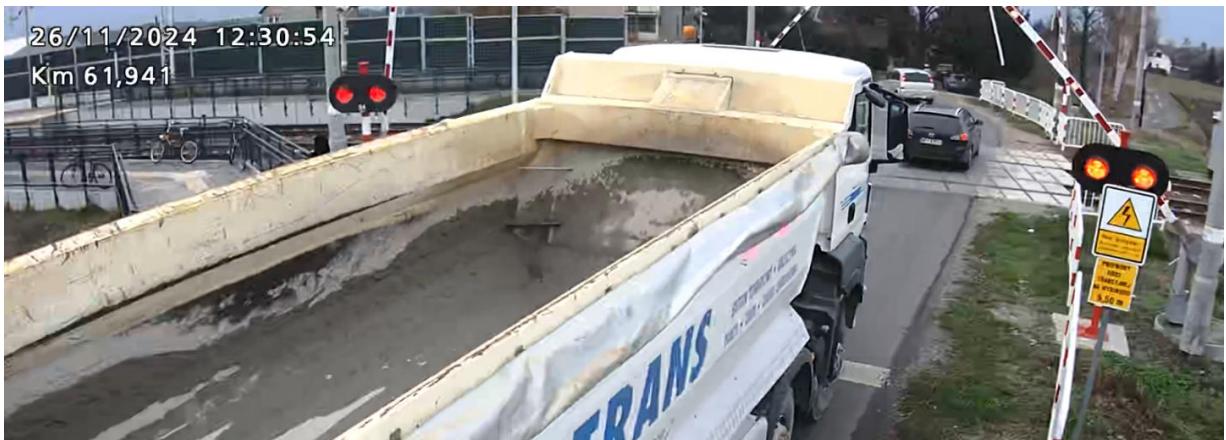
Photograph 6 – A view from the camera from the side of the N2 drive showing the crossing at the moment when the lorry is in front of the P-14 line (source: PKP PLK S.A.).

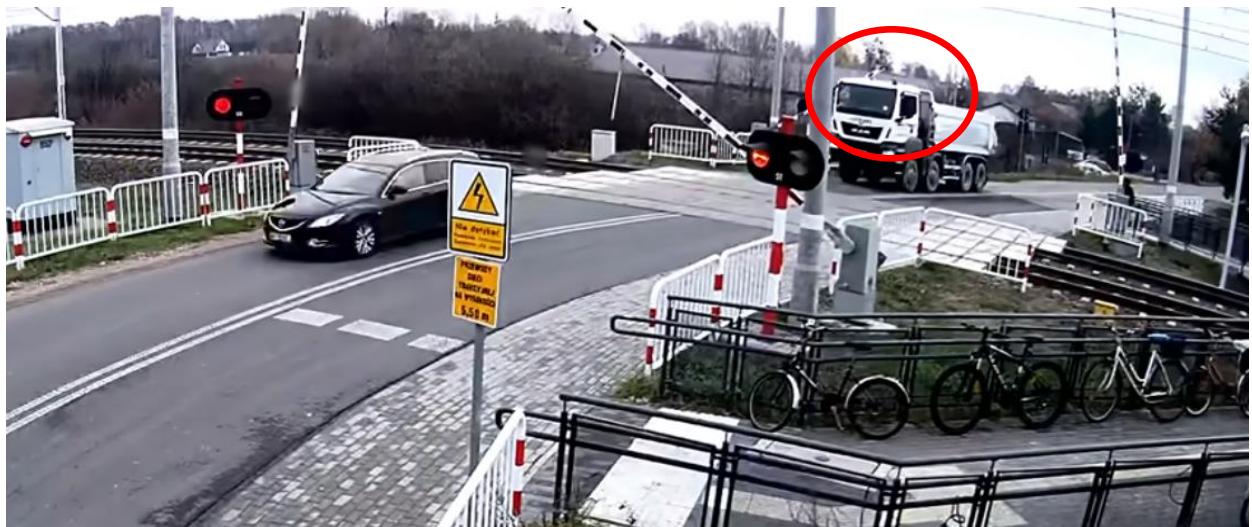
The driver of the lorry continues to drive and, as he enters the level crossing, bends the aluminium profile of the N2 half-barrier drive which is then lowered between the cab and the loading area (photographs 7 and 8).

Photograph 7 – A view from the camera from the side of the N1 drive showing the lorry entering the crossing and the barrier being bent (source: PKP PLK S.A.).

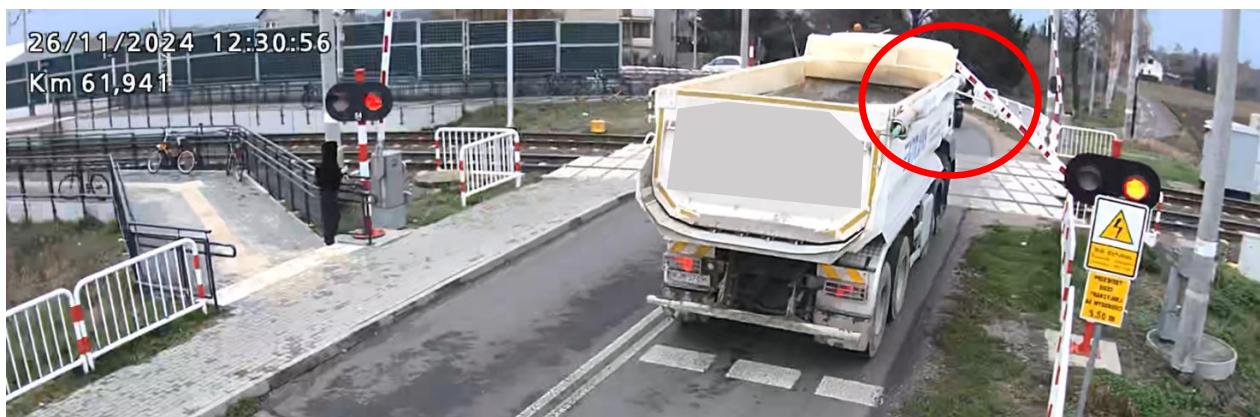
Photograph 8 – A view from the camera from the side of the N2 drive showing the lorry entering the crossing and the barrier being bent (source: PKP PLK S.A.).

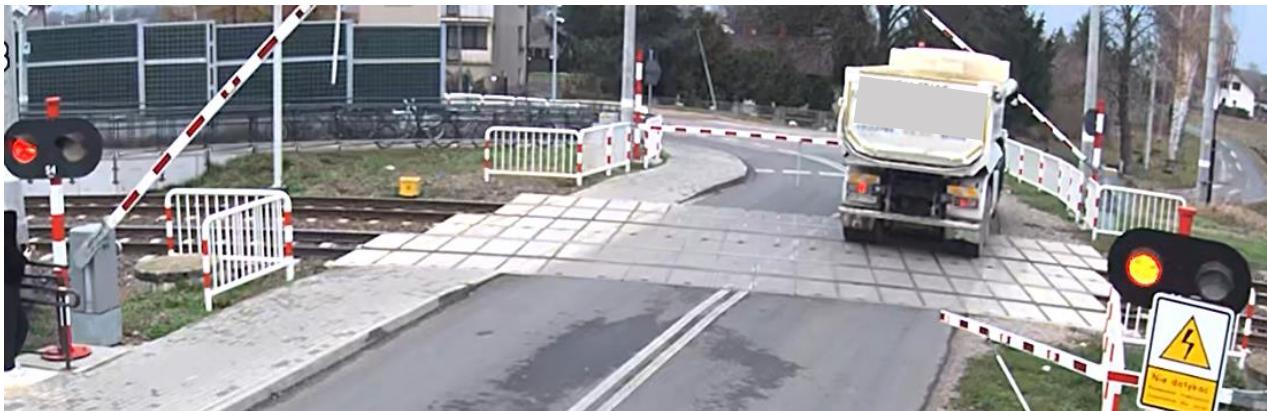
The two passenger cars travelling in front of the lorry managed to leave the crossing before the exit barriers were lowered. The bent exit half-barrier of the N2 drive had reached the horizontal position and, in accordance with the closing sequence, the process of closing the exit barriers had started. At that time, the lorry traversed track no. 2 and stopped in the gauge of track no. 1 in front of the closing exit barrier of the N3 drive (photographs 9 and 10).

Photograph 9 – A camera view from the side of the N1 drive - the lorry stops in front of the closing exit barrier of the N3 drive (source: PKP PLK S.A.).

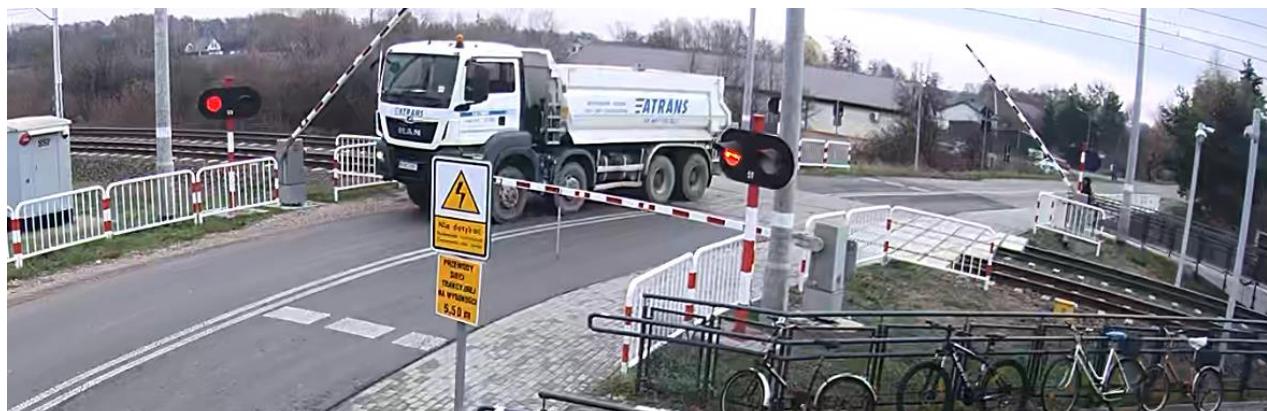
Photograph 10 – A camera view from the side of the N2 drive - the lorry stops in front of the closing exit barrier of the N3 drive (source: PKP PLK S.A.).

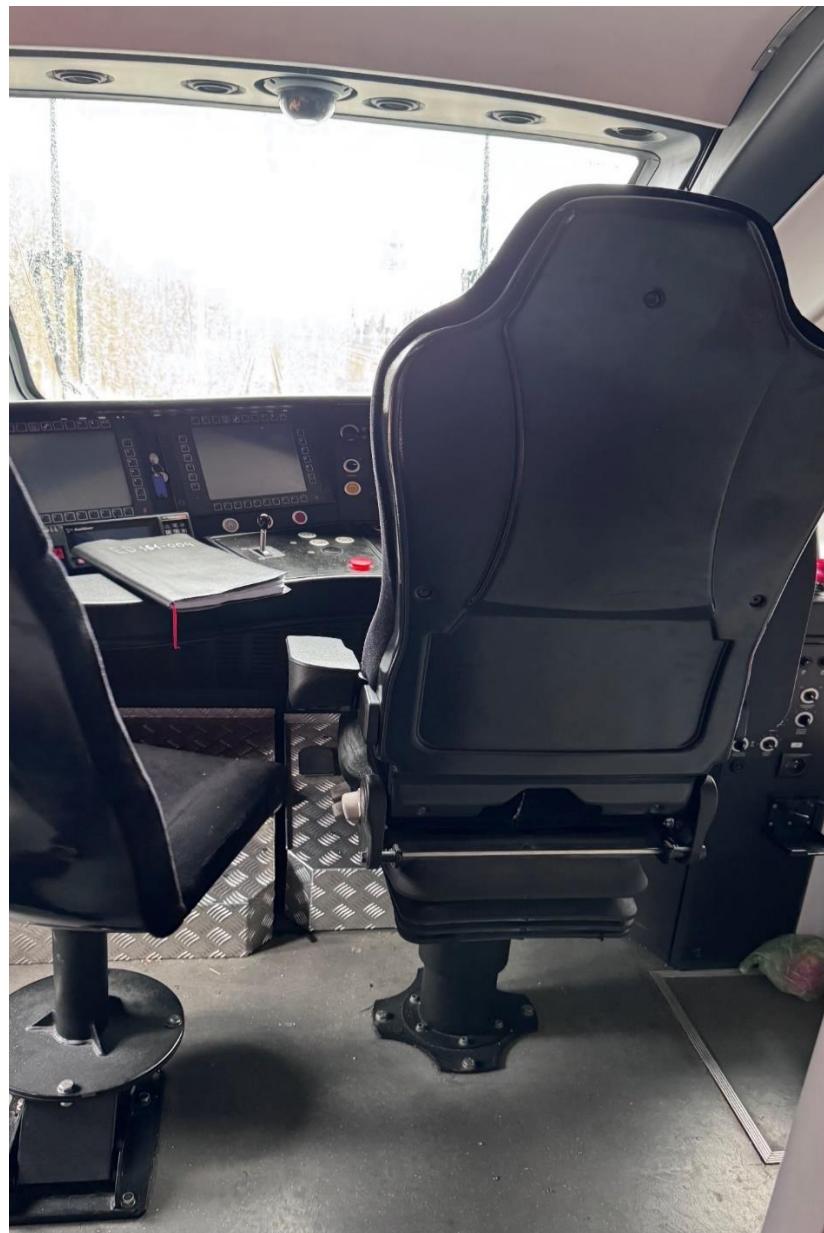
There are two seats installed in the cab of ED161-004 (photograph 11). One is for the driver (pictured right), the other is for another person authorised to be in the in the cab. The installation of the seats in such a way, in the event of an emergency and the need to leave the cab immediately, makes evacuation from the cab virtually impossible; evacuation is significantly hindered where there is one person in the cab. Turning either seat blocks it against the other, thus blocking the escape route. Such positioning poses a threat to train drivers performing their duties on their work positions, especially as every second is of the utmost importance in the event of evacuation.

Analysis of the evidence gathered in the case confirmed the difficulties associated with evacuation from the driver's cab on ED161-004. After emergency braking was implemented and once it was clear that there was no way to avoid the accident, the train drivers decided to remain in the cab, as the time to evacuate the cab safely was too long due to the positioning of the seats. The Investigation Team considered this way of installation of the seats as another irregularity, unrelated to the incident.

Photograph 11 – A view of the seats installed in the cab of ED161 004 (photo by PKBWK)

During a post-occurrence inspection and after analysing the documentation collected, the Investigation Team found that it was difficult for the train drivers to evacuate from the cab in the event of an emergency. This fact was considered by the Investigation Team as another irregularity unrelated to the causes of the occurrence.
