**STATE COMMISSION ON RAILWAY ACCIDENT INVESTIGATION**  
**Ministry of Interior and Administration**

**REPORT No. PKBWK 06/2025**

**on the investigation of the railway accident  
that occurred on 3 November 2024 at 16:30 hrs on the Spychowo - Pisz route,  
track no. 1, Category D level crossing, at km 76.274  
of railway line no. 219 Olsztyn Główny - Elk,  
area of the railway infrastructure manager PKP PLK S.A.  
Railway Line Plant in Gdynia**

**WARSAW, 30 October 2025**

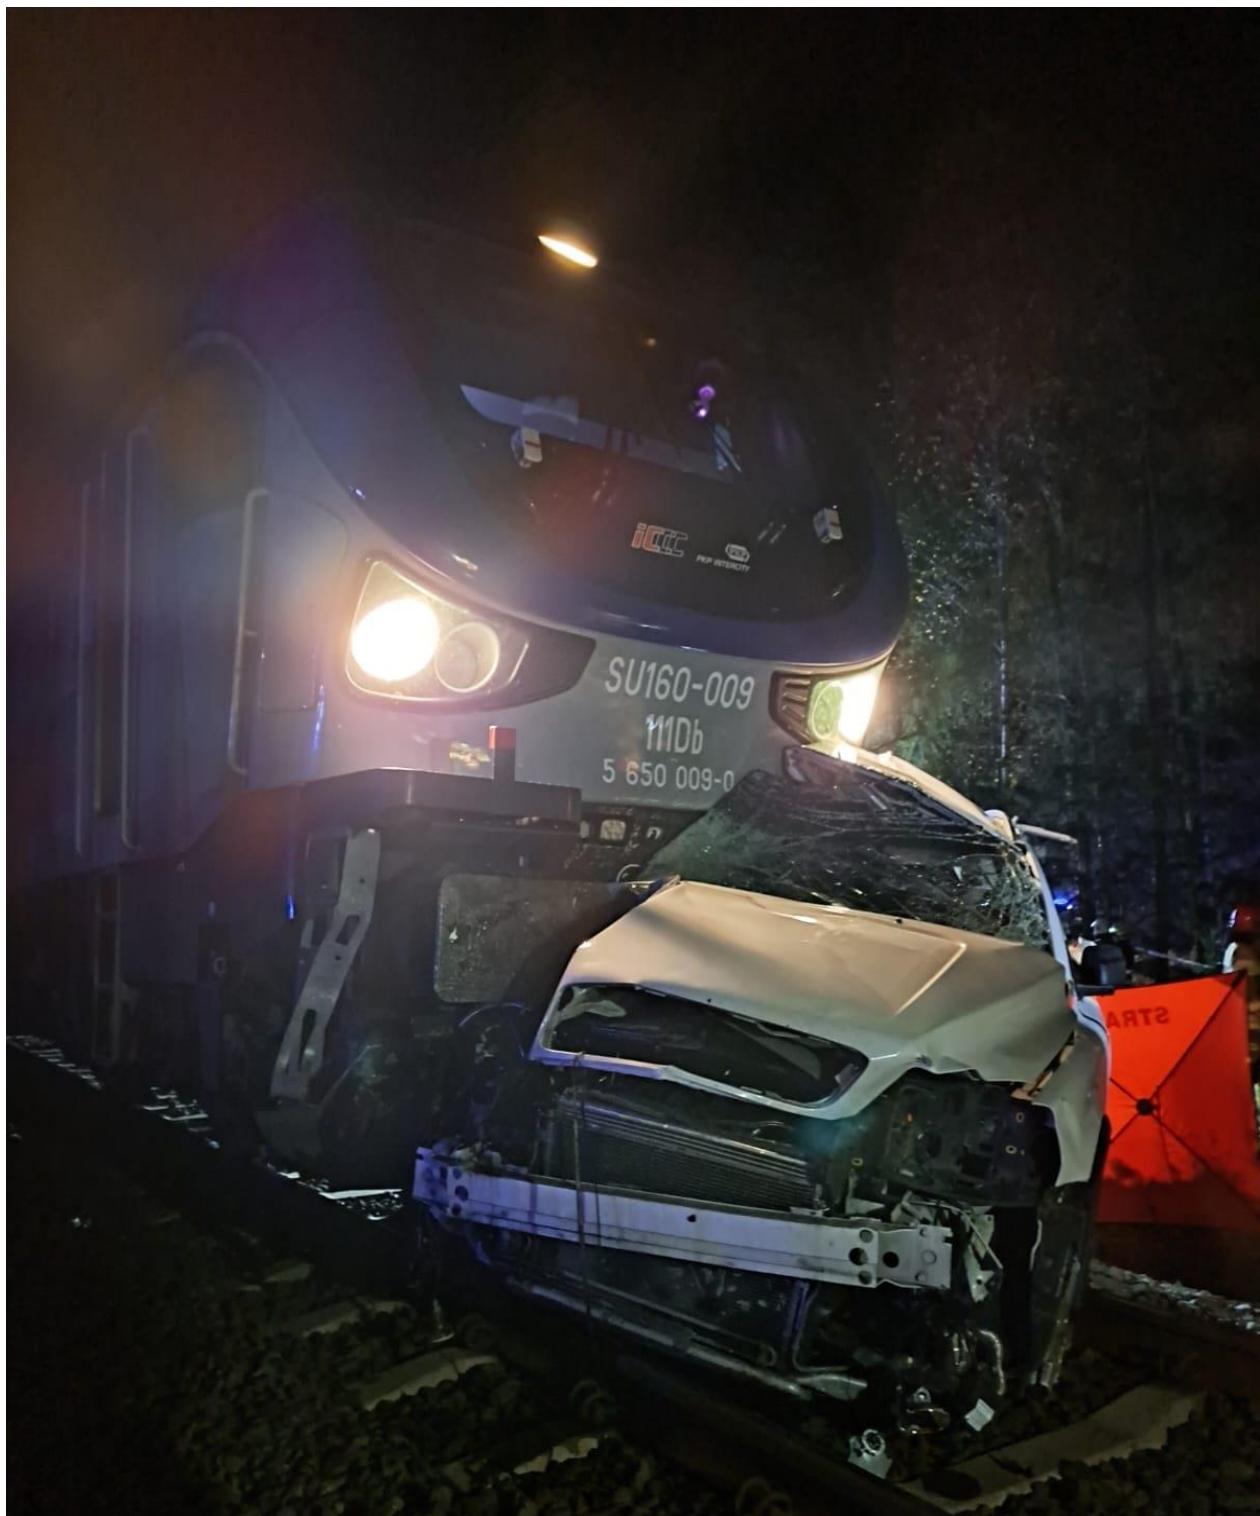
**Consequences of the occurrence:** As a result of the occurrence, the driver of the road vehicle and four passengers in the passenger car died instantly. The passenger car was destroyed and the powered railway vehicle was damaged.

Photo 1. A view of the consequences of the occurrence (source: the railway commission)

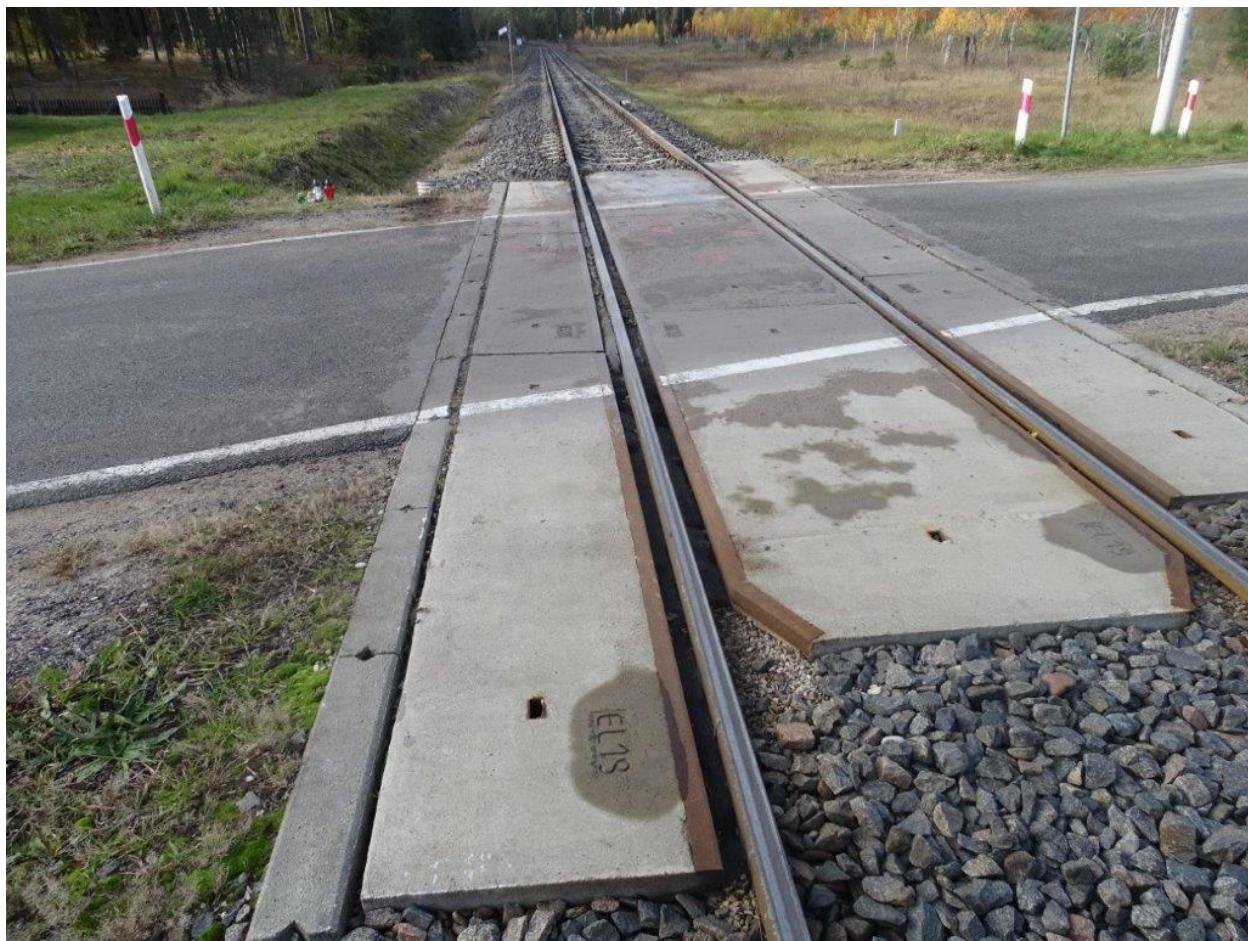
Photo 2. A view of the scene of the occurrence from the direction of the moving train (source: the railway commission)

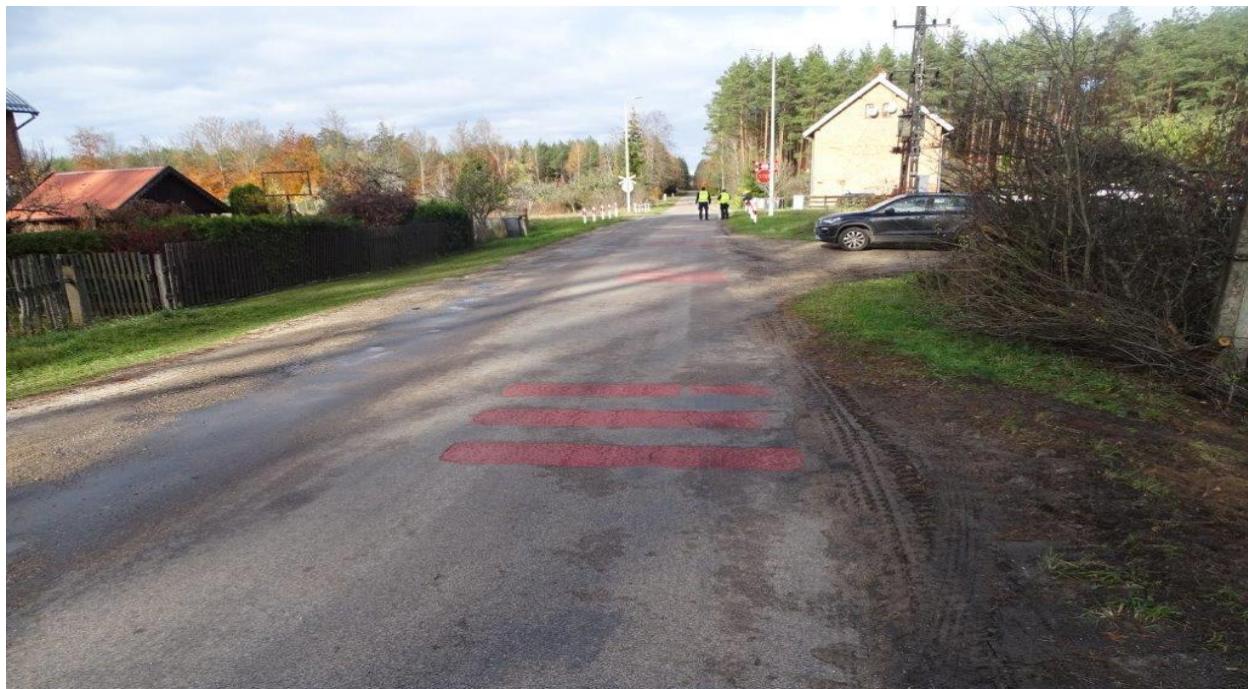
Photo 3. A view of the level crossing from the direction of the passenger car's travel (source: the railway commission)

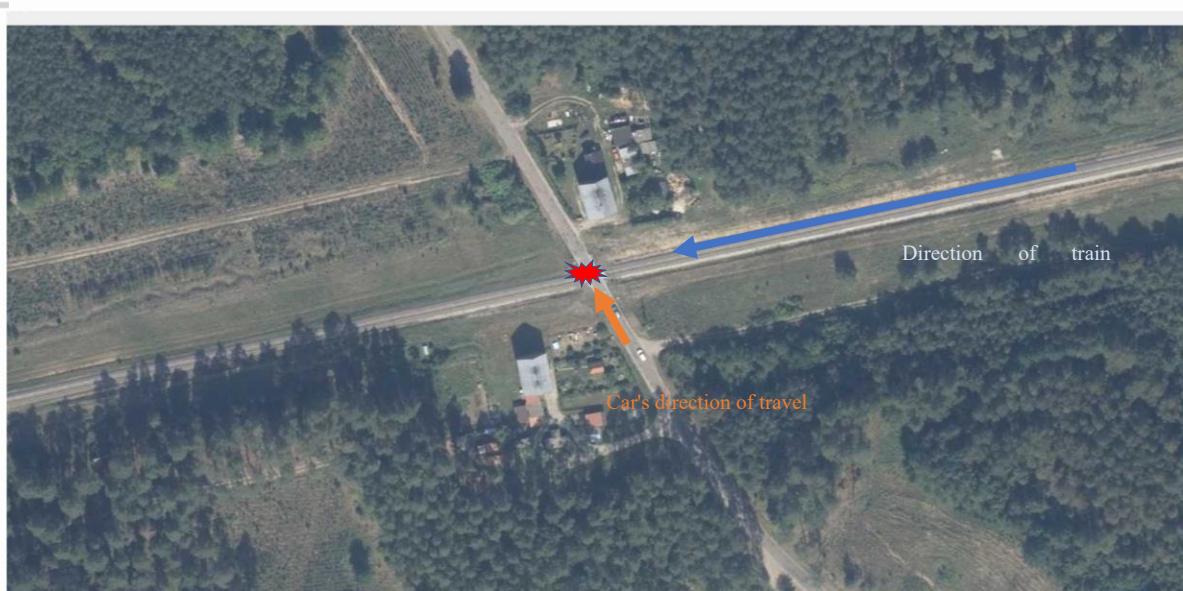
Photo 5. Positioning of the vehicles before the accident (source: Google maps)

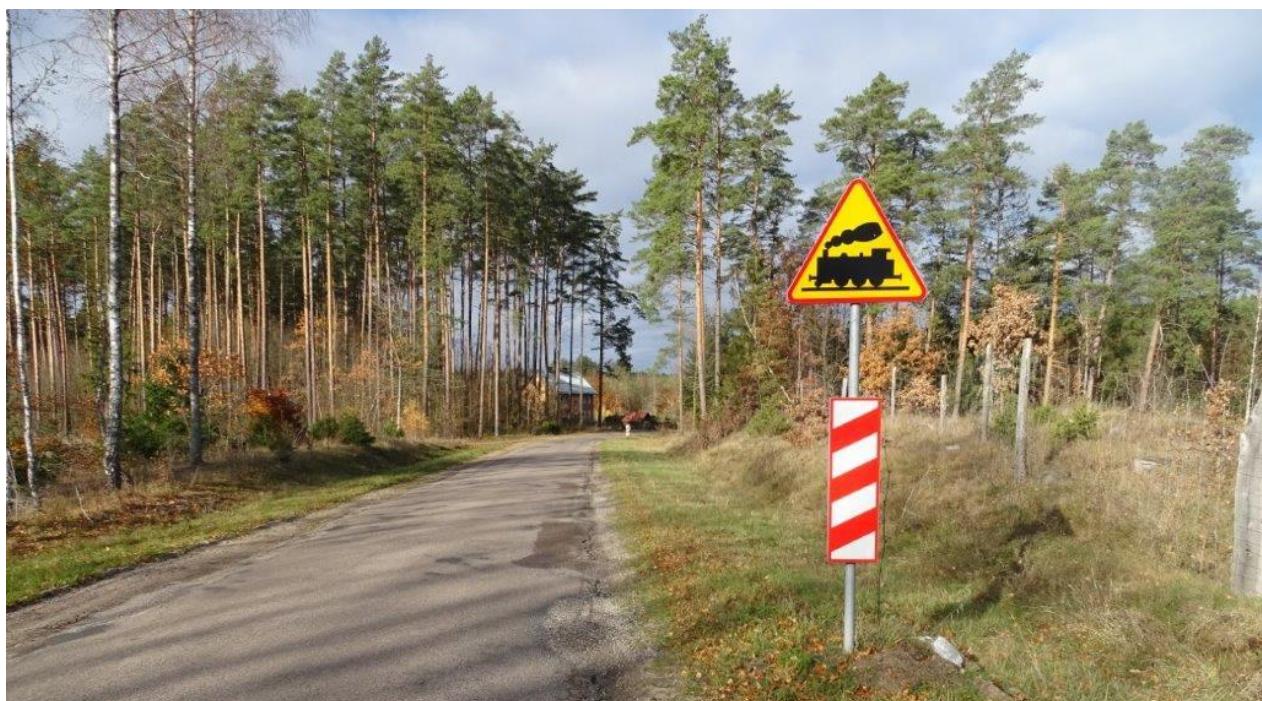
Photo 6. A10, G1a signs positioned approximately 160m before the level crossing (source: the railway commission)

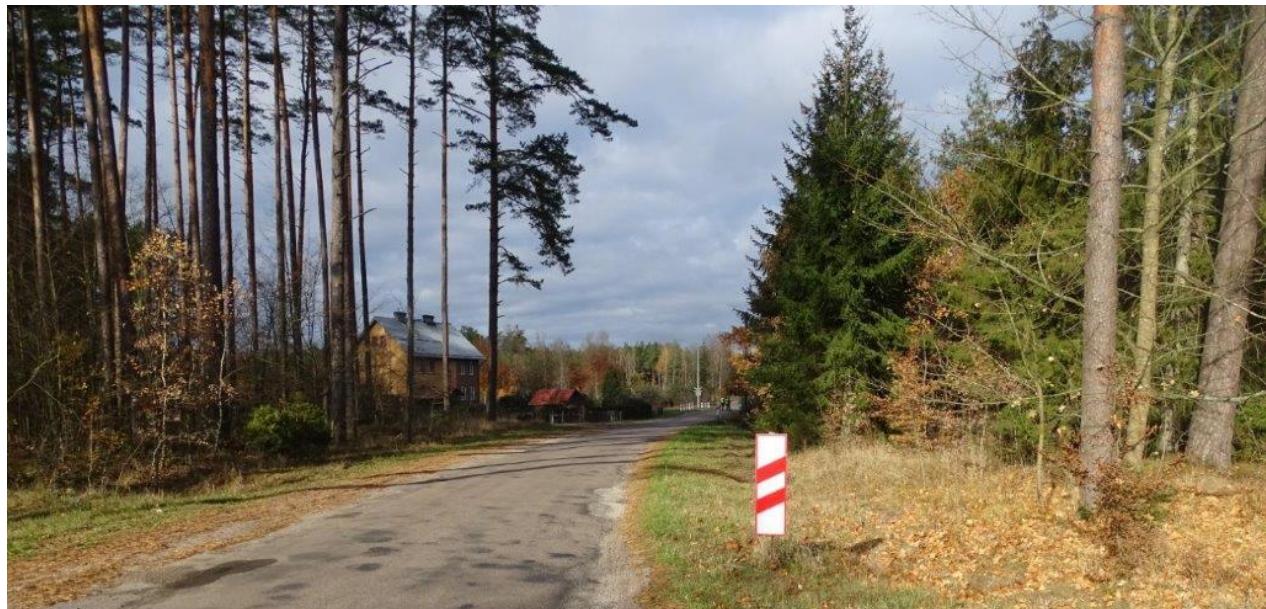
Photo 7. A G-1b sign positioned approximately 105m before the level crossing (source: the railway commission)

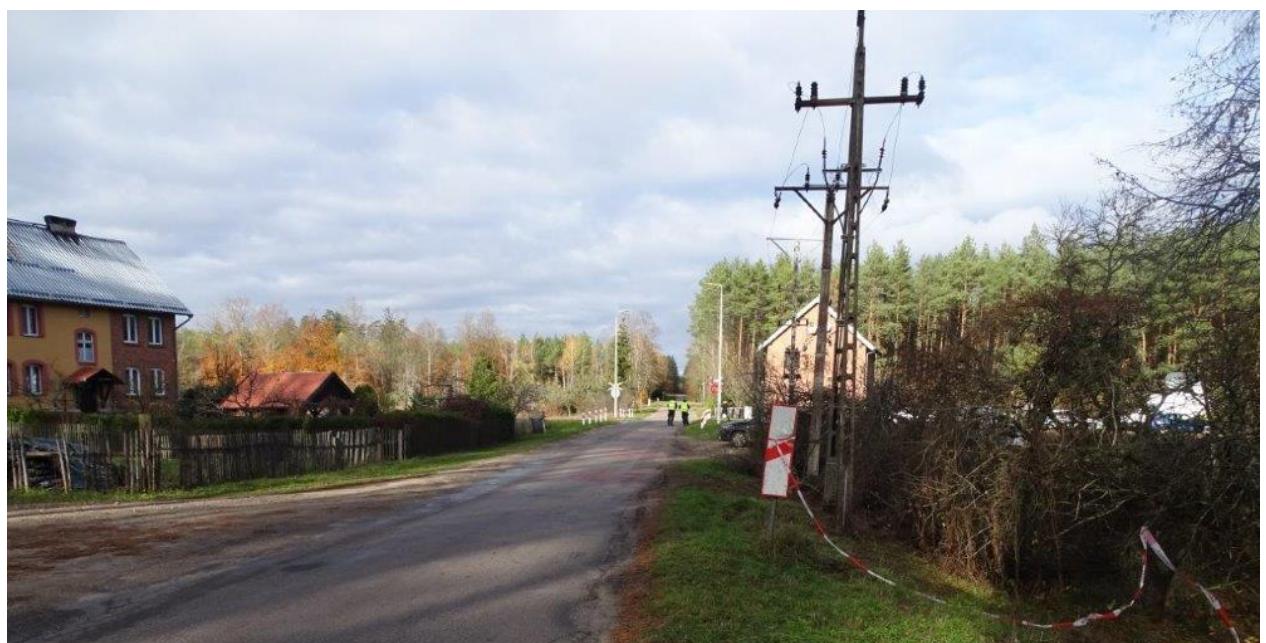
Photo 8. A G-1c sign positioned approximately 60 m before the level crossing (source: the railway commission)

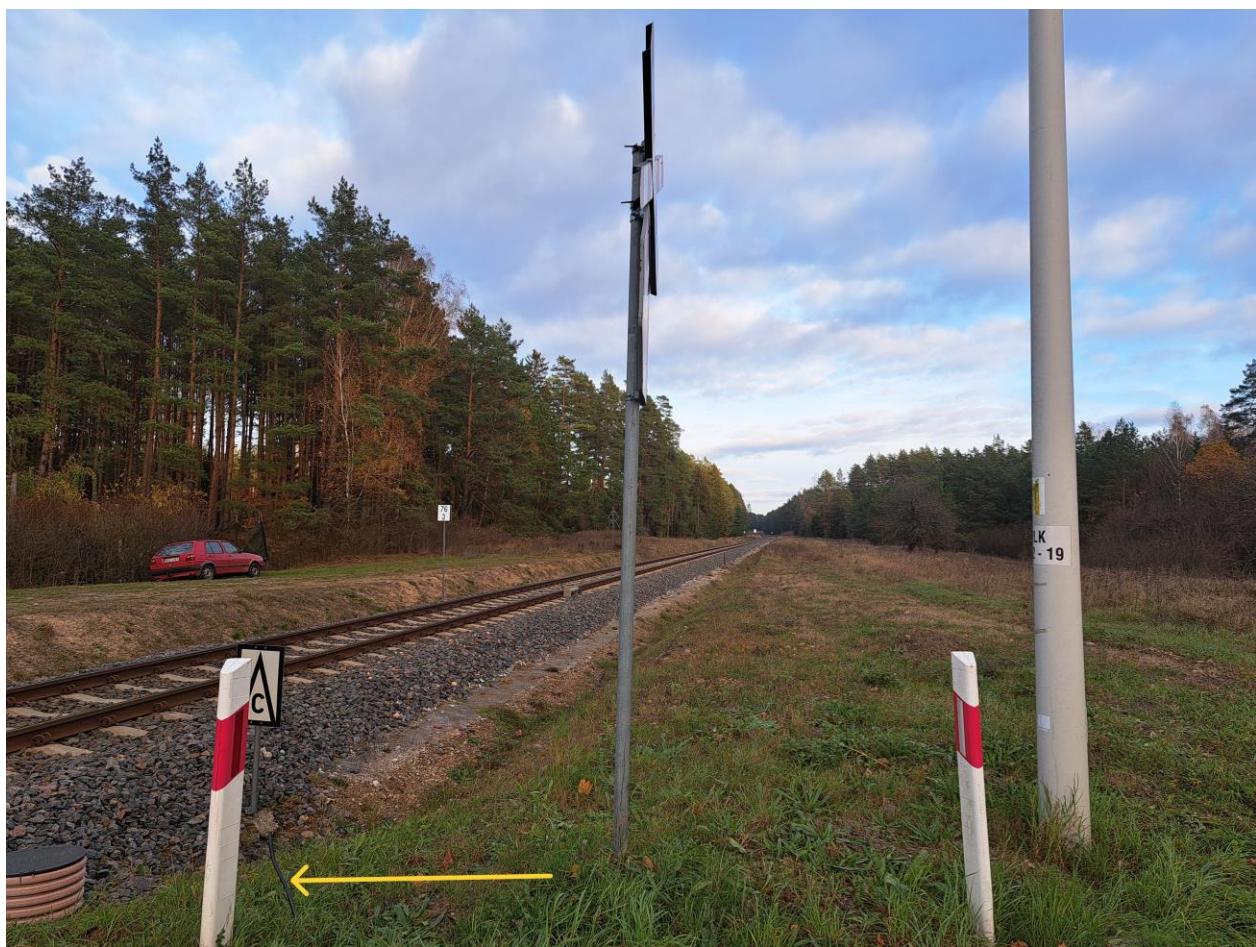
The orange colour indicates the visibility distances of the train head from the road from the direction of travel of the road vehicle, as included in the level crossing's data sheet.

Photo 9. Visibility of the head of the train from the road from the direction of travel of the road vehicle (from 5m)

After the accident, the Pisz County Road Administration renovated the poorly visible P-12 horizontal lines on both sides of the level crossing and conducted a survey of visibility conditions from the road at the level crossing. For the direction of travel of the car involved in the accident, the visibility of the crossing from the road is 130 m, with the required visibility 120 m.

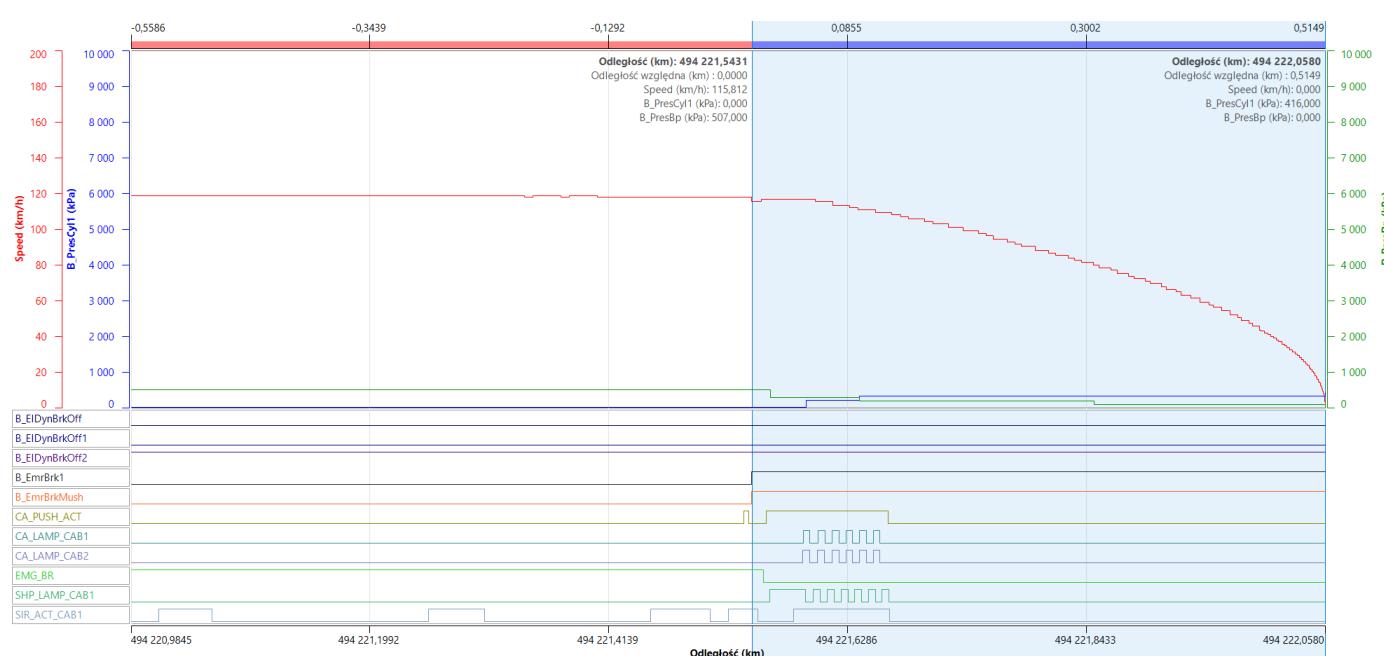
Figure 2. Diagram of the driving parameters of diesel multiple unit SU160-009 as a function of distance (author: PKBWK)

The diagrams below show, among others, the following driving parameters of train MPS 15102:

1. speed,
2. pressure in the main line,
3. pressure in the air reservoir,
4. use of the active vigilance device button,
5. use of the Automatic Train Braking (SHP) button,
6. use of the sound signal,
7. cabin identification - control from cabin B.
