**REPUBLIC OF BULGARIA**  
**NATIONAL AIR, MARITIME AND RAILWAY TRANSPORT, ACCIDENTS**  
**INVESTIGATION BOARD (NAMRTAIB)**

**FINAL REPORT**

**Investigation of significant railway accident – derailment of DFT № 80694 between the stations  
Lyubenovo distributing station – Simeonovgrad on 15.08.2025**

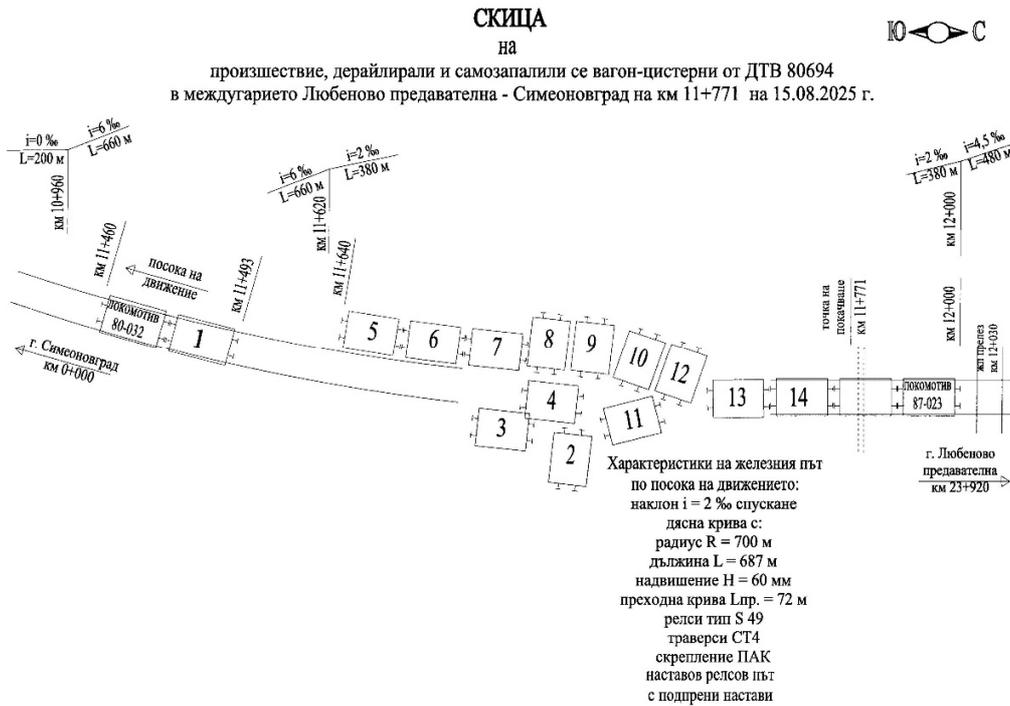
**Fig. 1.1 Scheme of the place of derailment of DFT № 80694**

The event occurred between the stations Lyubenovo Predatelna and Simeonovgrad at km 11+771 at 05:23 on 15.08.2025. The derailment zone of the first derailed wagon No. 31527850315-8 is in a right curve with radius  $R=700$  m, length  $L=687$  m, elevation  $H=60$  mm, transition curves  $2xL_{sp.}=72$  m and profile  $i=2\%$  in descent in the direction of train movement. The rail track is laid with rails type S49 – 25 meters, reinforced concrete sleepers type ST-4, fasteners ПАК-68I (fig. 1.1, 1.2, 1.3, 1.4).

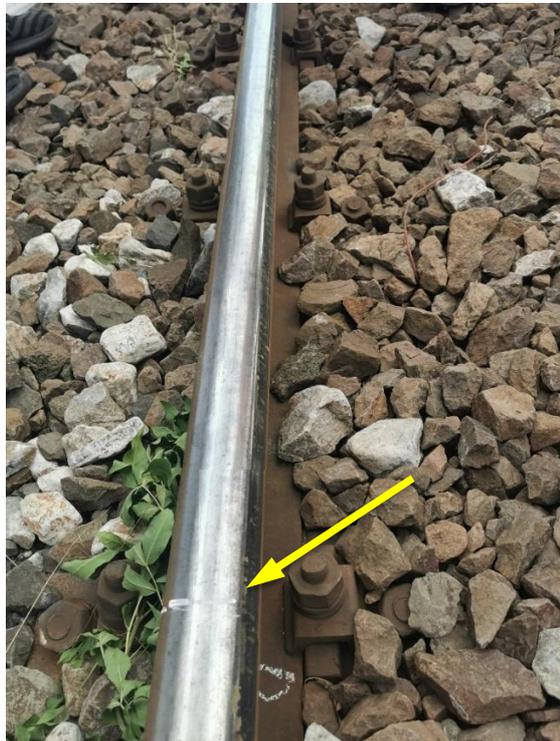
4.4.1. Regulatory framework conditions. ....	57
4.4.2. Processes, methods and results from the activities on the risk assessment and monitoring that the involved entities performed: ....	57

Within the movement of DFT № 80694 in the transitional curve with length 72 m, at 41 m after its end at km 11+771 in the circular curve of the second wagon of the third wheelset the left wheel stepped on the crown of the left rail in the curve with radius  $R=700\text{ m}$  and superelevation  $H=60\text{ mm}$  (fig. 4.14).

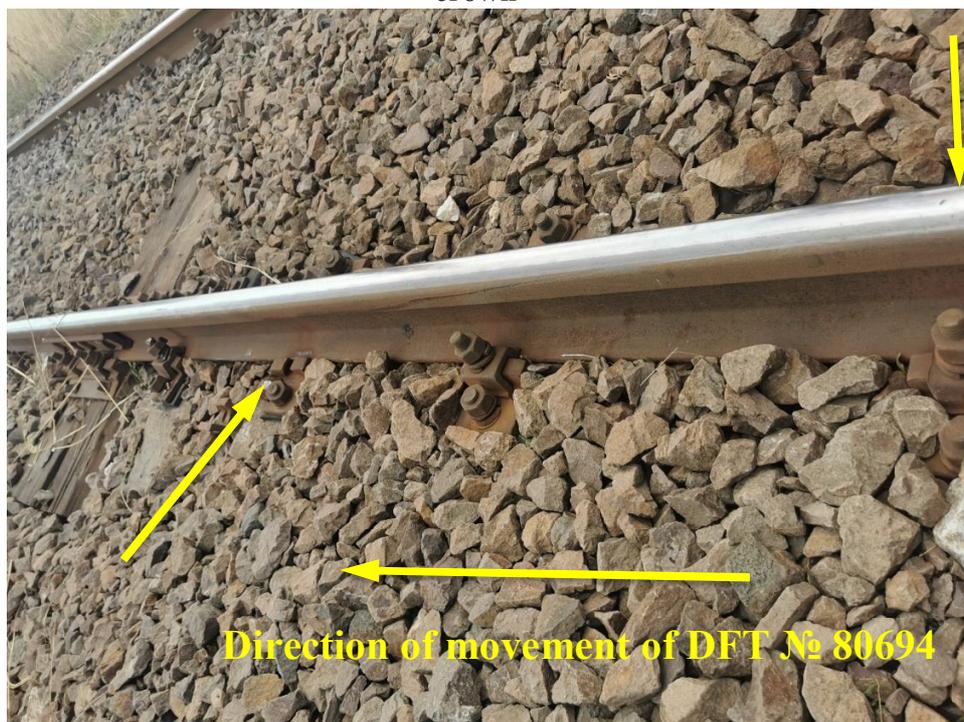
**Fig. 4.15 Point of slide of the left wheel from the rail**

The flange of the left wheel moved along the head of the rail without leaving a serious mark and after 2.9 m the wheel slid to the left from the outer part of the rail, leaving a visible mark at km 11+768.10 m (Fig. 4.15). The second wheelset of the second bogie of the wagon also derailed.

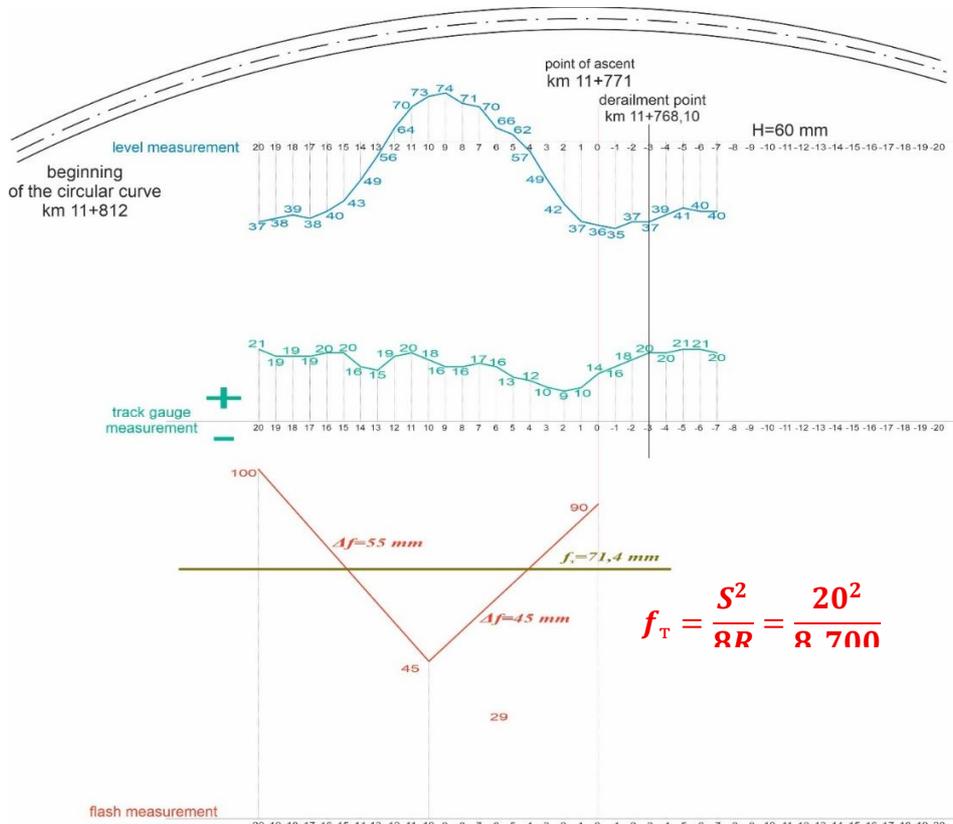
**Fig. 4.18 Chart of amendment of parameters of the rail track:**  
 blue – measuring of level; green – measuring of gauge; red –  
 measuring of levelling

Extracts of the transverse level in the circular curve with  $H = 60 \text{ mm}$  out of the admissible deviations in the superelevations, exceeding the limits for  $V_{max} \leq 60 \text{ km/h} = \pm 15 \text{ mm}$ , measured in p.p. 0, 1, 2, 16, 17, 18, 19, 20 (fig. 4.18).

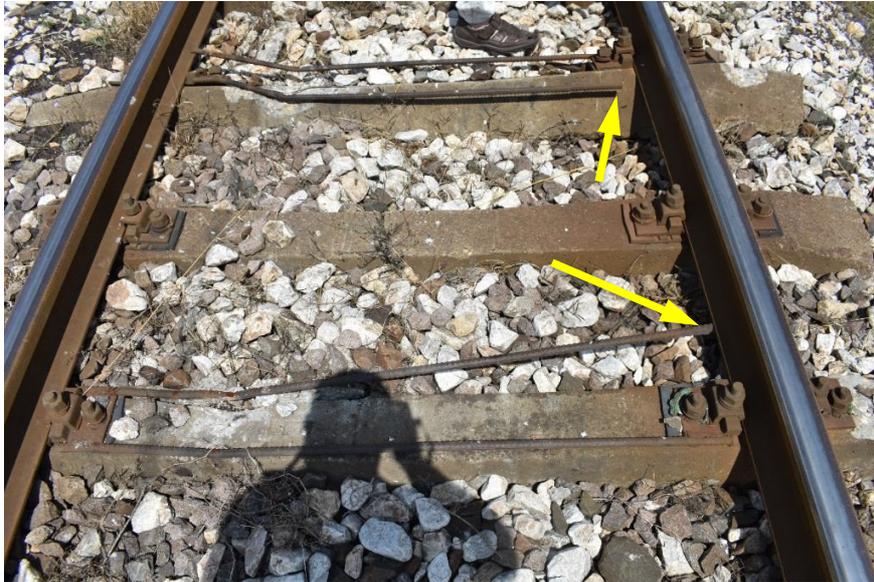
**Fig. 4.19.**

1. In the cited section, a large number of metal braces were inserted, welded to the ribbed pads in order to maintain the track gauge within standards (due to the breakage of the sealing sleeves in the reinforced concrete sleepers) (Fig. 4.19)

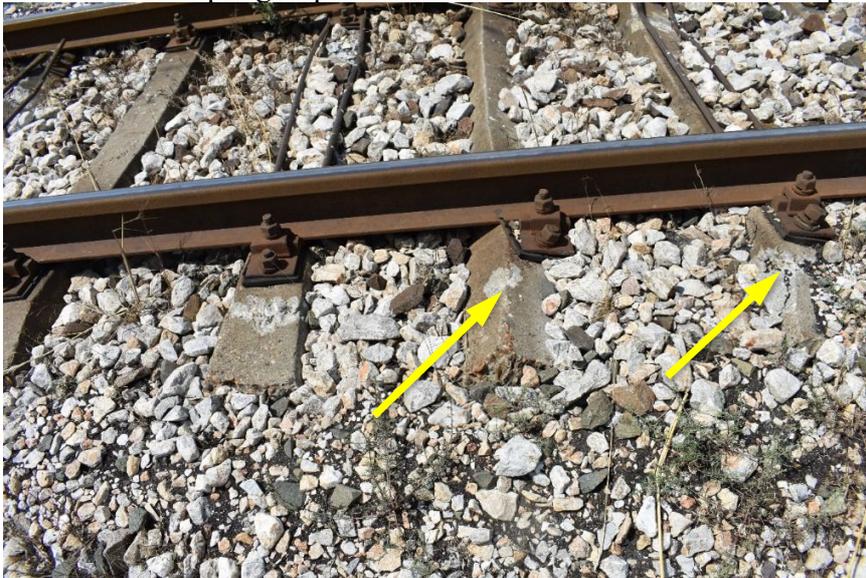
**Fig. 4.20.**

2. There were established multiple groups of inclined reinforced concrete sleepers, and due to that

fact the rails foot were in contact with the concrete of the sleepers, which led to compromising the bolt connecting the metal pad with the sleeper (fig. 4.20).

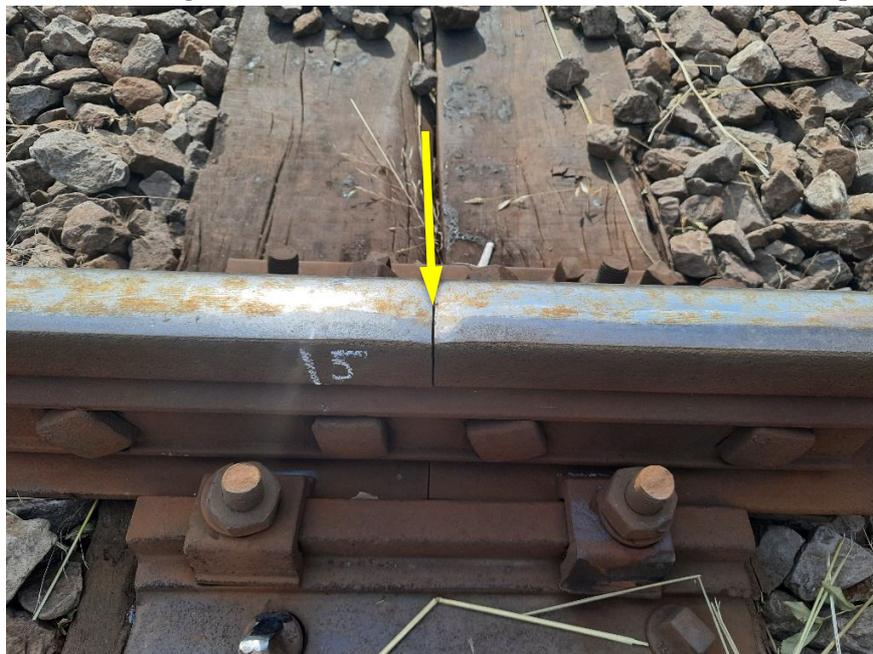
**Fig. 4.21.**

The combination of irregularities under axis and level before and around the point of stepping up,

causing horizontal transverse taking over and bouncing in the vertical plane of RRS caused the derailment of the wagons.
