MINISTRY OF
CONSTRUCTION AND TRANSPORT
TRANSPORTATION SAFETY BUREAU

FINAL REPORT

2023-0661-5
(HU-10426)

Railway Accident / Derailment
Tiszatenyő - Mezőtúr, 9th July 2023

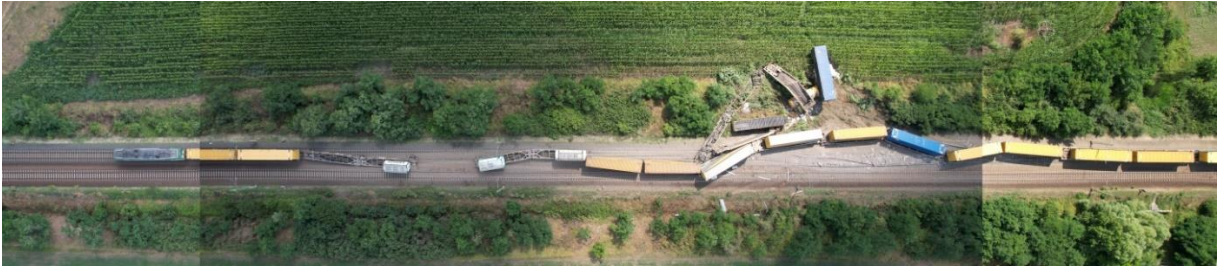
Figure 2: Location of the wreckage (compiled from several images)

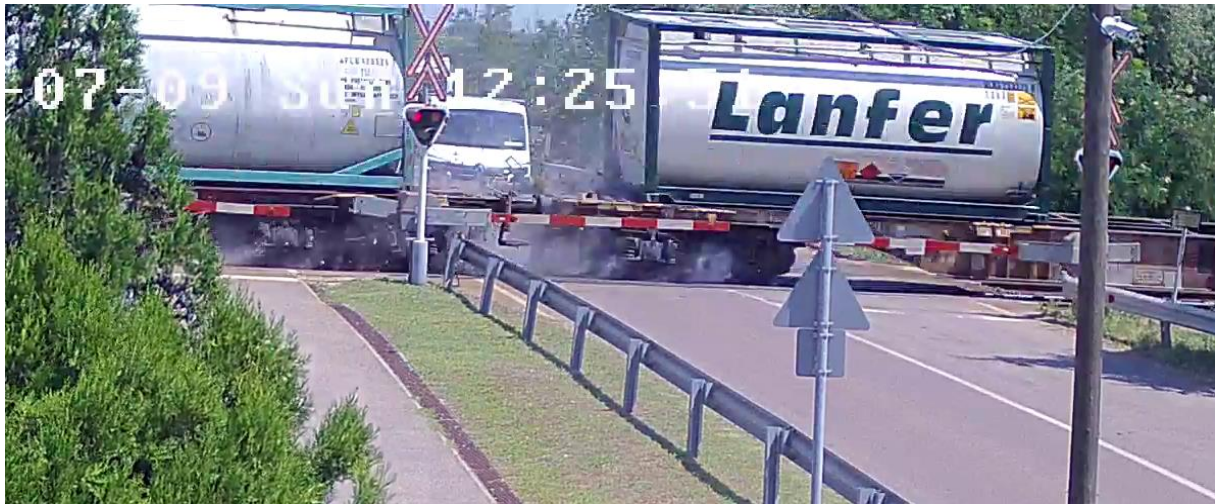
12:15:45 [+1.8 km] The derailed bogie jumped onto the STRAIL elements of the crossing at section 180+51, causing the train to break up.

Figure 3: Part of a frame of a surveillance camera image, showing the derailed bogie reach the level crossing

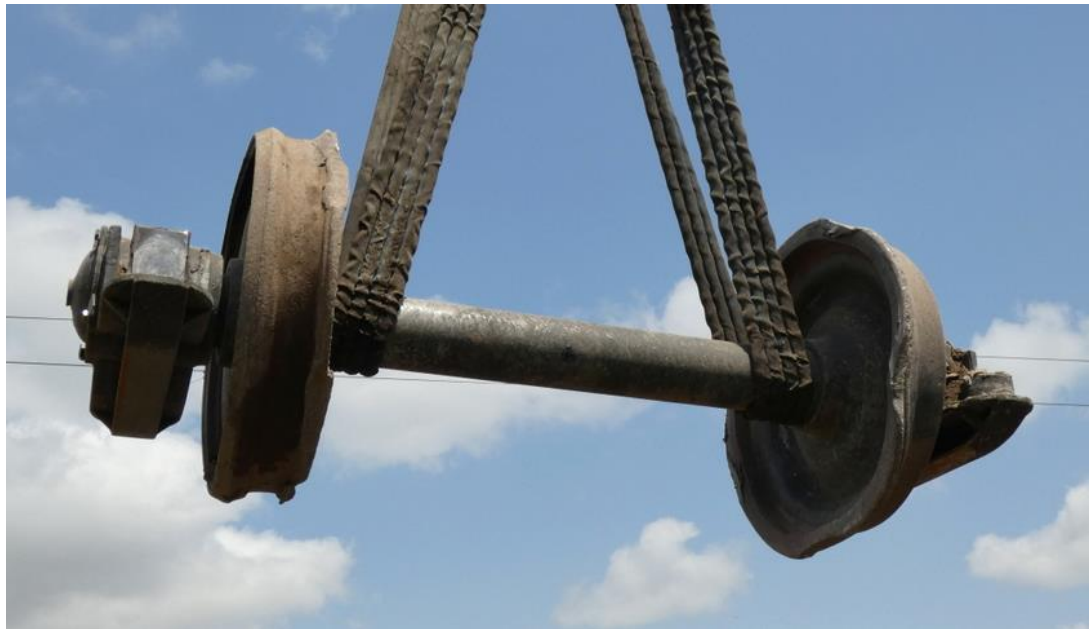
The wheels of the third bogie of the second wagon (wheelsets 1 and 2 according to the numbering of the wagon) suffered a deformation (Figure 4) that caused them to lose their running safety and leave the track.

Figure 4: The fifth wheelset (numbered 2) of the second carriage in the direction of travel

- a) Only the backing plates of the brake blocks remained in the bogie frame, with skid marks following the direction of rotation of the wheels on them, indicating that their composite body had been lost while running;
- b) Brake parts were found on the railway track, metal lattices from brake blocks, already about 3 km before the derailment, with discolouration indicating high temperatures and rotational slip marks, suggesting that the disappearance of the brake blocks was caused by wear over the entire length;
- c) Brushfires broke out along the railway track after the train had passed (3.2.3), which is a typical consequence of melt and sparks from a brake block.

All those above suggest that the bogie was running with the brakes on, the friction of the running train heated up the brake blocks and the discs, the brake blocks wore out and burnt, the discs were softened, their shape was distorted by the wheel load and they lost their running stability.

The deformation of the wheel was caused by the thermal load from the brake assembly remaining braked.

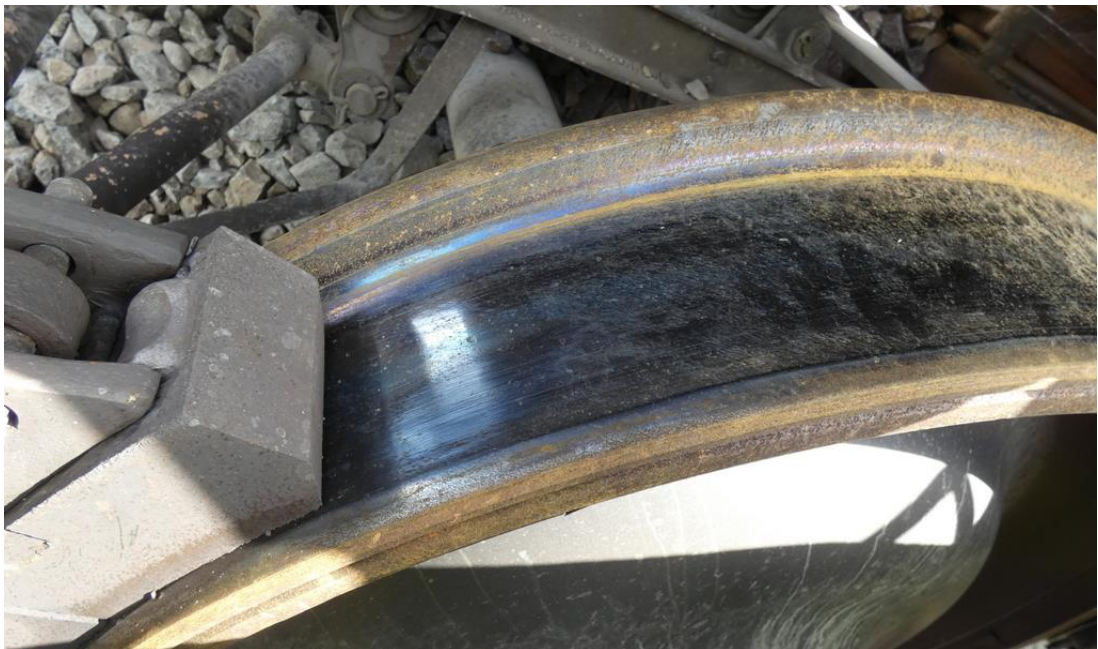
During the on-site inspection, a bluish discolouration was also visible on other wheelsets of the wagon, indicating a heating of about 300°C, which suggests that other bogies of the wagon were also braked to a lesser extent.

Figure 5: Discoloured wheel in the second bogie of the wagon with reg. No. 470-4 (contrary to what the picture suggests, the tread is not damaged, there is no external pseudo-marking on the wheel)

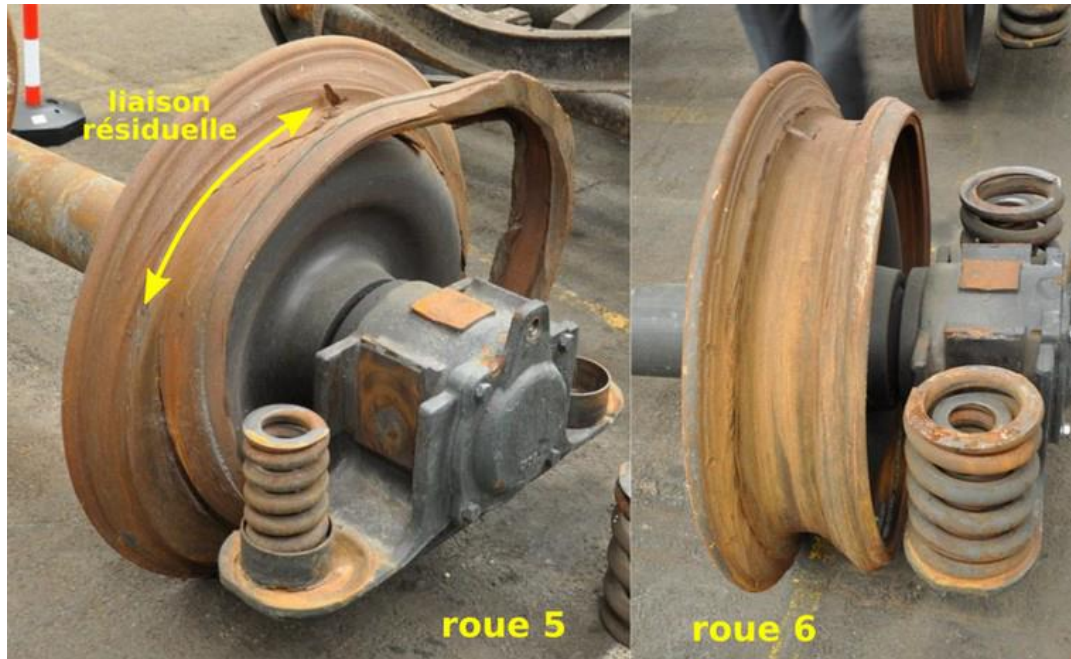
The French accident investigation body (BEATT) found that a wheelset of one of the freight wagons fitted with LL - IB116* brake blocks was badly damaged (Figure 6), the wagon was missing brake parts, damage was identified on the track and there were several fires along the railway track.

Figure 6: Damage to the wheels (source: French final report of the occurrence)

Following a brake test after starting the wagon, the wagon remained braked due to a pneumatic fault and the LL brake blocks used caused the wheel to overheat.

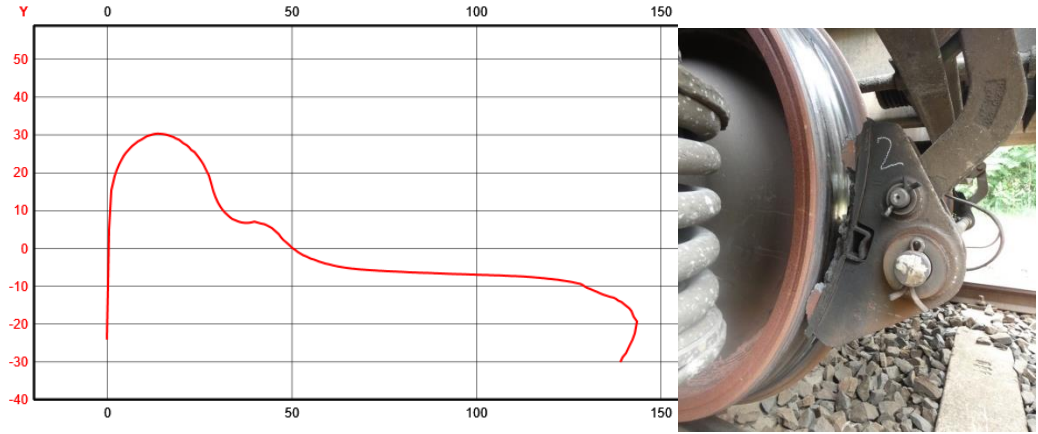
The wheels of the wagon fitted with LL - IB116* brake blocks were deformed and the brake blocks were largely burnt (Figure 7), while the wheels and brake blocks of the wagon fitted with the similarly braked K brake blocks (also a composite type of brake block) were slightly damaged.

Figure 7: Damaged profile and brake block of one wheel braked with an LL - IB116* brake block

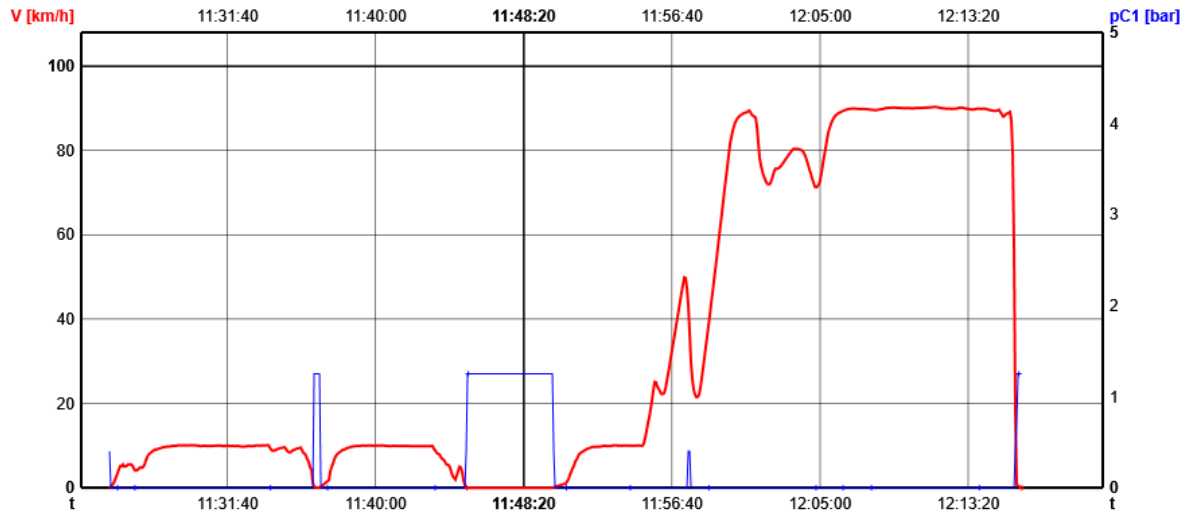
The data read out from the locomotive's travel data recorder is illustrated in Figure 8. The times of the running data had to be corrected by 7203 seconds to synchronize with the MFB data.

Figure 8: locomotive running data
red: speed
blue: locomotive brake cylinder pressure band
