REPUBLIC OF SERBIA
CENTER FOR INVESTIGATION OF ACCIDENTS IN TRANSPORT
SECTOR FOR INVESTIGATION OF ACCIDENTS IN RAILWAY TRAFFIC
Nemanjina 11, 11000 Belgrade

FINAL REPORT ON ACCIDENT INVESTIGATION

Accident type: Train derailment

Train No.: 51202

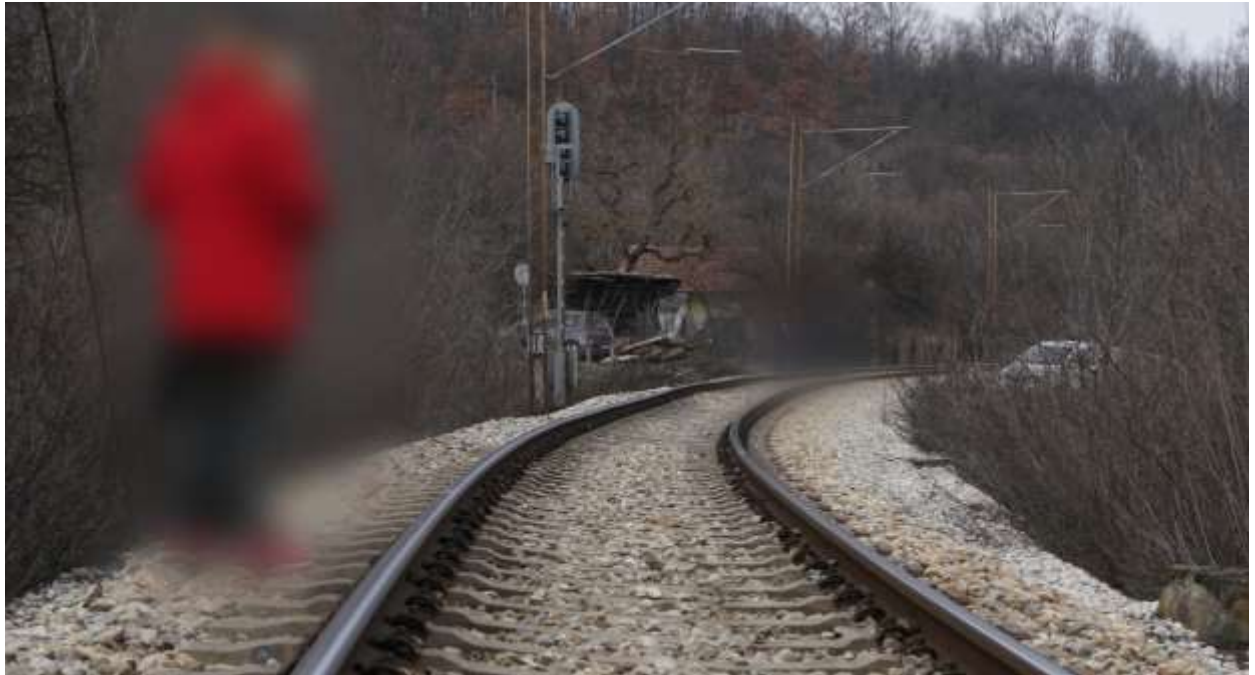
Figure 2.1.2.1: View of the derailment site (view in the direction of train movement)

The appearance of the derailment site of train No. 51202 is shown in Figures 2.1.2.1. and 2.1.2.2.

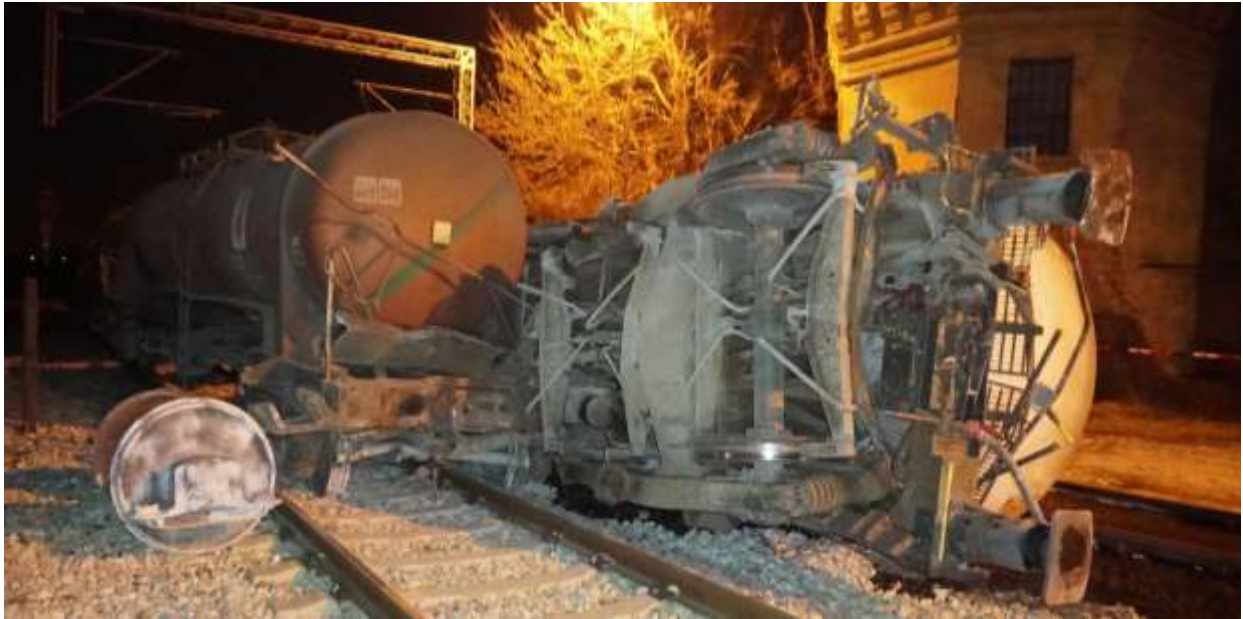
Figure 2.1.2.3: View of the wagon overturning site

The appearance of the tank wagon overturning site is shown in Figures 2.1.2.3. and 2.1.2.4.

From the tank of the overturned wagon, leakage of sulphuric acid occurred at the tank lid.

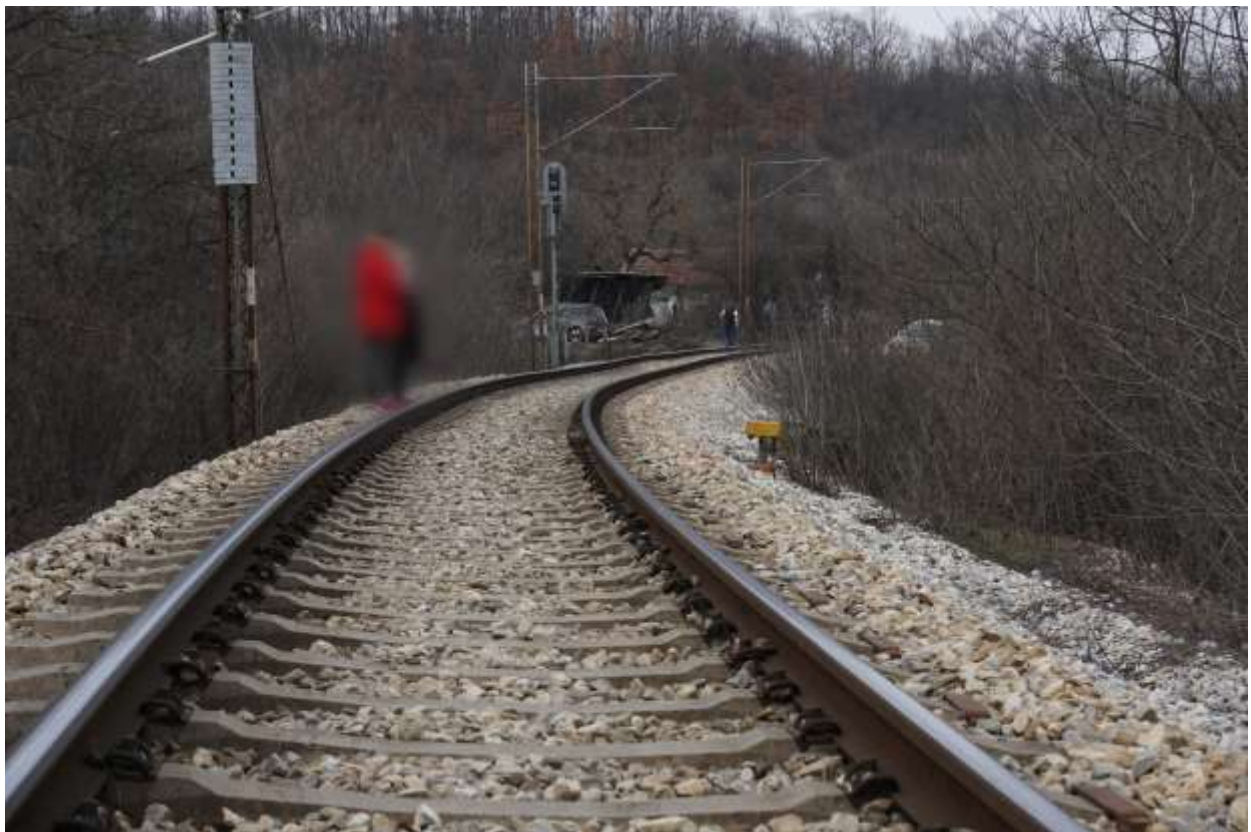
Figure 3.4.2.2: Appearance of the track in the derailment zone of train No. 51202

The appearance of the subgrade in the derailment zone is shown in Figure 3.4.2.2.

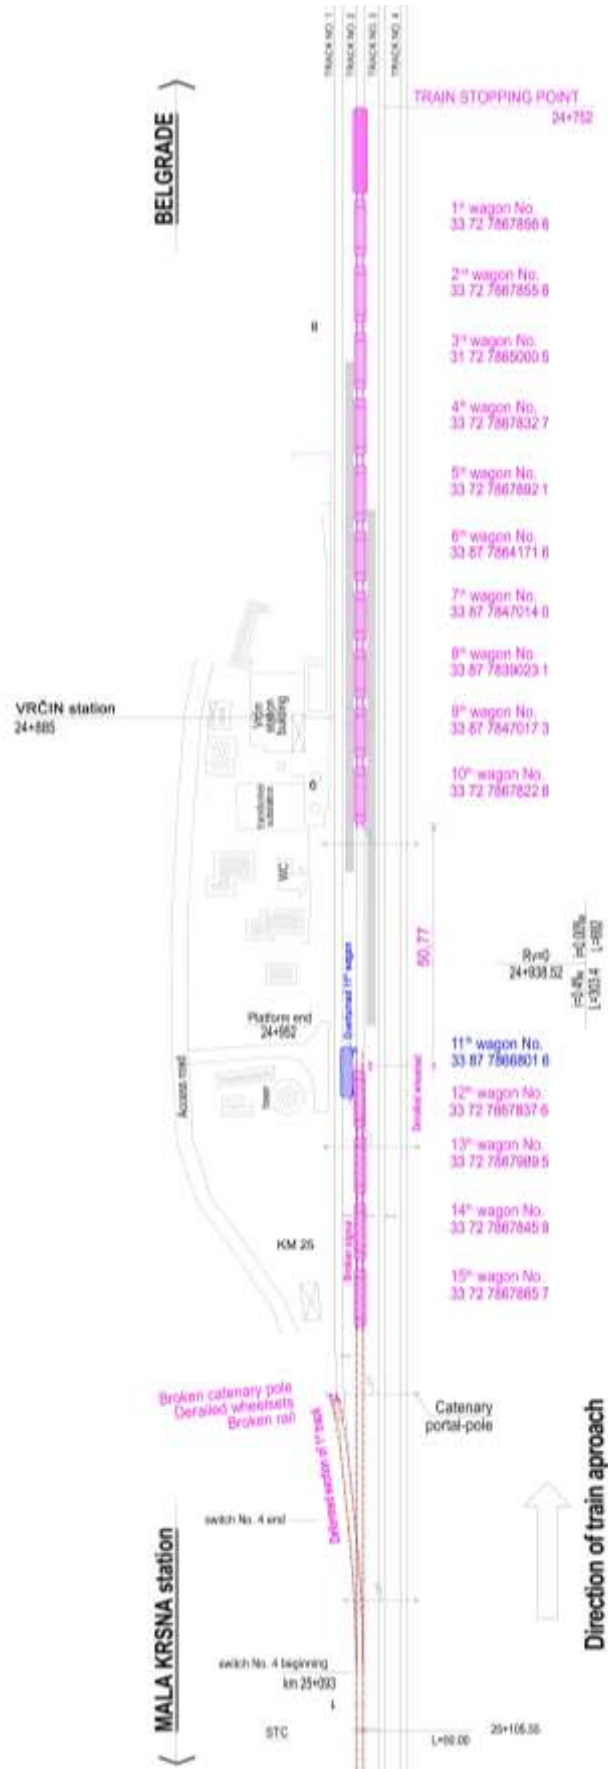
Figure 3.4.2.3: Sketch of the overturning of the eleventh wagon and the stopping location of train No. 51202

Sketch of the overturning of the eleventh wagon, derailment of the twelfth wagon, and stopping location of the train at Vrčin station is shown in Figure 3.4.2.3.

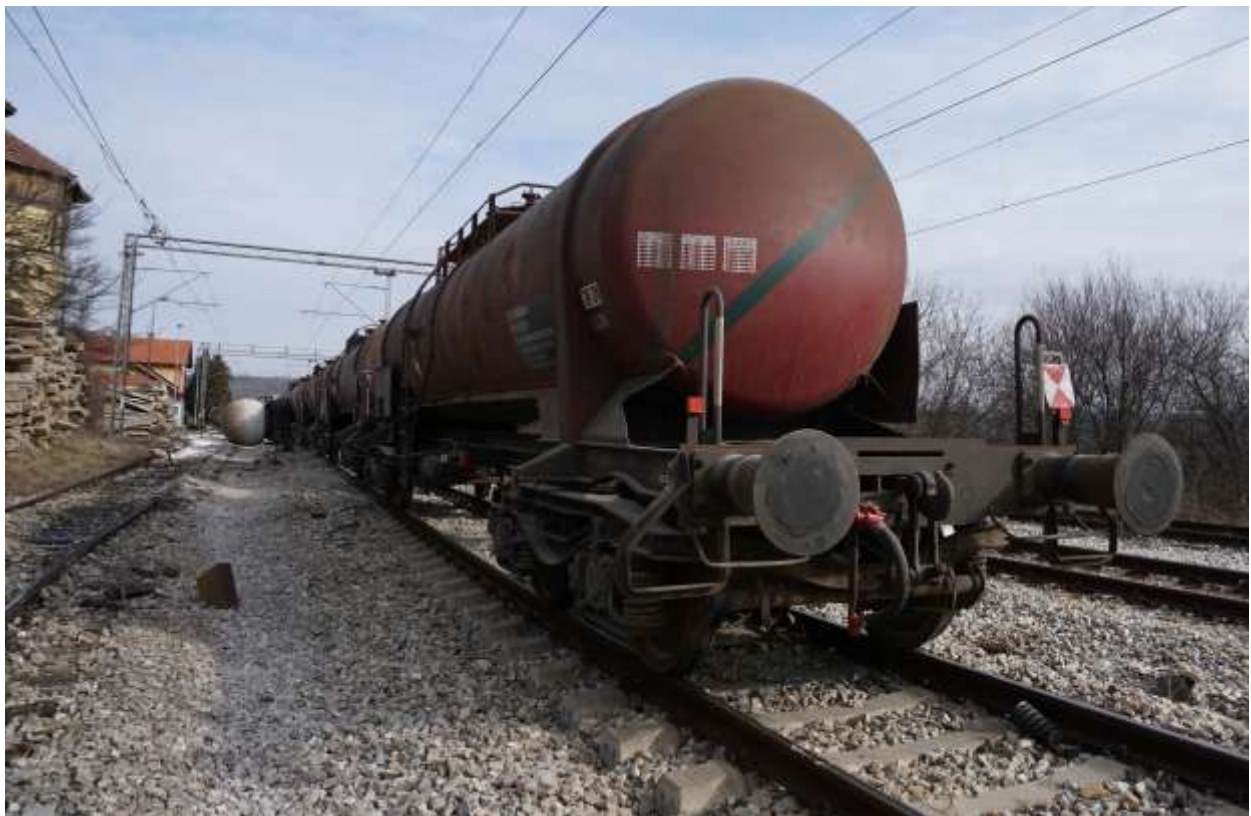
Figure 3.4.4.1: Appearance of the rear part of train No. 51202

The appearance of train No. 51202 at Vrčin station is shown in Figures 3.4.4.1. and 3.4.4.2.

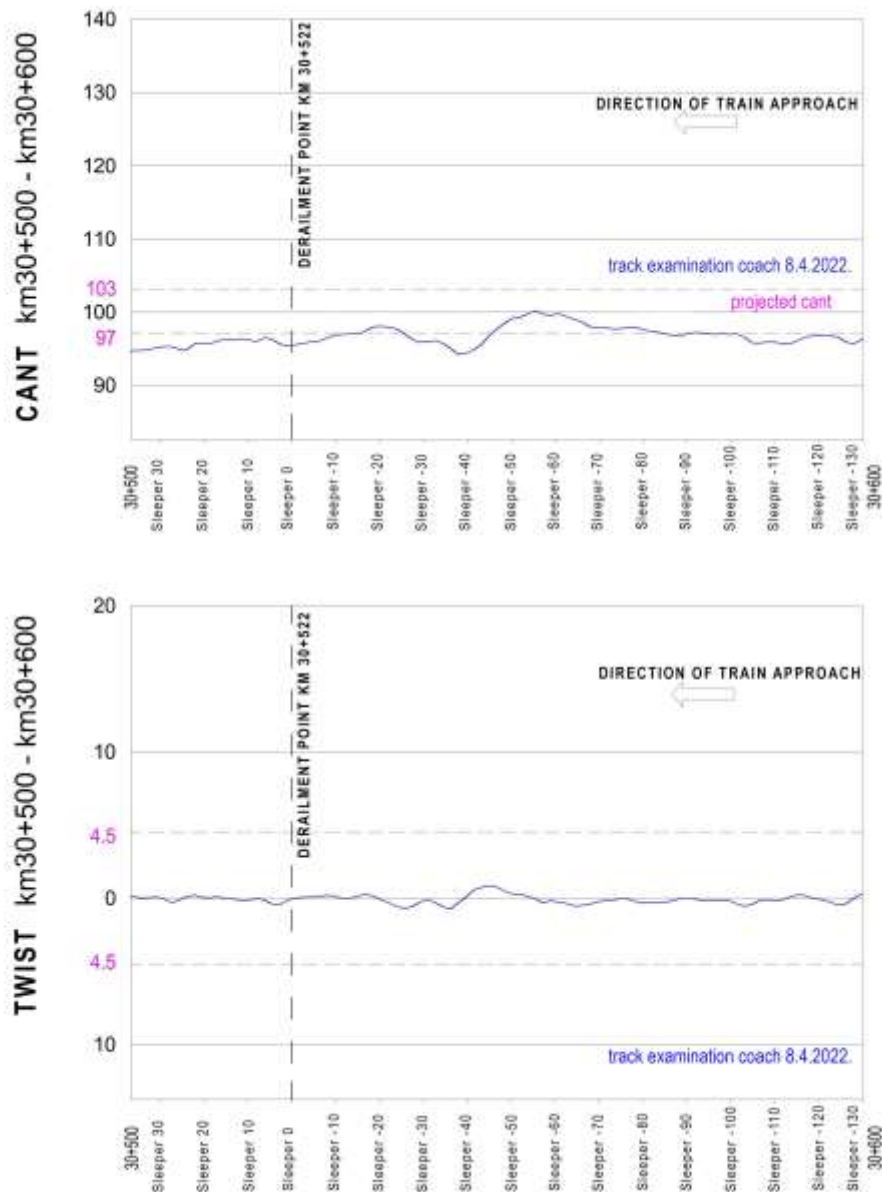
Figure 4.2.1.1: Track geometry measurement results obtained with the track recording vehicle on 08.04.2022, with limits for acceptance of works after renovation from the version of the Regulations that is in force on 08.04.2022

Figure 4.2.1.1. shows the measurement results in the zone where the derailment occurred, with acceptance limits for track works (for $v \leq 80$ km/h) of ± 3 mm for cant and ± 4.5 ‰ for twist (measured over a 3 m base).

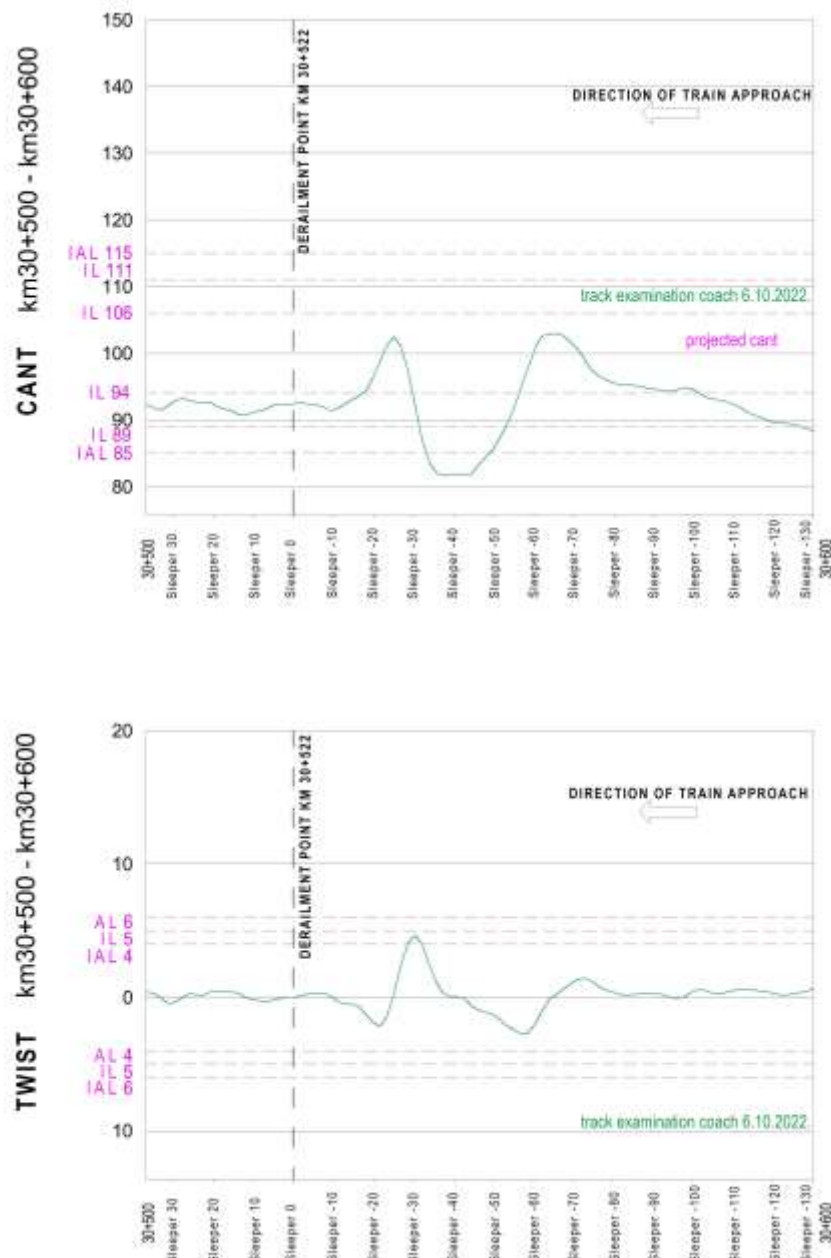
Figure 4.2.1.2: Track geometry measurement results obtained with the track recording vehicle on 06.10.2022. with limits for maintenance

Figure 4.2.1.2. shows the results of cant and twist measurements in the zone where the derailment occurred, with the maintenance limits. For the observed curve, the relevant IAL of 6 ‰ was entered for the twist, which is explained in chapter 4.2.4.

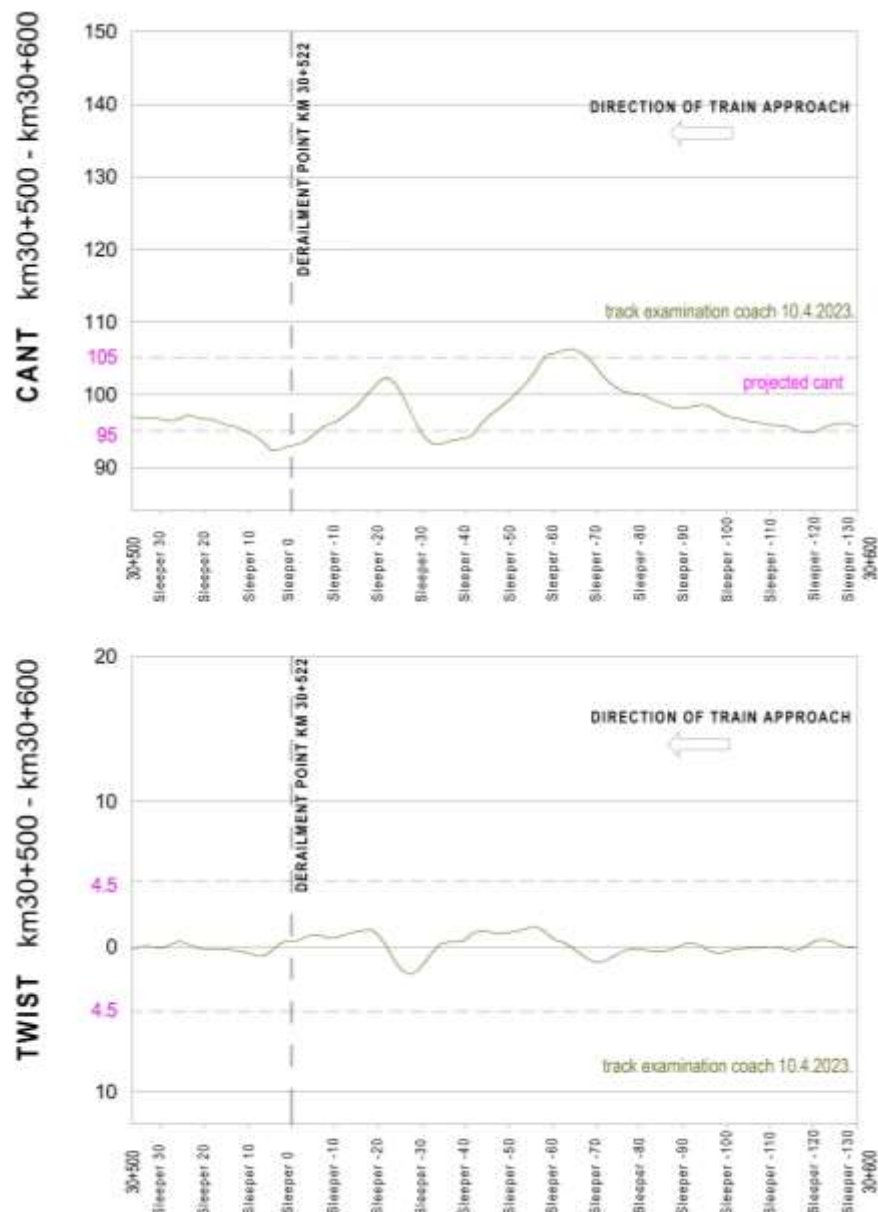
Figure 4.2.1.3: Track geometry measurement results obtained with the track recording vehicle on 10.04.2023. with maintenance acceptance limits, according to the applicable SRPS EN 13231-1 standard.

MEASUREMENT 10.04.2023.	Defects:							
	#	Param	Start	End	Threshold	Extremum	Length	Degree
	Summary:							
	Param	GU		GI		GHI		
		Len, m	Count	Len, m	Count	Len, m	Count	
	D1 VERSINE L	4.40	2	0.00	0	0.00	0	
	D1 VERSINE D	3.00	3	0.70	1	0.00	0	
	CANT	55.50	12	0.00	0	0.00	0	
	Total	62.90	17	0.70	1	0.00	0	
	Track condition assessment	Very good						
TQC STD	E

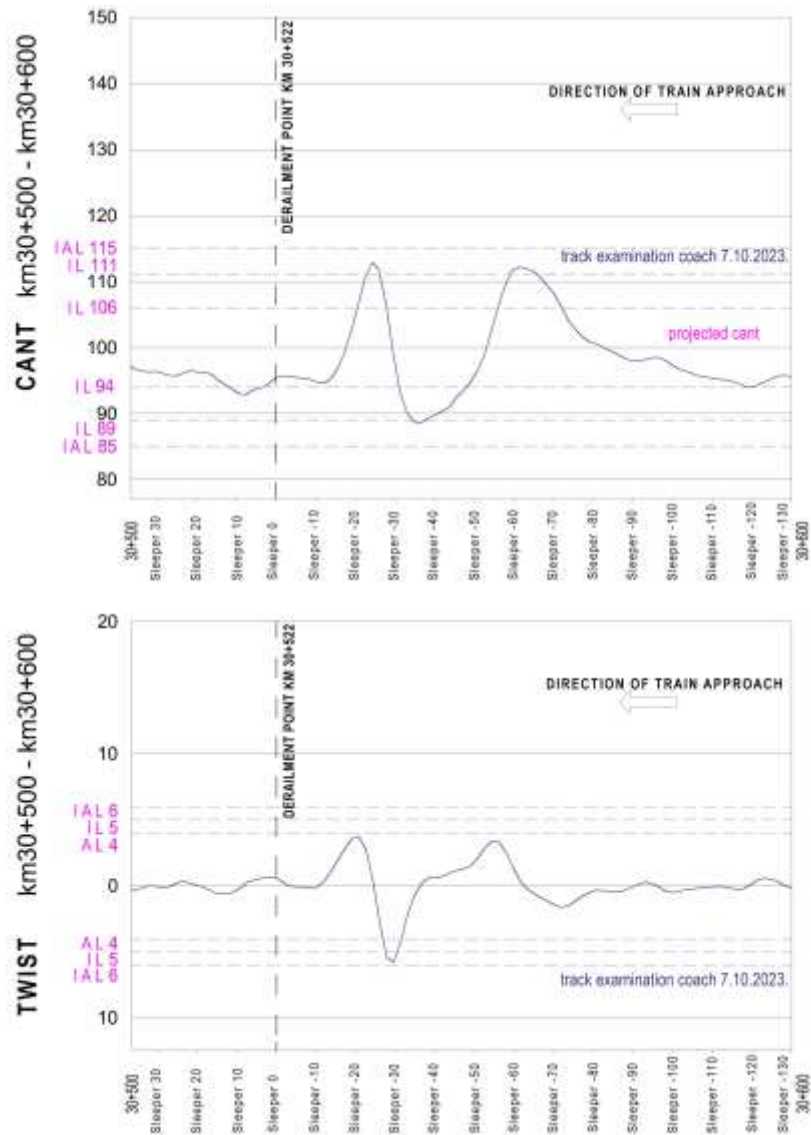
Figure 4.2.1.4: Track geometry measurement results obtained with the track recording vehicle on 07.10.2023. with maintenance limits.

MEASUREMENT 07.10.2023.	Defects:							
	#	Param	Start	End	Threshold	Extremum	Length	Degree
	1	CANT	30.130	30.111	-15.00	-49.57	18.70	GHI
	Summary:							
	Param	GU		GI		GHI		
		Len, m	Count	Len, m	Count	Len, m	Count	
	D1 STABILITY L	3.30	1	0.00	0	0.00	0	
	D1 STABILITY D	3.90	1	0.00	0	0.00	0	
	CANT	95.00	27	11.10	6	18.70	1	
	TWIST	9.80	8	10.50	4	0.00	0	
VERTICAL RAIL WEAR L	7.70	3	0.00	0	0.00	0		
LATERAL RAIL WEAR L	0.80	1	0.00	0	0.00	0		
Total	120.50	41	21.60	10	18.70	1		
Track condition assessment	Satisfactory							
TQC STD	E

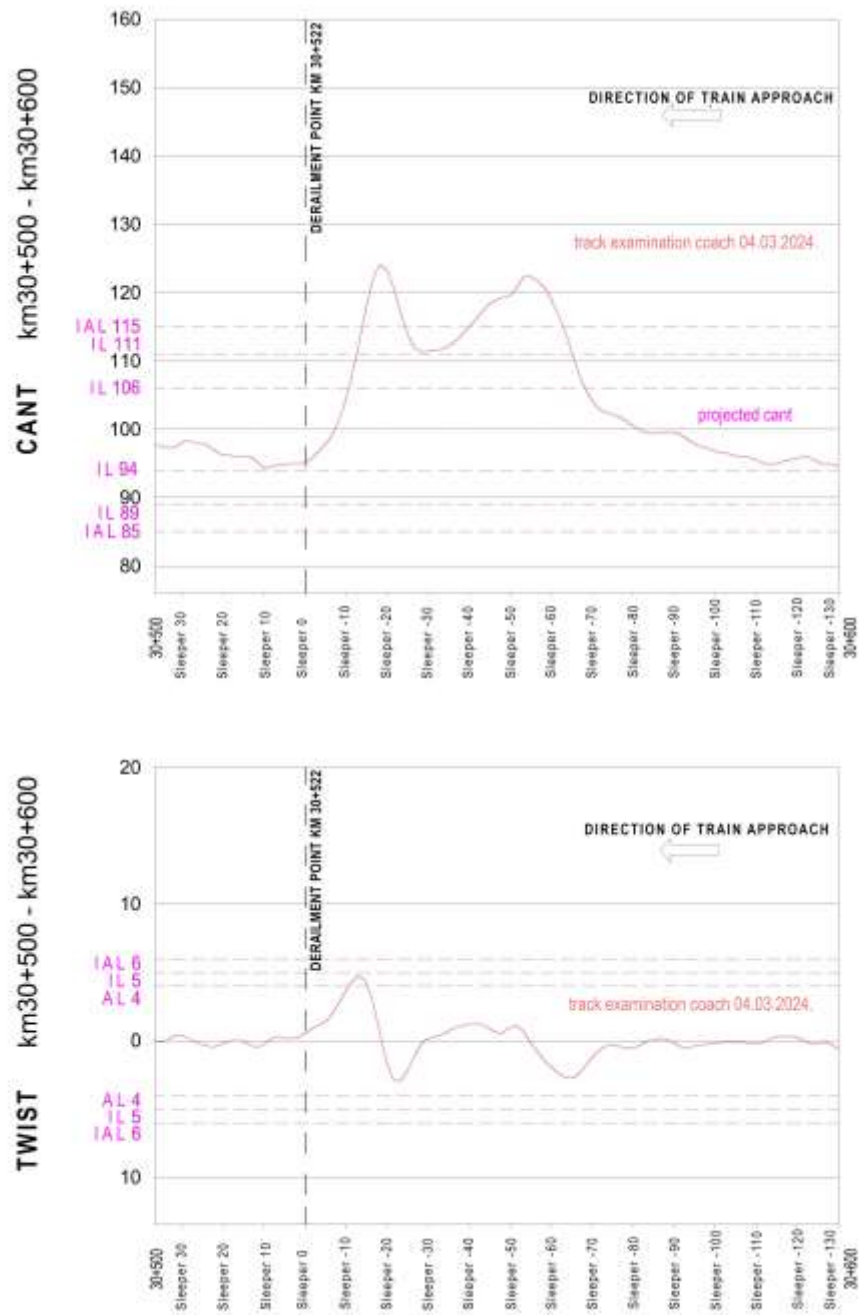
Figure 4.2.1.5: Track geometry measurement results obtained with the track recording vehicle on 04.03.2024. with maintenance limits.

1294	CANT	30.563	30.561	-6.00	-10.96	1.80	GU
1295	VERTICAL RAIL WEAR R	30.566	30.565	12.00	12.93	0.40	GU
1296	VERTICAL RAIL WEAR R	30.567	30.566	12.00	14.62	0.70	GU
1297	VERTICAL RAIL WEAR R	30.572	30.569	12.00	15.99	2.80	GU
1298	VERTICAL RAIL WEAR R	30.575	30.572	12.00	15.93	2.30	GU
1299	VERTICAL RAIL WEAR R	30.581	30.577	12.00	16.07	4.40	GU
1300	VERTICAL RAIL WEAR R	30.599	30.594	12.00	16.21	5.50	GU

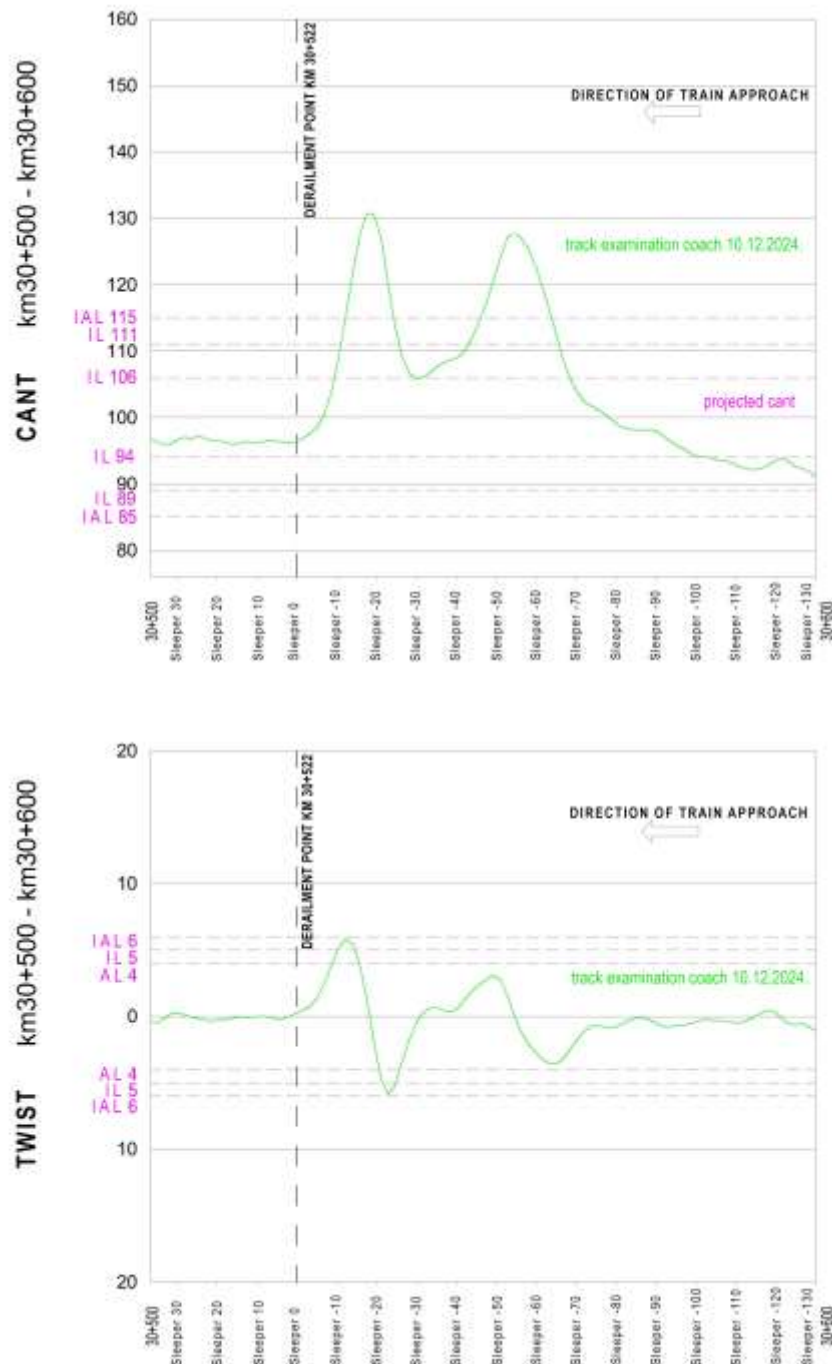
Figure 4.2.1.6: Track geometry measurement results obtained with the track recording vehicle on 10.12.2024. with maintenance limits.

1528	LATERAL WEAR R	30.561	30.561	6.90	6.61	0.20	GU
1529	VANT	30.561	30.563	-6.00	-10.79	1.60	GU
1530	LATERAL WEAR R	30.562	30.564	6.20	6.87	1.80	GU
1531	LATERAL WEAR R	30.574	30.575	6.90	6.59	1.60	GU
1532	LATERAL WEAR R	30.578	30.579	6.90	7.15	0.80	GU
1533	LATERAL WEAR R	30.580	30.580	6.90	6.64	0.20	GU
1534	CANT	30.584	30.594	6.00	7.70	9.70	GU

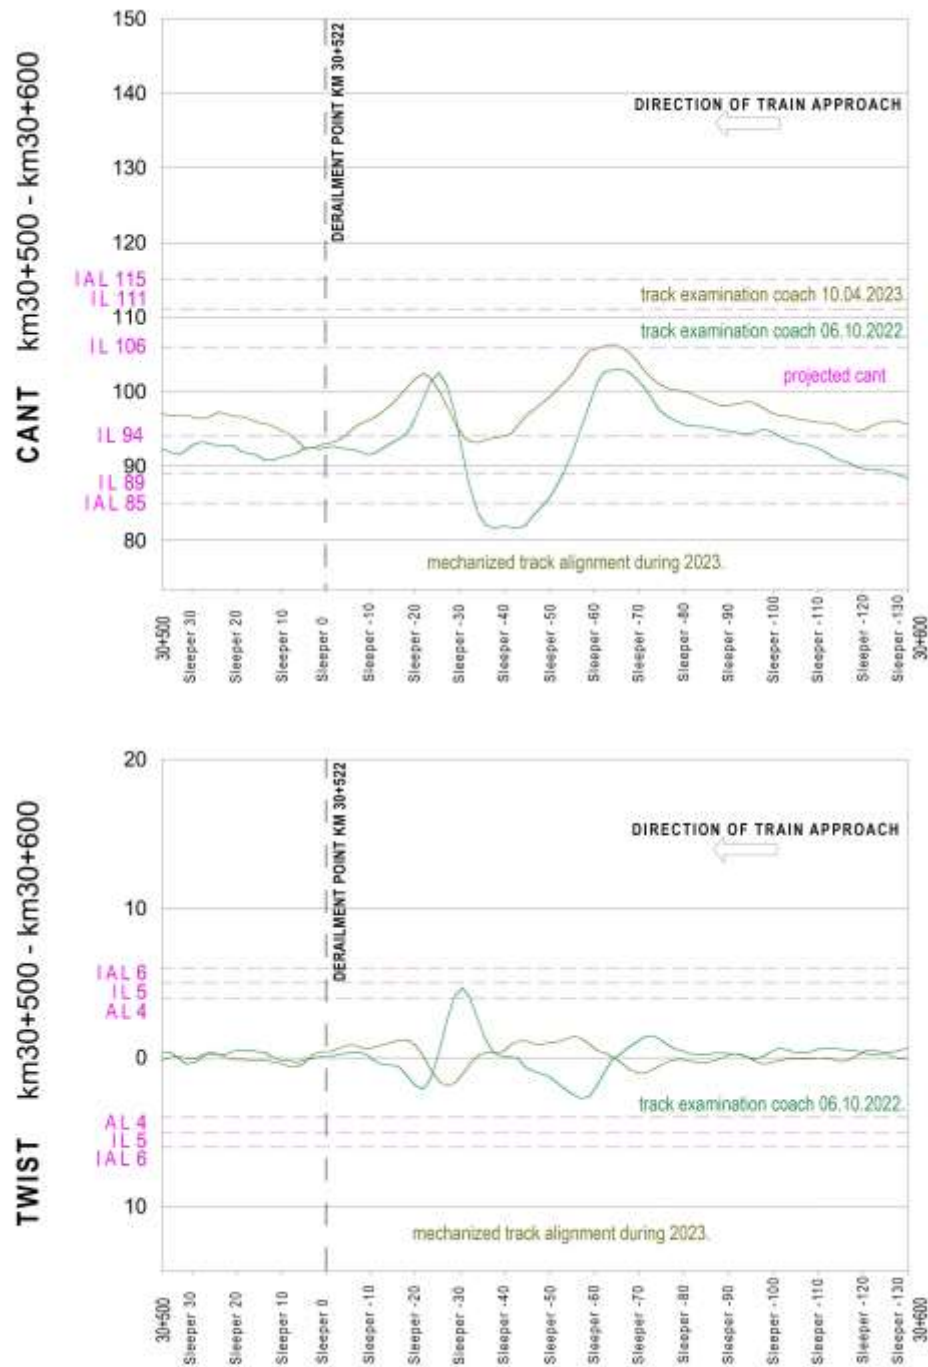
Figure 4.2.3.1: Cant and twist variation in the derailment zone before and after mechanized track alignment at the beginning of 2023

On main line No. 103, from km 12+045 to km 99+716, the only mechanized maintenance was performed at the beginning of 2023, following supervision by the Internal Control Center of "IŽS"a.d. The Internal Control Center Report dated 05.03.2024 notes that mechanized track adjustment was carried out over a length of 7,790 m, partially prioritized in certain areas. The improvement results for the section from km 30+500 to km 30+600 can be seen in the overlaid diagram of twist and cant (Figure 4.2.3.1.), but these results did not meet the acceptance limits for maintenance works according to the SRPS EN 13231-1 standard, as specified in the Instruction on Amendments and Supplements to the Instructions on Uniform Criteria for Track Condition Control on the JŽ Network ("Official Gazette ZJŽ", Nos. 6/01 and 4/04), document No. 4/2022-3496-718 dated 25.03.2022 (see Section 3.3.6.).

Except for a single mechanized track adjustment performed in 2023, the track geometry parameters have been in continuous decline (Figure 4.2.3.1.), as evidenced by the number of UIC urgent (IAL), intervention (IL), and warning (AL) errors, as well as the track condition assessments for each measurement conducted.

- БП_07/26** “IŽS” a.d. should carry out a review of the causes leading to the recurrence of track geometry defects at the same location (see section 4.2.3.2.). Upon determining the causes and assessing the safety risks that have arisen as a result, it should take effective measures to eliminate the identified safety deficiencies, in accordance with the requirements of Article 5 of the Law on Railway Traffic Safety (“Official Gazette of the Republic of Serbia”, No. 41/2018).

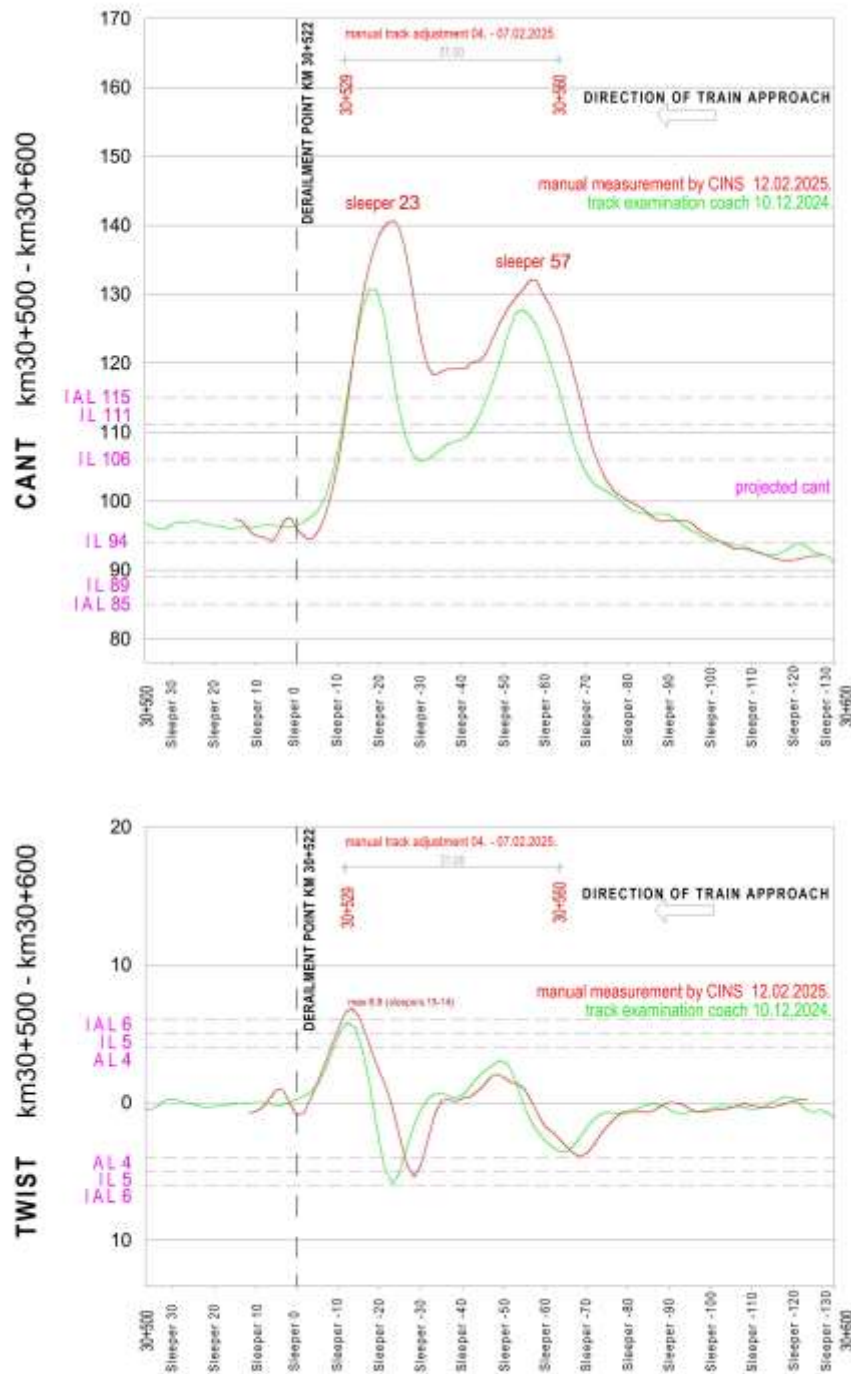
Figure 4.2.3.3: Comparison of measurement results obtained by the track recording vehicle on 10.12.2024 and manual measurements carried out after the accident on 12.02.2025

28.08.2024, was initiated only after the inspection by the Internal Control Center, which commenced on 03.02.2025. On the overlaid diagram of cant and twist from 10.12.2024 and the CINS manual measurement taken the day after the accident (Figure 4.2.3.3.), no correction of the track geometry is visible, although such an adjustment should have been carried out via manual regulation and, according to the provided documentation, was completed four days before the accident (07.02.2025).

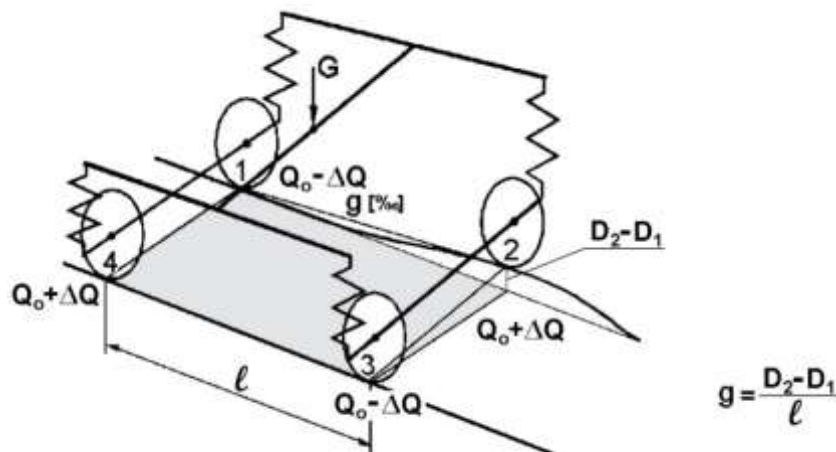
Figure 4.2.4.1: Influence of twist on wheel unloading

In the SRPS EN 13848-5 standard, the twist is defined as: "The algebraic difference between two cants, taken at a defined distance, usually expressed as the gradient between two measurement points. It is expressed in ‰ or mm/m". Therefore, the twist g for different measurement bases can simply be obtained as the difference in cant (D - the designation for cant in the standard) expressed in mm in two sections at a distance l , divided by that distance in m: $g = (D_2 - D_1) / l$.

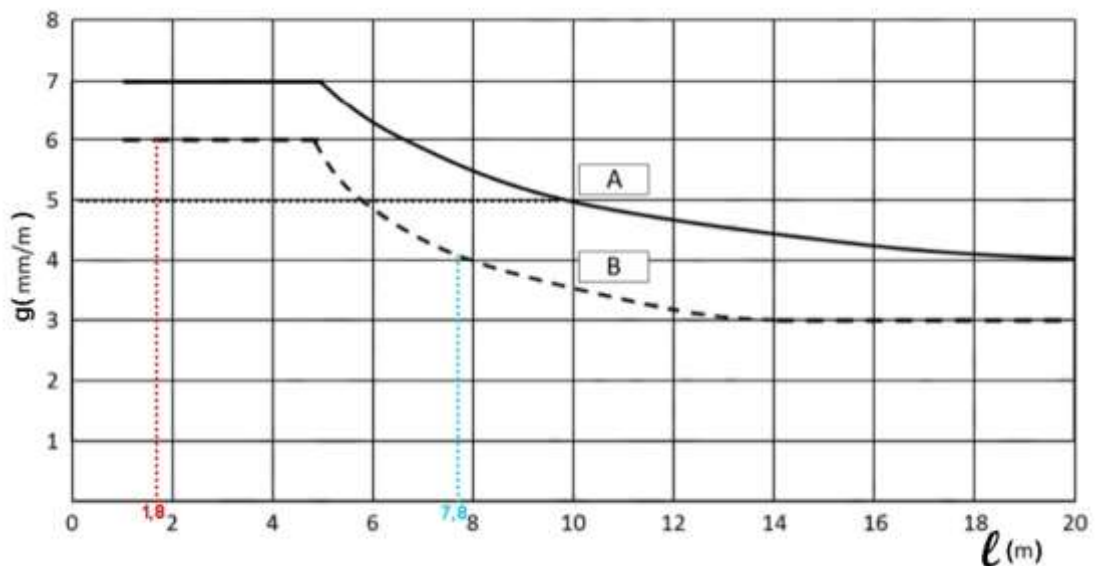
Figure 4.2.4.2: Limit values of twist

The limit values of twist requiring immediate intervention according to Curve “B” are determined using the formula: $IAL = ((20/\ell) + 1,5)$, with a maximum value of 6 mm/m and a minimum limit value of 3 mm/m.

- SR_08/26** “IŽS” a.d. should, through amendments and supplements, align the Instruction on Uniform Criteria for Monitoring the Condition of Railway Lines on the ŽS Network with the requirements of the Rulebook on the Maintenance of the Railway Tracks Super and Sub Structure with regard to the application of standard SRPS EN 13848-1 for the acceptance of works (see section 4.2.1.) and standard SRPS EN 13848-5 with respect to the GHI for twist (see section 4.2.4.).

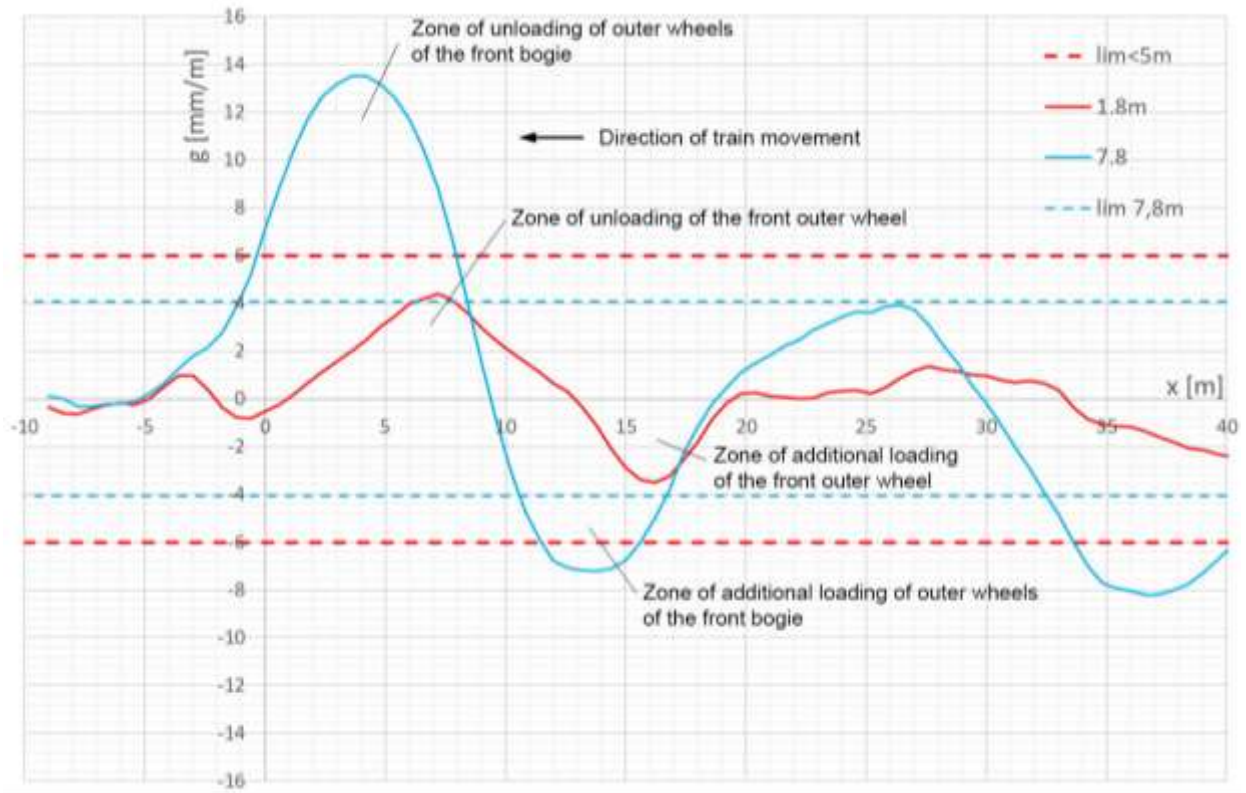
Слика 4.2.4.3: Twist based on the dimensions of the derailed wagon

The direct and immediate cause of the accident was wheel climb on the rail in a sharp curve with a radius of 295 m, due to track twist over the relevant distance between the bogie centers axis, significantly exceeding the permissible limit of GHI, in combination with cant exceeding the GHI. The condition of the center bowl assembly of the leading bogie of the derailed wagon, most likely contributed, to a lesser extent, to an increase in the yawing/turning moment and, consequently, to an increase in the lateral (Y) force acting on the leading wheel and the Y/Q force ratio, which is decisive for this type of derailment.

With regard to the specific derailment, the governing parameters are the track twist based on the distance between wheelsets in bogie, which for the derailed wagon was 1.8 m, and the track twist based on 7.8 m, corresponding to the distance between bogie centres. Based on the cant data measured in the derailment zone immediately after the accident by CINS, as presented in Table 4.2.2.1, the calculated twist values are shown in Figure 4.2.4.3. The figure also shows the limit values according to the Curve “B” from the SRPS EN 13848-5 standard for measuring bases of 1.8 m and 7.8 m (see Figure 4.2.4.2.).

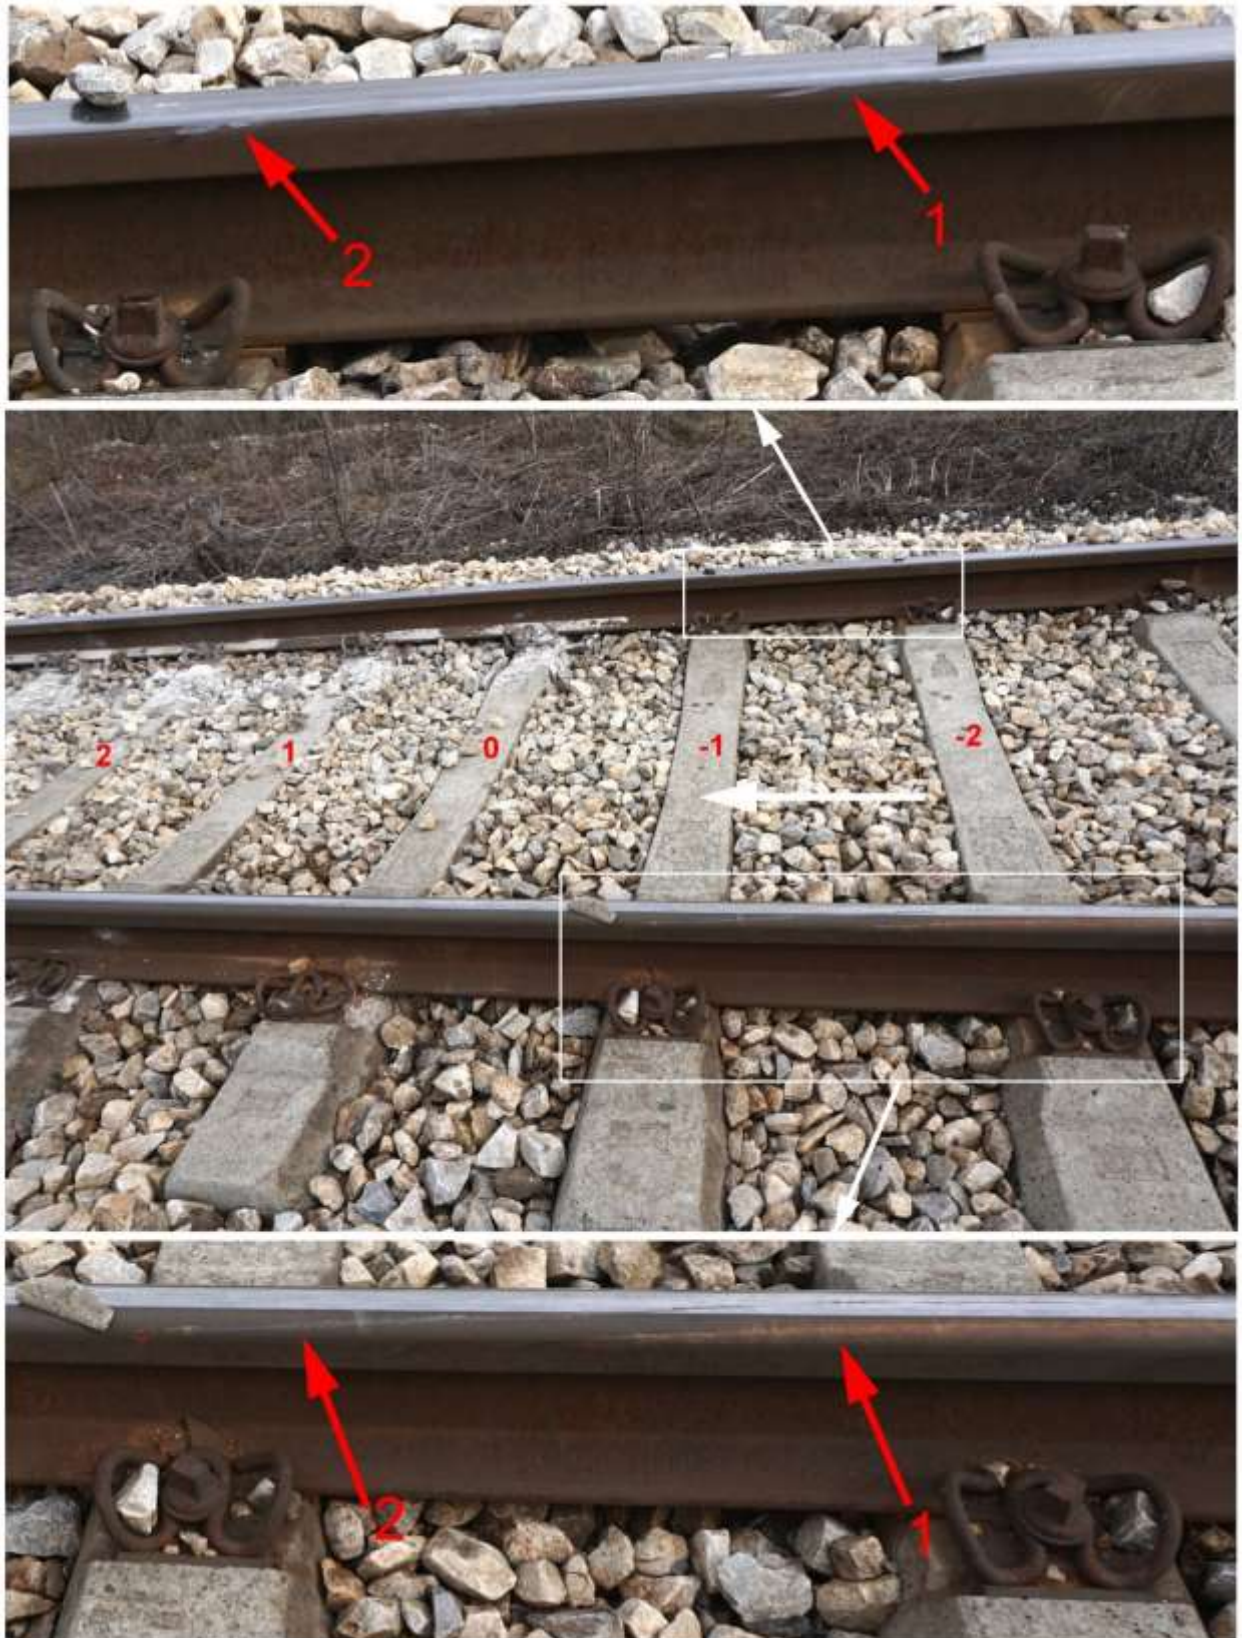
Слика 4.2.8.1: Point of the derailment of Train No. 51202

The direction of train movement is indicated by a white arrow. Details relevant to the investigation are indicated by red arrows and, where necessary, numbered. Enlarged details are shown in the upper and lower parts of Figure 4.2.8.1, where marks on the rails caused by derailment of wheels from two wheelsets are visible.

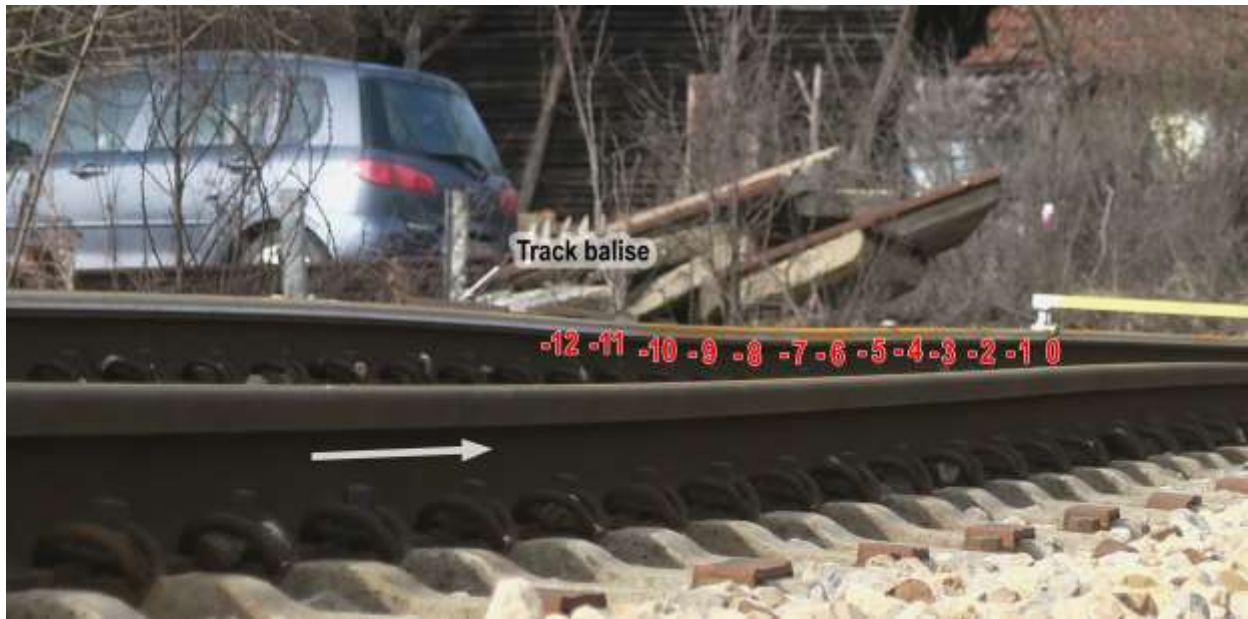
Figure 4.2.8.4: Track layout in the derailment zone

In Figure 4.2.8.4, the measuring device is positioned above sleeper 0. Climb of the outer wheel of the first wheelset of wagon No. 33 87 7866 801-6 began approximately at sleeper -12. The wheel flange climbed onto the rail between sleepers -10 and -9, began descending towards the outer side of the rail at sleeper -2, and struck sleeper 0 from the outer side, as shown in the previous figures.

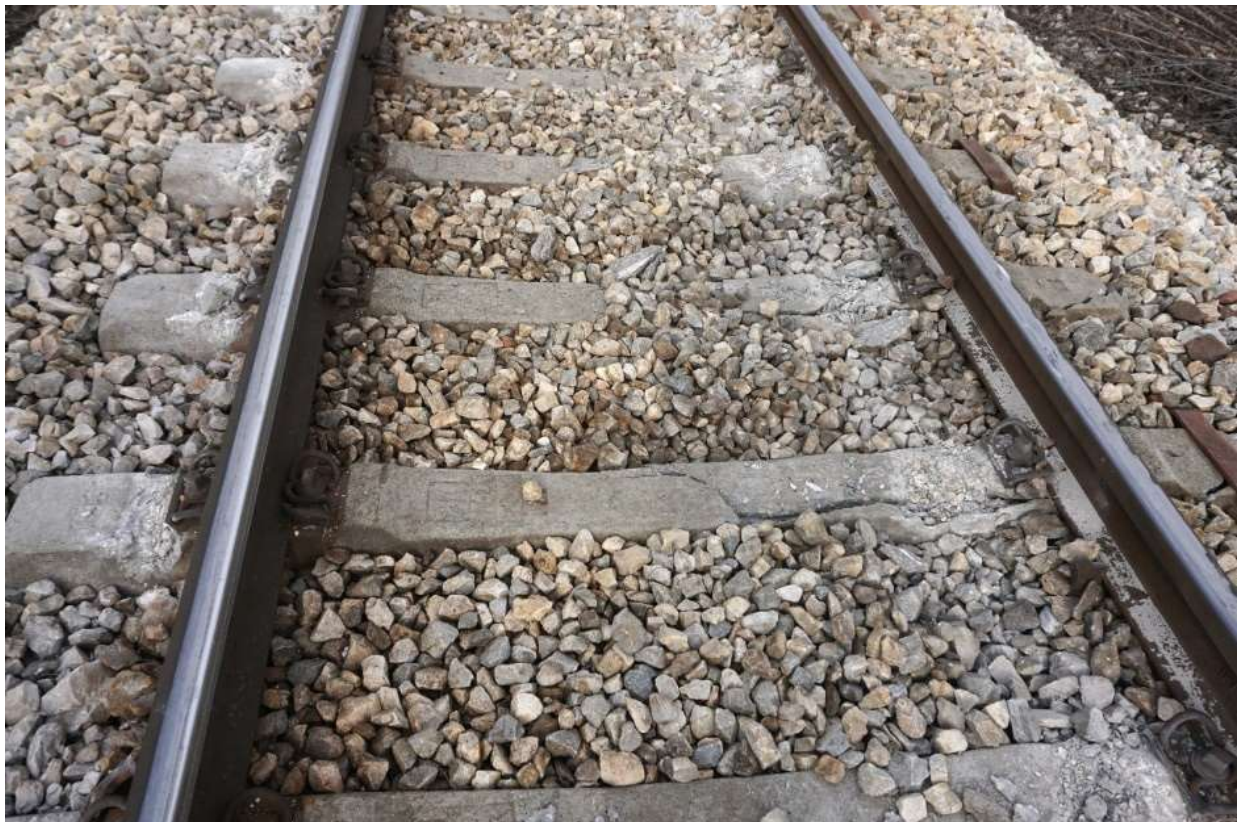
Figure 4.2.9.1: Damaged and broken sleepers

From sleeper 0 to Vrčin station, marks of derailed wheelsets and broken or damaged sleepers can be traced, as illustrated in Figure 4.2.9.1.
