REPUBLIC OF SERBIA
CENTER FOR INVESTIGATION OF ACCIDENTS IN TRANSPORT
SECTOR FOR INVESTIGATION OF ACCIDENTS IN RAILWAY TRAFFIC
Nemanjina 11, 11000 Belgrade

FINAL REPORT ON ACCIDENT INVESTIGATION

Accident type: Train derailment

Train No.: 51202

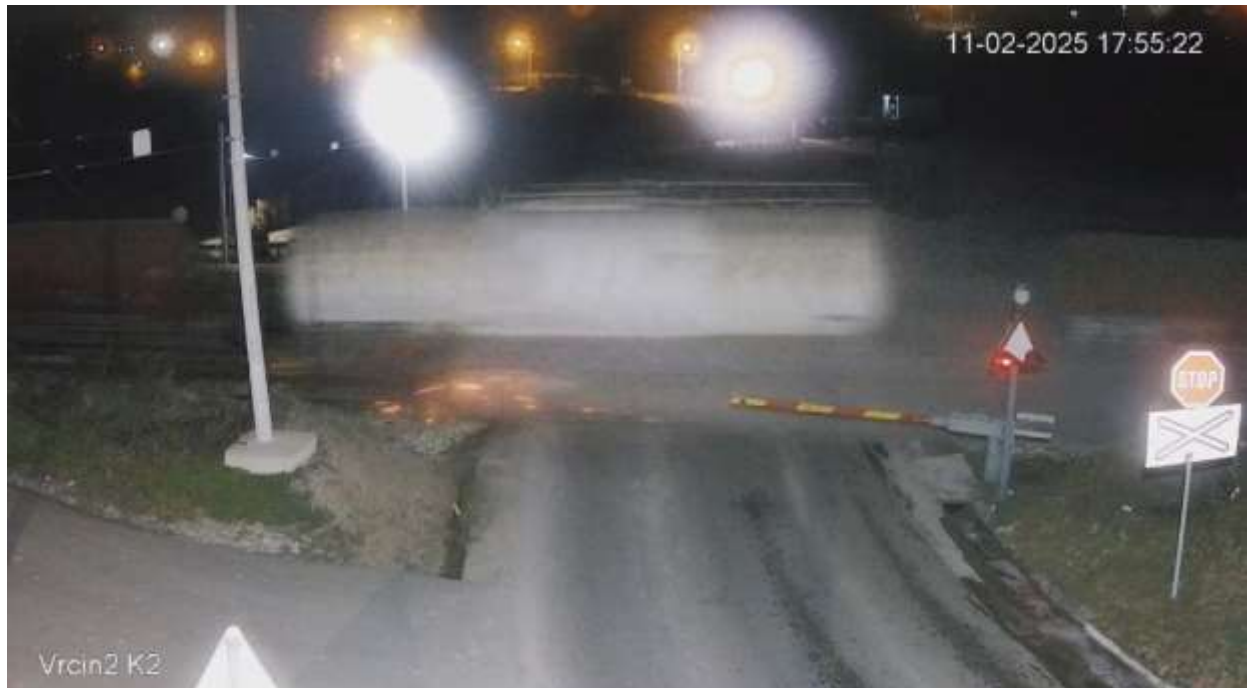
Figure 4.2.9.2: Sparking caused by impacts of derailed wheels of the eleventh wagon against the track structure (source: “IŽS” a.d.)

Figure 4.2.9.2. shows a frame from a CCTV camera at level crossing PBE-1 (Vrčin 2). Intense sparking caused by impacts of the wheels of the leading bogie of the eleventh wagon against sleepers and ballast can be observed.

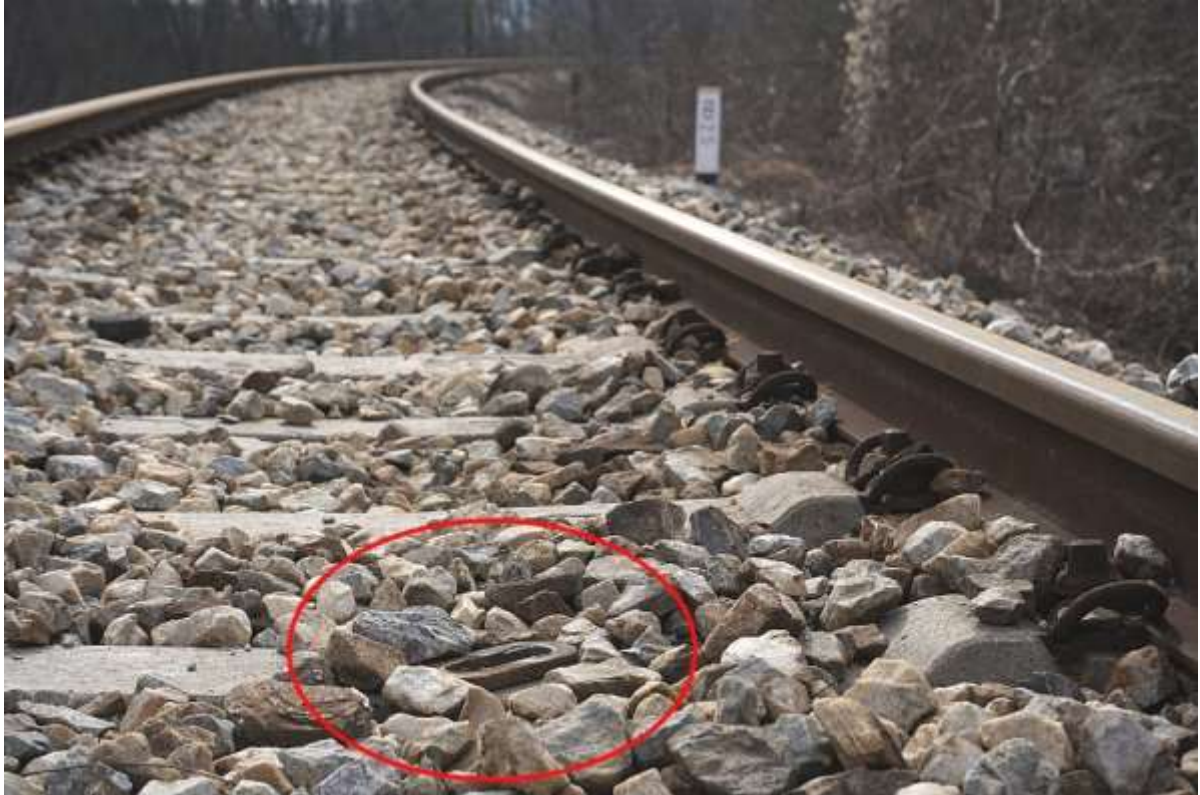
Figure 4.2.9.3: Fallen out suspension link

In the track area between the derailment site and Vrčin station, some suspension components of the front bogie of wagon No. 33 87 7866 801-6 became detached. One suspension link was found at km 25+800, Figure 4.2.9.3. Several broken parts were located between the entrance signal Eu 91 and the entrance switch No. 6 at Vrčin station. The front bogie’s broken headstock of the eleventh wagon was found approximately 50 m before switch No. 4 at Vrčin station. All these components detached as a consequence of impacts with sleepers and ballast over a distance exceeding 5 km, from the derailment site to Vrčin station.

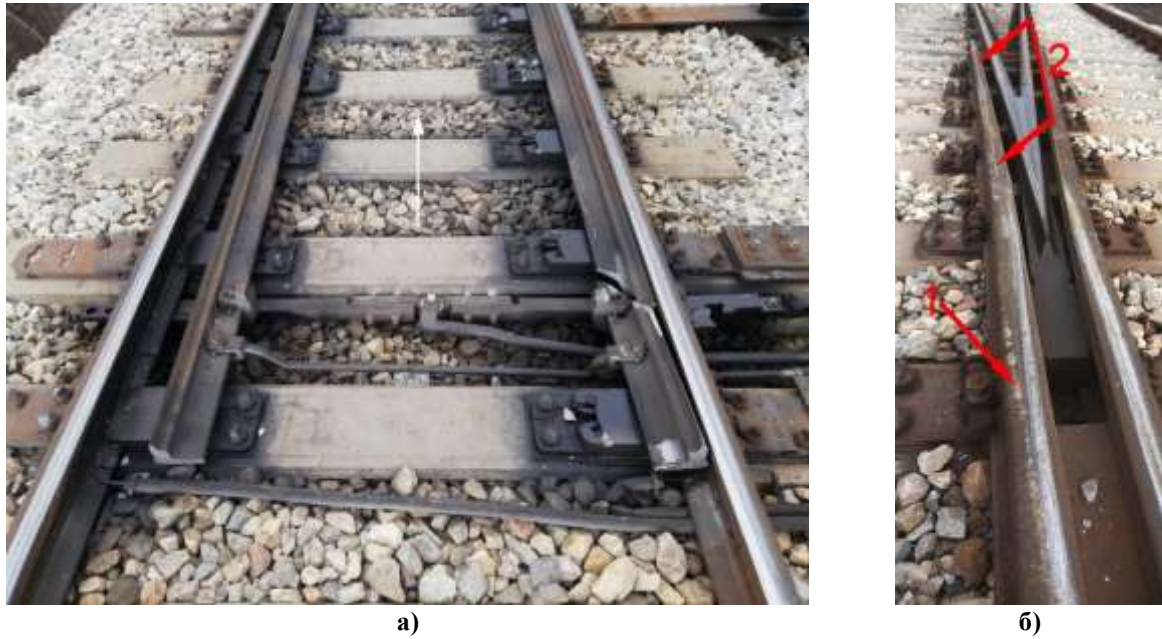
Figure 4.2.10.1: Broken switch blade and wheel marks on the switch point of switch No. 6 at Vrčin station

At the entry of Vrčin station, on the right-hand entrance switch No. 6, which was set in straight position, the derailed right wheel impacted the right switch blade base and broke it (Figure 4.2.10.1.a). Subsequently, the right wheels of the first and second wheelset impacted the switch point base and climbed onto the right stock rail (Figure 4.2.10.1.b)). Beyond the switch, the derailed wheelsets continued moving so that the left wheels left a mark along the outer side of the left rail and the right wheels along the inner side of the right rail in the direction of travel. At the end of the switch, in the welded rail joint zone, both left and right rails fractured.

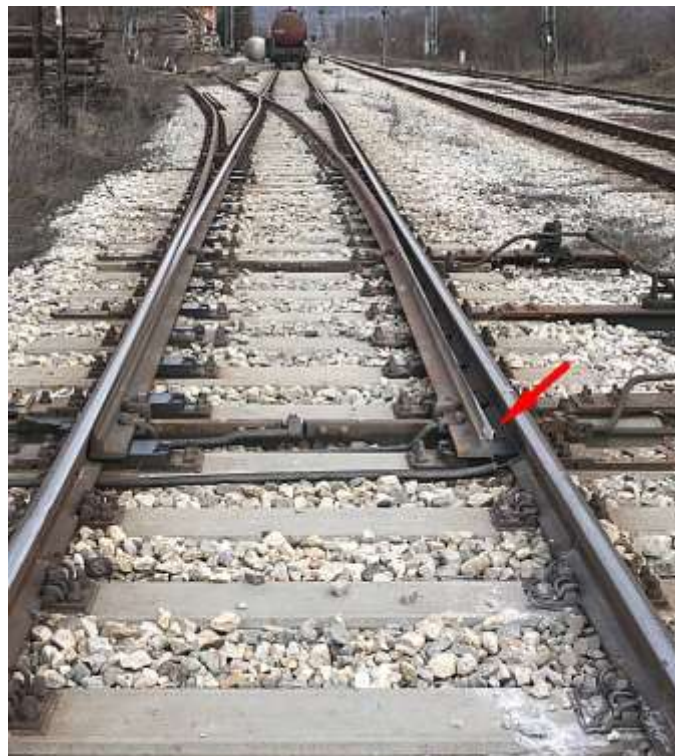
Figure 4.2.10.2: Broken switch blade and wheel marks on the switch point of switch No. 4 at Vrčin station

Upon reaching the left-hand switch No. 4, set in straight position, the derailed right wheels struck the right switch blade, which was in an offset position from the rail (Figure 4.2.10.2.), and climbed onto the displaced right stock rail of the switch.

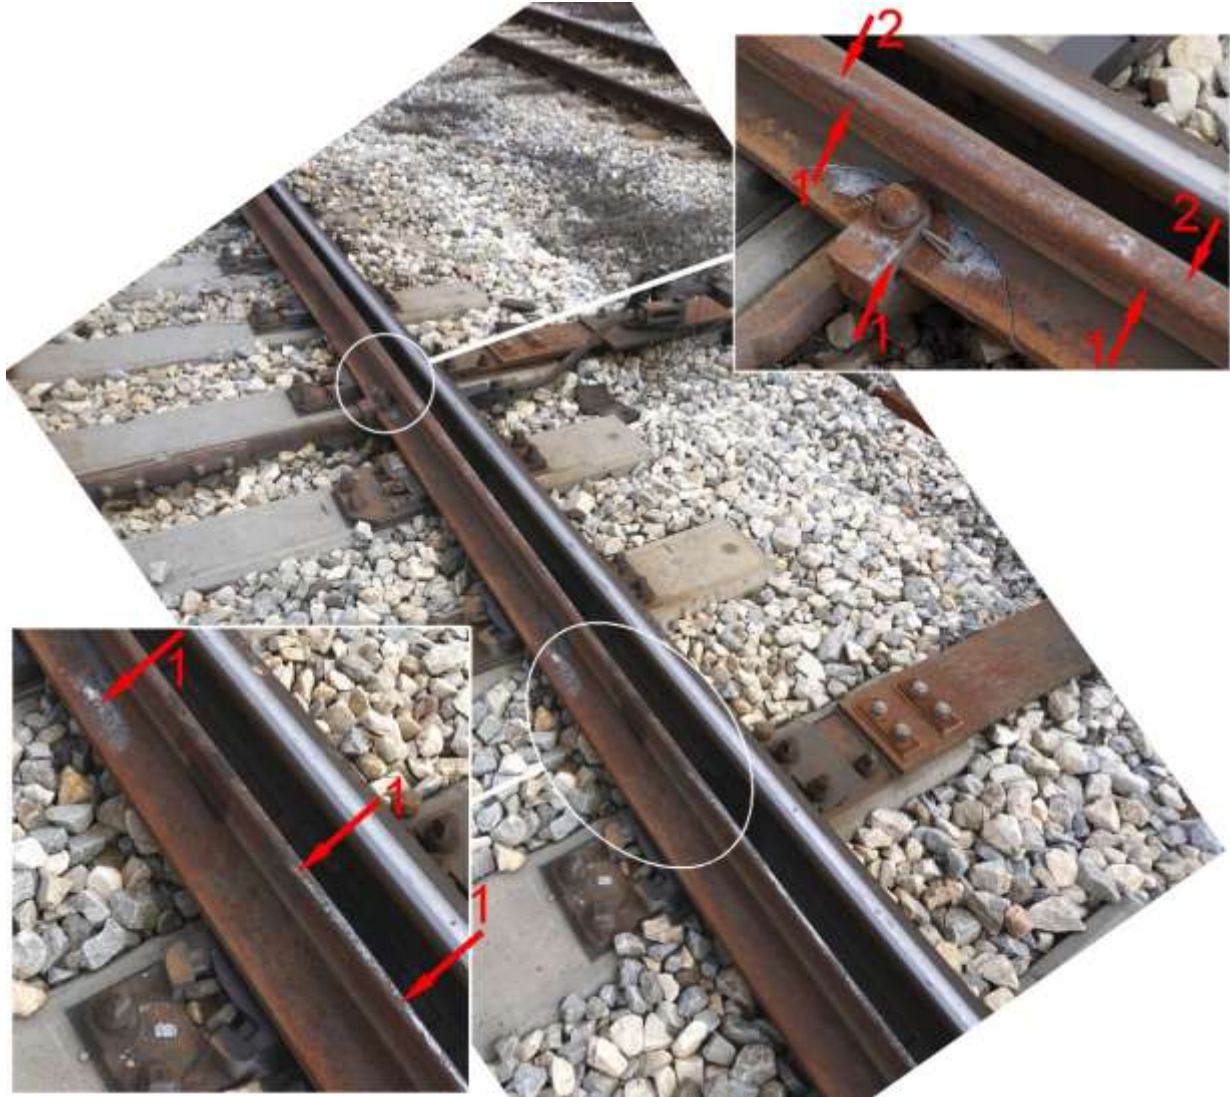
Figure 4.2.10.3: Traces of movement of the right derailed wheels on the right rail of the switchgear of switch No.4

After approximately 2.5 m, one wheel and then the other fall into the track to the left and the entire front derailed bogie of the eleventh wagon starts to turn towards the first track. Figure 4.2.10.3. shows the traces of this fall. In this case, the rail foot broke in the area where the switch rail connects to the switching mechanism (detail on the right, above, in Figure 4.2.10.3.).

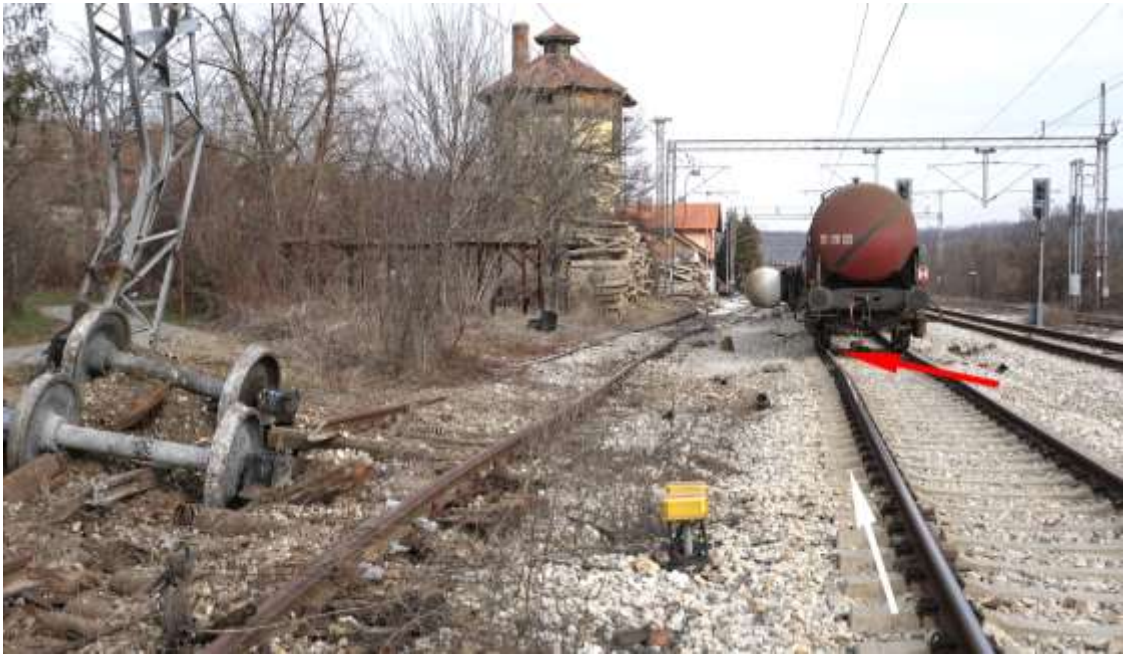
Figure 4.2.10.5: Position of detached wheelsets and overturned tank wagon

In the overturning zone, several springs were scattered, the rear coupler of the eleventh wagon was torn off, along with other detached wagon components, as shown in Figure 4.2.10.5. The transverse displacement of the second track is indicated by the red arrow in the figure.

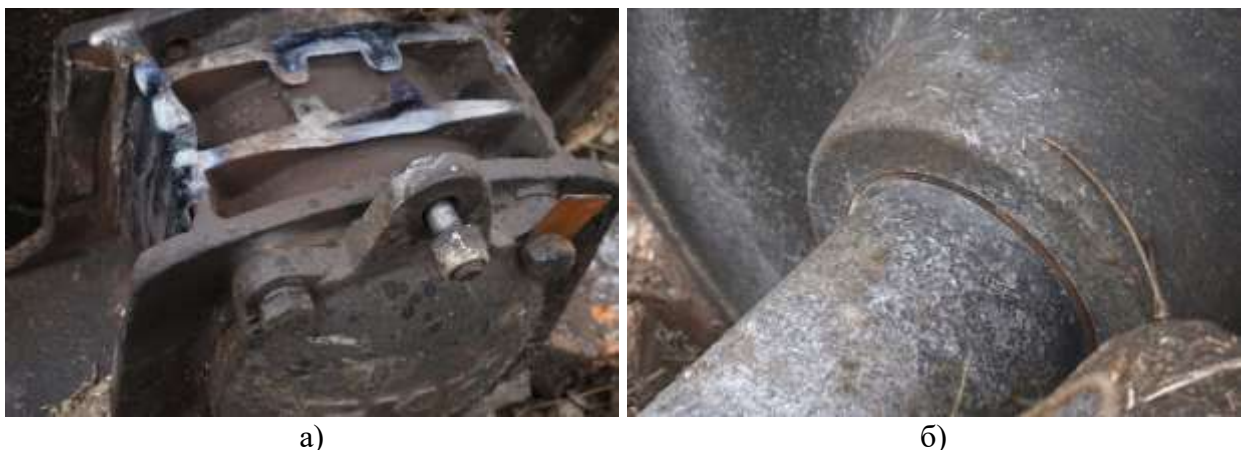
Figure 4.2.10.6: Right bearing housing and left wheel of the first wheelset of the eleventh wagon

In Figure 4.2.10.6.a), the right bearing housing of the first detached wheelset of the eleventh wagon is shown. On its upper surface and the rear wear plate, deformation marks and bluish discoloration are visible, indicating elevated temperatures developed during movement of the derailed wheelset. On the front wear plate of the left housing, as well as on the housings of the second wheelset, no such intensive material discoloration is observed. This suggests that on this housing, the suspension links and springs likely detached first, causing the longitudinal and vertical impacts of the wheel on the sleepers to be transmitted directly to the vertical stop and the contact of the rear wear plate with the bogie jaws. Due to the high number of strong impacts and surface friction, elevated temperatures developed, causing material discoloration.

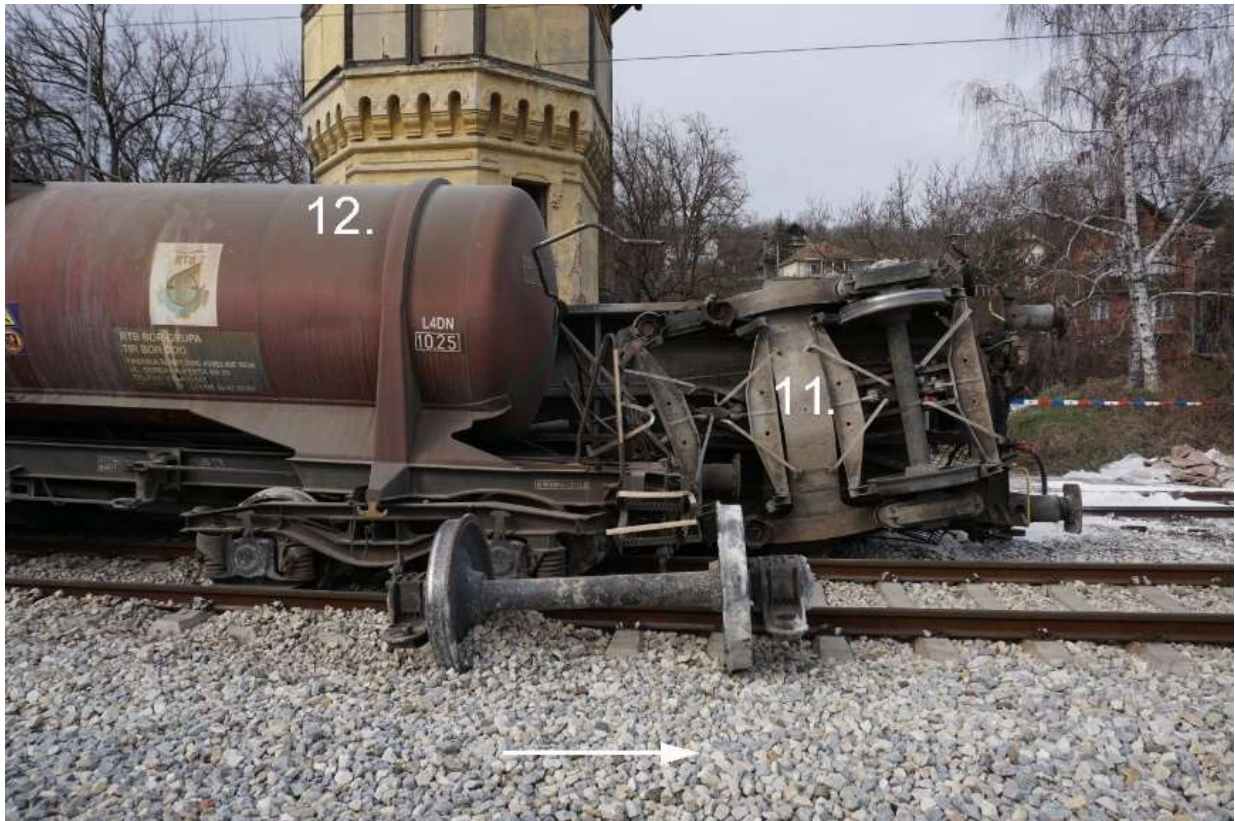
Figure 4.2.10.7: Position of the eleventh and twelfth wagon

could occur during the final impact, wheelsets detachment, and track damage. This is further indicated by the clean surface of the seat of the displaced axle.

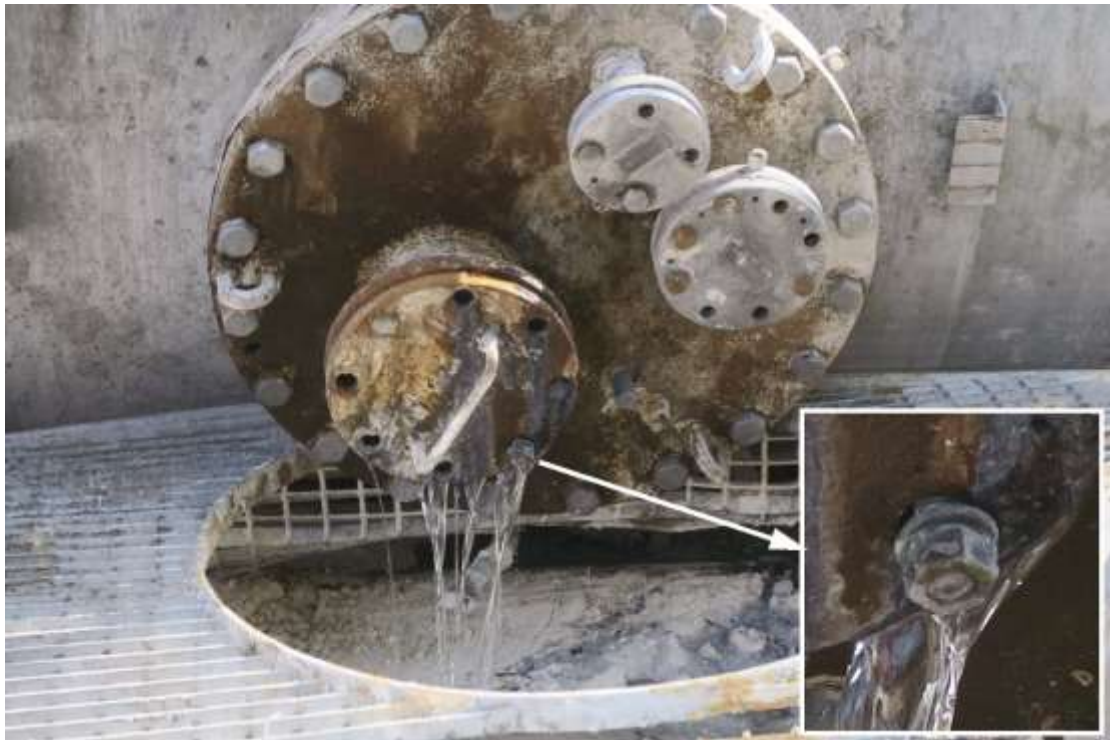
Figure 4.2.11.1: Acid leakage at the filling lid

From the tank of the overturned wagon, leakage of sulphuric acid occurred at the tank lid.

Sulfuric acid leakage occurred from the tank of the overturned wagon No. 33 87 7866 801-6 (Figure 4.2.11.1.). As visible in the figure, on the filling lids from which the acid is leaking, only three of the designed eight bolts are present, one of which is completely loose. On the gas-phase lid, only two of four bolts are present, and on the liquid-phase lid, only three of eight. Missing bolts on the lids were also noted on other wagons in the train set. This indicates shortcomings during tank filling and venting, i.e., non-compliance with the design specifications for pressure vessel lids.

- SR_11/26** *Elixir Group d.o.o. Šabac* should supplement its Instruction for the Proper Securing of Wagon-tanks after Loading and before Leaving the Factory Premises, in order to ensure the tightness of the tanks (checking the cleanliness and evenness of the seating surfaces, using undamaged prescribed gaskets, closing the openings with the designed number of bolts using a torque wrench with the torque specified by the manufacturer), provide the necessary conditions for its implementation, and additionally train the staff for correct handling (see section 4.2.11.).

- SR_12/26** *Serbia Zijin Copper d.o.o. Bor* should supplement its Instruction “Loading of Sulfuric Acid into Wagon-tanks” in order to ensure the tightness of the tanks (checking the cleanliness and evenness of the seating surfaces, using undamaged prescribed gaskets, closing openings with the designed number of bolts using a torque wrench with the torque specified by the manufacturer), provide the necessary conditions for its implementation, and additionally train the staff in correct handling (see section 4.2.11.).

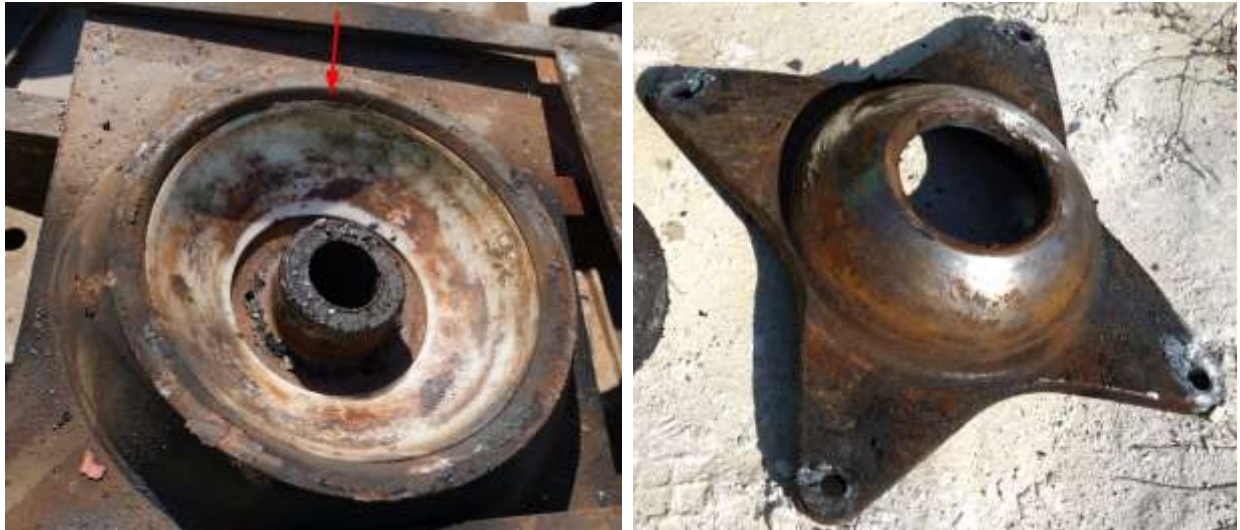
Figure 4.2.13.1: Upper and lower center bowl of the rear bogie

In Figure 4.2.13.1, the condition of the lower and upper center bowl of the rear bogie, viewed in the direction of train No. 51202 movement during the accident, is shown. No burrs or scratches were observed that could indicate increased resistance to rotation in the center bowl. On the upper edge of the composite insert, a small area with initial edge slippage is visible (indicated by an arrow). This is unusual, considering only four months had passed since the last scheduled overhaul and insert replacement.

SR_15/26 *Atir-Rail SA*, should analyze the frequency of unacceptable damage to the center bowl inserts during regular maintenance, in order to assess whether the quality of the insert compromises the functionality of the center bowl until the next scheduled overhaul, and in its maintenance instructions, provide appropriate measures for quality control during regular overhauls, including verification that an original center bowl insert is used during replacement (see items 4.2.12. and 4.2.13.).

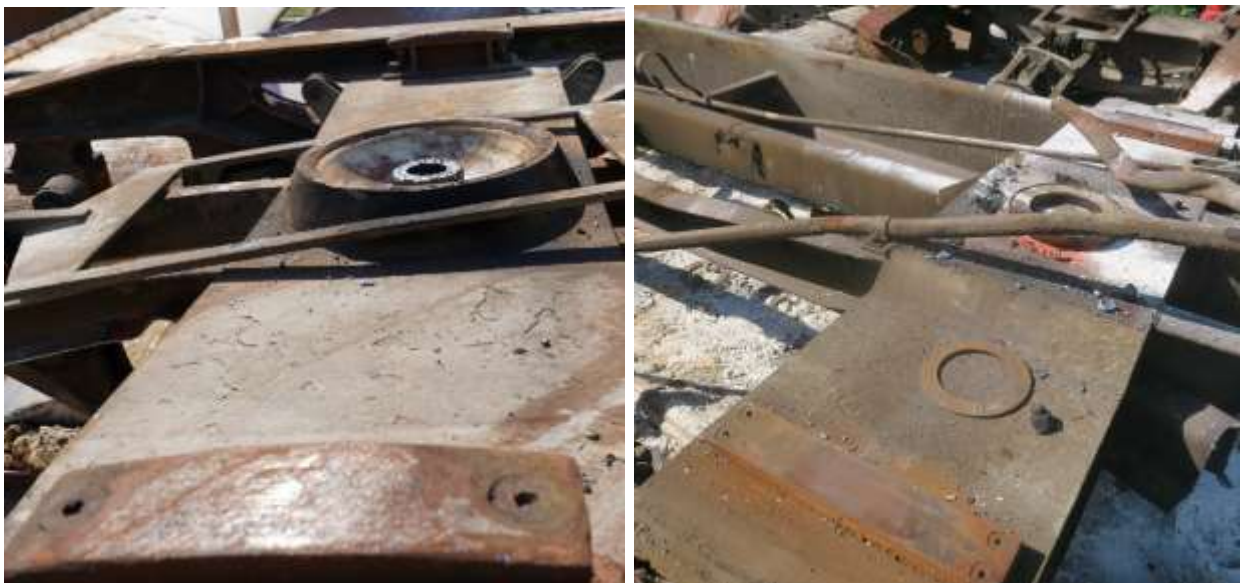
Figure 4.2.13.2: Upper and lower slide bearers of the rear bogie

Wagon No. 33 87 7866 801-6 is designed for S traffic ($V_{\max}=100$ km/h), and accordingly, it has fixed upper and lower side bearers with a clearance between them. In Figure 4.2.13.2, the lower and upper bearers of the second bogie are shown. No signs of abnormal wear were observed on the sliding surfaces that could affect the rotational moment of the bogie relative to the car body.

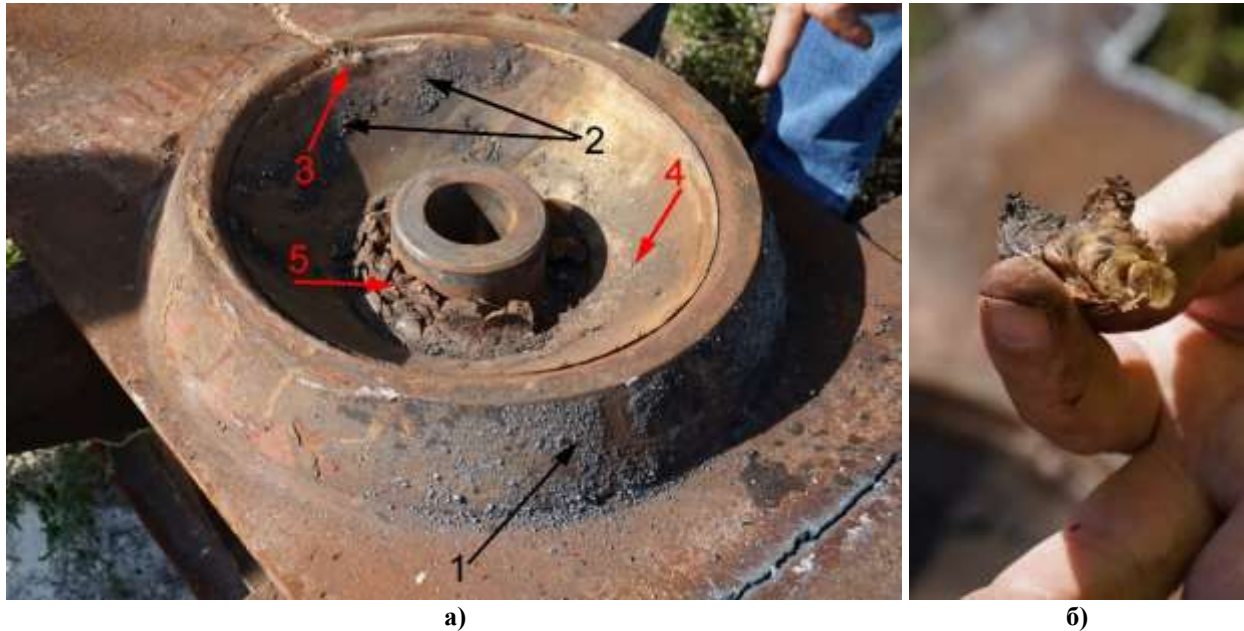
Figure 4.2.13.3: Uper center bowl of the front bogie

During the inspection of the lower center bowl of the front bogie, (Figure 4.2.13.3.a)), freshly torn metal fragments (indicated by black arrows and Nos. 1 and 2) are visible. These are the result of gas cutting in the immediate vicinity of the center bowl and are not relevant to this investigation.

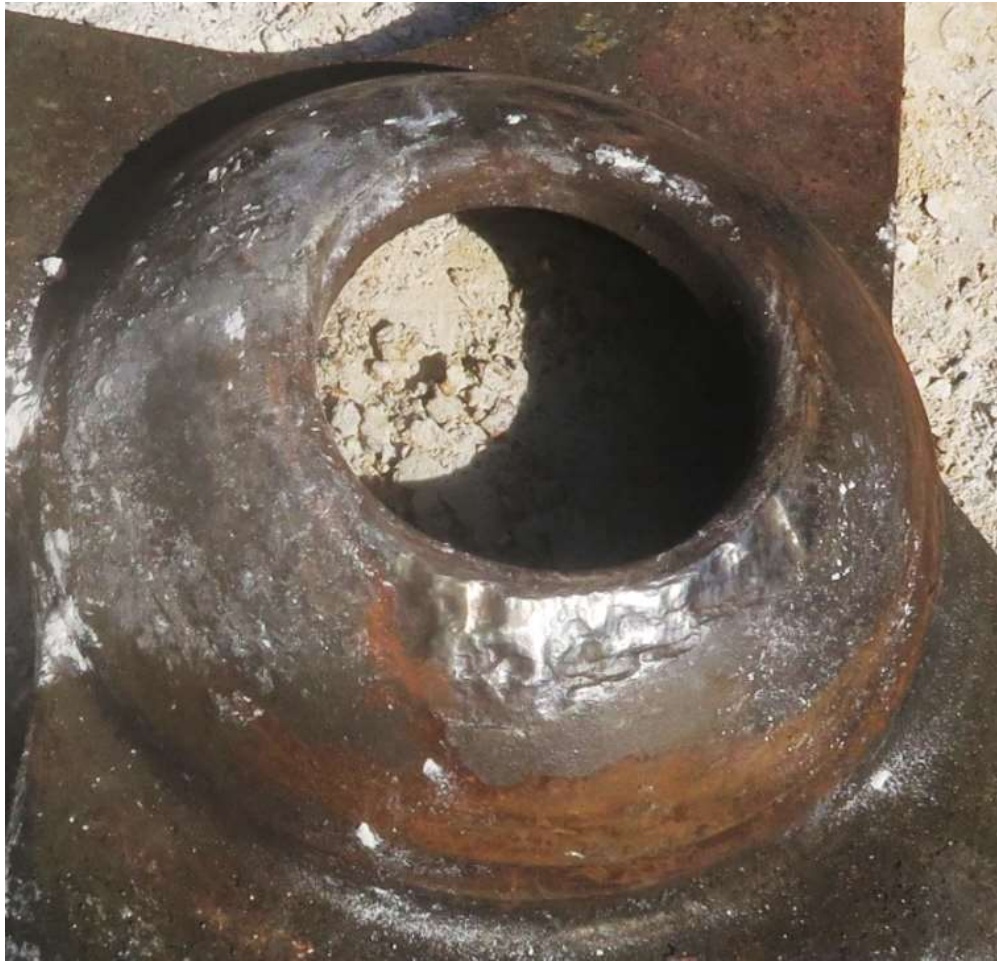
Figure 4.2.13.4: Upper center bowl of the respective bogie

During the routine overhaul of the derailed wagon, which was carried out only four months prior to the accident, no defects were identified on the upper center pivot that would have required its replacement (see sections 4.2.12. and 4.2.13.).

The observed condition of the upper bowl is shown in Figure 4.2.13.4. It can be seen that the lower part of the bowl has an uneven polished area covering approximately one-quarter of the circumference. This damage could not have occurred as a result of movement after derailment, since the upper bowl was in contact with the composite insert, which has significantly lower mechanical properties, and had no contact with the metal parts of the lower bowl that could have caused damage. No traces of detached fragments from the upper bowl are present. This irregularity of the upper bowl originates from prior damage. The damage should have been identified during routine maintenance, and the bowl should have been replaced. Flaking of the insert, being the weaker of the two materials in contact, as shown in Figure 4.2.13.3, is clearly caused by this prior damage to the upper bowl.
