Tram accident at Avenyn, Gothenburg

The Swedish Accident Investigation Authority has investigated a tram accident in Gothenburg, Västra Götalands county, on 20 June 2025

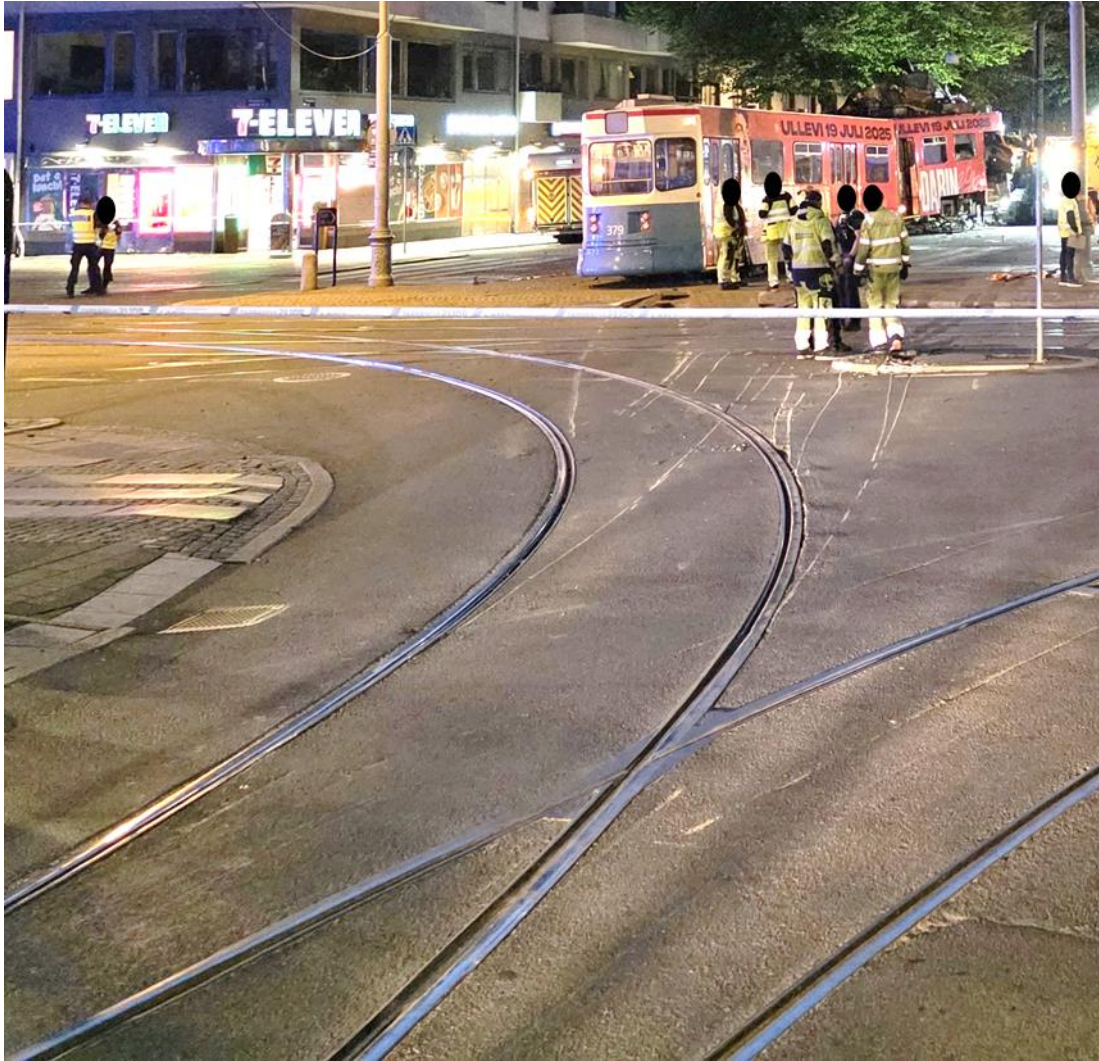
Figure 6. The left-hand curve after the Valand stop and the marks from the derailed wheelsets leading up to the tram in the background. Source: Göteborgs Spårvägar.

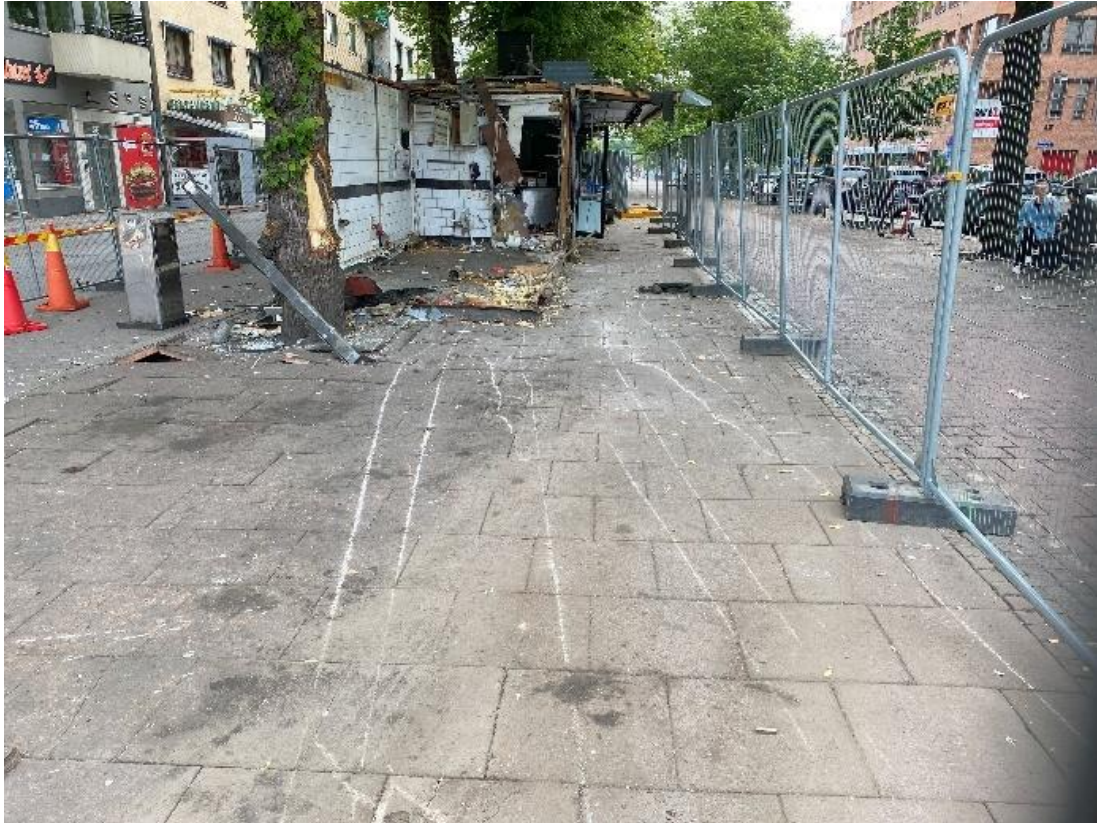
Figure 7. From SHK's site visit, showing the remains of the restaurant and the marks left by the tram's two leading wheelsets.

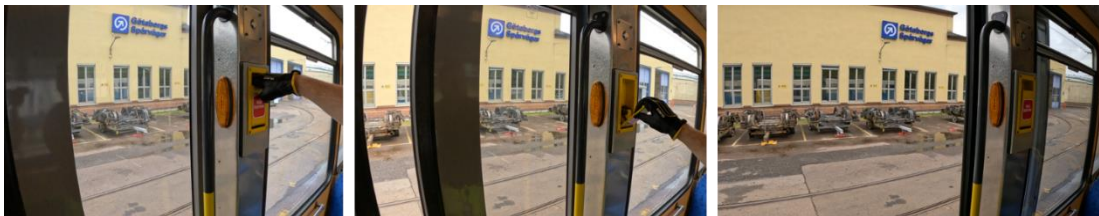
Figure 17. Sequence of images illustrating the emergency door opening function in the C section. Note that, in the final image, the emergency release handle has sprung back to its original position.

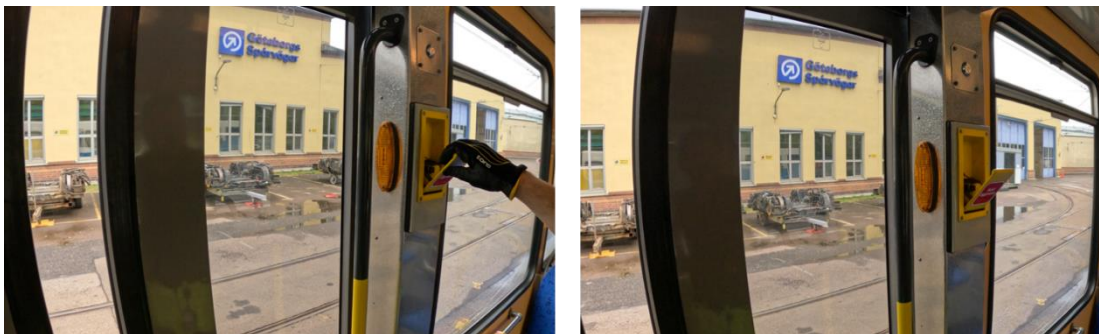
Figure 18. Emergency opening of a door in the C section, with the emergency release handle still in the emergency-open position. In this condition, the door can be opened and will remain open.
