## **Railway accident investigation final report № 5-02/4-25 (Extraction)**

### **Serious accident at railway level crossing No. 910 on 1 October 2025 on the Zaslauks–Priedaine railway section**

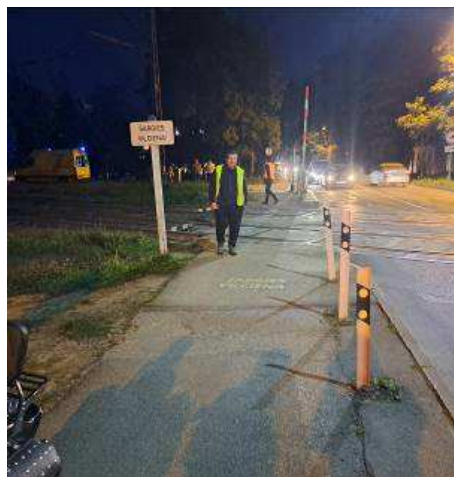
Figure 1. Location of safety signs and markings

Protected railway level crossing No. 910 is equipped with automatic level crossing signalling, which activates stop signals towards the road, and the automatic barriers assume the closed position sufficiently in advance of the arrival of rolling stock to allow road vehicles to clear the crossing. The automatic level crossing signalling continues to operate and the automatic barriers remain in the closed position until the rolling stock has completely cleared the crossing. At the time of the accident, the light signalling and barriers were operating, while a malfunction of the acoustic signalling had been identified on one side; no causal link between that malfunction and the accident was established. Signs reading “Beware of train” were placed at the crossing in clearly visible locations, and an equivalent inscription was also marked on the asphalt of the pedestrian path (see Figure 1).

a) View from the Akācījas iela side

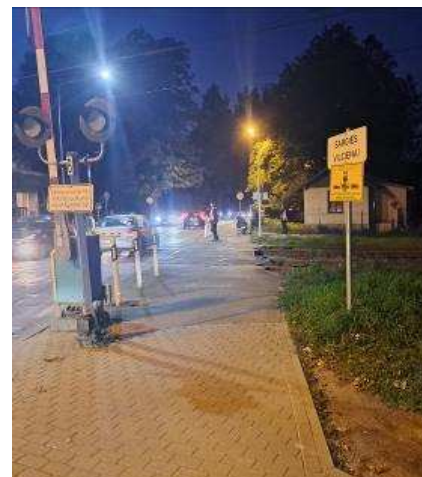
b) View from the Rostokas iela side

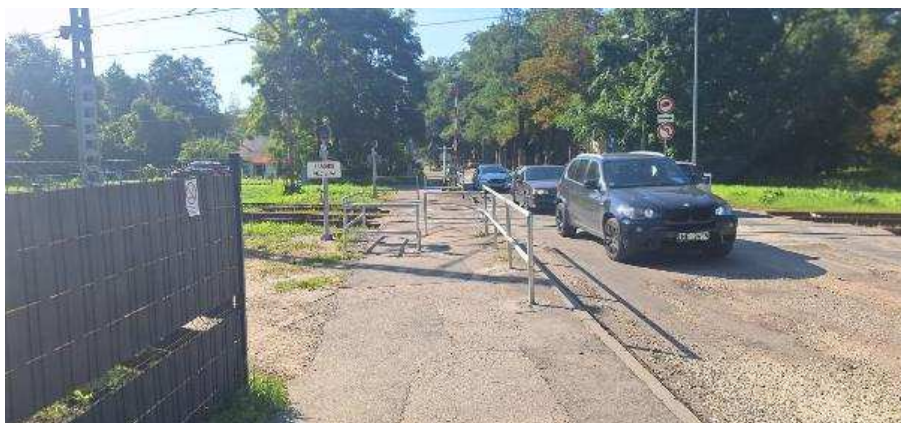
Figure 14. Pedestrian movement control barrier installed after the accident.  
View from the Akāciju iela side

- In December 2025, the Technological Processes and Diagnostics Division of the Track Department updated the data in the existing list of pedestrian crossings;
- The Track Design Division of the Track Department developed a layout for pedestrian movement control barriers (labyrinths) for the pedestrian crossing on Zolitūdes iela at level crossing No. 910, km 8 pk 2, on the Zaslauks–Priedaine section and, on 14 April 2026, equipped it with pedestrian movement control barriers (labyrinths); see Figures 14 and 15.

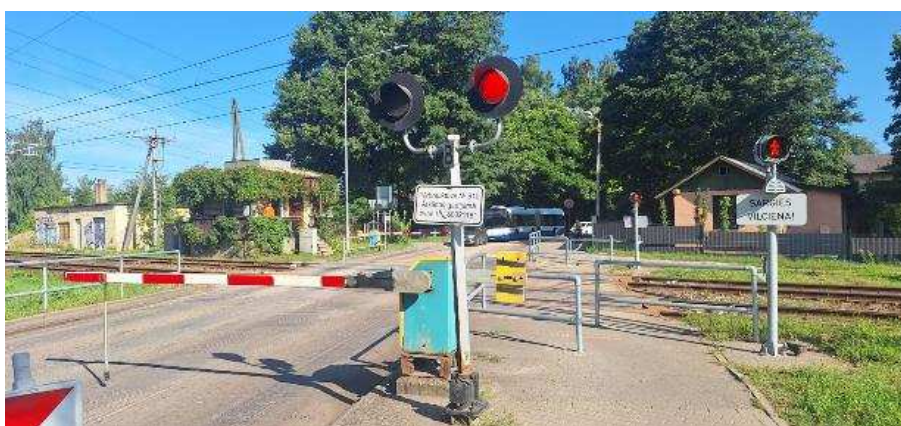
Figure 15. Pedestrian movement control barrier installed after the accident.  
View from the Rostokas iela side

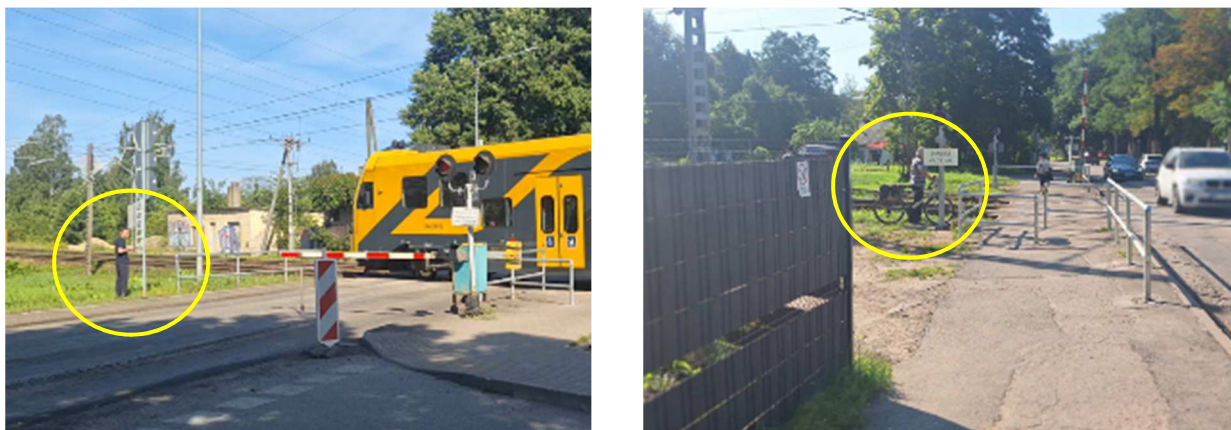
During the investigation, the project developed by the Infrastructure Manager to improve railway traffic safety at the Imanta railway level crossing was also examined. The project provides for the construction of fences on both sides of the pedestrian crossing in order to prevent bypassing the labyrinth-type barrier, as well as the construction of additional fencing at locations where it is currently possible to cross the railway tracks outside the pedestrian crossing; see Figure 16. At the time the investigation was completed, the safety measures provided for in the project had not yet been implemented.

Figure 16. Locations of additional fencing envisaged by the project

Justification: The existing solution does not restrict the possibility of bypassing the labyrinth-type barrier and accessing the railway tracks outside the designated pedestrian crossing point.

State joint-stock company “Latvijas dzelzceļš” should implement the engineering safety measures provided for in the project at the Imanta railway level crossing by constructing fences at both approaches to the level crossing in order to restrict the possibility of bypassing the labyrinth-type barrier and accessing the railway tracks outside the designated pedestrian crossing.
