#### RAILWAY ACCIDENT INVESTIGATION UNIT

#### ANNUAL REPORT

2016

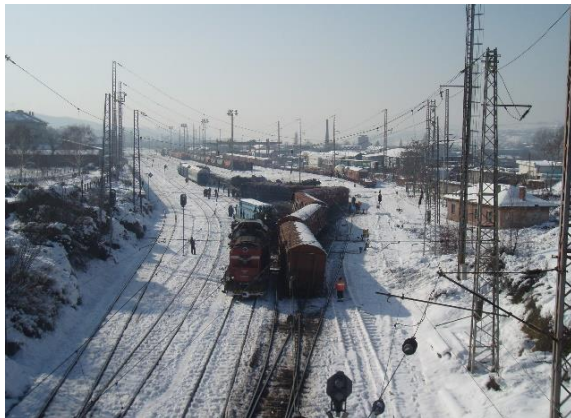
The train passed transit through Dyakovo station at 23:54 h. on the second main platform, with sparkling axes of the locomotive and of the first few wagons of the train. At Dupnica station the traffic controller on duty had prepared a route on the fourth deviation platform in the direction of Golyamo Selo station. At 00:04 h. the train entered Dupnica station with a speed of about 80 km/h, passed through points Nr. 2 and Nr. 4 and on point Nr. 10 the third wagon in line derailed, inclining on the right and dragging after it the next eight wagons, which derailed afterwards as well.

As a result from the derailing of the train there are no staff members injured; there are big property damages incurred to the rolling stock, the transported freight and the railway infrastructure.

The damages caused to the railway infrastructure amount to BGN 107 753, including the value of the recovery activities.

The direct cause for the derailing of nine wagons from the composition of freight train Nr. 50601 upon its entrance in Dupnica station is the insufficient breaking effect of the automatic train break, which has lead to exceeding of the speed permissible for the train upon its entrance on a deviation platform at Dupnica station. The causes for the insufficient breaking effect are the non-fulfillment of the provisions of the acting normative regulations in the railway transport regarding the executed shortened test (test “D”) of the automatic train break at Delyan station, and the non-conformity with the technology of management of a freight train at a long descending section at low ambient temperatures.

5. Holding BDZ EAD shall organize the implementation in operation of all locomotive devices which shall register in digital form and store all data on the condition of the locomotive.

„(2) The locomotive engine drivers, upon departure of a freight train from a profile station, shall perform as a must examination of the efficiency of the train breaking system at temperature lower than minus 10°C.“
- Undertaken measures*
- Recommendations 1 and 2 are fulfilled;
- Recommendation 5 is under process of implementation;
- Recommendations 3, 4 and 6 are accepted and are not fulfilled.

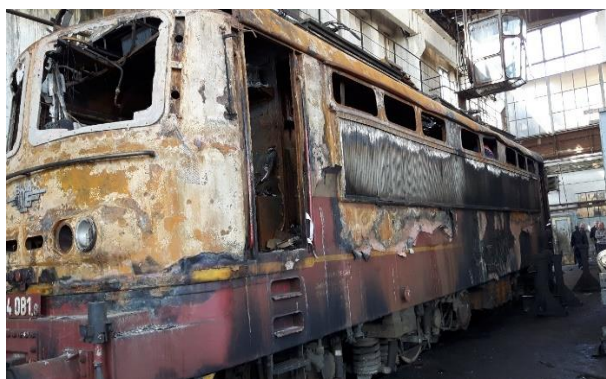
There are no diseased or injured persons. The damages caused on the rolling stock and the railway infrastructure amount respectively to BGN 1 274 030.85 and BGN 71 830.45.

The major cause for the occurrence of the accident is the unsatisfactory condition of the electric equipment of electric locomotive Nr. 44081.8. The most probable cause for bursting of the fire is mechanical destruction of one of the condensers of the R-C units for suppression of internal over-voltages in the traction el. currency rectifier of the first traction unit as a result of high temperature and exhausted resource. The spread liquid from a failed condenser has ignited upon its touch with the hot elements of the el. current rectifier's cabinet (resistors, condensers, conductors) and has initiated the burning process.

1. Immediate performance of examination of the fire prevention installations and the major safety systems of all locomotives.
2. Strengthening of control over the operational examinations of locomotives at the major and turnover depots, and at the operational stations.
3. Mounting of additional sensors to the fire signaling installation and spraying nozzles to the fire suppression installation in the fire hazardous areas.
4. Modernization of the locomotives from Series 44 and 45 by the construction of new fire signaling and fire suppression installations of the locomotives.
5. Strengthening of control over the performed examinations and checks on the condition of electric equipment, in accordance with the Rules on depot's repairing works and maintenance of electric locomotives of BDZ.

6. Strengthening of control over the observance of the norms on permission for operation of electric equipment and apparatus in locomotives, in accordance with the Rules on depot's repairing works and maintenance of electric locomotives of BDZ.

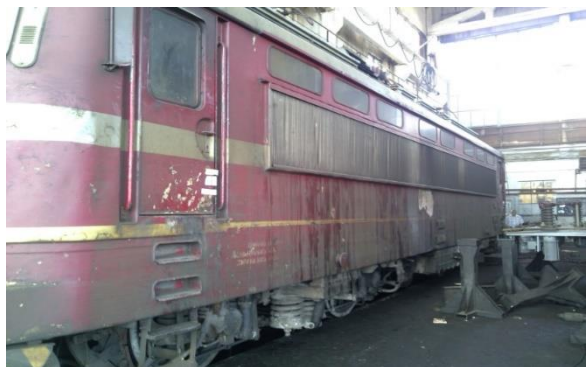
There are no accidents amongst the staff members and the passengers. The damages caused to the railway enterprise amount to BGN 2 726 130.42, and the damages caused to the railway infrastructure are minimal.

The cause for firing of locomotive Nr. 44085.9 is self-ignition of a wooden trunk placed irregularly under the bearing grid of the smoothing reactor of the auxiliary equipment, which is found over the radiator for cooling of oil in the traction transformer. The grid is welded many times at one and the same point due to fatigue of material resulting from vibrations in the grid upon travelling. After the last tearing of the welded seam, it was not recovered, instead a wooden trunk from pine tree material was fixed at the repair workshop, to support the grid during operation.

5. Re-make of the existing fire prevention installation of the locomotives and adding of smoke and flame detection sensors in the hazardous areas.

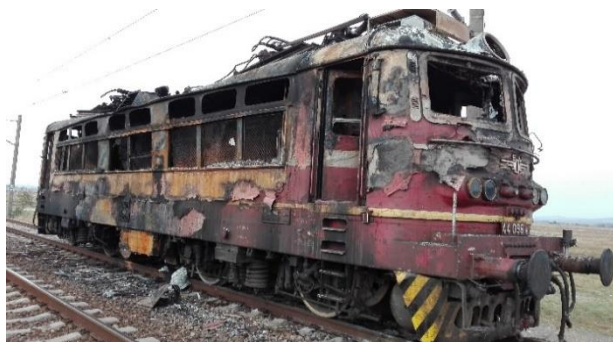
There are no accidents amongst the staff members and the passengers. There are property damages caused to the locomotive and the railway infrastructure amounting respectively to BGN 72 352.66 and BGN 238.49.

The cause for firing of locomotive Nr. 44096.6 is breaking of the rubber connection realizing the circulation of oil from the automatic transformer switch to the transformer, located above the oil cooling radiator in the transformer.

1. Carrying out of surveillance over the behavior upon trafficking of the voltage transformer of the electronic electric meters installed in electric locomotives Series 44 and 45. Assessment of the risk from the occurrence of hazards resulting from irregularities and the connection of electric meters.

2. Upon each small periodic repair, performance of examination of the condition and density of the oil cooling contour of the locomotive transformer, paying attention to the rubber connections.

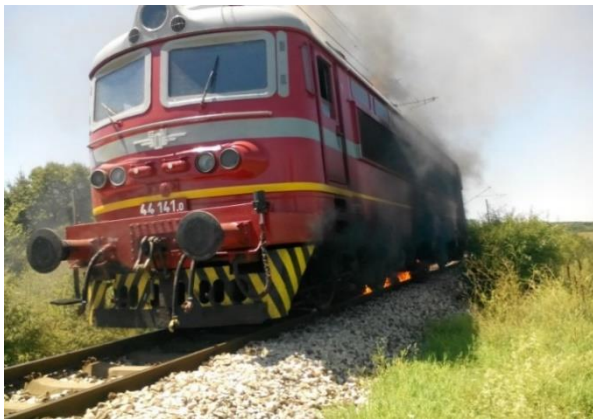
There are no accidents amongst the staff members and the passengers as a result from the fire burst. There are property damages caused to the locomotive and the railway infrastructure, amounting respectively to BGN 438 062,64 and BGN 6241,03.

The cause for bursting of fire in electric locomotive Nr. 44141.0 during trafficking is breaking in the body of the automatic transformer switch, caused by the occurrence of a voltage arch between the stationary power points and the rolls of the switch at stages, because of violation of the apparatus switching diagram.

3. The railway carrier BDZ Passenger Transport EOOD shall assess the risk of hazards connected with the “subjective factor” (the locomotive brigade and the transport brigade), as well as the hazards in part “technical factor”, pertaining to the maintenance and repair of electric locomotives.

4. The railway carrier BDZ Passenger Transport EOOD shall fill in “Register of hazards for the maintenance activities in Application Nr. 2”, with assessment of the probable risks, in connection with the respective level of maintenance, from bursting of fire upon operation in individual apparatus and aggregates during the performance of repair in the traction rolling stock.
