MINISTRY FOR
INNOVATION AND TECHNOLOGY
TRANSPORTATION SAFETY BUREAU

ANNUAL REPORT 2017
Transportation Safety Bureau
Hungary

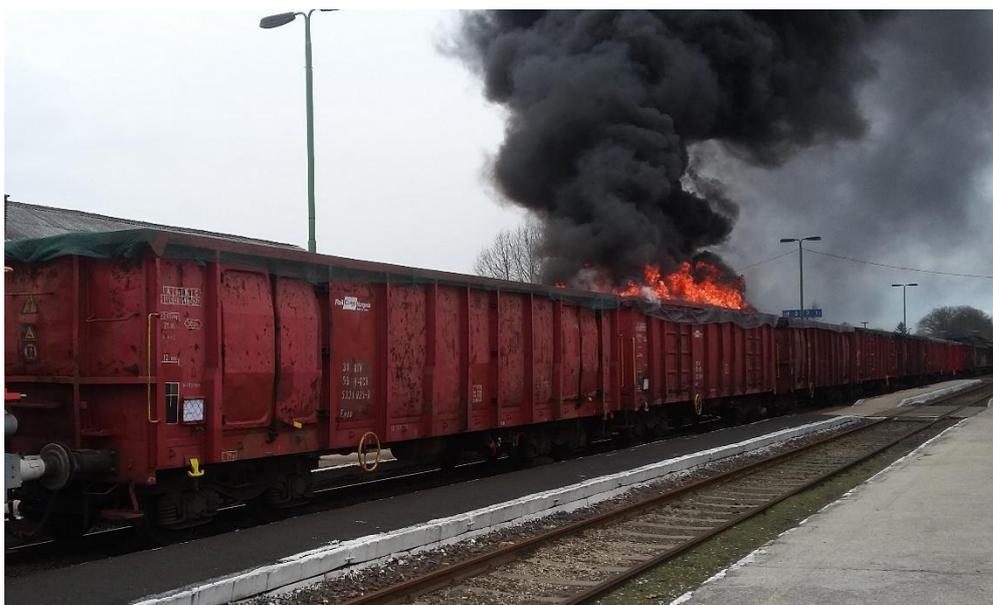
The investigation found in both cases that the hot oil drops and soot from the exhaust pipe of the Diesel engines of the trains had lit the plastic net used to cover the wagons in order to prevent cargo spills, from which the fire spread over to the cargo of the wagon (which was picked up as non-flammable substance).

Factual statements directly connected to the occurrence of the incident

The cargo loaded as not dangerous goods in open wagons was covered with plastic nets which had a lower flashpoint than the temperature of the fume and soot leaving the exhaust pipe of the engine, and so the net could catch fire which then spread over to the cargo.

BA2015-0639-5-01 *The Investigating Committee of TSB found during its investigation that Diesel-powered, outdated engines of the Series 628 emit such hot solid and gaseous substances through the exhaust system during normal operation which can light flammable substances situated nearby.*

TSB recommends Railway Authority Division, Ministry of National Development to review the technical state of the Diesel-powered, non-modernised engines of the Series 628 in service in Hungary, with special regard to the risk of fire implied by the hot solid particle content of the exhaust leaving the exhaust system, and take action as necessary.

BA2015-0639-5-02 *The Investigating Committee of TSB found that the material used to prevent cargo spill in the case of bulk goods has a lower flashpoint than the temperature of the soot particles and oil drops emitted by Diesel-powered engines.*

TSB recommends National Directorate General for Disaster Management to review the conditions of use of cargo fasteners used in railway transport from the aspect of fire protection and propose a recommendation as necessary for a solution by legislation or other regulation.

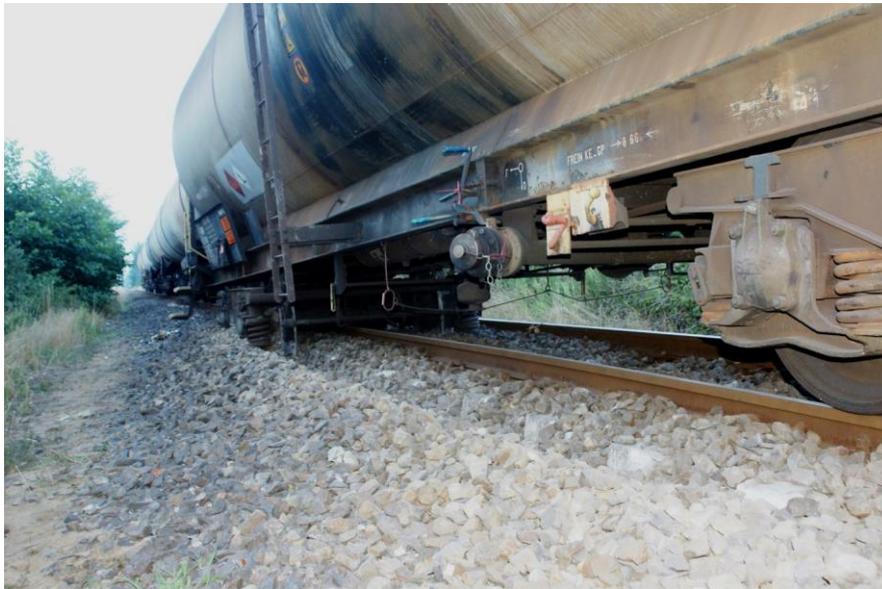
At 00:02 o'clock on 27 July 2015, between the stations Záhony and Mándok, the 6th and 10th loaded wagon of the train with Reg. № 68151 derailed with one bogie. The rail track was damaged in a length of ca. 90 m during the occurrence. After the derailed wagons were lifted back on the track, the wagon with Reg. № 33 87 785 3633-8 derailed again while being towed back to Záhony station.

At 22:20 o'clock on 15 September 2015, between the stations Mándok and Záhony, the loaded wagon with Reg. № 33 55 797 0024-6 of the train with Reg. № 68158 derailed with one bogie. Neither the undercarriage nor the container body of the wagon was damaged in the occurrence.

During investigations of the occurrences, the IC found that, in several cases, the instrumental track measurements performed at the location of the occurrences a few days before the first occurrence showed error values which were close to the limit where operation must be suspended.

- the railway track was so worn-out at the time of the occurrence that the values measured during track measurement were close to the limit where operation must be suspended,
- The cant values measured in the curved track section exceeded the specified limit at certain points,
- the bogies of the derailed vehicles involved in the occurrence of 27 July 2015 were different type than those of the other vehicles in the train, and were more sensitive to the state of the rail track,
- it was found with the vehicle involved in the occurrence of 15 September 2015 that the wheel load differences (measured after the derailment) slightly exceeded the permitted limits.

During the repair works at the scene of the first derailment of 27 July 2015, 130 sleepers were replaced in the damaged track, and 4 at the scene of the second derailment. Manual track-realignment was also done crushed stone was added during the remedial works.

Employers of the infrastructure manager replaced 150 damaged sleepers during the repairs following the derailment of 15 September 2015.

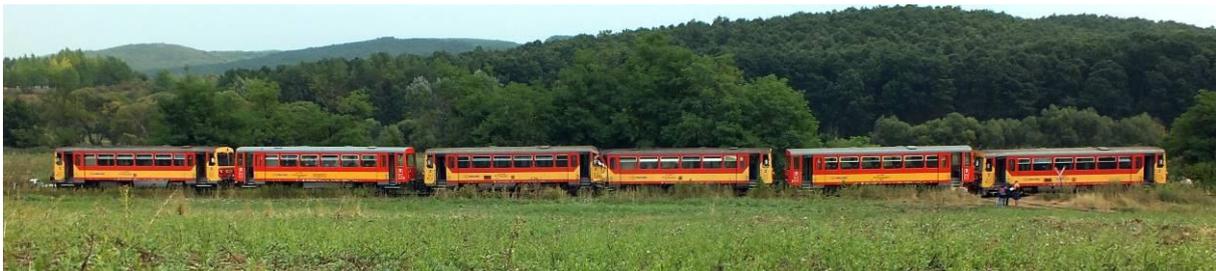
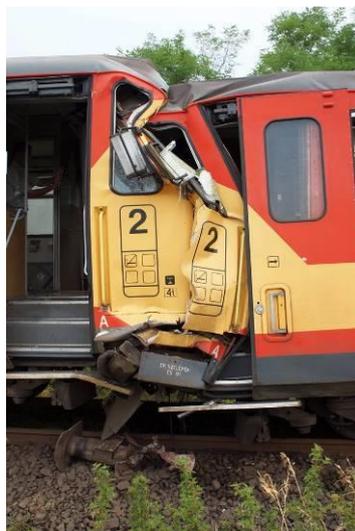
The two motor cars and a wagon were damaged badly as a consequence of the collision. 27 people were injured altogether; five of them suffered severe injuries.

Factual statements directly connected to the occurrence of the incident

- The traffic manager of Galgamácsa station did not read out the contents of the written instruction when delivering it, and delivered it at different times to the engine driver and the ticket inspector in charge.

The IC has formulated a safety recommendation relating to the requirements for the form and contents of safety critical communication.

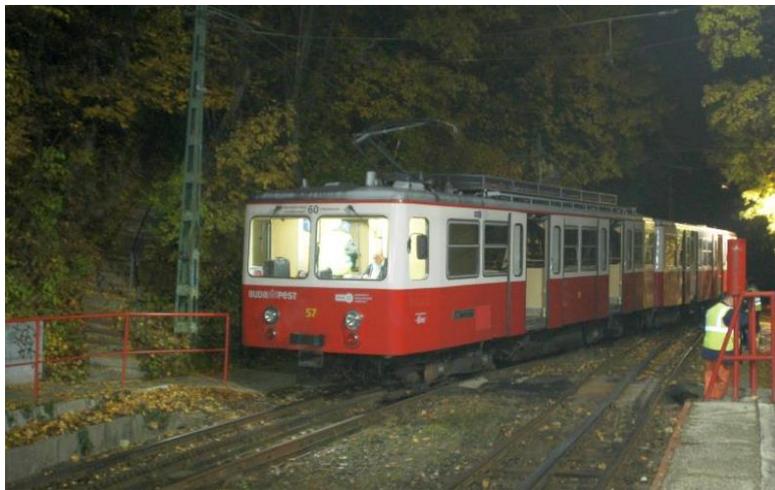
The track maintenance organisation cannot keep pace with the wear of the racks and/or they do not have the spare parts necessary to replace the racks.

Factual statements directly connected to the occurrence of the incident

The guard iron of the railway vehicle broke away and the leading bogie derailed when rolling over it.

The IC proposes that a safety recommendation be issued relating to the revision of the track maintenance processes.

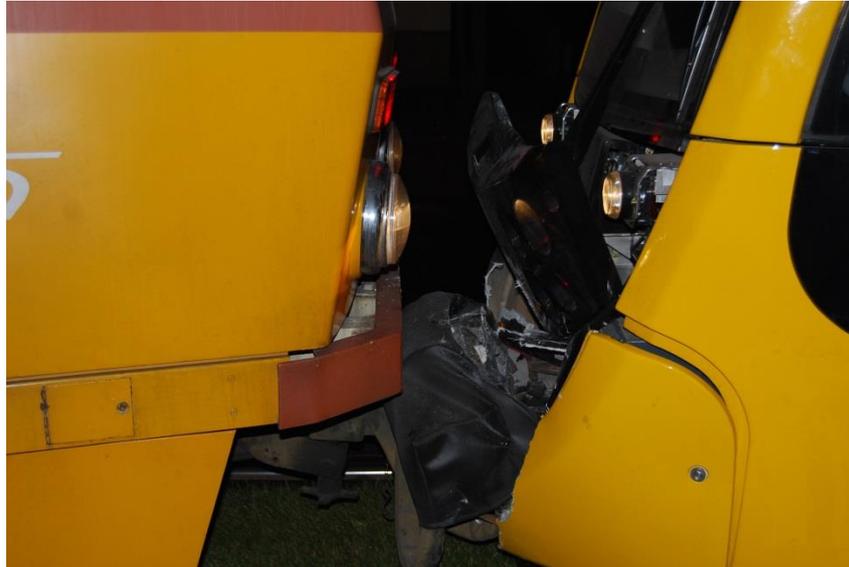
On 9 November 2015, at 16:25, in Hengermalom street, Budapest, a tram performing a test run crashed into a number 1 tram (at a speed of 5-6 km/h) which was staying on the track in front of the terminal due to traffic-related reasons.

No one was injured in the accident. The vehicles involved were damaged.

The IC found during the investigation that the occurrence can be attributed to exceeding the speed limit, malfunction of the track brakes, and slippery rail track.

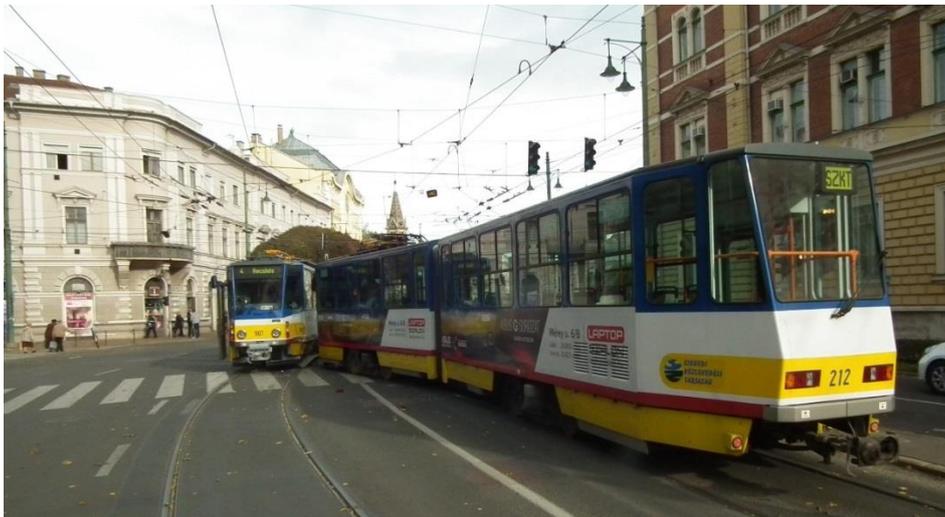
The layout of the switch operating apparatus also contributed to the drivers' practice which caused the occurrence (the setting point is too close to the switch), as well as the fact that the tram drivers are not aware enough with the rules, they had no real chance to acquire such rules, and the company did not always require that the rules be observed.

Factual statements directly connected to the occurrence of the incident

The driver of the № 3 tram failed to observe the display of the switchpoint light and to check the position of the switch tongue, so he accessed the switch no. 409 which guided his tram to the no. 4 tram which was coming from the opposite direction.

TSB issues a safety recommendation in the subject of issuing and inspection of internal rules.

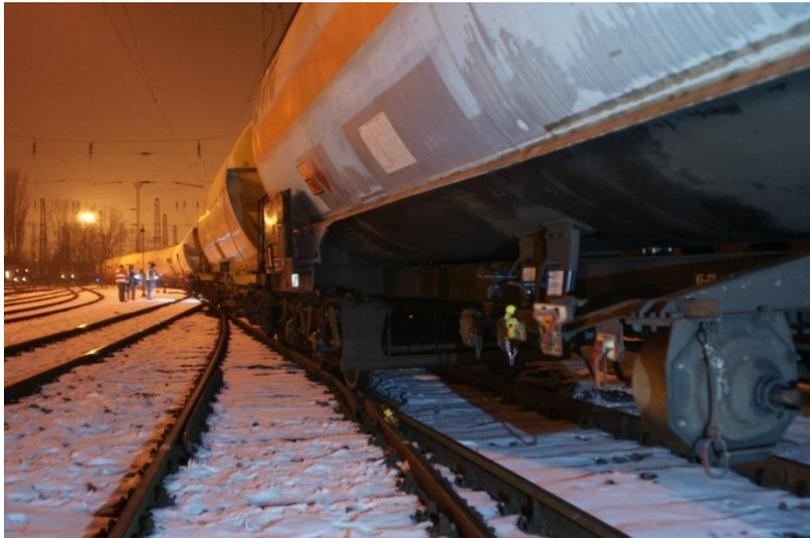
The seventh wagon of the freight train with Reg. № 90770 derailed with two axles on the turnout № 553 while leaving the shunting yard Ferencváros-Keleti, Budapest. No one was injured, but the track and the derailed wagon were damaged. A securing chock with the signs of destruction typically caused by blockage was found at the switch diamond of the turnout № 553 during the investigation of the scene. The attributed the derailment to the chock left in front of the wheel of the train.

Factual statements directly connected to the occurrence of the incident

- Prior to the start of the train with Reg. № 90770, the shunting master did not check if there were securing chocks under the first 10 wagons in the train, so he did not detect and remove the chock under the 7th wagon.

The IC proposes no safety recommendation, but invariably finds the implementation of the safety recommendation issued during the investigation of the occurrence № 2006-048-5-01 necessary.

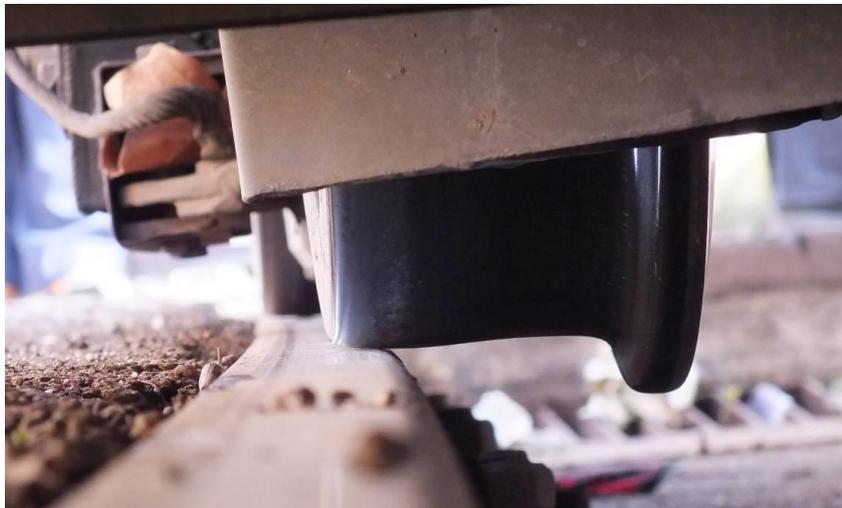
The infrastructure operator had identified the track defect prior to the derailment, and took action to introduce speed restriction and repair, but the latter was scheduled for a period following the occurrence.

Factual statements directly connected to the occurrence of the incident

The bolts of the rail fastening in the track were broken, which allowed the track to open under the vehicle, which in turn let the wheels drop between the rails.

The IC proposes a safety recommendation relating to the construction of rail fastening.

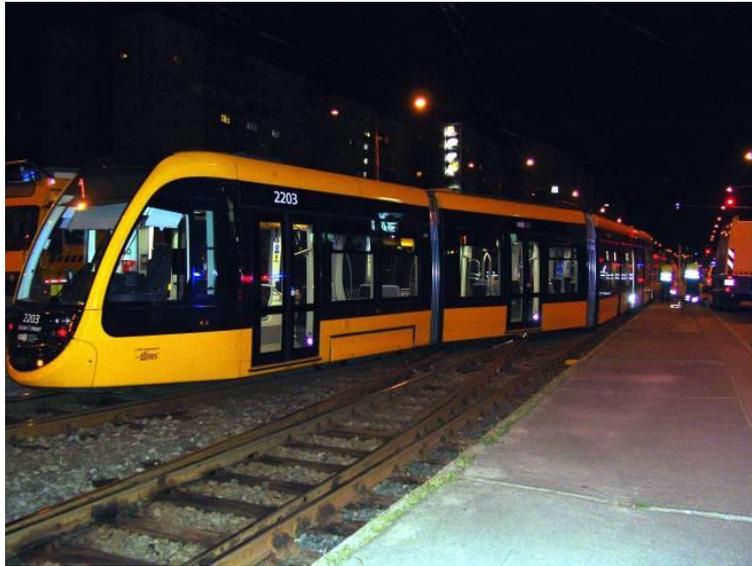
A tram derailed with two bogies on the Switch № 23, touched opposite the tongue, at the terminal in Bécsi street, Budapest. No one was injured, but the tram was slightly damaged.

The IC attributed the occurrence to technical malfunction and maintenance of the turnout involved. The IC formulates no safety recommendation.

Factual statements directly connected to the occurrence of the incident

The fastening bolts of the tension springs of the switch № 23 got loose and came off, so the switch tongues got unfastened. The switch tongue moved away from the stock rail under the tram running opposite the switch tongue, so the tram derailed.

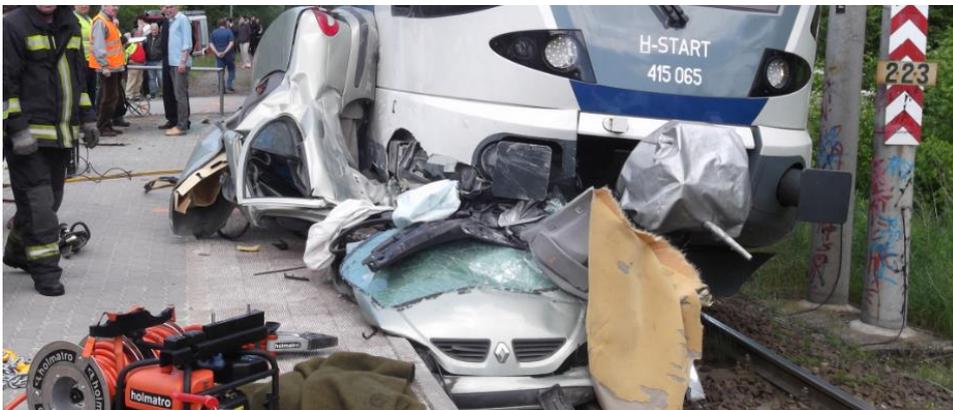
The IC found during investigation of the scene that visibility of the railway track, the level crossing and its markings is not unobstructed, so TSB issued an immediate safety recommendation, under № BA2016-0534-1-5-01 to Pest County Government Office.

Factual statements directly connected to the occurrence of the incident

The accident was due to causes attributed to human factors on the part of the driver of the automobile. The driver disregarded the danger signal displayed by the warning lights working properly and started to cross the level crossing without looking around.

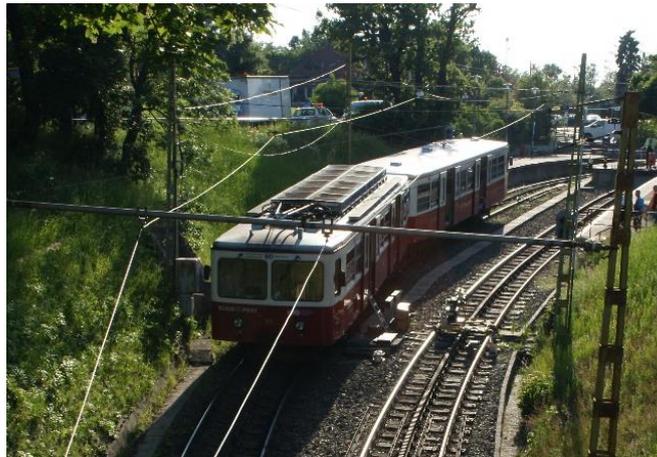
Factual statements directly connected to the occurrence of the incident

The linking rod of middle part of the switch fell apart due to loosening and falling off of the fastening nut, and so the pinion of the vehicle was blocked by the track.

The railway company modified the construction of critical parts of the switch at the time of the investigation, started replacement of the worn-out racks of the track, and reorganised the maintenance staff, so it is not necessary to issue a safety recommendation.

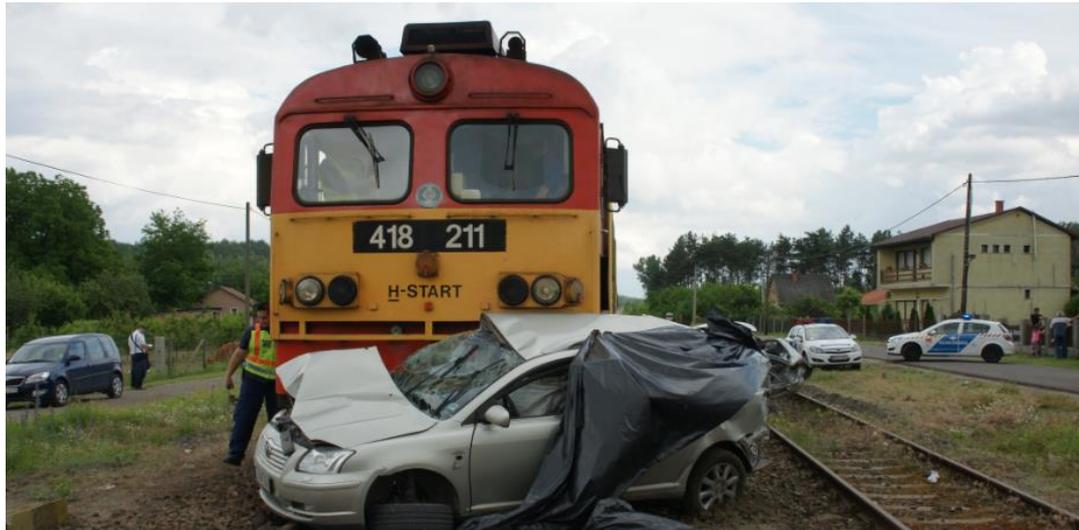
The cause of the occurrence is attributable to the environment of the level crossing and to human factors. The driver of the road vehicle started to cross the level crossing – which lacked full visibility of the railway track and protection or any traffic sign requiring stopping – without due care.

Investigation of the scene showed that visibility of the railway track as well as the related traffic signs from the road is limited, so TSB issued an immediate safety recommendation (under no. BA2016-0602-1-5-01) to Pest County Government Office for the sake of action is taken as necessary.

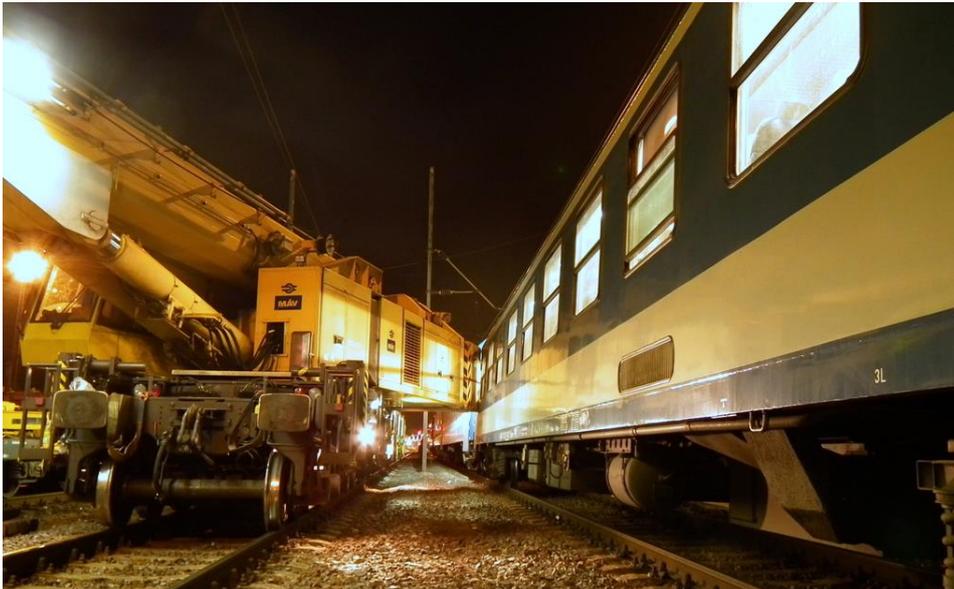
Factual statements directly connected to the occurrence of the incident

The crane was in a turned aside position in the structure clearance of the adjacent track when a train was moving on the adjacent track.

As the above shortcomings did not infringe existing rules, TSB is issuing safety recommendations relating to revision of rules applicable to the preparation and management of track possession

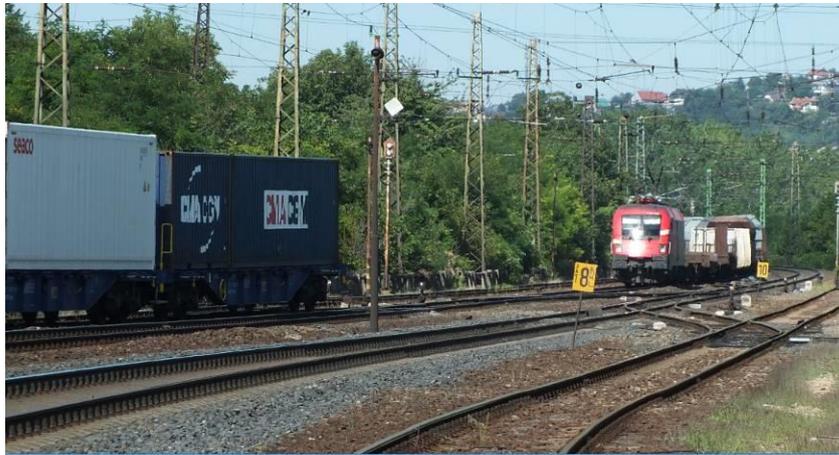
The IC attributed the occurrence to human factors on the part of the personnel involved in the shunting move. The foreman shunter misunderstood an earlier conversation between him and the traffic manager, and authorised the locomotive driver to start shunting without being authorised by the traffic manager to do so. Regarding that similar occurrences can be prevented by observing the relevant rules, the IC proposes no safety recommendation.

Factual statements directly connected to the occurrence of the incident

The foreman shunter authorised the locomotive driver to start shunting without being authorised clearly by the traffic manager to do so, and he realised the wrong setting of the Switch № 13 too late.

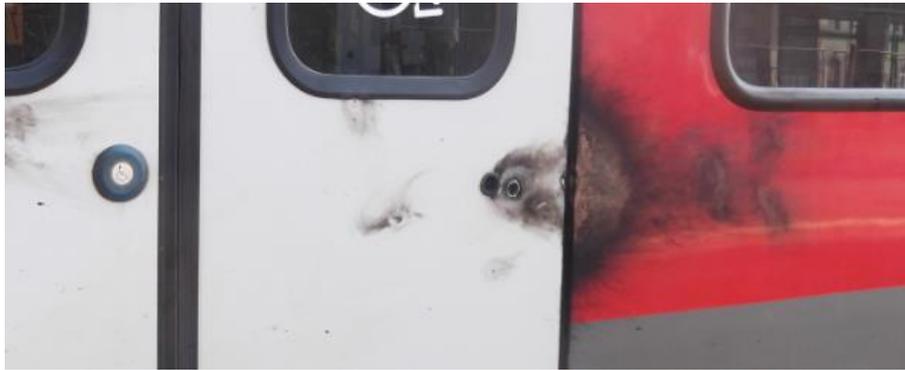
According to the position of the IC, the non-equipotential interface between the window frame and the wagon body implies hazards for the future as well, so the IC recommends revision of every vehicle with insulated metal window frames, and to make galvanic connection between the window frame and the wagon body.

Factual statements directly connected to the occurrence of the incident

The IC attributes the occurrence to the following direct causes:

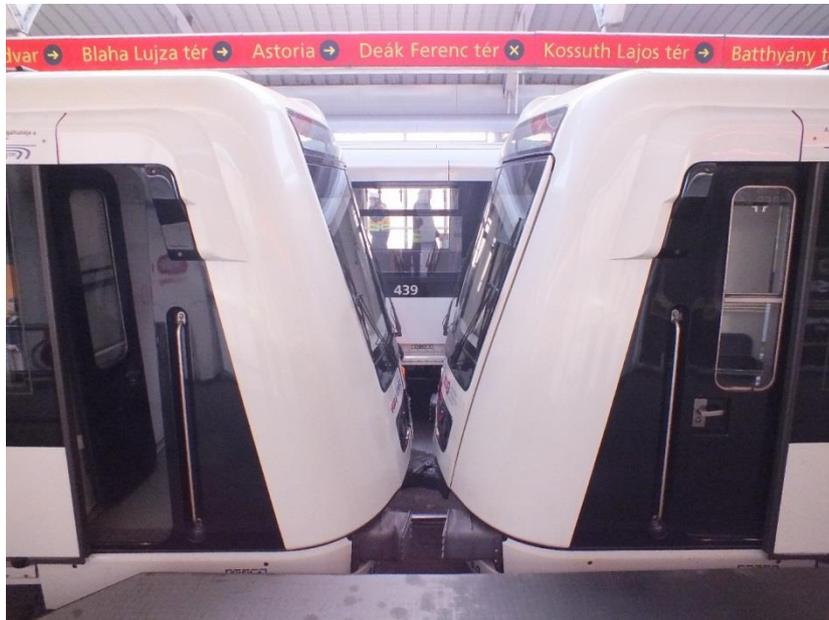
Factual statements directly connected to the occurrence of the incident

- As an effect of the adverse weather in December (low temperatures, falling leaves, strong winds, ground frost) the rails became extremely slippery along the surface section of the underground line M2. The trains were not equipped with devices that increase adhesion, and the wheel slide protection system was not able to compensate for the given loss of adhesion, so the wheels started to skid.
- The actions taken to eliminate slipperiness of the rails caused by adverse weather were not adequate to prevent the occurrence, but continuous speed restriction was not introduced.

- reconstruction of the track-vehicle interface,
- modification of the training of the personnel affected,
- changing the technology applied in special situations.

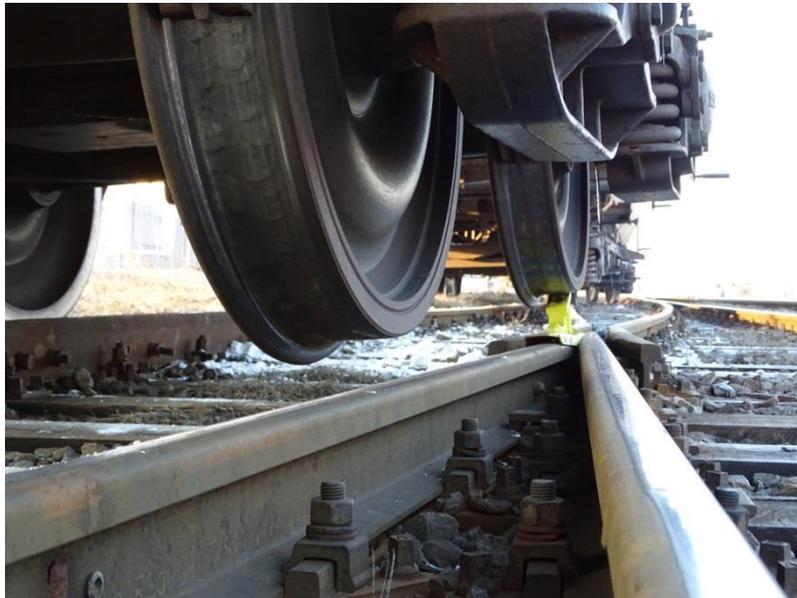
Factual statements directly connected to the occurrence of the incidents

A securing chock was left under the train when the train was started, and that chock got stuck on the switch and derailed the train.

The infrastructure operator took action to modify the technology at Debrecen station. The IC proposes a safety recommendation relating to securing trains against run-away (regardless of the occurrence under review).
