NIB Annual Report 2017

Swedish Accident Investigation Authority

Ref. No A 133/18

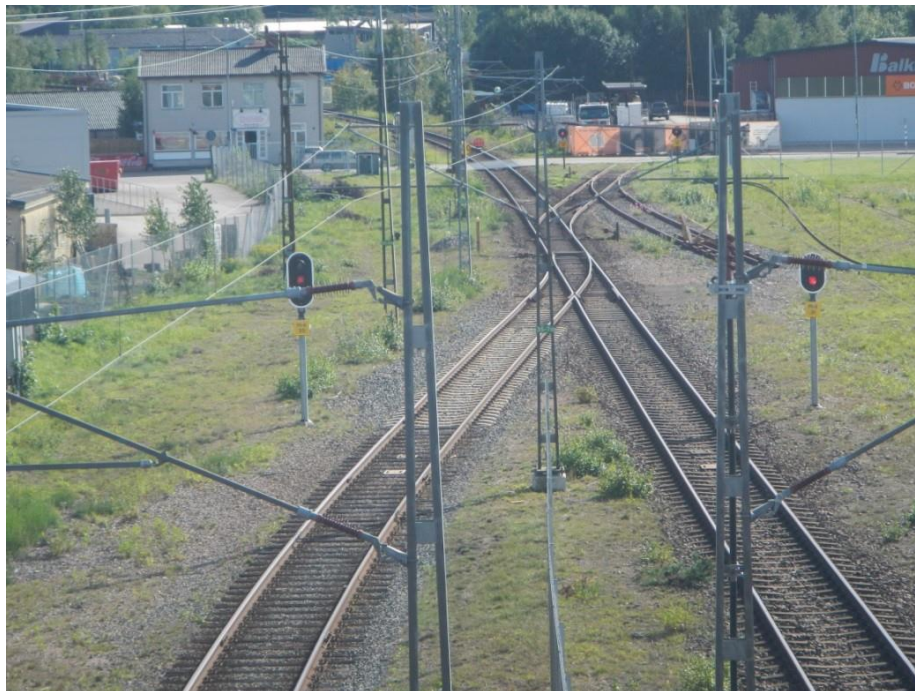
2.4.1 *Final report RJ 2017:01 – Two technicians struck at Markaryd, Kronoberg County, 25 May 2016*

Two train technicians were struck by a train (80849) while carrying out repair work at a set of points on the main line at Markaryd. The traffic management was not aware of the work and certain measures had not been taken to protect the activity. The train was travelling on a locked route with signals that allowed a train speed of 100 km/h. The driver saw the technicians a short distance ahead and had no opportunity to stop the train before the collision occurred. One technician was seriously injured, the other was also injured, albeit not seriously.

The accident occurred because the technicians were working in the safety zone without taking measures to protect themselves against vehicle movements on the track.

A contributory reason was that no risk assessments were carried out before the work.

An underlying factor was that the contractor had no reliable and effective system for appointing safety and security officers in connection with directly planned engineering work, which in turn contributed to an unclear distribution of roles within the work team.

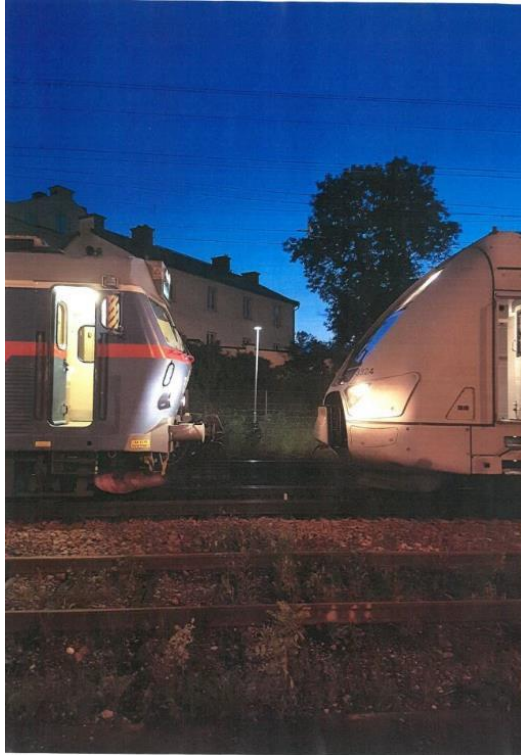
2.4.2 *Final report RJ 2017:02 – Near-miss between a train and shunting rolling stock at Västerås, Västmanland County, 7 June 2016*

Shunting rolling stock passed by a dwarf signal that showed the message 'Stop' and was issued on the route for an approaching train, with passengers on board, in Västerås. Both trains braked to a standstill and stopped about 1.6 m from each other. The approaching train was travelling at approximately 60-70 km/h when the danger was discovered.

The direct cause of the incident was that the shunting rolling stock with vehicles from train 768 was not stopped by signal 138 because the signal was not observed; in this way, the shunting rolling stock was brought onto the route of the approaching train 2169.

The reason that signal 138 was not observed is probably due to the fact that other visual stimuli, in particular the headlights of the approaching train 2169, were in the field of vision and drew attention.

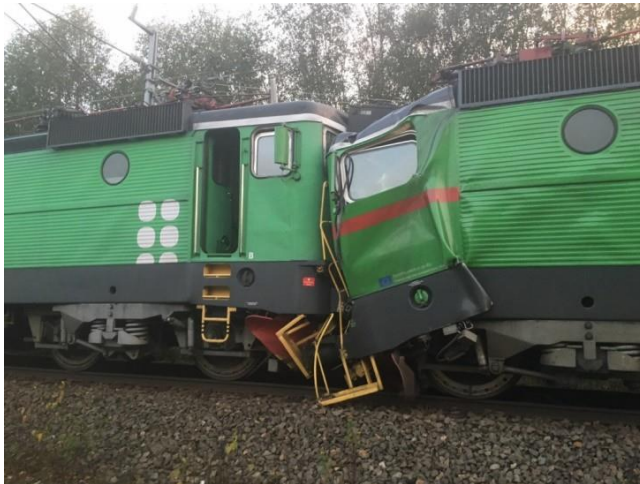
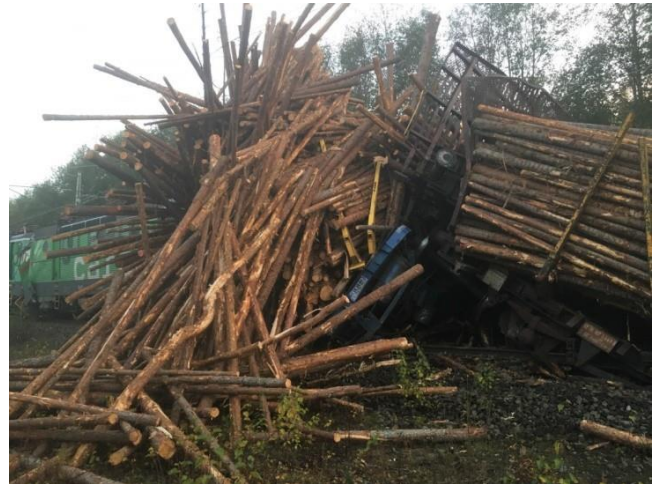
2.4.3 Final report RJ 2017:03 – Collision between train 9207 and train 6032 on the Piteå – Arnemark section, Norrbotten County, 21 September 2016

On 21 September 2016, train 9207 collided with train 6032 near the Öjebyn industrial area, on the Piteå – Arnemark section. Train 6032 had left Piteå with permission to pass signal L2, which showed ‘stop’. However, train 9207 had not left the route, but was heading for Piteå. At the time of the collision, train 6032 had already stopped, while train 9207 was still travelling at about 50 km/h, despite the driver slowing down as soon as he realised there was a risk of a collision.

The three people who were on board the train suffered minor injuries. Significant material damage occurred at the site in both trains and also to wagons and freight. Extensive damage was caused to approximately 50 metres of track.

The direct cause of the accident was that the check carried out by the mainline train dispatcher of the route (i.e. check of every train that was previously located on the section) led to the erroneous conclusion that train 9207 was in Piteå and that the section towards Arnemark was therefore free for train 6032.

The underlying reason for the assumption was that the mainline train dispatcher confused which trains were entering Piteå and in his checks had greater confidence in notes on a help form for points at Piteå yard, rather than indications in the Argus train control system and the train dispatch documentation that was expected to be carried and available in the STEG documentation and the planning tool.

The underlying cause at system level was that the infrastructure manager was not aware of whether the mainline train dispatcher, who had limited experience, had sufficient understanding of how to check the train dispatch documentation, what status the different help systems have in relation to each other and how their information should be interpreted.

Further potential influencing factors were that the infrastructure manager had only let experienced train dispatchers participate in the preparation of the system when STEG was being developed, and did not further analyse the risks that may be being taken when introducing a system with an increased focus on planning to replace previous documentation systems.

- Regarding the checks to be performed by mainline train dispatchers before a train is allowed to pass a signal that shows ‘stop’, analyse the possibility of selecting the control method and using only a control method that entails sufficient security.
(RJ 2017:03, R1)

A proposal has been put forward to amend the regulations. This means that the train dispatcher must initially call the driver, supplemented by matching the driver’s information to signal box indications and train dispatch documentation as follows.

‘The train dispatcher shall check where the trains that could be located on the surveillance section actually are by talking to the drivers and matching the drivers’ information about position with current signal box indications and the train dispatch documentation. If a driver cannot be reached and the train is expected to have reached its final destination, the train dispatcher can make sure of this by contacting the railway undertaking concerned.’

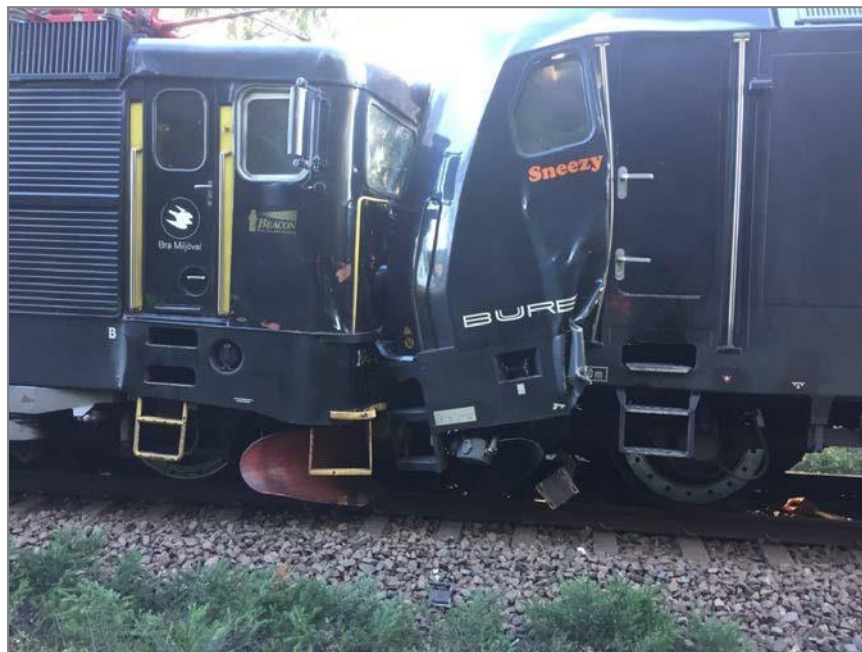
2.4.4 *Final report RJ 2017:04 – Collision between a train on single-line working with an auxiliary vehicle and a stationary train on the Deje – Molkom section, Värmland County, 30 September 2016*

On 30 September 2016, a freight train was stationary in an upturn between Deje and Molkom on the Kil – Daglösen single-track stretch. An auxiliary vehicle, consisting of two Rc3 locomotives, was sent out to help the stationary train. However, the auxiliary vehicle collided with the train, one of the drivers was injured and the vehicles suffered extensive damage.

The direct cause of the collision was that the speed of the auxiliary vehicle was not matched to the circumstances of the situation.

The following factors probably contributed to the accident:

- The driver's desire to complete the auxiliary vehicle driver assignment as soon as possible so as to also be able to complete his regular assignment.
- The driver's limited experience in applying the rules for and driving auxiliary vehicles.
- The driver's perception of a lack of obstacles on the track may have been affected by the location information exchanged between the drivers about where the stationary train was situated.

‘consider whether the upper speed limit for “full visibility” should be one of the parameters that should be included when the maximum permissible speed for single-line working with auxiliary vehicles on system M is to be determined and fed into the train protection system before single-line working begins. (RJ 2017:04 R1)’.

The Swedish Transport Administration has decided to investigate whether it is possible to adapt the requirements of the TTJ to the requirements set out in TSD Operations and Traffic Management, as regards information on where the train requiring assistance is located. The adjustment is scheduled to be completed by 1 June 2020.

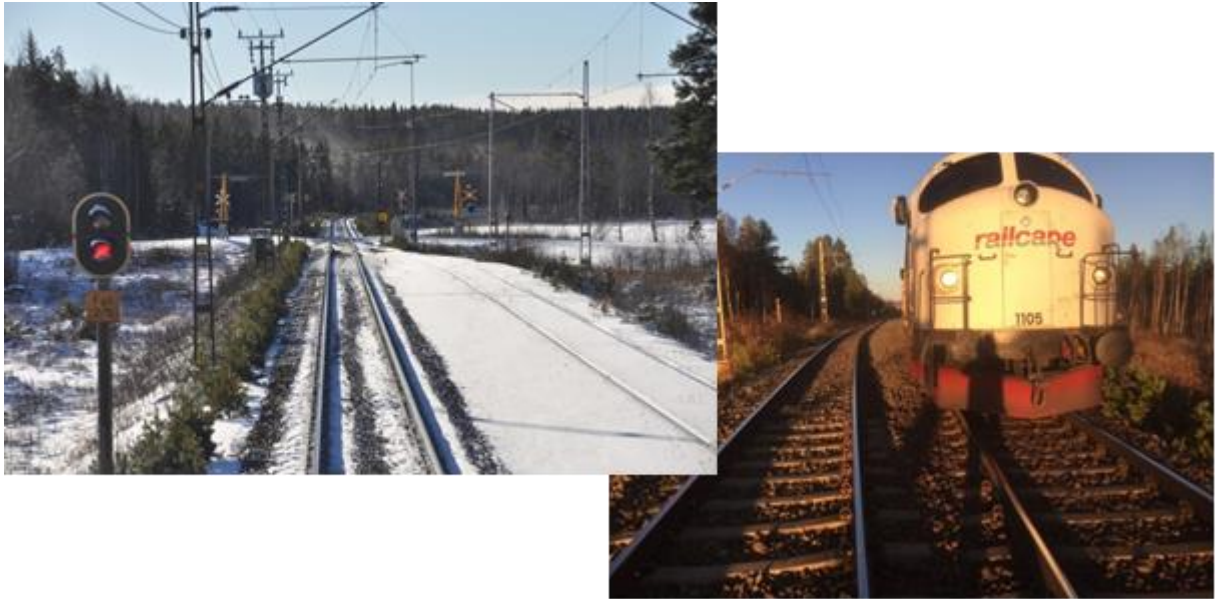
2.4.5 Final report RJ 2017:05 – Collision between train 34871 and train 26890 at Fångsjöbacken manoeuvring area, Jämtland County, 11 October 2016

On 11 October 2016, a collision occurred between freight trains 34871 and 26892 at Fångsjöbacken, Jämtland County. The trains were to meet at the Fångsjöbacken manoeuvring area.

The manoeuvring area has two main tracks that allow simultaneous entry on a single track. Train 34871 had the signal aspect ‘proceed, await stop’ on the entry signal to one track. The driver of train 34871 has stated that, due to direct sunlight, he did not notice the restrictive signal, nor the visual information from the vehicle’s ATC train protection system. The driver also did not notice the sound alert from the ATC system.

As the driver approached the intermittent signal, he saw that it showed ‘stop’ and also noticed that the ATC system was intervening and braking, whereupon the driver also applied the emergency brake. Although the maximum braking force was employed, train 34871 did not stop until it had passed the intermediate signal, a subsequent stop light and arrived at the track separating points at the other end of the manoeuvring area. The rear section of train 26890 was still in the points.

A handle, rear-view mirror and an external emergency stop button on train 34871’s locomotive struck one of the wagons of train 26890 and suffered minor damage. No one was injured in the incident.

The driver of train 34871 did not notice the restrictive signal of the entry signal to Fångsjöbacken, nor the visual information or visual warning in the vehicle's ATC panel. The driver also did not notice the sound alert from the ATC panel. Contributory reasons for the message not being noticed were likely to be mainly direct sunlight and the fact that the noise level of the ATC system warning sound was set to minimum while headphones were being used.

The ATC system initiated braking late due to the fact that the values entered into the ATC panel concerning the braking ability of the vehicle did not match the actual values.

The fact that the deceleration was slower than normal when the brakes were applied was due to flaws in the braking system.

A contributory reason why the incorrect entry into the ATC system was not detected was that no deceleration check could be performed due to the upcurve. Although a deceleration check could not be performed, no lower deceleration value had been entered.

One underlying reason for the incident was that Railcare T AB had not ensured that the information to staff had also been understood and applied in practice. Another underlying reason was that the maintenance programme applied by Railcare T AB was not adequate to detect current flaws in the braking system.

In addition to the measures already taken, consider whether physical improvements can be made to the driver environment in the current type of locomotive in terms of visibility, light and sound conditions.

In the case of noise, it is difficult to fix this due to the construction and age of the locomotive. Therefore, Railcare T AB has decided not to take any measures regarding the visibility or sound conditions of the vehicles, but we will, on the other hand, ensure the maintenance of the existing toning of the of the toning of the windscreens.
