# ANNUAL REPORT

of the Investigation Body for  
Railway Accidents and Incidents

# 2018

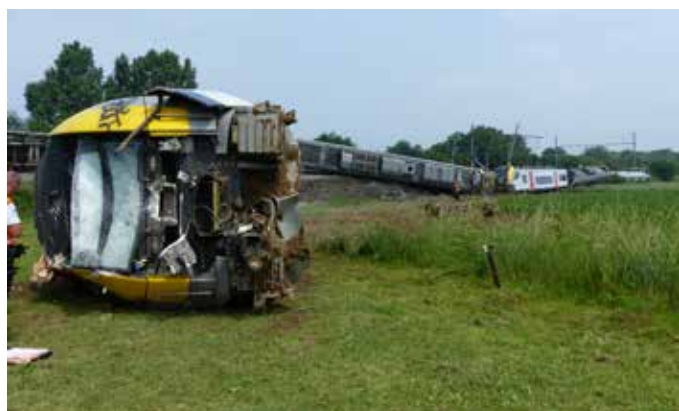
Neufvilles: 8 June 2018

At about 10:33 a.m., the train derailed on the siding, causing major damage to infrastructure and rolling stock. The train driver suffered minor injuries (according to the definition by law).

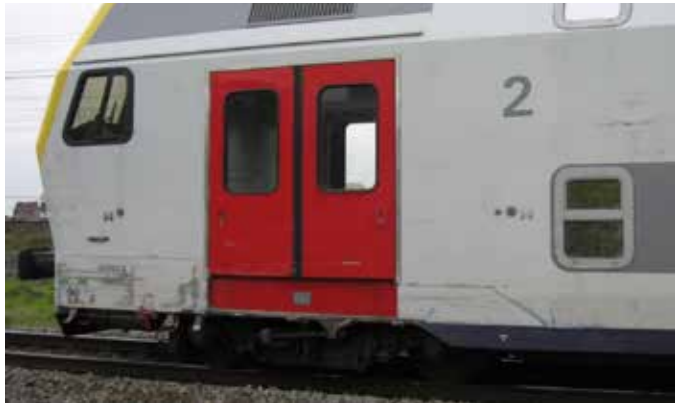
Bruxelles-Nord: 24 April 2018

On Tuesday 24 April 2018, following a defect, train E2178 comprised of two AM08 Desiro railcars (08118 + 08564) was declared in distress.

The two defective railcars were towed by three other AM08 Desiro railcars to the Brussels-North railway station.

The railcars passed through a switch and continued their route. They collided lightly with the side of train 17907 (a technical train with no passengers), only causing mild damage. The runaway railcars came to a halt around 800 metres from the platforms of Brussels-North.

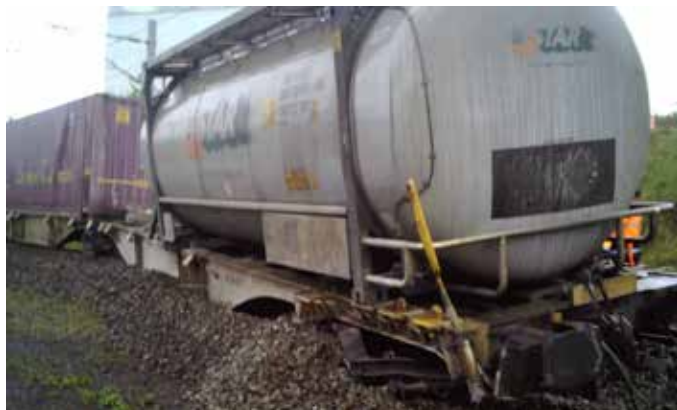
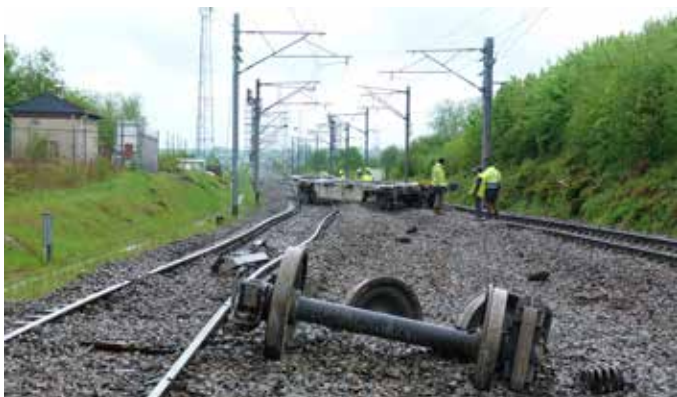
Aubange: 19 May 2017

The inspection of the train by the driver reveals that the two last wagons of the train have derailed. The infrastructure is severely damaged over a distance of 14 kilometres.

The initial inspections of the rolling stock, of the tracks and of the area surrounding the tracks reveal that one of the wheels of the penultimate wagon n° 3368 4952 072-9 broke some 17 kilometres from the train's stopping point, causing the derailment of the wagon. The wagon remained attached to the train, causing damage to the infrastructure. Four pieces of the broken wheel were found in the tracks.

The derailment of the 24th wagon (n°3368 4952 072-9) is the result of the broken right wheel of the 3-3' axle of the wagon, of cracks and thermal splitting which spread in the wheel.

- significant deterioration of the paint on the plate/rim connection appeared;
- cracks formed on the wheel tread.

- the observed phenomena confirm the significant increase of the rim's temperature during the wagon's operations;
- the heating affected all the wheels of the bogie;
- the heating would be due to overly-intense braking and/or the use of an unsuitable wheel/pad couple, despite the wheel/pad couple being in line with the specifications as presented in the document V-BKS (LL) referring to UIC-leaflet 541-4;
- the issue affecting the broken wheel is not so much a problem of the height of the flange or equivalent conicity value as it is a problem relating to its resistance to thermal stress and to the stress cycles imposed on the wheel.

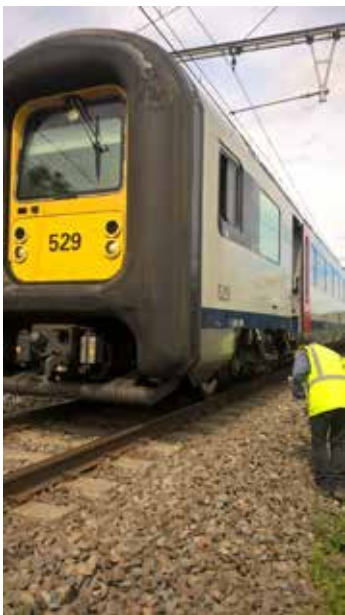
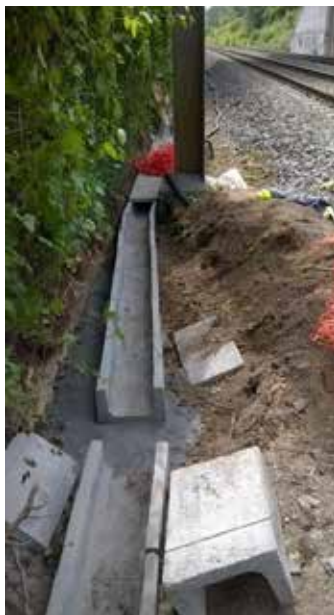
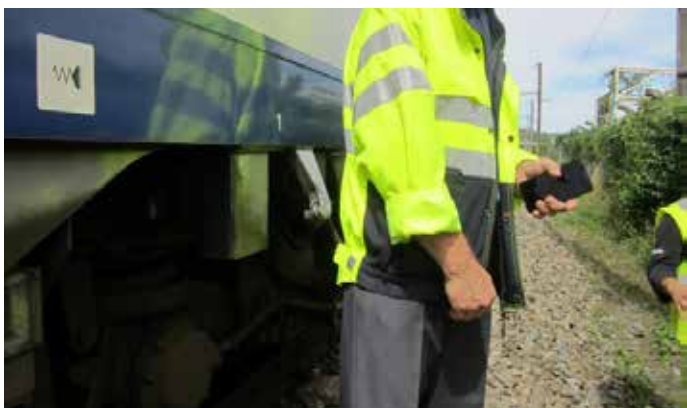
Engis: 31 July 2017

On Monday 31 July 2017, at around 1:30 p.m., SNCB/NMBS passenger train 3835 hit an agent who, as he was working along the tracks, found himself within the loading gauge.

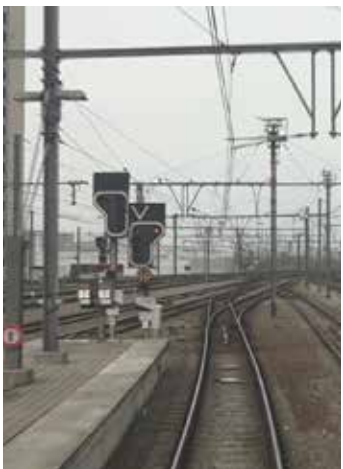
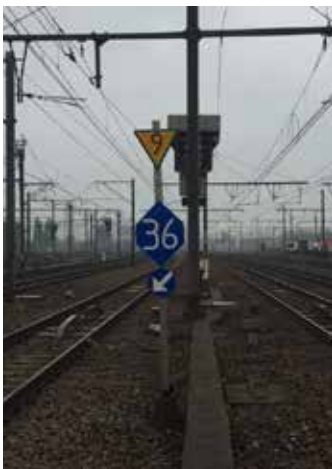
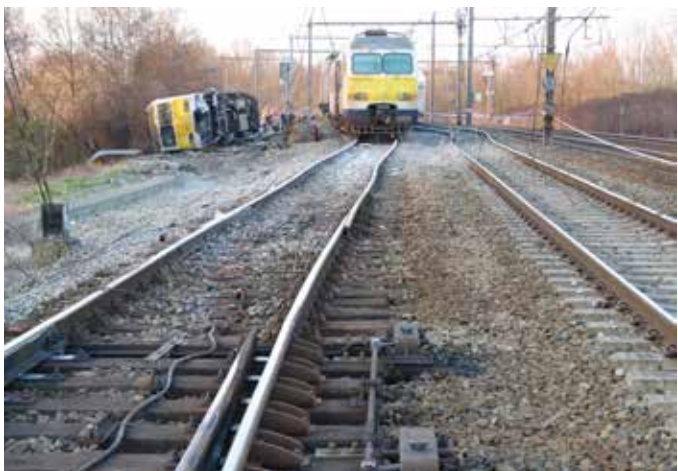
Leuven: 18 February 2017

According to the retained hypothesis, the direct cause of the derailment is the inappropriate speed of the train during the passage over an S-shaped curve formed by two connecting switches.

According to the retained hypothesis, the first indirect factor is the incorrect processing of the signalled information (orders) relating to the speed restrictions that must be observed, due to an incorrect mental perception (cognitive bias).

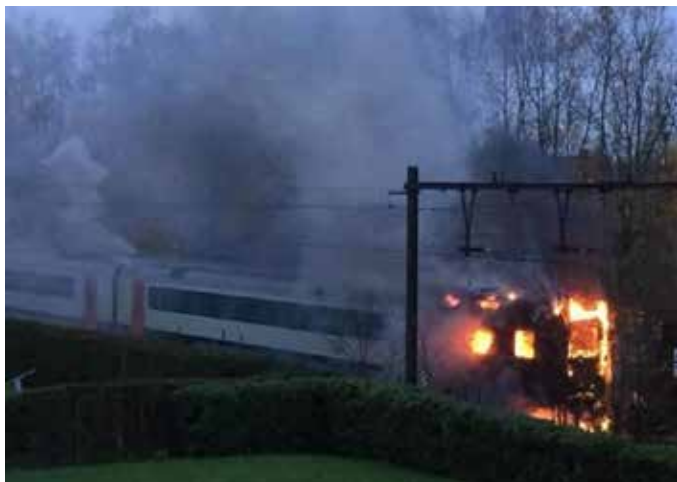
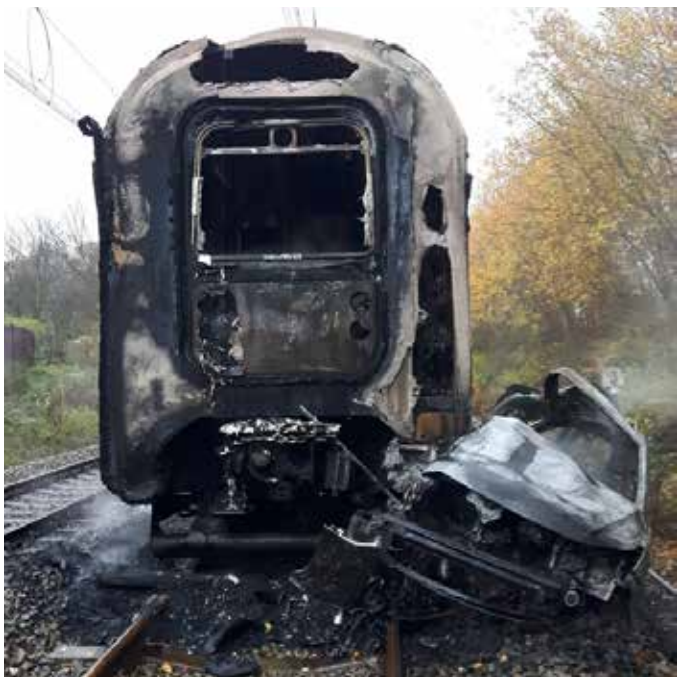
Morlanwelz LC: 27 November 2017

The accident did not claim any victims, but caused significant damage to the vehicle, the railcar and the infrastructure.

This accident is considered as a precursor. Indeed, after the collision with the vehicle, the rolling stock had to be "re-railed", which caused another accident with dramatic consequences.

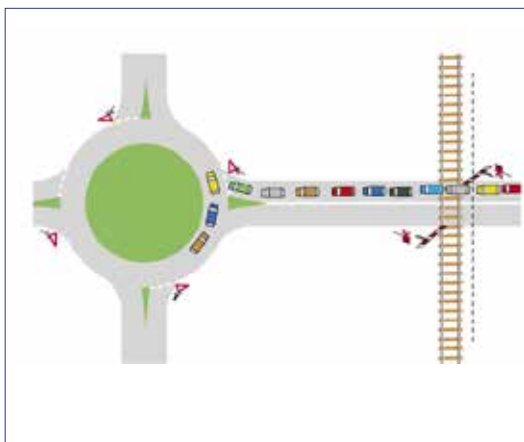
Morlanwelz LC: 27 November 2017

The Investigation Body determined that the configuration of the area surrounding the level crossing can lead, in certain conditions, to traffic jams and the immobilisation of vehicles as they are driving over the level crossing.

Our analysis delved deeper and revealed that in various cases, the configuration of the area surrounding the level crossing can create a traffic jam effect, i.e. the traffic conditions are such that a jam is created in advance of the level crossing and extends to the level crossing, causing the vehicles to stop.

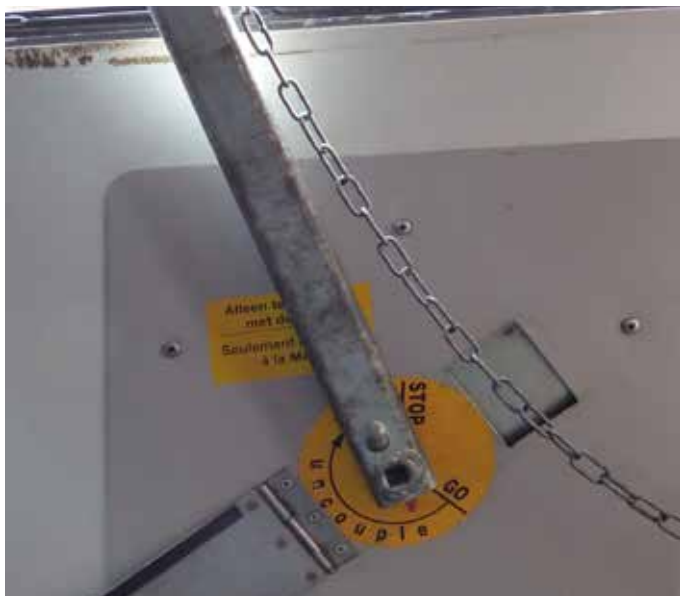
Without personnel or the driver of the re-railing train realising, the AM449 disconnected from the convoy during towing to Piéton, and the railcar rolled back down the sloping track towards Morlanwelz.

A few seconds after the announcement from the guard at the level crossing, a message announced that personnel from the infrastructure manager had been struck by the runaway railcar: 2 agents were fatally struck and 4 others were injured.

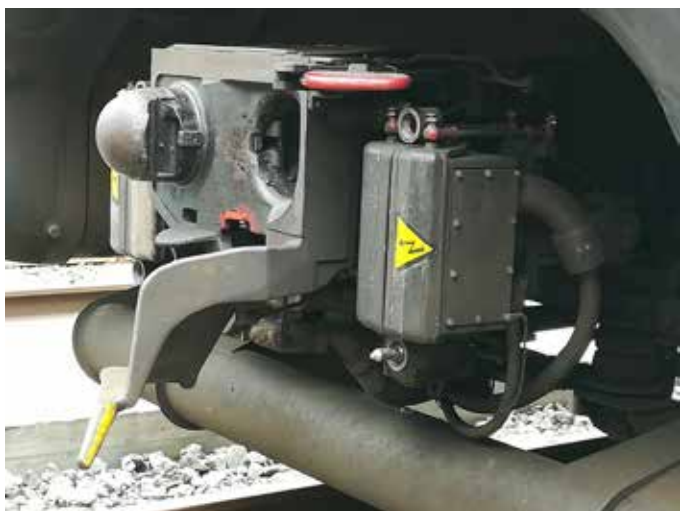
Bracquegnies / Morlanwelz: 27 November 2017

The railcar continued its drifting and passed by La Louvière-Sud before reaching line 118: the emergency procedures undertaken by the various Infrabel services did not manage to stop the escape.

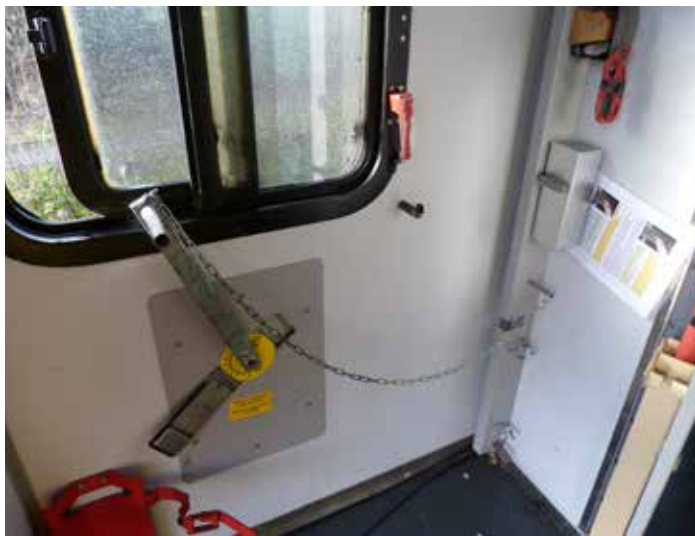
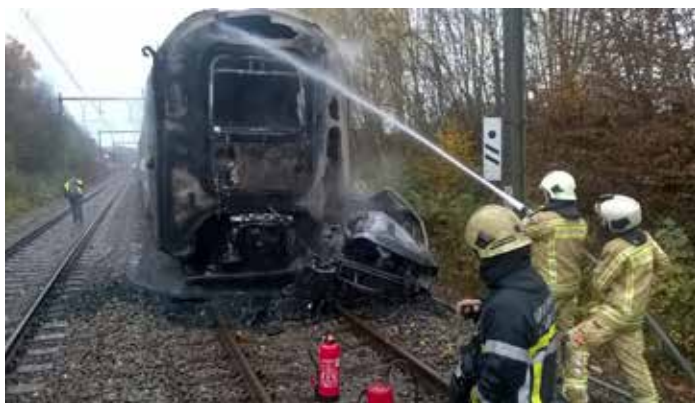
Bracquegnies / Morlanwelz: 27 November 2017

The AM96 are electric railcars composed of 3 crates, easily recognisable thanks to the pneumatic diaphragms located at both ends of each unit. While 2 of these railcars are coupled, the diaphragms compress against one another and form a tight seal, whereas the front walls (doors) can fold completely in, making the driver's cabin disappear against the sides of the railcars and allowing movement of passengers and personnel between the 2 railcars.

The presence of these two diaphragms pressed against one another has several consequences, including blocking access to the couplings.
