KÖZLEKEDÉSBIZTONSÁGI  
SZERVEZET

# **ANNUAL REPORT 2010**

## **Transportation Safety Bureau**

### **Hungary**

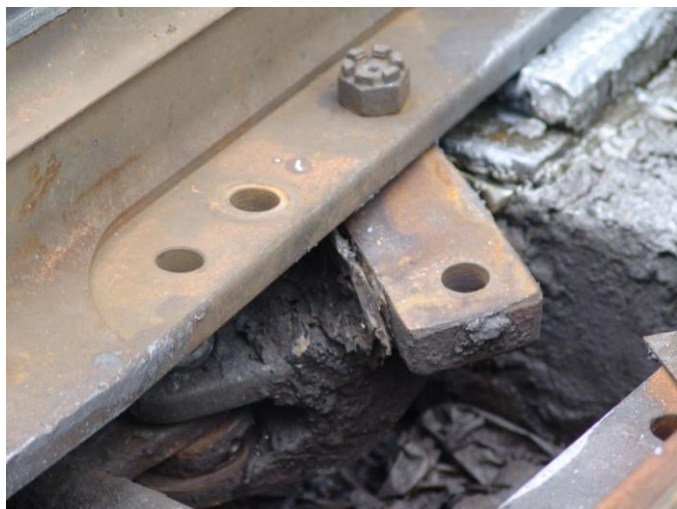
##### 2007-328-5

On 7 September 2007, four carriages of passenger train no. 3434 derailed on switch no. 6 (double slip) when departing from Budapest-Keleti pu.

No one was injured. The derailed carriages did not fall onto their side but sustained damage of different extent. The rail track also sustained damage and the occurrence caused some delays on the railway line.

The suspension tab of the connecting rod for one of the blades at no. 6 double slip got separated from the blade. Under its own flexibility and free of the retraction of the connecting rod, the blade got close enough to the main rail to derail the passing train. The IC noticed that the safety pin of the nut-and-bolt fastening of the suspension tab was missing, indicating the possible cause of the separation of the tab from the blade.

The nut-and-bolt fastenings were not secured at the last repair of the double slip and this fact remained unnoticed when accepting the work done.

The lack of equipment securing the nut-and-bolt fastenings and the loosening of the bolts remained unnoticed and unrepaired at the periodical inspection of the switch.

**BA-2007-328-5-01:** The IC recommends infrastructure managers to ensure that after the switch have been repaired, only professionally and adequately assembled equipment are accepted and released into service. Therefore the current practice of acceptance-release should be reviewed and if necessary, detailed guidelines/checklist should be compiled with regard to the aspects of inspection.

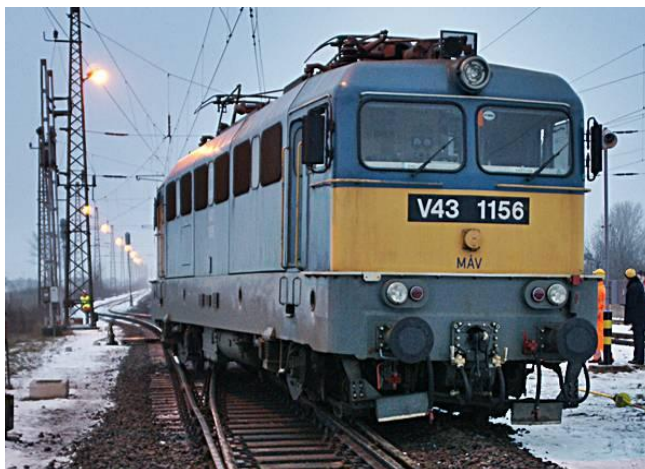
### 2008-0008-5

On 7th January 2008, locomotive (reg. no. V43-1156) of train no. 5122, upon leaving Tarcál station, derailed with one bogie and one axle between switch no. 17 and 11 on the open track after the exit signal.

After the report of the accident, the IC conducted a site survey. Based on the gathered data and information, the IC established that the cause of the accident was a defect in the rail track, i.e. the lack of vertical reinforcing on several sleepers on track III of the station at the small-radius arch before switch no. 11.

The IC established in the course of the investigation that the derailment of train no. 5122 was caused by the fact that the lateral rigidity of track III of Tarcál station was not sufficient.

The locomotive generated such a gauge widening that caused the derailment of the train when it was departing from the station at the small-radius arch before switch no. 11 - where several sleepers had previously become unstable due to the breakage of the rail bolts.

It was found in the course of the investigation that the breakage of the rail bolts in the small-radius arch is a result of a longer process.

The IC established in the course of the site survey that some of the wooden sleepers had rotted away. The lower parts in a relatively good condition kept the seeping water in the holes. As a consequence, the bolts soon got corroded; their necks 4-5 centimetres below the head became thin due to the corrosion, and the bolts eventually broke under the excess load and pressure.

The signs of decay were visible. The switch of Tarcál station were measured in June 2007 when sudden and significant gauge widening was found, which showed that some abnormal process was happening in the rail track.

No further action has been taken after the switch inspection. The broken rail bolts remained unnoticed and even though the gauge widening was established, no speed limit was introduced.

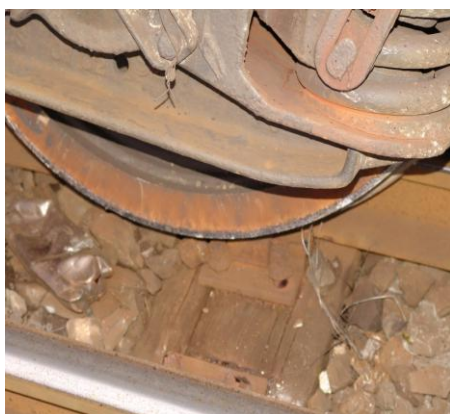
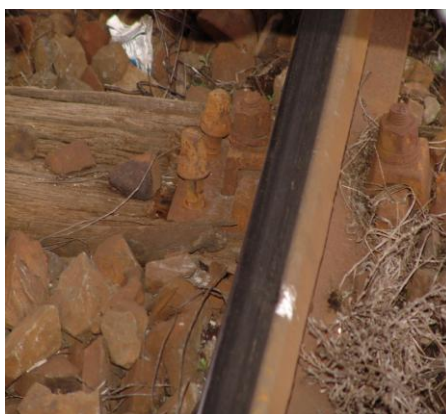
**2008-052-5**

On 7 February 2008 at 8:50 hrs, when leaving track VII of Budafok-Háros station, the 6<sup>th</sup> wagon (reg. no. 33 55 785 1029-9) - loaded with petrol - of freight train no. 83521 derailed in section no. 64+15 and after stopping it fell onto its side.

The accident occurred due to the gauge widening which can be attributed to the bad, worn away condition of the rail track.

The accident occurred due to the gauge widening which can be attributed to the bad, worn away condition of the track network - among them track VII - of Budafok-Háros station.

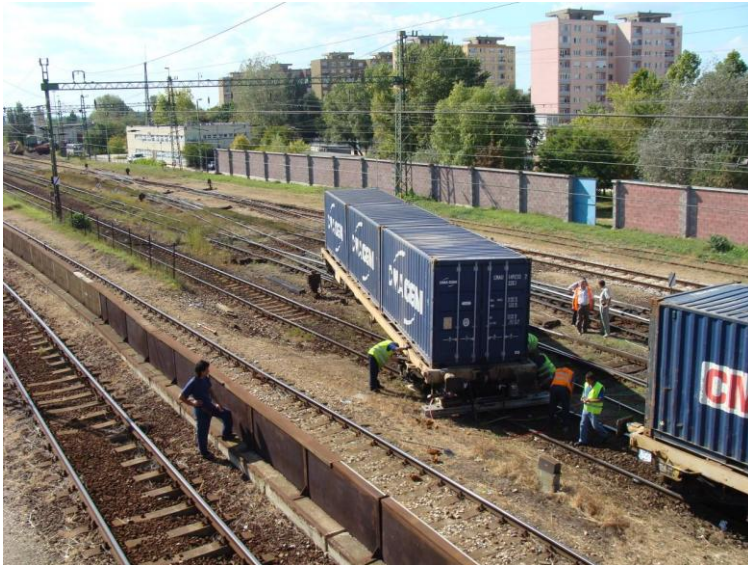
- Significant gauge defects and rail distortions were found on the track where the train derailed.
- The wheel loads of the derailed vehicle were asymmetric exceeding the permitted value.

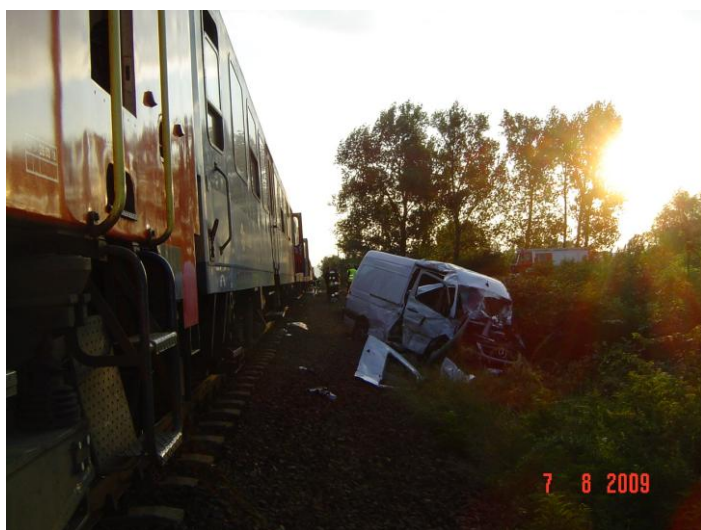
**2009-382-5**

On 7 August 2009, fast train no. 529 departed from Sátoraljaújhely station at 03:51 hrs to Budapest-keleti pu according to schedule. Upon leaving the station, it collided with a Mercedes Sprinter 318 CDI Ukrainian bus at LC no. SR-2 - protected with warning lights - in section no. 443+70. As a consequence of the collision, one of the passengers of the bus died at the site, 2 suffered serious and 6 suffered minor injuries.

The locomotive (reg. no. M 41-2334) became inoperative. Entry signal 'A', mast 'c' of the LC and one end of the insulated rail section sustained damage. The bus was written off.

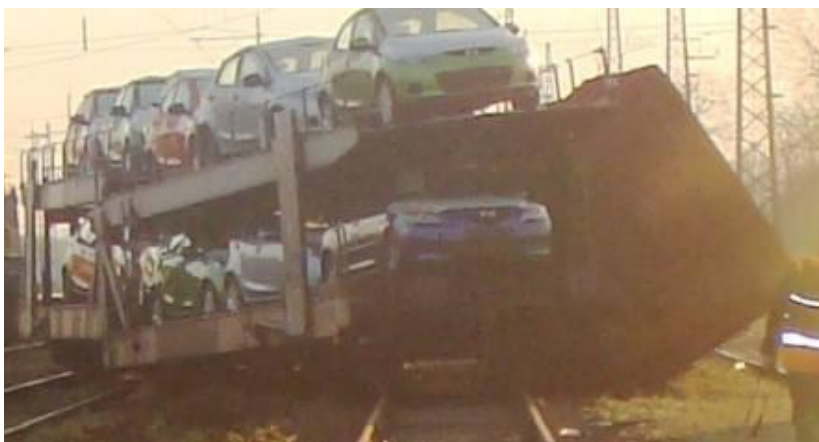
### **2008-136-5**

On 26 March 2008 at 01:18 hrs, the 15<sup>th</sup> and 16<sup>th</sup> twin wagon (nos. 23 80 435 1919-4 and 25 80 436 805-5, carrying cars) of train no. 44405-2 derailed at switch no. 22 when approaching track XIII of Kőbánya-felső station. The second half of the 15<sup>th</sup> wagon was running towards track XIV and collided with an Eas wagon (scrapped) standing on the track.

The railway vehicles sustained minor damage and the rail track was damaged on an approximately 200-metre length.

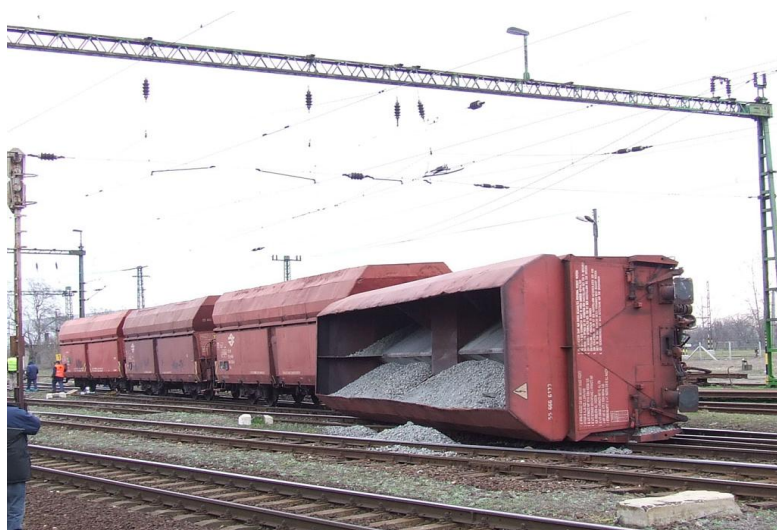
**2009-113-5**

On 23 March 2009, the first wagon of freight train running from the Vác factory of DDC to its Beremend factory (carrying cement bricks) derailed and tipped to its side when departing from track VIII of Pusztaszabolcs station. Further two wagons derailed with one axle. The rail track and the signal box sustained damage. When the still standing wagons were trailed away, there was a similar derailment at the other end of the station.

The IC conducted a site survey in the course of which it found that the cargo was not adequately arranged in the wagons. Therefore the IC examined the loading technique/procedures and made checking calculations as well. The rail track repair works had begun before the site survey, however, the data obtained from the infrastructure manager showed that the track had already been deformed beyond the size limit prior to the accident.

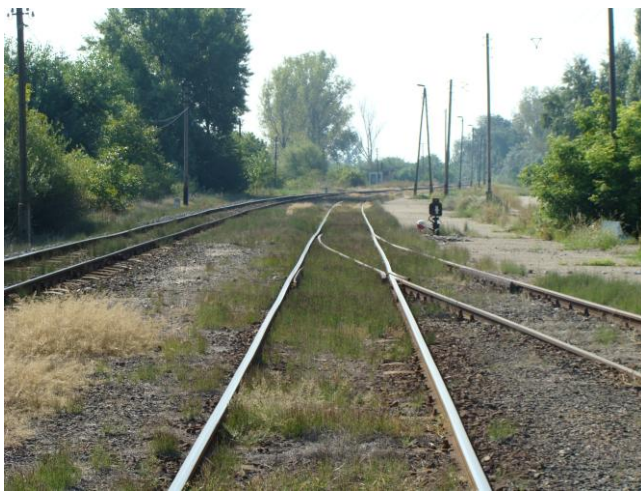
**2009-413-5**

On 23 August 2009 at 21:18 hrs, freight train no. 98658 - running from Veszprém to Paks and carrying stone - approached the main transit track (III) of Aba-Sárkeresztúr station and ran through it without previous authorization. It travelled on the same track as passenger train no. 38421 - which departed from Sárbogárd station at 21:13 hrs with permission - in opposing direction. The traffic controller notified the engine-drivers (through the locomotive running foremen) via mobile phone to stop the trains. The two trains then stopped approximately 3400 metres from each other on the open track.

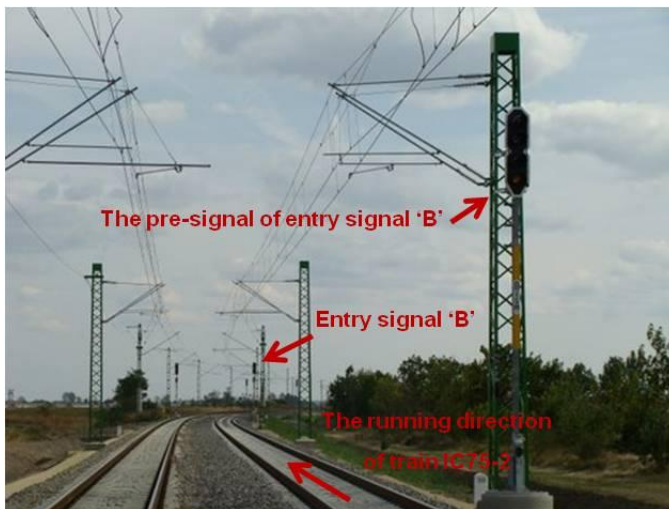
## **2009-0443-5**

On 5 September 2009 at 09:23 hrs, train no. IC 75-2 passed entry signal 'B' signal at danger at Nagylapos crossover and approached the track of Nagylapos station on which train no. 7442 was standing. The movements inspector noticed the occurrence and gave a 'Stop' signal to train IC 75-2 (which was running with approximately 10 km/h speed). Train IC 75-2 stopped 150 metres from the rear of train no. 7442.

The block system between the two stations developed a fault due to the previous day's storm. As a consequence, block signal no. AT376 became inoperative (red light was on the signal) and it was impossible to send clear signal onto entry signal 'B' of Nagylapos crossover. At the same time, traffic control was also impossible between Nagylapos and Gyoma.

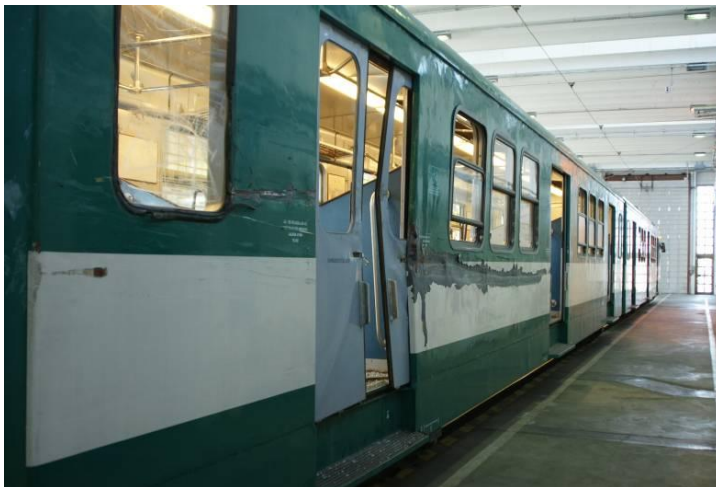
#### 2009-0503-5

On 4 October 2009 at 11:29 hrs train no. 2042 collided with a tractor at an unprotected LC between Tököl and Szigetcsép stations, at railway section no. 267. As a consequence of the collision, 3 passengers of the train suffered injuries and the first and second carriages of the train sustained damage.

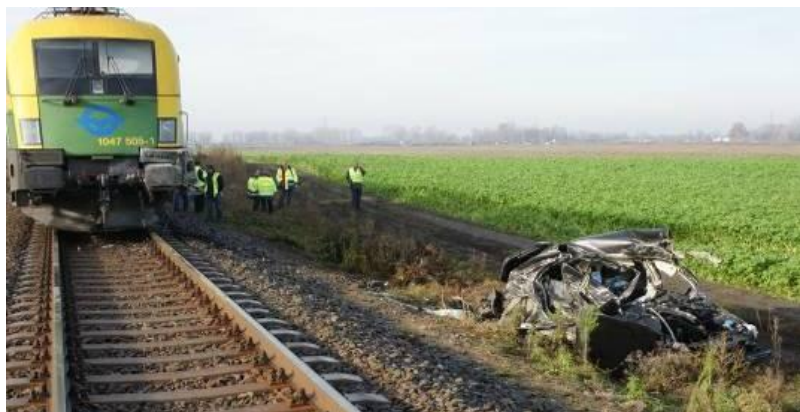
### **2009-583-5**

On 19 November 2009 at 7:10 hrs train no. 999 collided with a car between Ikrény and Enese stations at Rábapátona stop at LC no. AS137 protected by half barriers and warning lights.

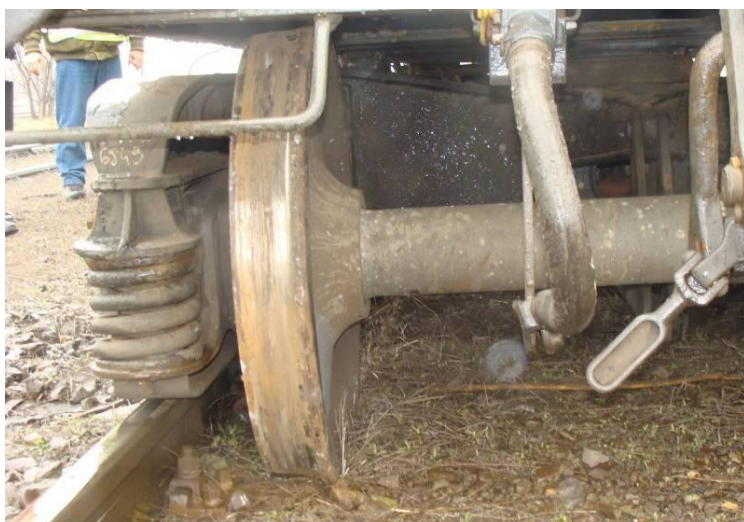
#### **2009-052-5**

On 4<sup>th</sup> February 2009 at 8 hours 45 minutes, the fifth wagon (reg. no. 33 87 787 6849-3) of train no 45213 running from Slovakia derailed with 4 axles on track X while approaching Rajka station. As a consequence of the derailment, the rail track and the derailed wagon sustained minor damage.

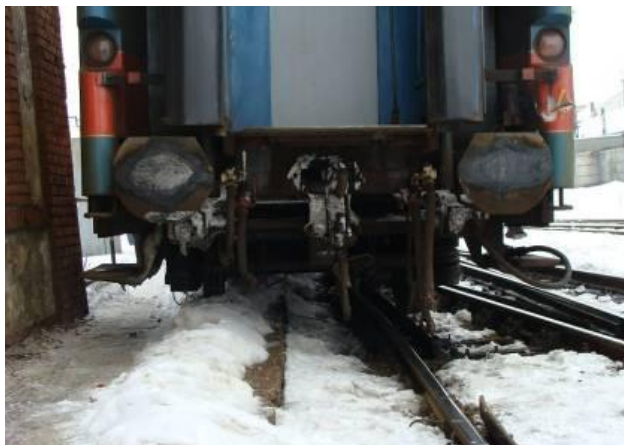
**2010-069-5**

On 9 February 2010 at 08:27 hrs, 2010, one carriage (the penultimate) of train no. 2759 derailed with four axles between points no. 13 and 19 when approaching track XIV of Budapest-Nyugati station.

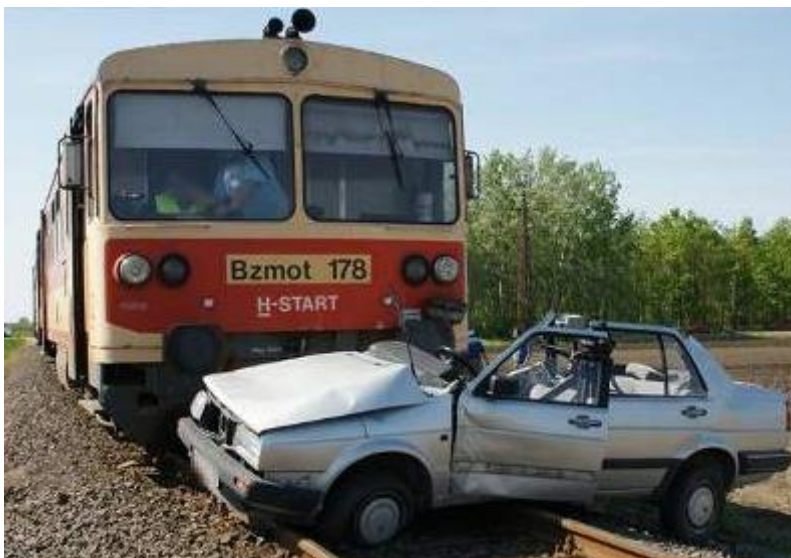
## **2010-0190-5**

On 29 April 2010 at 12:40 hrs, train no. 37015 collided with a car at an unprotected LC between Makó and Apátfalva stations, in railway section no. 795+76. As a consequence of the accident, the driver and the passenger of the car suffered serious head injuries and they were taken to hospital in Szeged by an ambulance helicopter. No one was injured on the train. The train was delayed by 128 minutes.

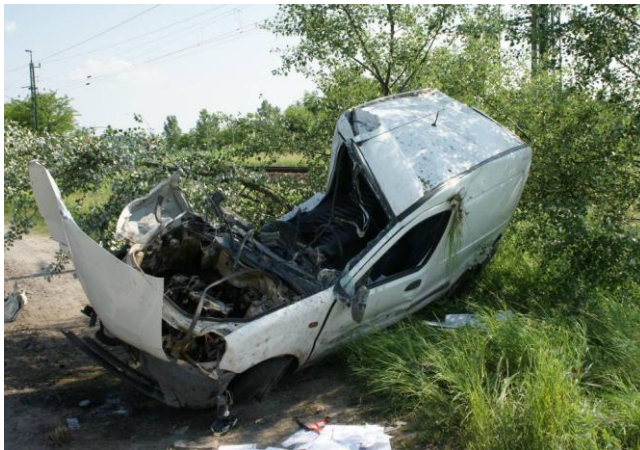
### **2010-229-5**

On 25 May 2010 at 14:00, the locomotive (reg. no. V 43-1128) of train IC 704 collided with a car at LC SR2 - protected with warning lights - at Szatymaz station.

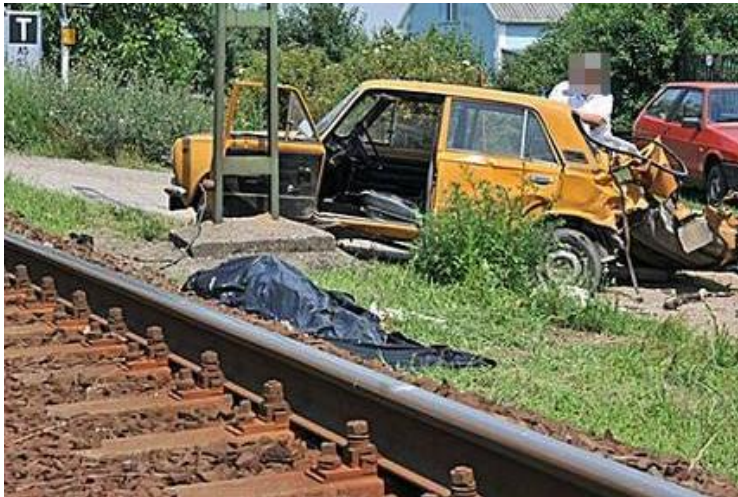
### 2010-0304-5

On 16 July 2010 at 10:25 hrs, train no. 35045 collided with a car at LC AS13 between Nyékládháza and Hejőkeresztúr stations. The LC is protected by warning lights which were operating normally at the time of the accident. As a consequence of the collision, the driver of the car lost his life at the site, his passenger suffered minor injuries. Two trains were cancelled and one train was delayed by 35 minutes.

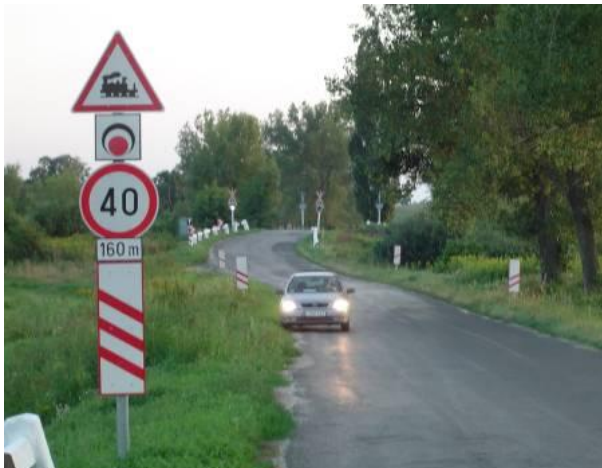
## **2010-354-5**

Train no. 9235 collided with a motorbike at LC AS386 (protected with warning lights) between Pápa and Vaszar stations.
