TRANSPORTATION SAFETY
BUREAU

ANNUAL REPORT 2011

Hungary

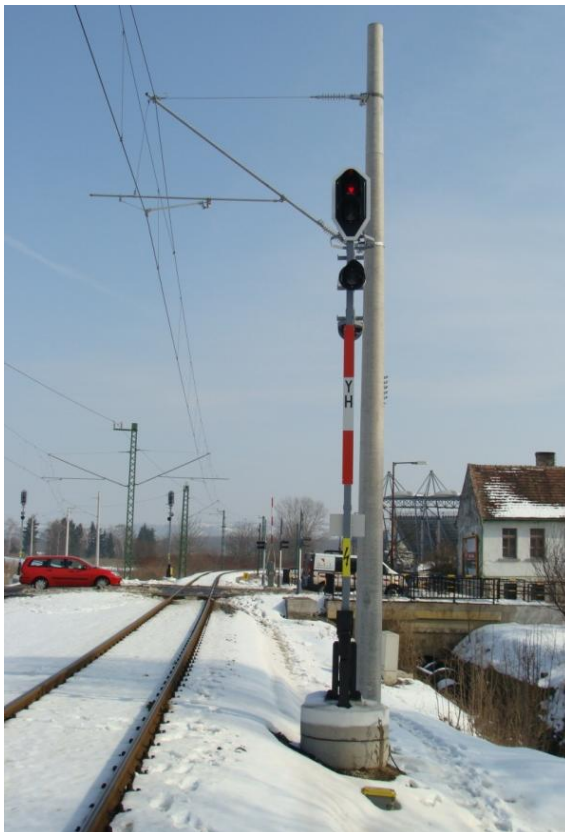
On 11th February 2010 at 12:15 hrs, train no. 1247 passed the signal YH at danger, the locomotive and the first carriage of the train passed the open level crossing protected with warning lights and half-barriers SR4. No one was injured.

- Based on documents and the analysis of videos and pictures taken on the site, the IC established that the SPAD was caused by the fact that the engine driver had not been able to notice the red light (Stop indication) of the YH in time. When noticing the Stop indication, he immediately applied the emergency brake, but the train, not having enough room to stop, passed the signal and stopped on the open level crossing protected with half-barriers, with its locomotive and first carriage passing over it.
- After analysing the information recorded by the data recorder of train no. 1247, the IC established that the actual

- The actual structure of the safety installation at Andrásidai junction allows the possibility of a human factor caused error of directing, without any previous indication on the entry signal, a train travelling at 100 km/h – supposed to be following according to the schedule the straight direction through the Y1 – to the diverging direction of the junction. As a consequence, the train could enter at a speed of as much as 100 km/h the section to which speed limit of 60 km/h applies.

TSB therefore recommends the NTA to revise, in cooperation with MÁV Co., the function of the junction at Andrásida and take the necessary measures to create a uniform regulation regarding the junction concerned and those of similar structure (extant or to be established).

TSB therefore recommends the NTA to examine, in cooperation with the operator of the infrastructure, the system of “Clear” indications distributable to the signal YE by the safety installation in the junction at Andrásida and take the necessary measures according to the findings.

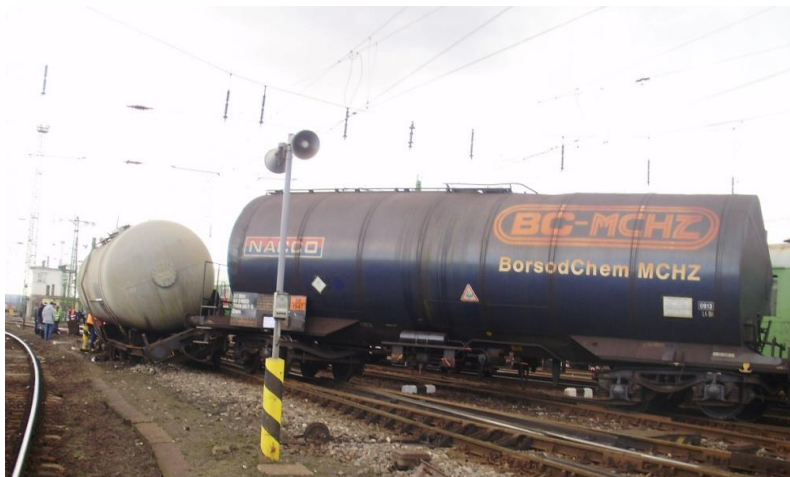
On 15th March 2010 at 09:30 hrs, 3 wagons of freight train no. 53410 derailed when departing from Miskolc - Rendező station to Bánréve - first the 24th wagon, used for transport of dangerous goods, but empty at the time of the accident, after which the 23rd and 25th wagons derailed. The 24th tank wagon (Zas) had a Polish owner. The rail track and the derailed wagons sustained damage.

The investigation established that the 6th spindle of the wagon had already been faulty, had fallen apart and the bearing box had fallen off the wagon right before the occurrence, which resulted in the derailment of the wagon.

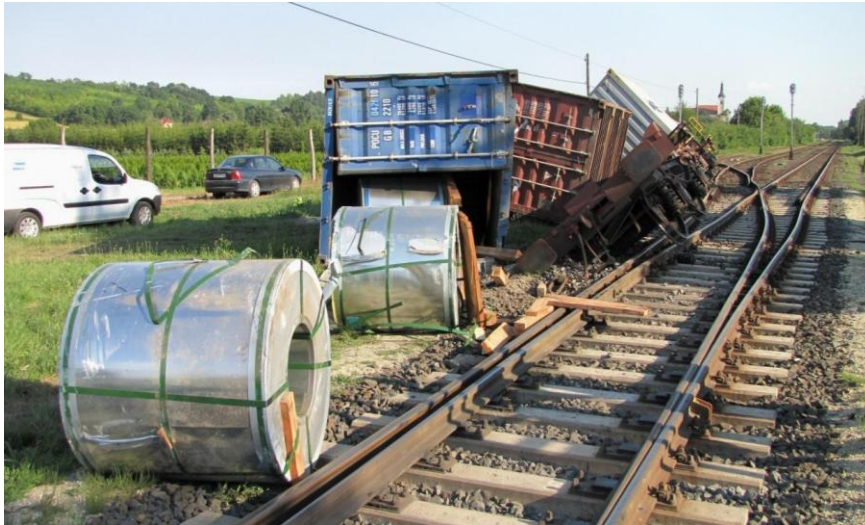
On 11th July 2010 at 16:10 hrs, when freight train no. 45220-1 (M62-307) was departing from track III. at Búcsúszentlászló station, the last wagon (no. 33 54 496 0992-4) of the train derailed, broke from the train and fell over blocking the track on

the last track section before points no. 4. The engine driver, realizing the occurrence of the accident, used the emergency brake, this resulting in the rupture of the screw coupling of wagon no. 83 35 549 6518-2 and the split of the train. The IC

established that before the accident a loose to gauge and track alignment error within the allowable error margin were measurable at the location. Frame stability was not assured, sleeper screws were not constraining properly the bottom of the rails. Direct cause of the derailment was the buckling of the rail below the moving train, being caused by the high temperature lasting for more days and the bow wave effect.

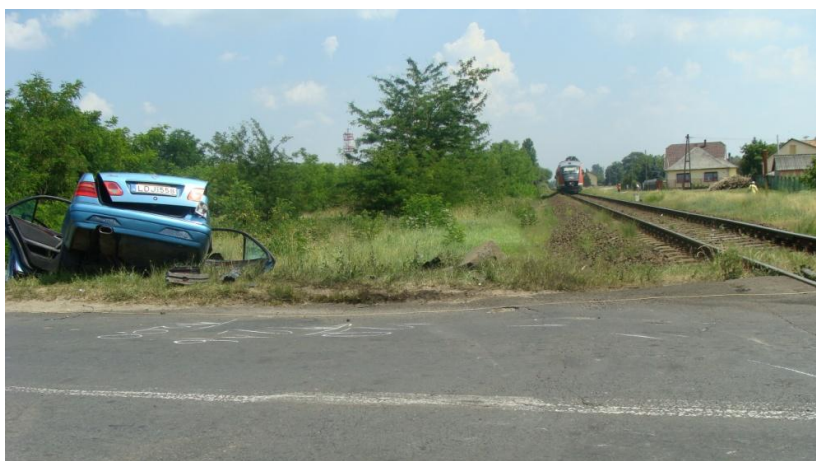
2010-297-5

On 14th July 2010 at 12:26 hrs, on the level crossing SR2 protected with warning lights operating properly a car crashed into the left forefront of train no. 2842 (motor train set no. 95 55 34 2001-2) arriving to Örkény station with all signals operating properly.

The car was shoved by the train to the left side of the track.

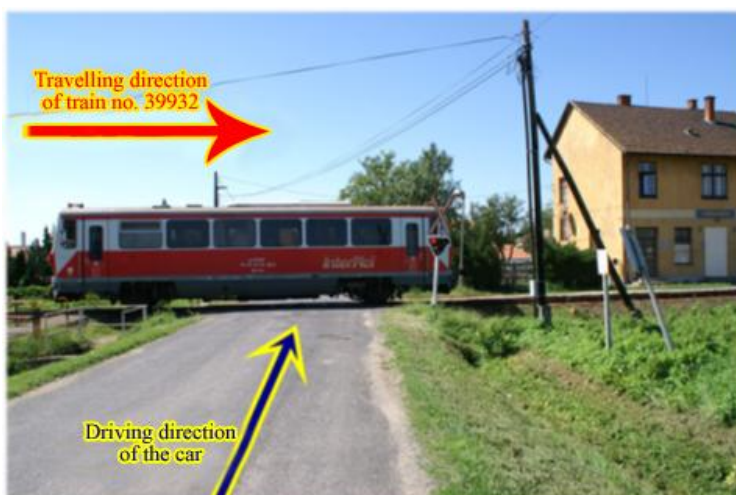
On 16th July 2010 at 10:19 hrs, between Szombathely and Kőszeg stations, power car no. Bz-354 of train no. 39932 collided with a car at Lukácsháza halt on the level crossing protected with warning lights no. AS52 2010 operating properly.

As a consequence of the accident the driver of the car suffered serious injuries that resolve in more than 8 days. No passengers of the train were injured. Power car no. Bz-354 was slightly damaged, but remained operative, the car was seriously damaged. The train delayed 87 minutes as a consequence of the accident.

In the course of the investigation the IC established that the light signal was operating properly at the time of the accident, it was flashing red lights towards the direction of the road. The structure of the level crossing complied with the laws in force, the passenger train

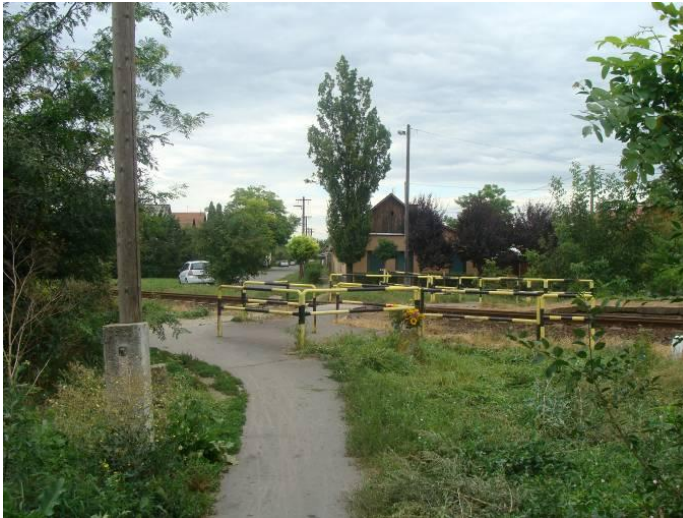
On 17th August 2010 at 13:07 hrs, power car Bzmot 168 of train no. 7254 struck a children’s bicycle on the rail pedestrian crossing in railway section no. 24+90 at Bereghát halt between Szentés and Szegvár stations. As a consequence of the collision the bicycle was pushed out by the power car to the right (in relation to the travelling direction). The bicycle hit the child causing so serious injuries that the child died at the site. The IC examined the site of the accident, the construction of the rail pedestrian crossing, the visibility conditions and the actions to be taken by the staff of the train in case of an incident or an accident. The IC considered the occurrence of the accident as being caused by human factors relating to the bicyclist boy, but had

further findings concerning the notification procedure to be followed in case of the occurrence of an accident. The IC issued a safety recommendation in order to assure that the ambulance would be notified in the shortest time of the occurrence of an accident.

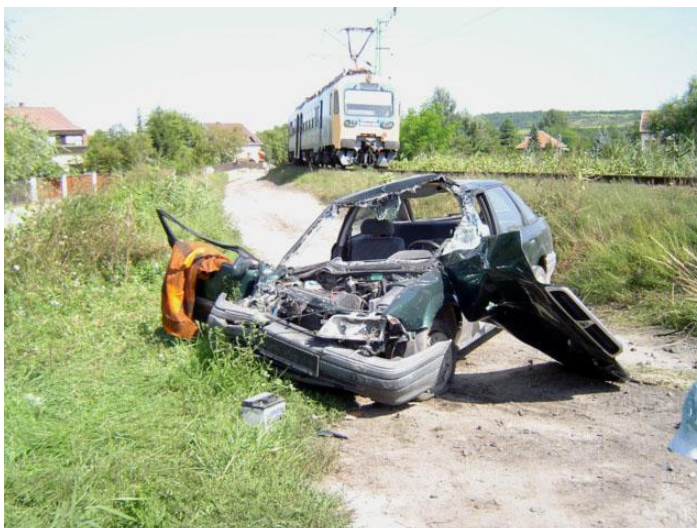
2010-382-5

On 21st August 2010 at 10:04 hrs, train no. 2422 (power car no. BDV 020) leaving Órbottyán station with signals operating properly collided with a car entering in front of the train on the unprotected level crossing in railway section no. 235+95. The train pushed the car aside the track.

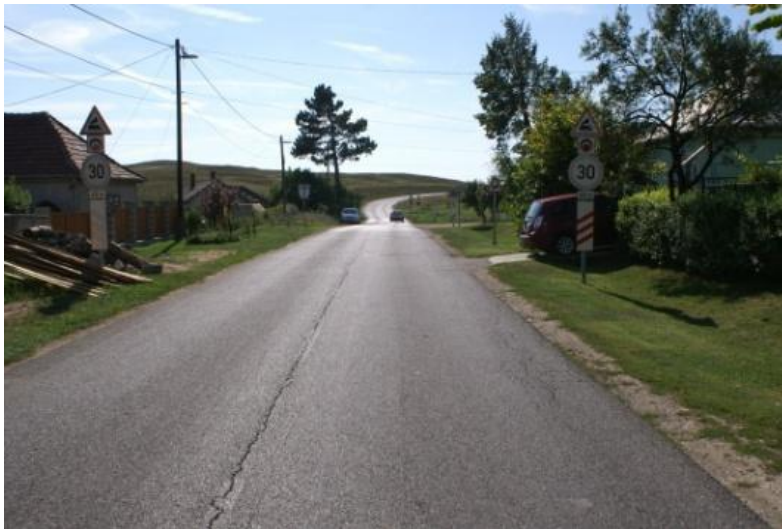
2010-383-5

On 21st August 2010 at 16:50 hrs, between Hajmáskér and Pétfürdő stations near settlement Öskü, passenger train no. 9053 struck a cyclist on the level crossing protected with warning lights no. AS316 operating properly. The cyclist died at the site. No one of the passengers or personnel of the train was injured.

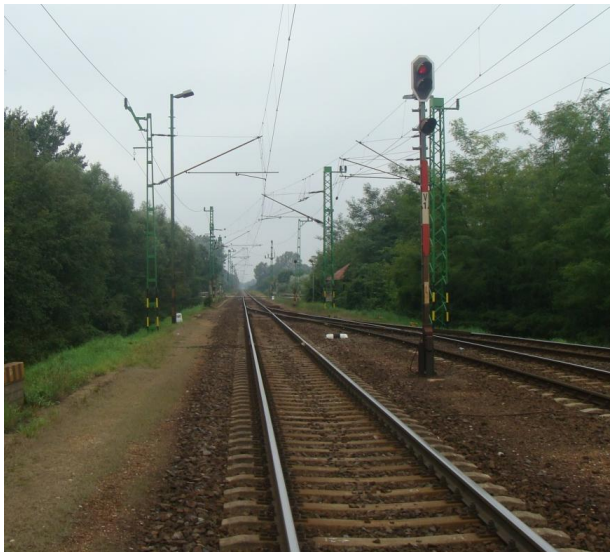
On 4th September 2010 at 10:54 hrs, train no. 9912, scheduled to stop at Ikrény station, ran unauthorized through the station, passed exit signal V1 at danger, split points no. 1 and stopped as a result of the operation of the train protection system.

No one was injured in the occurrence.

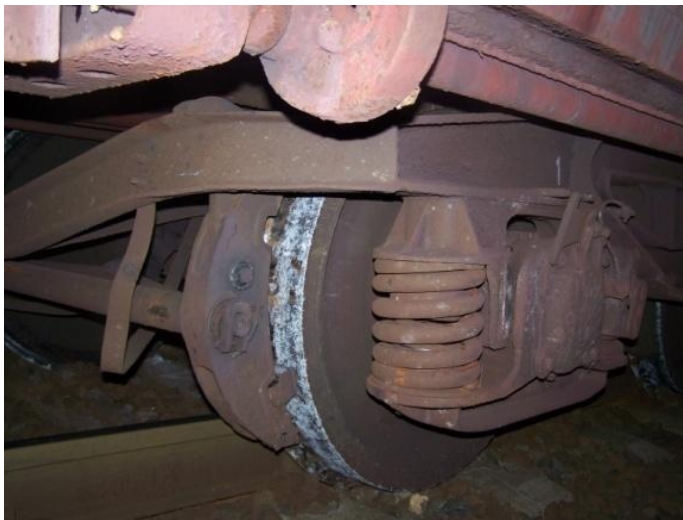
2010-443-5

On 27th September 2010 at 03:40 hrs, 2nd wagon (a 4-axle wagon) of freight train no. 68215-2 arriving to Adony station with signals operating properly, derailed with 2 axles in the curve before the enter signal. The wagon derailed was hauled by the train on a further 500 m distance.

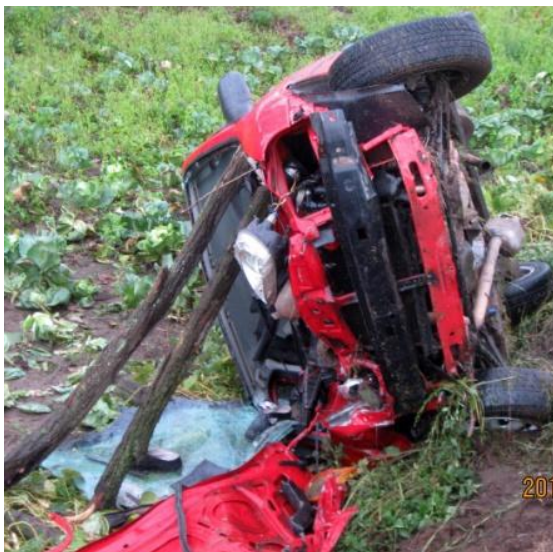
2010-455-5

On 5th October 2010 at 11:00 hrs, train of locomotive no. 6381 collided with a car of type Opel Corsa on the non-protected level crossing between Nyírgelse and Nyíradony stations in railway section no. 313+59. The driver of the car was seriously injured and transported to the hospital by an emergency helicopter. There were minor damages to the locomotive, no one of the personnel of the train was injured.

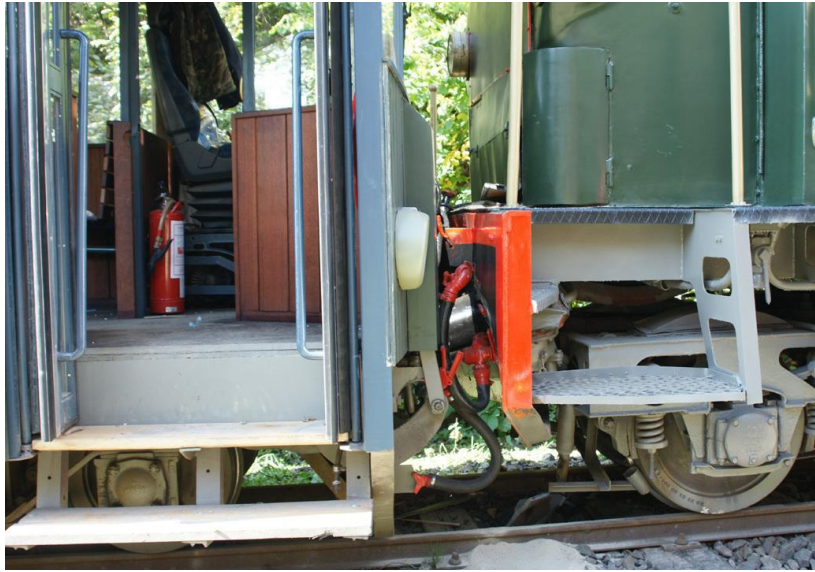
The trains were scheduled to cross at Hártókút station, but the train travelling in the pair direction – arriving earlier to the station – had not waited for the other and leaving the station collided with it on the curve with poor visibility near the station.

The IC established that traffic control procedures were not applied, train crossings were completely based on the knowledge of schedule of the train crew. There had already been a similar occurrence in 2009 on the same railway line – with no collision that time – related to which TSB also established traffic control

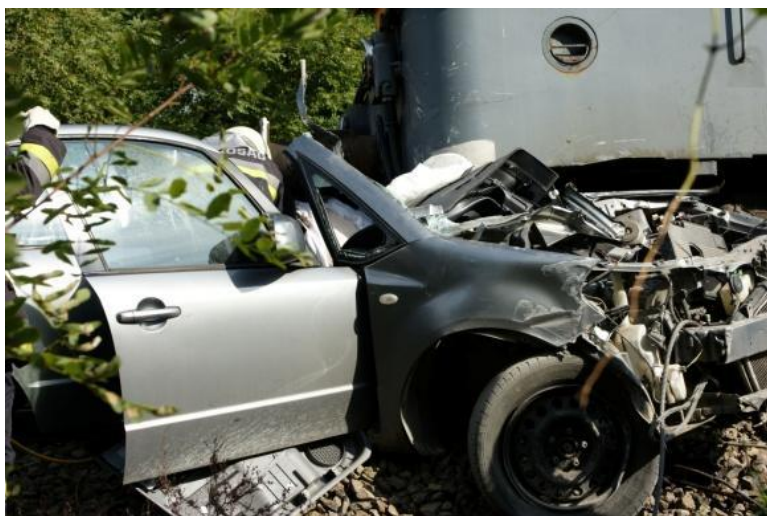
On 13th October 2010 at 12:27 hrs, between Kiskunfélegyháza and Petőfiszállás stations locomotive no. V43-1010 of intercity train no. IC705 collided with a car on the level crossing AS628 protected with properly operating warning lights indicating red lights toward the road.

The driver of the car died at the site. Locomotive no. V43-1010 sustained minor damages, the car was totalled. No one of the passengers of the train was injured.

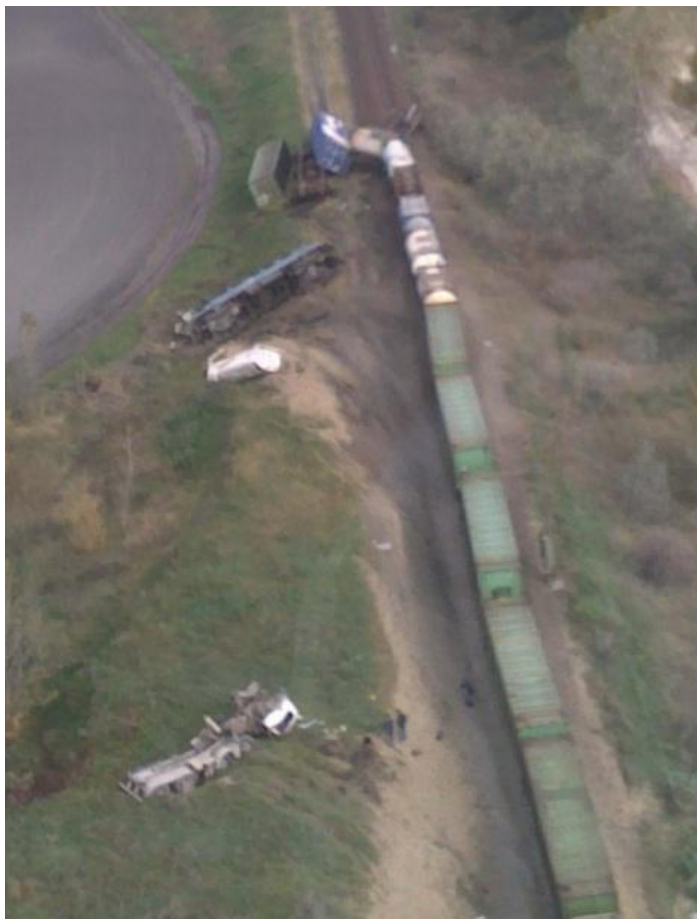
2010-490-5

On 20th October 2010, freight train no. 40760-1 collided with a lorry loaded with sand between Kiskunlacháza and Délegyháza stations on the level crossing AS322 protected with properly operating warning lights. The locomotive and the first 2 wagons of the train derailed, the locomotive fell over to the embankment, the track and the overhead contact line was damaged in a 250 m length, the lorry was totalled. The engine driver died at the site, the driver of the truck was seriously injured. The traffic on the damaged track was started on 21st October 2010 at 12:33 hrs, at the reduced speed of 10 km/h.

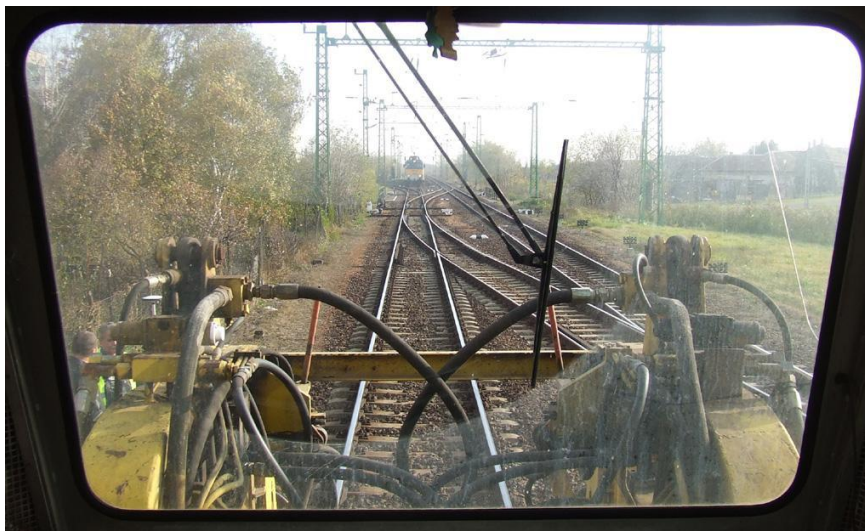
On 4th November 2010, a ballast compactor running from Jászkisér to Godisa passed exit signal at danger on track II at Újszász station, split points no. 11 and approached from opposite direction to passenger train no. 3315. The two trains stopped at a 100-200 m distance from each other.

The IC established during the investigation that the occurrence was caused by lack of attention and incorrect application and interpretation of hand signals. Beyond that some of the statements of the involved

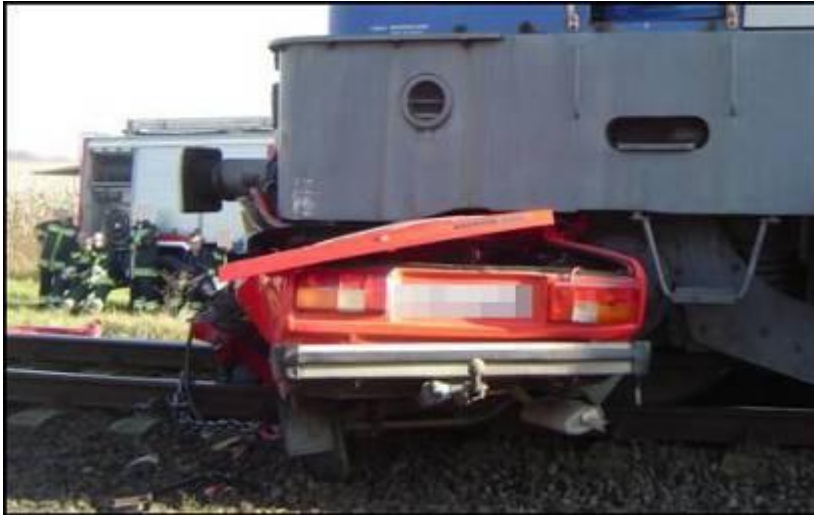
crossing, toward the road traffic and railway traffic as well, were complying with the regulations. Train no. 6200 was travelling at the speed specified in the schedule and the engine driver took every action possible in order to avoid the collision.

The IC considers that the driver of the car was not approaching the level crossing with due foresight and entered it ignoring the “Stop” indication of the warning lights and the closed position of the half-barriers. He could not exit the level crossing before the train arrived and this resulted in the

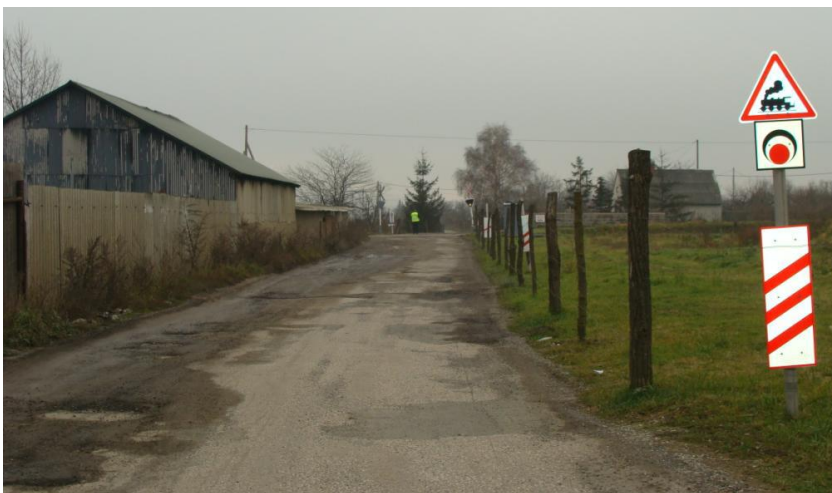
2010-533-5

On 23rd November 2010, passenger train no. 9626 collided with a car between Tapolca and Lesencetomaj station on the level crossing AS438 protected with properly operating warning lights. The car driver entered the level crossing ignoring the “Stop” indication of the

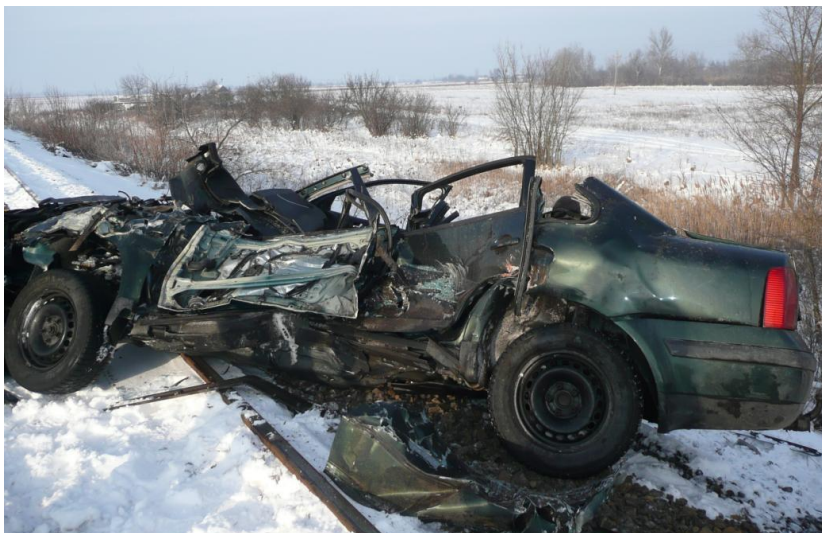
On 19th December 2010, passenger train no. 7245 collided with a car on the level crossing AS319 protected with warning lights between Hódmezővásárhelyi Népkert and Mártély stations. The driver of the car suffered serious injuries. The motor coach train was damaged, the car was totalled.

The IC examined the structure and operation of the level crossing and established that the warning lights were flashing red lights toward the road at the time of the accident. The train was not exceeding the speed limit.

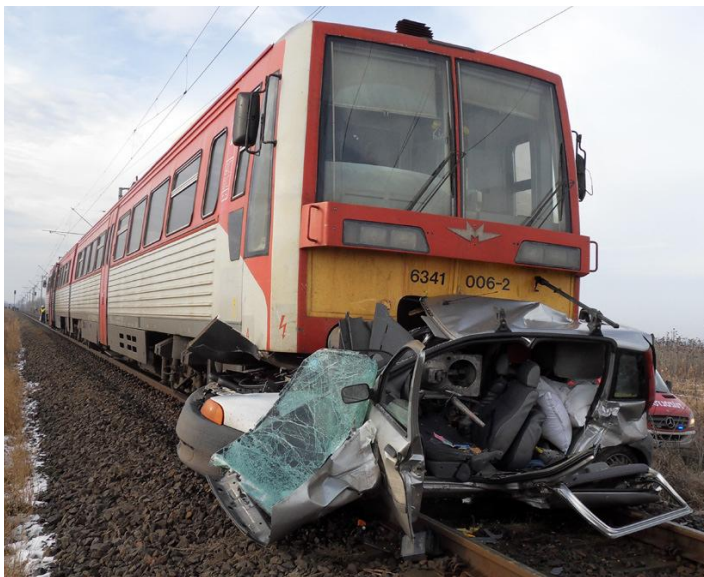
- warning lights were operating properly at the time of the accident,
- road traffic signals were partly missing, but the indications of the warning lights were clearly visible,
- the railway vehicle was travelling at a speed not exceeding the speed limit.

The IC considers that the accident was caused by human factors related to the driver of the car.

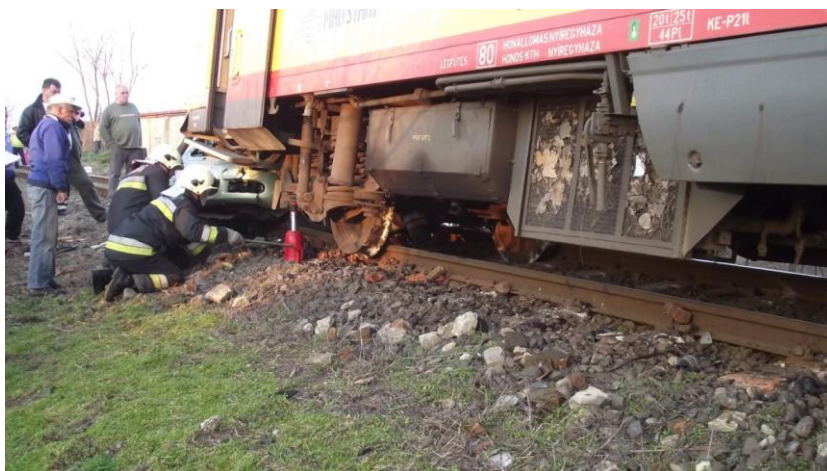
2011-145-5

On 29th March 2011, passenger train no. 6346 collided with a car between Mátészalka and Vásárosnamény stations on the level crossing AS341 protected with warning lights. The driver of the car died at the site. The power car of the train derailed

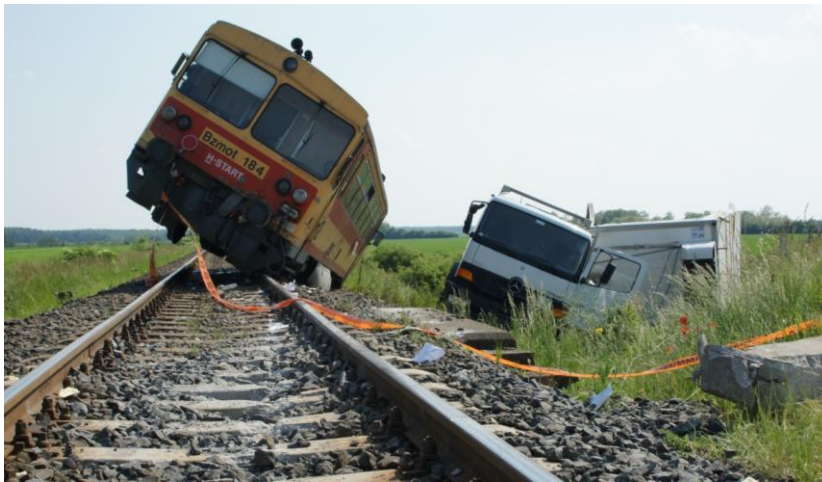
On 20th May 2011 at 12:38 hrs, passenger train no. 39822 collided with a lorry on railway line Hegyeshalom-Szombathely, between Ölbö-Alsószeleste and Porpác stations on the level crossing AS24 protected with warning lights located in railway section no. 24+85. The driver of the lorry and his passenger suffered minor injuries, the power car derailed as a consequence of the accident.

The driver of the lorry and his passenger suffered minor injuries and were transported to the hospital. The train was formed of one motor coach of type Bzmot, on which one of the crew suffered minor, another suffered serious, 6 of the passengers suffered minor, one

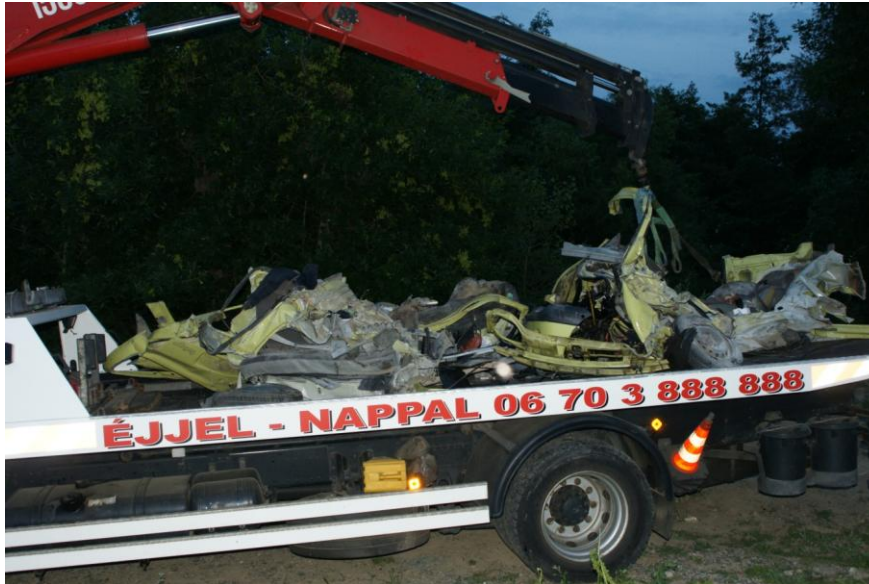
The railway track was cleared at 22:25 hrs, passengers of 5 passenger trains had been transported by supplement bus service.

The IC established during the investigation that the warning lights were flashing red lights toward the road at the time of the accident, the train was not exceeding the speed limit.
