The Rail Safety  
Inspection Office

# **NIB ANNUAL REPORT 2010**

according to Article 23(3) of Directive 2004/49/EC

August 2011

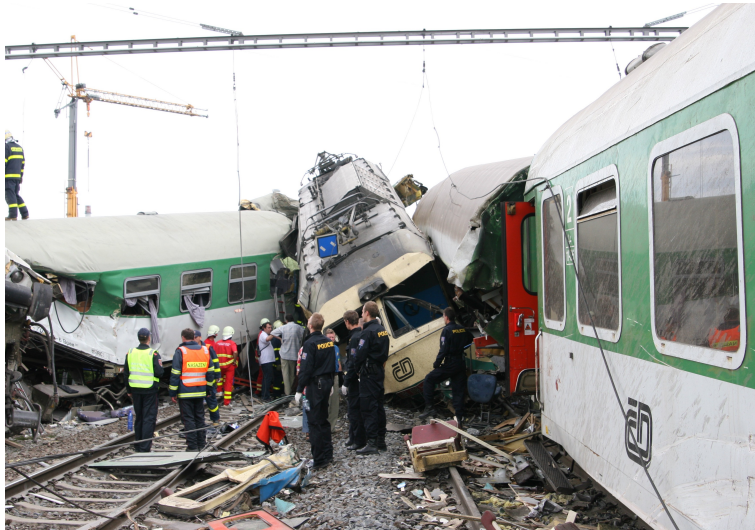
Grade:	serious accident
Date and time:	16 <sup>th</sup> February 2009, 09:02 (08:02 GMT)
Occurrence type:	trains collision
Description:	regional passenger train No. 3101 passed a signal at danger and collided with regional passenger train No. 3116.
Type of train:	regional passenger train No. 3101 regional passenger train No. 3116
Location:	open line between Vratimov and Paskov stations, km 13,459 (Ostrava hl. n. – Valasske Mezirici main line)
Parties:	Sprava zeleznicni dopravni cesty, statni organizace (IM) Ceske drahy, a. s. (RU)
Consequences:	no fatality, 57 injuries total cost CZK 14 073 507,61
Direct cause:	train driver's operational error (didn't respect red signal)
Contributing factor:	absence of technical equipment preventing train from passing signal at danger
Underlying cause:	no measures taken despite a series of similar accidents occurred before
Root cause:	none
Recommendations:	<p>1) Addressed to infrastructure manager Sprava zeleznicni dopravni cesty, statni organizace:</p> <ul style="list-style-type: none"><li>● It is recommended to hurry on introduction of ETCS to both main and regional lines.</li></ul> <p>2) Addressed to railway undertaking and operator of infrastructure manager Ceske drahy, a. s.:</p> <ul style="list-style-type: none"><li>● It is recommended to hurry on installation of mobile components of ETCS into railway vehicles in order to allow use of full functionality of ETCS as soon as the infrastructure is ready.</li><li>● It is recommended to improve procedures in stations where passenger trains are dispatched by signals only, in order to prevent train on departure from passing signal at danger.</li></ul> <p>3) Addressed to Czech National Safety Authority (Drazni urad):</p> <ul style="list-style-type: none"><li>● It is recommended to take own measure forcing implementation of the above recommendation.</li></ul>

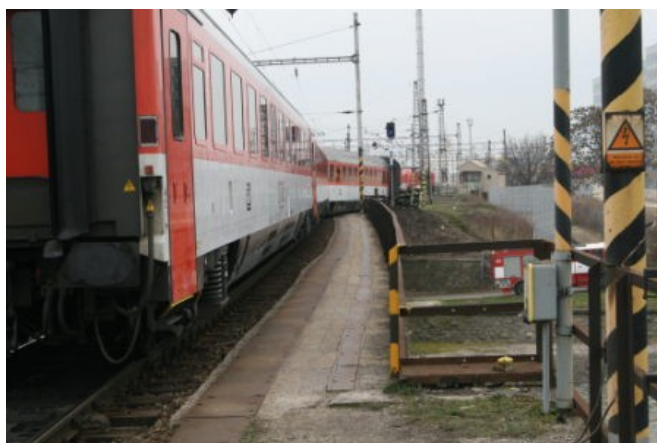
Grade:	accident (according to our national law it is serious accident due to damage which is more than 5 000 000,- CZK)
Date and time:	1 <sup>st</sup> April 2009, 07:02 (05:02 GMT)
Occurrence type:	train derailment
Description:	derailment of 3 carriages of shunting train set during shunting operation in Brno hl. n. station
Type of train:	shunting movement
Location:	Brno hl. n. station, switch No. 29, km 142.352
Parties:	Sprava železniční dopravní cesty, státní organizace (IM) Česke drahy, a. s. (RU)
Consequences:	no fatality, no injury total cost: 7 481 228,- CZK
Direct cause:	improper track layout (insufficient length (2.479 m) of straight track in between two reverse curves)
Underlying cause:	track layout parameters not verified after reconstruction of switches No. 28 and 26 nor before bringing carriages of length of 26.4 m into operation
Root cause:	systemic and continuous registration, evaluation and verification of track layout parameters not performed nor before allowing operation of carriages of length of 26.4 m

Recommendations: 1) Addressed to Sprava železniční dopravní cesty, státní organizace (IM):

It is recommended to verify track layouts within the whole railway network whether length of straight track in between two reverse curves and radii of these curves are in line with technical norm ČSN 73 6360-1 „Konstrukční a geometrické uspořádání kolejí železničních drah a její prostorová poloha – Cast 1: Projektování“ (Paragraph 8.4.2 and Table C.3.1) with regard to operation of carriages 26.4 m long and longer.

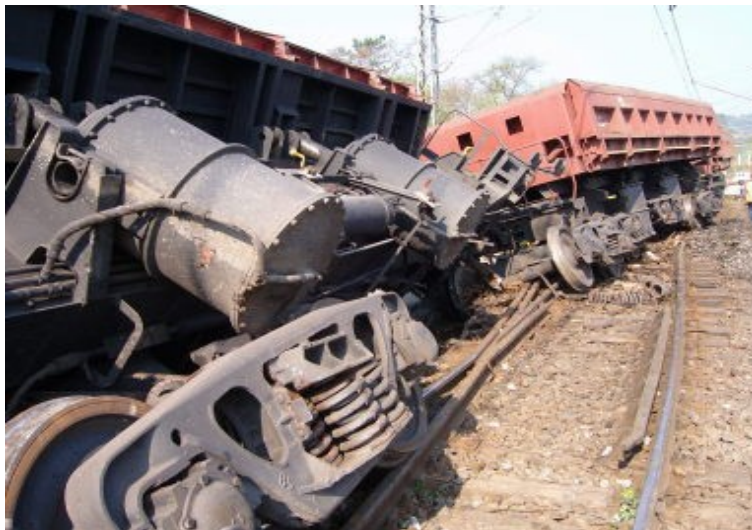
Grade:	accident
Date and time:	24 <sup>th</sup> April 2009, 4:10 (2:10 GMT)
Occurrence type:	train derailment
Description:	derailment of 4 loaded wagons of freight train No. 1.nsl Pn 69911
Type of train:	freight train No. 1.nsl Pn 69911
Location:	Cercany station, track No. 2a, km 144,478
Parties:	Sprava zeleznicni dopravni cesty, statni organizace (IM) OKD Doprava, akciová společnost (RU)
Consequences:	no fatality, no injury total cost CZK 1 530 000,- (EUR 58 000,-)
Direct cause:	improperly loaded wagon – unbalanced freight (rolling stock / freight / operational failure)
Underlying cause:	method for verification of freight's balance not specified (procedure inadequate)
Root cause:	risk caused by unbalanced freight not recognized (SMS / safety targets)
Recommendations:	Addressed to railway undertaking OKD Doprava, akciová společnost: It is recommended to modify procedure for visual inspection of freight in order to ensure that wagons with unbalanced freight are prevented from running.

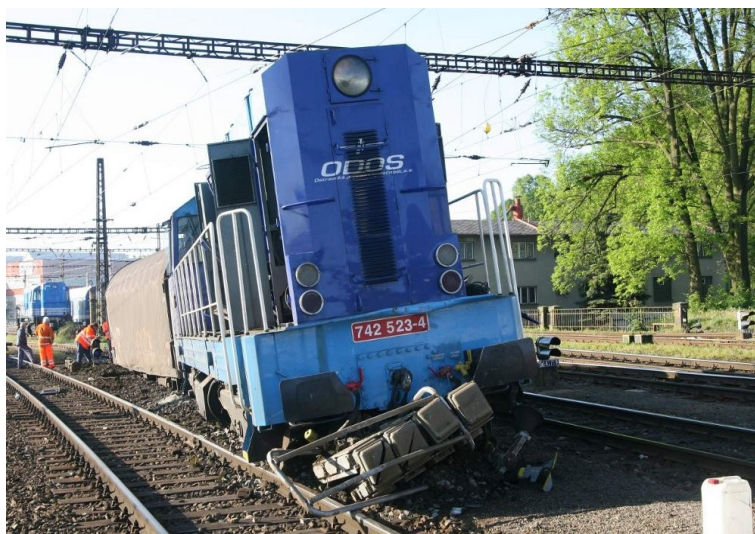
Grade:	accident
Date and time:	16 <sup>th</sup> May 2009, 21:50 (19:50 GMT)
Occurrence type:	trains collision with consequent derailment
Description:	group of 5 wagons run away from track No. 233. The group passed whole station and collided with stationary locomotive on track No. T 408. Wagons and the locomotive consequently derailed.
Type of train:	shunting movement
Location:	Ceska Trebova station, track No. 233
Parties:	CD Cargo, a. s. (RU) ODOS, a. s. (owner of the locomotive) Sprava zeleznicni dopravní cesty, statni organizace (IM)
Consequences:	no fatality, no injury total cost CZK 3 684 000,-
Direct cause:	rolling stock (handbrake failure)
Underlying cause:	maintenance (improper)
Root cause:	none
Recommendations:	Addressed to railway undertaking CD Cargo, a. s.: <ul style="list-style-type: none"><li>● It is recommended to take safety measures preventing wagons from running away from shunting yard of Ceska Trebova station with regard to situations, when stop-shoes situated at the bottom of the yard are not effective due to mass of wagons and their distance from the stop-shoes.</li></ul>

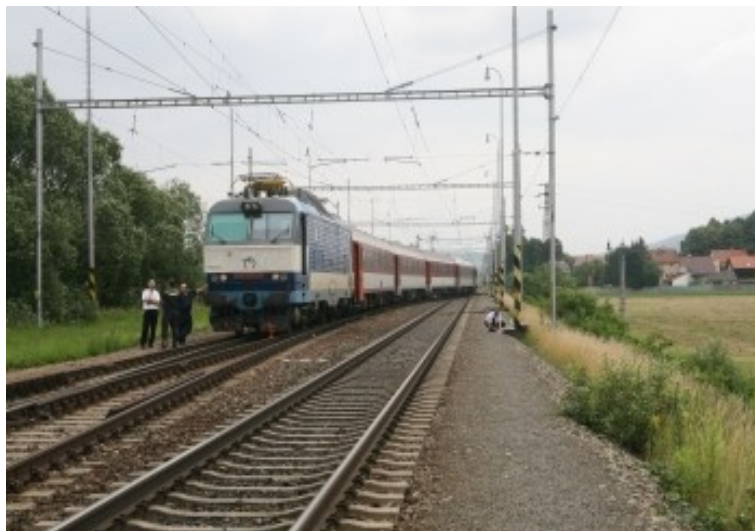
Grade:	incident
Date and time:	27 <sup>th</sup> June 2009, 11:51 (09:51 GMT)
Occurrence type:	uncontrolled movement (collision of passenger train with shunting freight train)
Description:	Eurocity train No. 174 stopped at Rajec-Jestrebi station due to engine fault. Later on the train started to move downhill backwards without its driver and was stopped by emergency brake after several hundreds meters. During its uncontrolled ride it passed "red" signal.
Type of train:	long distance passenger train
Location:	Rajec-Jestrebi station
Parties:	Ceske drahy, a. s. (RU) Sprava zeleznicni dopravni cesty, statni organizace (IM) Zeleznicna spolocnost Slovensko, a. s.
Consequences:	no fatality, no injury no cost
Direct cause:	operations (driver's violation)
Contr. factor:	operations (runaway train wasn't stopped immediately)
Underlying cause:	none
Root cause:	none
Recommendations:	not issued

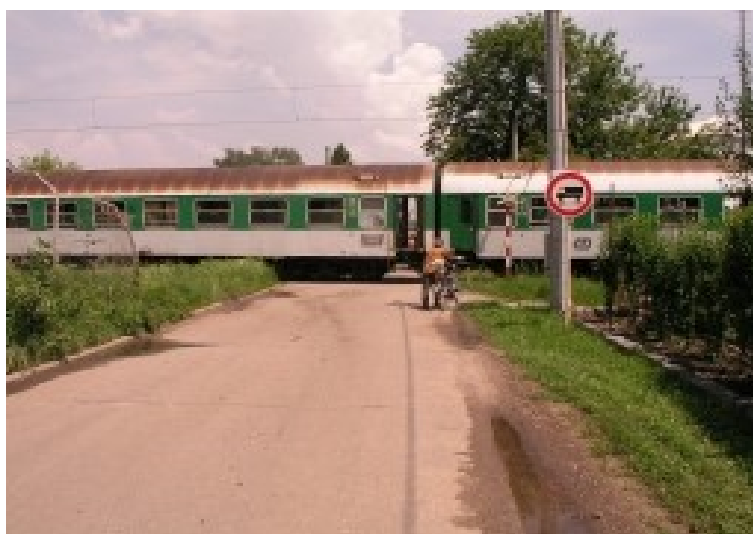
Grade:	accident
Date and time:	1 <sup>st</sup> July 2009, 10:20 (08:20 GMT)
Occurrence type:	level crossing accident
Description:	Eurocity train No. 30276 collided with rear part of a lorry passing the crossing
Type of train:	Eurocity train No. 30276
Location:	passive level crossing in km 2,067 between Hodonin-zastavka stop and Hodonin station
Parties:	Ceske drahy, a. s. (RU) Sprava zeleznicni dopravní cesty, statni organizace (IM) Vodovody a kanalizace Hodonin, akciová společnost (owner of the lorry)
Consequences:	no fatality, no injury total cost CZK 1 244 209,-
Direct cause:	poor level crossing condition (insufficient visibility)
Underlying cause:	1. improperly calculated visibility 2. improper procedure for level crossing inspection and maintenance
Root cause:	safety management system didn't prevent use of IM's internal regulation No. SZDC (CSD) S 4/3, which is not in line with valid legislations and technical norms

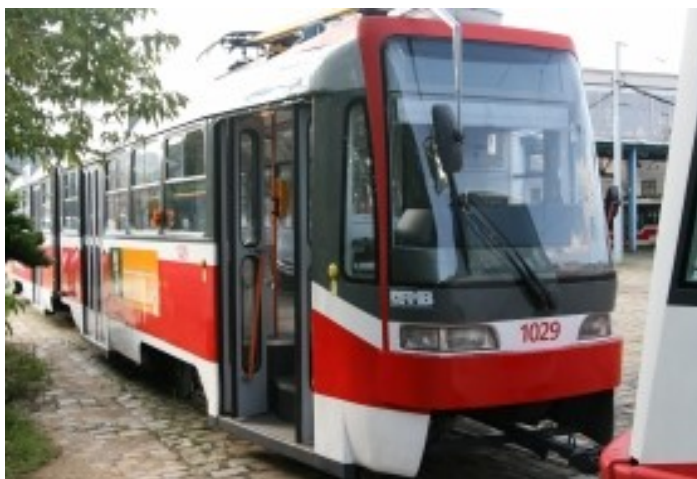
Grade:	accident
Date and time:	17 <sup>th</sup> August 2009, 16:11 (14:11 GMT)
Occurrence type:	accident caused by rolling stock in motion
Description:	two passengers were slightly injured by nearby electric arc when operating defective vent which touched the pantograph.
Type of train:	tram K2R.03 type
Location:	the City of Brno, between Porici and Nemocnice Milosrdnych bratri tram stops
Parties:	Dopravni podnik mesta Brna, a. s. (IM + RU)
Consequences:	0 fatalities, 2 light injuries, total cost CZK 0.- disruption to traffic 0 hours
Direct cause:	an electrical short-circuit initiated when the vent touched the pantograph
Underlying cause:	improperly adjusted mechanism of the vent due to insufficient maintenance procedure
Root cause:	none
Recommendations:	1) Addressed to Dopravni podnik mesta Brna, a. s. (RU): It is recommended to develop procedure for proper adjustment of first roof-vent and include it into maintenance manual for trams of K2R.03 type.  2) Addressed to NSA (Drazni urad): It is recommended to disseminate the above recommendation to all undertakings running trams of K2R.03 type.  3) Addressed to Pars nova, a. s., Sumperk (manufacturer of trams of K2R.03 type): It is recommended to develop internal regulation for exchange of safety-relevant information regarding inspections and maintenance of railway vehicles they produce, renew or maintain.

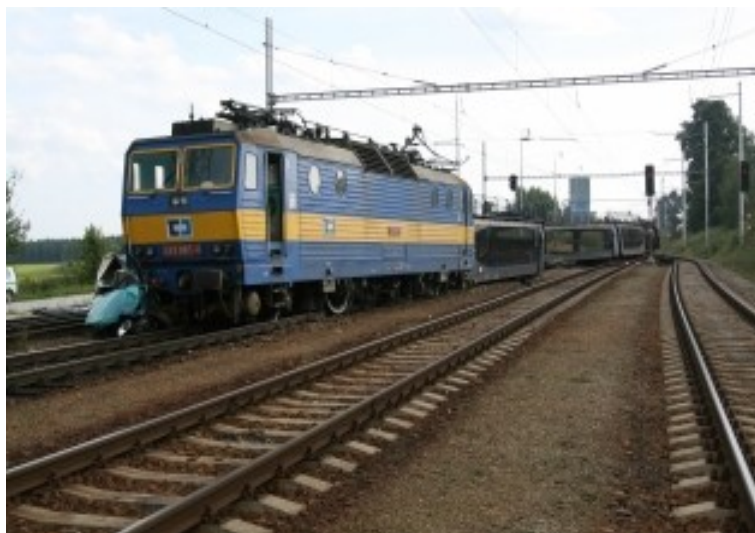
Grade:	accident
Date and time:	15 <sup>th</sup> September 2009, 14:42 (12:42 GMT)
Occurrence type:	level crossing accident
Description:	collision of freight train No. 48162 with a passenger car at the level crossing with consequent derailment (active level crossing equipped with warning lights only)
Type of train:	freight train No. 48162
Location:	Omlenice station, level crossing in km 79,532 (Ceske Budejovice – Horni Dvoriste statni hranice main line)
Parties:	Sprava zeleznicni dopravní cesty, statni organizace (IM) CD Cargo, a. s. (RU) GEFCO TLA/GMO/WAG (owner of wagons) level crossing user
Consequences:	1 fatality (car driver) total cost: 16 159 394,- CZK
Direct cause:	third party (level crossing user)
Underlying cause:	none
Root cause:	none
Recommendations:	not issued

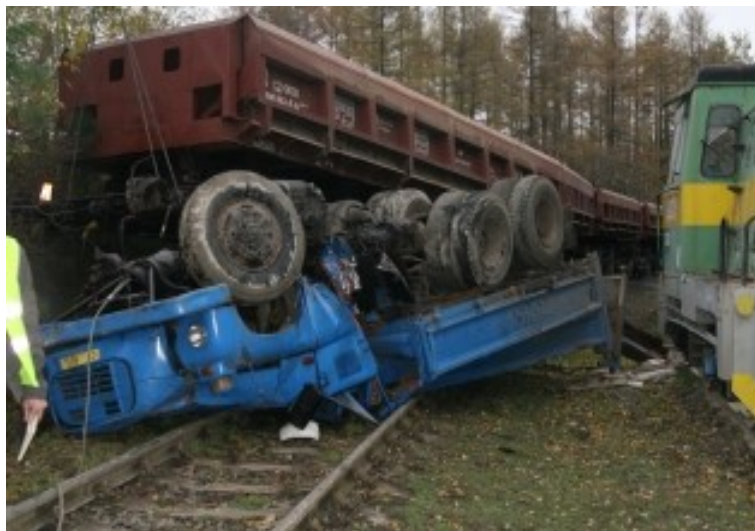
Grade:	accident
Date and time:	10 <sup>th</sup> November 2009, 11:10 (10:10 GMT)
Occurrence type:	level crossing accident
Description:	level crossing accident (collision of shunting wagons with a lorry) with consequent derailment
Type of train:	shunting movement
Location:	passive level crossing in km 0,070 of Kamenolom Zarubka siding (originating in km 57,898 of 507A Havlickuv Brod – Pardubice main line)
Parties:	Ceskomoravsky sterk, a. s. (owner of the siding) Ceskomoravsky cement, a. s. (infrastructure manager of the siding) OKD, Doprava, akciová společnost (railway undertaking) Správa železniční dopravní cesty, státní organizace (main line infrastructure manager) Česke dráhy, a. s. (operator of the main line infrastructure manager)
Consequences:	1 fatality (lorry driver), no injury total cost CZK 320 000.-
Direct cause:	1) Gravity shunting across passive level crossing not secured by responsible staff (operations) 2) Way not given to railway vehicles at level crossing (third party)

Contributory factor:	gravity shunting without engine performed on 16‰ descend (procedures not followed – violation)
Underlying cause:	none
Root cause:	none
Recommendations:	not issued

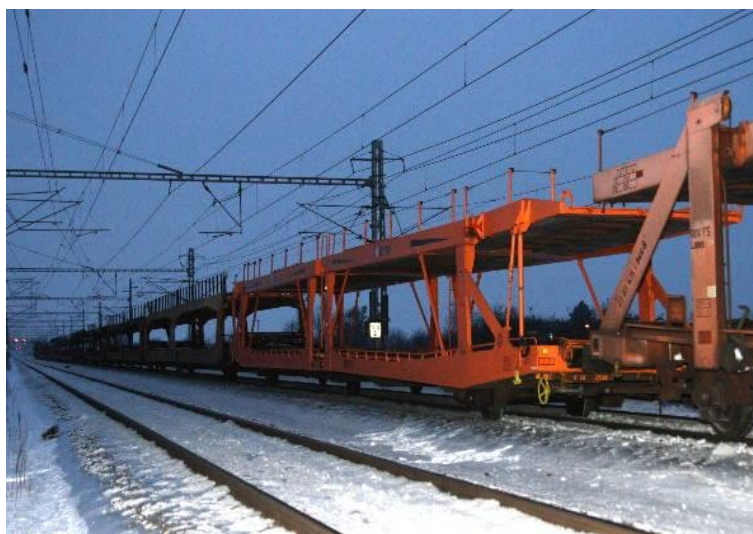
Grade:	accident
Date and time:	21 <sup>st</sup> January 2010, 23:55:30 (22:55:30 GMT)
Occurrence type:	train derailment
Description:	Derailment of 1 wagons (13 <sup>rd</sup> wagon) of freight train No. 46723 while running between Prerov and Prosenice stations
Type of train:	freight train No. 46723
Location:	Open line between Prerov and Prosenice stations, track No. 2, km 186,780; (Bohumín – Prerov main line)
Parties:	Správa železniční dopravní cesty, státní organizace (IM) CD Cargo, a. s. (RU) Società Italiana Trasporti Ferroviari Autoveicoli S. p. A. (SITFA), Via Bruno Buozzi 28, 10024 Moncalieri (owner of the wagons)
Consequences:	no fatality, no injury total cost CZK 4 140 292,33,-
Direct cause:	technology – rolling stock (technical failure – missing components in the bogie)
Underlying cause:	none
Root cause:	none
Recommendations:	not issued

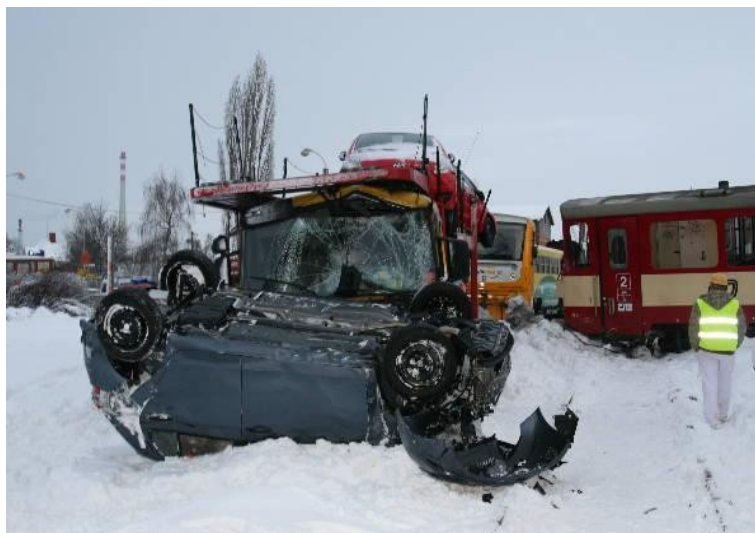
Direct cause: third party (truck driver's violation)

Underlying cause: none

Root cause: none

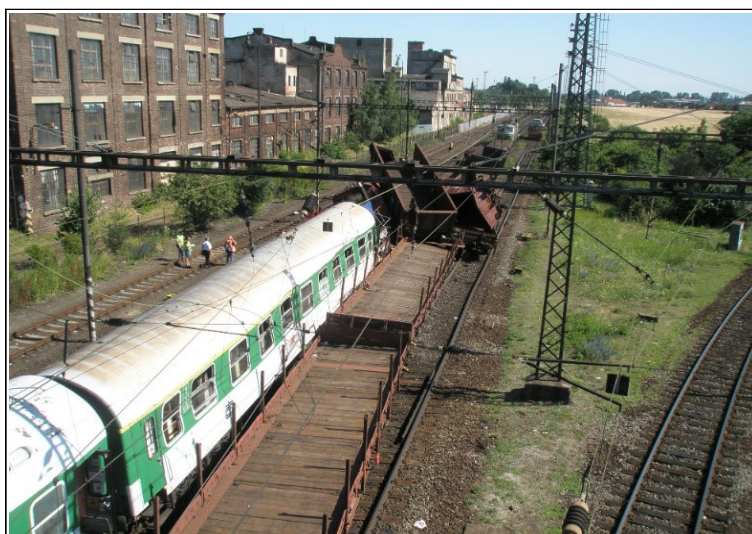
Grade:	accident (according to our national law it is serious accident due to damage which is more than 5 000 000,- CZK)
Date and time:	3 <sup>rd</sup> July 2010, 13:04:30 (11:04:30 GMT)
Occurrence type:	trains collision (associated with SPAD and derailment)
Description:	the shunting train SPADed, collided with the freight train No. 53033 in Olomouc main station. Both trains derailed.
Type of train:	freight train No. 53033 shunting train (consist of locomotive + 5 empty passenger carriages)
Location:	Olomouc hlavní nadraží, switch No. 9, km 205,248 (Prerov – Ceska Trebova main line)
Parties:	CD Cargo, a. s. (RU of the freight train No. 53033) Správa železniční dopravní cesty, státní organizace (IM) Česke drahy, a. s. (RU of the shunting train)
Consequences:	no fatality, no injury total cost CZK 6 086 243,07
Direct cause:	train driver's operational error (driver of the shunting train didn't respect stop signal)

Underlying cause:	human factor – immediate situation
Root cause:	none
Recommendations:	not issued
