## **NIB ANNUAL REPORT 2008**

according to Article 23(3) of Directive 2004/49/EC

The Rail Safety Inspection Office

September 2009

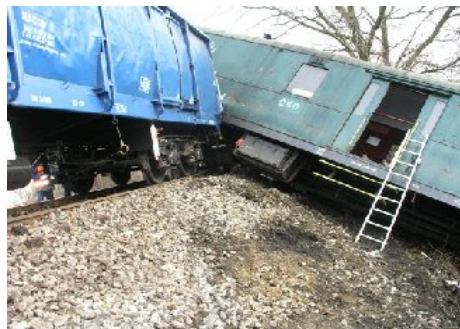
Grade:	accident
Date and time:	20th February 2007, 11:48 (10:48 GMT)
Occurrence type:	train derailment
Description:	derailment of locomotive and 6 wagons of freight train
Type of train:	freight train No. 85956
Location:	between Mnisek pod Brdy and Cisovice stations
Consequences:	no fatality no injury total cost CZK 1 009 120 (cca EUR 40 365)
Direct cause:	infrastructure (track failure)
Underlying cause:	maintenance planning, handover maintenance - operations
Root cause:	none
Recommendations:	addressed to infrastructure manager Ceske drahy, a. s.:  1) It is recommended to develop safety rules focusing on infrastructure maintenance performed by external supplier (outsourced maintenance). 2) It is recommended to supervise whether an external supplier observes safety rules.

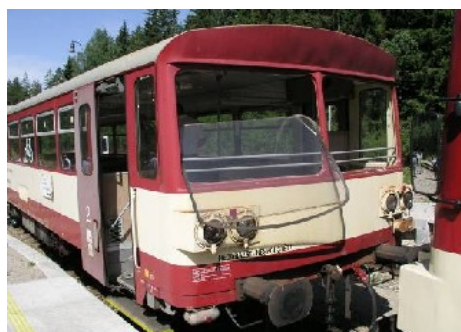
Grade: serious accident

Direct cause: operations (engine driver's violation)

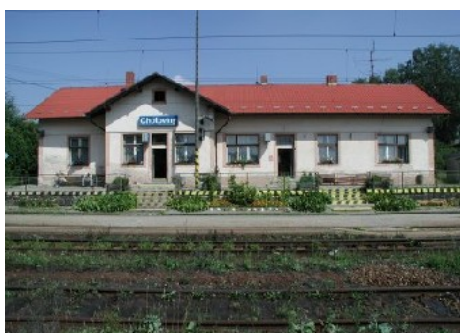
Grade: incident

Direct cause: wrong side signalling failure

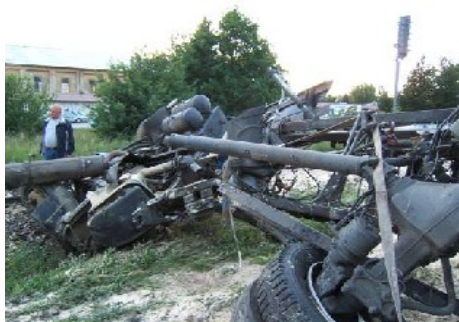
Grade:	accident
Date and time:	4th July 2007, 18:44 (16:44 GMT)
Occurrence type:	level crossing accident
Description:	level crossing accident - collision of fast train No. 648 and a lorry
Type of train:	fast train No. 648
Location:	active level crossing in km 56,245 in Veseli nad Luznici station
Consequences:	no fatality 2 injuries (engine driver – light, lorry driver – serious) total cost CZK 2 491 265 (cca EUR 99 650)
Direct cause:	level crossing user (lorry driver violence)
Underlying cause:	none
Root cause:	none
Recommendations:	addressed to infrastructure manager Ceske drahy, a. s., National Safety Authority (Drazni urad) and owner of the railway Sprava zeleznicni dopravní cesty, s. o.:  It is recommended to equip the level crossing with barriers or to replace it with graded crossing.

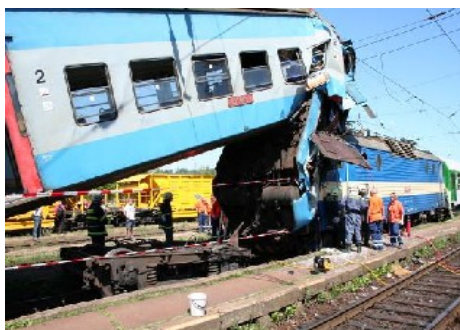
Grade:	serious accident
Date and time:	14th July 2007, 10:06 (08:06 GMT)
Occurrence type:	trains collision (with consequent derailment)
Description:	collision of fast train No. 633 with an empty passenger train No. 9122
Type of train:	fast train No. 633 passenger train No. 9122
Location:	Cercany station, track No. 1
Consequences:	1 fatality (engine driver of passenger train) 6 light injuries (1 engine driver and 5 passenger of fast train), total cost CZK 4 089 216 (cca EUR 163 569)
Direct cause:	operations (station and dispatch personnel violation + driver's operational error)
Underlying cause:	none
Root cause:	none
Recommendations:	1) addressed to infrastructure manager Ceske drahy, a. s.: <ul style="list-style-type: none"><li>• It is recommended to perform regular psychological and neurological examination of station and dispatch personnel aged 50 and above.</li><li>• It is recommended to perform psychological and neurological examination of a member of station or dispatch personnel whenever their doctor recommends to do so.</li></ul> 2) addressed to the National Safety Authority (Drazni urad): <ul style="list-style-type: none"><li>• It is recommended to apply the above recommendations to all relevant railway infrastructure managers.</li></ul>

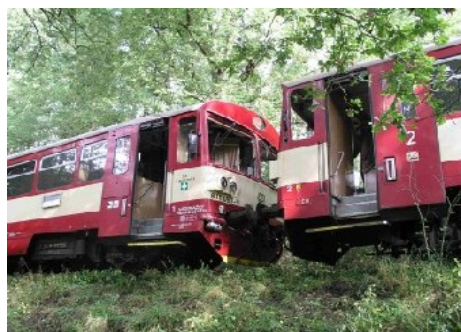
Grade:	serious accident
Date and time:	1st September 2007, 08:10 (06:10 GMT)
Occurrence type:	trains collision
Description:	collision of passenger train No. 18003 with passenger train No. 18032
Type of train:	passenger train No. 18003 passenger train No. 18032
Location:	between Bavorov and Vodnany stations, km 9, 915
Consequences:	no fatality 13 injuries (7 passengers – serious, 5 passenger + 1 staff – light) total cost CZK 137 145 (cca EUR 5 486)
Direct cause:	operations (engine driver's violation)
Underlying cause:	none
Root cause:	none
Recommendations:	addressed to infrastructure managers, railway undertakings and owners of railways:  It is recommended to equip busy regional lines without interlocking with an technical interlocking system ensuring that trains can't enter occupied part of line.

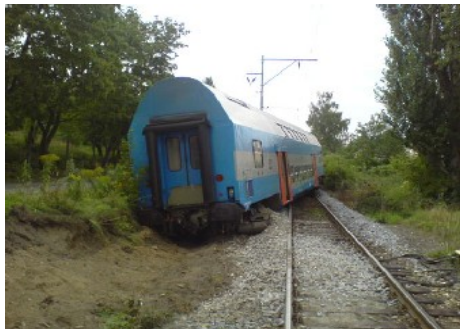
Grade: accident

Direct cause: infrastructure (track – equipment failure)

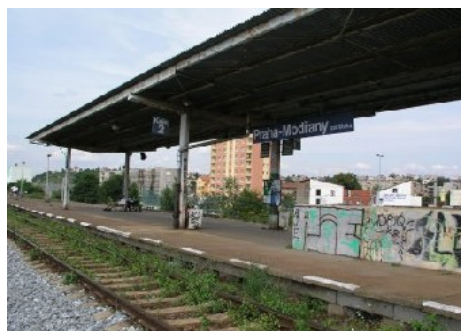
Grade:	incident
Date and time:	10th September 2007, 14:36 (12:36 GMT)
Occurrence type:	other (train entered track already occupied by another train)
Description:	passenger train No. 9009 entered track already occupied by another train (passenger train No. 19010)
Type of train:	passenger train No. 9009 passenger train No. 19010
Location:	between Praha-Modrany and Praha-Branik stations
Consequences:	no fatality no injury no cost
Direct cause:	operational failure (improper behaviour of station personnel)
Underlying cause:	inadequate safety procedure
Root cause:	inadequate supervision (supervisors hadn't recognised improper practise)
Recommendations:	not issued

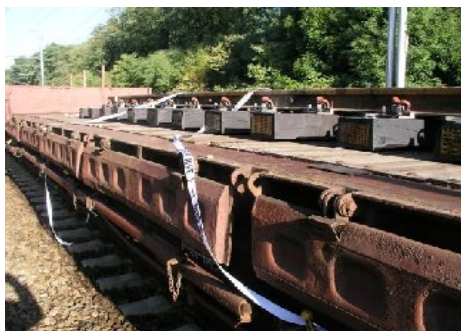
Grade:	accident
Date and time:	20th September 2007, 4:43 (2:43 GMT)
Occurrence type:	train collision (collision with an obstacle within the clearance gauge with consequent derailment)
Description:	collision of freight train No. 51422 with an obstacle within the clearance gauge (load released and lost by freight train No. 61310)
Type of train:	freight train No. 51422 freight train No. 61310
Location:	between Krasikov and Rudoltice v Cechach stations
Consequences:	no fatality no injury total cost CZK 592 746 (cca EUR 23 709)
Direct cause:	rolling stock-freight-operations (load release and consequent loss)
Underlying cause:	procedure not available procedure incorrectly applied
Root cause:	none
Recommendations:	addressed to Ceske drahy, a. s. and CD Cargo, a. s. railway undertakings:  1) It is recommended to create procedure for loading and transporting switches secured by textile belts.  2) It is recommended to revise contemporary way of transporting of oversized goods from DT Vyhybkarna a strojirna, a. s., Prostějov company, in order to ensure the safety, before the procedure for loading and transporting switches secured by textile belts is created.

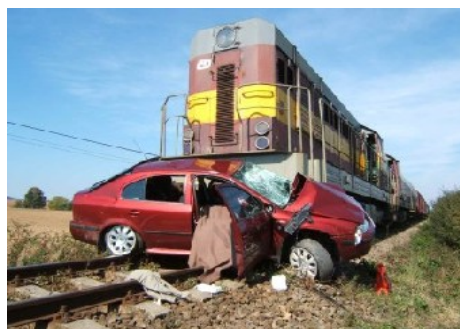
Grade:	accident
Date and time:	21st September 2007, 11:10 (09:02 GMT)
Occurrence type:	level crossing accident
Description:	level crossing accident of freight train No. 52241 and a car
Type of train:	freight train No. 52241
Location:	passive level crossing between Jaromerice nad Rokytinou and Moravske Budejovice stations
Consequences:	2 fatalities (in the car) no injury total cost CZK 558489 (cca EUR 22 339)
Direct cause:	level crossing user (car driver's violation)
Underlying cause:	none
Root cause:	none
Recommendations:	addressed to infrastructure manager Ceske drahy, a. s.:  1) It is recommended to put internal rule ČD S4/3 into accordance with norm ČSN 736380.  2) It is recommended to check visibility condition at all the level crossings, where visibility reduction has been applied by the internal rule ČD S4/3, and to modify these level crossings according to the norm ČSN 736380.

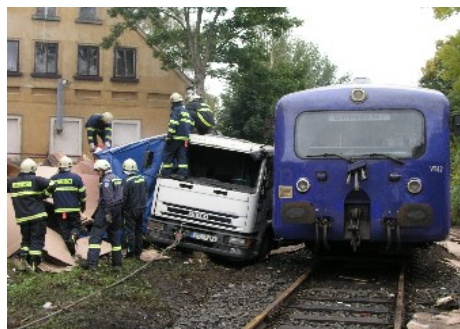
Grade:	accident
Date and time:	2nd October 2007, 09:47 (07:47 GMT)
Occurrence type:	level crossing accident
Description:	level crossing accident of passenger train No. 83077 and a lorry
Type of train:	passenger train No. 83077
Location:	active level crossing in km 11,454 between Varnsdorf and Seifhennersdorf stations
Consequences:	no fatality 2 light injuries (train driver and lorry driver) total cost CZK 3 108 000 (cca EUR 124 320)
Direct cause:	level crossing user (lorry driver's violation) operations (station and dispatch personnel violation)
Underlying cause:	maintenance (organisation)
Root cause:	none
Recommendations:	not issued

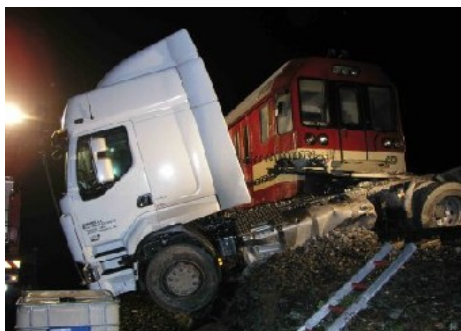
Grade:	accident
Date and time:	30th October 2007, 18:06 (17:06 GMT)
Occurrence type:	level crossing accident
Description:	level crossing accident - collision of fast train No. 827 with a truck stuck at the level crossing
Type of train:	fast train No. 827
Location:	active level crossing in km 32,212 between Domasov nad Bystrici and Moravsky Beroun stations
Consequences:	no fatality no injury total cost CZK 1 894 878 (cca EUR 75 795)
Direct cause:	level crossing user (truck driver 's behaviour) operations (station and dispatch personnel violation)
Underlying cause:	manufacture (level crossings are not equipped with ID-numbers for their unique identification)
Root cause:	organisation of work (management of external communication)
Recommendations:	addressed to infrastructure manager Ceske drahy, a. s. and owner of the railway Sprava zeleznicni dopravní cesty, s. o.:  It is recommended to equip each level crossing with visible ID-table with unique level crossing ID-number and an emergency telephone number, in order to avoid misunderstandings when alerting emergency services or infrastructure manager in case of emergency (see safety recommendations issued within accidents Vranany 19th March 2007 and Jablunka 7th May 2007).

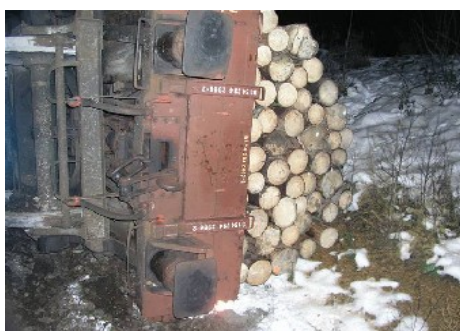
Grade: serious accident

Direct cause: rolling stock

Underlying cause: axle bearing failure

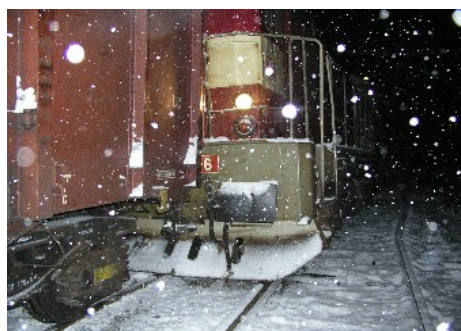
Grade:	accident
Date and time:	27th November 2007, 19:01 (18:01 GMT)
Occurrence type:	train derailment
Description:	derailment of a locomotive of freight train No. 80 203
Type of train:	freight train No. 80 203
Location:	Bystrice nad Olsí station
Consequences:	no fatality no injury total cost CZK 1 443 720 (cca EUR 57 748)
Direct cause:	infrastructure (switch failure)
Underlying cause:	inadequate maintenance
Root cause:	procedure not available
Recommendations:	addressed to infrastructure manager Správa železniční dopravní cesty, s. o.:  1) It is recommended to create and regularly apply procedure for preventative checking of mechanisms of manually operated switches.  2) It is recommended to modify maintenance procedure for mechanisms of manually operated switches in order to avoid rough manipulation with the mechanism.

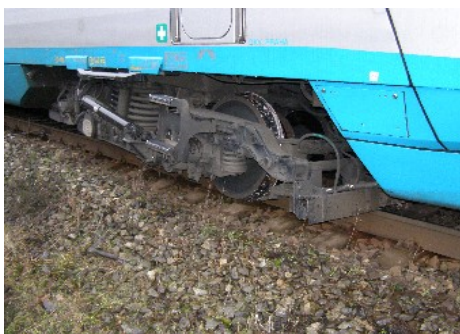
Grade:	serious accident
Date and time:	1st December 2007, 11:50 (10:50 GMT)
Occurrence type:	train derailment
Description:	derailment of seven carriages of supercity train No. 507
Type of train:	Supercity train No. 507 (Pendolino)
Location:	between odbočka Kyje and Praha-Bechovice
Consequences:	no fatality no injury total cost CZK 25 330 271 (cca EUR 1 013 211)
Direct cause:	infrastructure (track failure)
Underlying cause:	none
Root cause:	none
Recommendations:	addressed to infrastructure manager Správa železniční dopravní cesty, s. o.:  1) It is recommended to improve training scheme of personnel performing non-destructive testing of rails.  2) It is recommended to implement European technical norms into scheme of non-destructive testing of rails.  3) It is recommended to carefully evaluate results of non-destructive testing of rails, especially when combined defect is detected.  4) It is recommended to determine maximal life of rails according to frequency and character of their load.

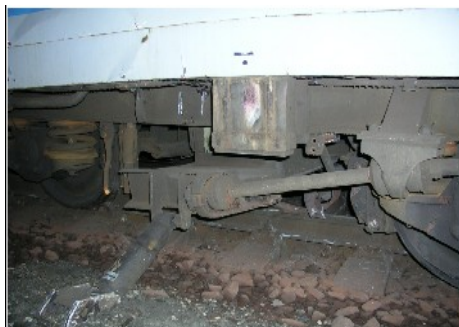
Grade: accident

Direct cause: rolling stock (carriage boogie failure)

Underlying cause: inadequate planning and organisation of maintenance

It is recommended to create maintenance scheme for electric unit class 460 based on regular monitoring of real technical condition of the vehicle.

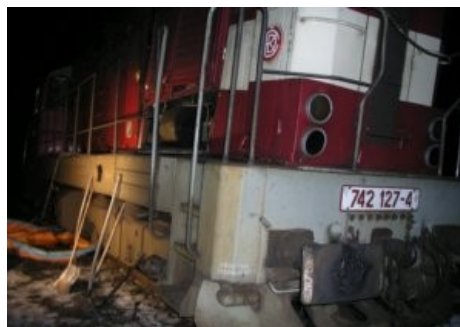
Grade:	accident
Date and time:	9th January 2008, 14:51 (13:51 GMT)
Occurrence type:	collision of shunting locomotive with another locomotive
Description:	A solo running shunting locomotive collided with a locomotive waiting on track No. 26. There was consequent leak of the fuel.
Type of train:	shunting locomotive solo locomotive
Location:	Nymburk hl. n. station, track No. 26
Parties:	Ceske Drahy, a. s. (IM) CD Cargo, a. s. (RU)
Consequences:	no fatality 2 light injuries (both the drivers) total cost CZK 4 700 000 (cca EUR 188 000) leak of 370 l of fuel
Direct cause:	operations (station and dispatch personnel violation) operations (locomotive driver's violation)
Underlying cause:	none
Root cause:	none
Recommendations:	not issued

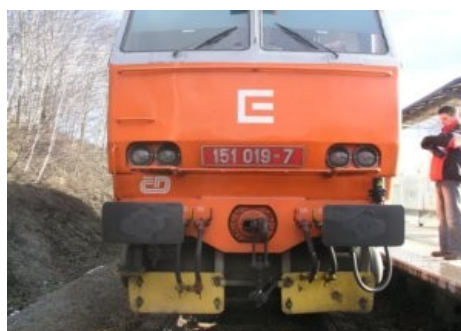
Grade:	accident
Date and time:	23rd January 2008, 09:57 (08:57 GMT)
Occurrence type:	train collision with an obstacle (collision of long distance passenger train with rail grinder)
Description:	Long distance passenger train No. IC 540 collided with a rail grinder working on switch No. 5 at Trebovice v Cechach station. Track workers managed to escape in time. Despite they were warned via radio, they didn't have time enough to clear the track. The train didn't derail.
Type of train:	long distance passenger train No. IC 540
Location:	Trebovice v Cechach station, switch No. 5
Consequences:	no fatality no injury total cost CZK 69 090 (cca EUR 2 764)
Direct cause:	operations (trackside personnel violation) procedures (inadequate procedures)
Underlying cause:	none
Root cause:	none
Recommendations:	addressed to railway infrastructure managers:  1) It is recommended to require railway workers working on the track to declare, before they start working, time necessary for safe evacuation of the workplace (including removal of all their equipment).  2) It is recommended to ensure that their regulations guarantee safety of track-workers with regard to train speed limit and time necessary for safe evacuation of the workplace.

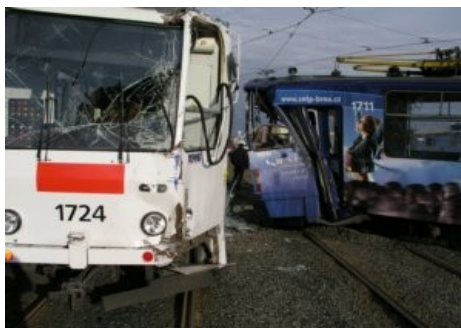
Grade:	accident
Date and time:	10th April 2008, 6:34 (04:34 GMT)
Occurrence type:	tram collision (collision of an uncontrolled empty tram with another tram)
Type of train:	tram (uncontrolled movement)
Location:	Brno, Husova - Palackeho crossing
Consequences:	no fatality no injury total cost CZK 3 000 000 (cca EUR 120 000) disruption to traffic 3 hours and 53 minutes
Direct cause:	rolling stock (on board control-command system failure)
Underlying cause:	maintenance insufficiency weakness of on board control-command system design
Root cause:	none
Recommendations:	1) Addressed to all railway undertakings running trams KT8D5 with TV3 traction equipment: <ul style="list-style-type: none"><li>• It is recommended to have regular check of connectors KP1 – KP4 included in maintenance procedures.</li></ul> 2) Addressed to the National Safety Authority (Drazni urad): <ul style="list-style-type: none"><li>• It is recommended to consider improvement of all trams with TV3 traction equipment in order to ensure proper function of the brake pedal in case of false acting of ORJ relay.</li></ul>

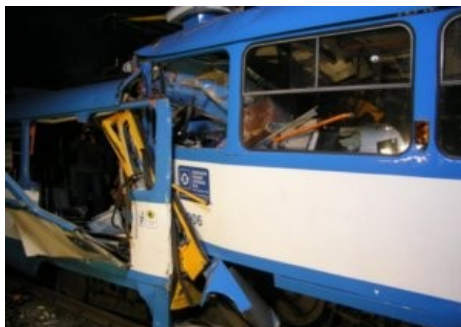
Grade:	serious accident
Date and time:	11th April 2008, 17:51 (15:51 GMT)
Occurrence type:	trams collision
Description:	A pair of tramways collided with an other pair of tramways running in the opposite direction on single-track tramway line.
Type of train:	tramway
Location:	between Poruba koupaliste and Vresina tram-stops (single-track tramway line)
Parties:	Dopravni podnik Ostrava, a. s. (RU + IM)
Consequences:	3 fatalities (passengers) 11 serious injuries (passengers), 23 half-serious injuries, (21 passengers + 2 tram-drivers), 22 light injuries (passengers), total cost CZK 2 613 220 (cca EUR 104 529)
Direct cause:	operations (tram-driver) – violation
Underlying cause:	procedure inadequate
Root cause:	organisation of work and SMS (accidents of the same type not investigated)
Recommendations:	Addressed to Dopravni podnik Ostrava a. s.:  1) It is recommended to equip bi-directional single-track tramway lines with interlocking system preventing tram from entering track occupied with another tram running in the opposite direction.  2) It is recommended to equip bi-directional single-track tramway lines with interlocking system capable to switch off the power if a tram enters track already occupied with another tram running in the opposite direction.  3) It is recommended on bi-directional single-track tramway lines to ensure that a tram immediately stops when the power supply is lost.  4) It is recommended to to equip interlocking systems on bi-directional single-track tramway lines with a data recorder logging the operation.

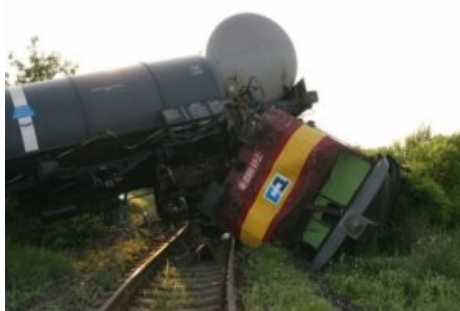
Occurrence type: level crossing accident (collision of freight train No. 60750 with a truck at the level crossing) with consequent derailment of locomotive and 3 wagons and leak of 500 litres of fuel

Direct cause: level crossing user (truck driver's violation)

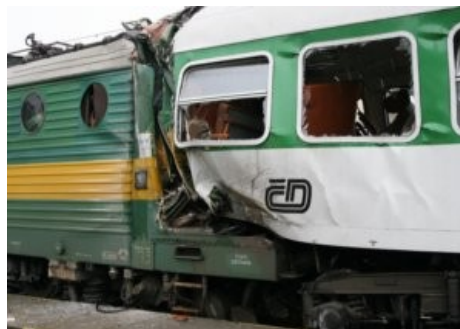
Grade:	serious accident
Date and time:	19th May 2008, 4:48 (2:48 GMT)
Occurrence type:	trains collision with consequent derailment (associated with wrong side signalling failure)
Description:	A solo running locomotive (train No. 72461) was given allowance to enter the station (green signal), despite the track was occupied with passenger train. The locomotive consequently crushed into rear carriage of passenger train (No. 5011) departing from Moravany station.
Type of train:	solo running locomotive - train No. 72461 passenger train No. 5011
Location:	Moravany station, track No. 1 (Ceska Trebova – Praha-Liben main line)
Consequences:	1 fatality (train driver of the solo running locomotive) 4 light injuries (3 passengers and train driver of train No. 5011) total cost CZK 12 643 092 (cca EUR 505 724)
Direct cause:	1) track circuit contact loss between train No. 5011 and track circuit 1K 2) reaction of interlocking system ESA 11 on unexpected change of station track No. 1 status of occupation

Underlying cause:	1) incompatibility of railway vehicles and track circuits as far as sanding is concerned 2) internal logic of interlocking system ESA 11, as far as processing of information about station track occupation received after track circuit re-activation is concerned
Root cause:	operation of railway vehicles incompatible with track circuits without adequate safety measures
Recommendations:	1) It is recommended to all infrastructure managers operating interlocking system ESA 11 to improve it, in order to process in the safe way change of station track status of occupation after track circuit re-activation.  2) It is recommended to The National Safety Authority (Drazni urad) to require implementation of the above mentioned recommendation for all existing devices of that type and of similar types.  3) It is recommended to the new infrastructure manager Sprava zeleznicni dopravní cesty, s. o. to equip renewed main lines with system for emergency remote train stopping.  4) It is recommended to all operators operating class 163 locomotives to improve sanding indicator in order to indicate real status of sanding device.  5) It is recommended to The National Safety Authority (Drazni urad) to require all new locomotives to have sanding indicator according to paragraph 4 of this recommendation.

6) It is recommended to all operators operating class 163 locomotives and similar to have regular check and maintenance of pneumatic sander valves included in maintenance procedures.

7) It is recommended to The National Safety Authority (Drazni urad) to archive documentation of components, devices and sets they certify for accident investigation and other purposes.

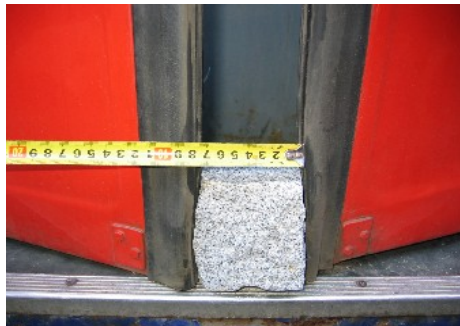
Grade:	accident
Date and time:	2nd June 2008, 16:01:13 (14:01:13 GMT)
Occurrence type:	accident to person caused by rolling stock in motion
Description:	a child's right leg was locked into the doors and the tram was towing the child for 100,5 m
Type of train:	tramway
Location:	Olomouc, Wolkerova street, Wolkerova tram-stop
Parties:	Dopravni podnik mesta Olomouce, a. s., (RU + IM)
Consequences:	no fatality 1 serious injury (the child) no cost
Direct cause:	operations – tram driver's violation (unsafe departure)
Underlying cause:	procedures incorrectly applied
Root causes:	none
Recommendation:	<p>1) Addressed to all railway undertakings running T3 trams with DBR relay: It is recommended to check (and adjust) within maintenance procedures whether “door open” is indicated as soon as the distance between two doors is greater than 2 cm at the bottom.</p> <p>2) Addressed to all railway undertakings running T3 trams with DBR relay: While performing regular maintenance it is recommended to adjust the doors in order to minimize possibility of opening the door at their bottom-while their top is locked in “door closed” position.</p> <p>3) Addressed to all railway undertakings running T3 trams: It is recommended to equip all T3 trams with the emergency brake buttons placed above all entrance doors indoors.</p> <p>4) Addressed to all railway undertakings running trams: It is recommended to standardize form and labelling of emergency brake buttons within all types of trams.</p> <p>5) Addressed to The National Safety Authority (Drazni urad): It is recommended to force relevant railway undertakings to accept the above recommendations 1 – 4.</p>

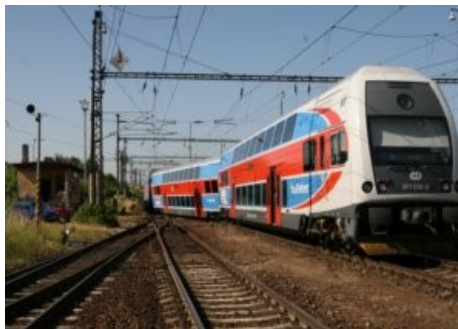
Grade: accident

Direct cause: operations - signaller's violation (switch was operated while a train was passing)

Underlying cause: procedures - procedure incorrectly applied

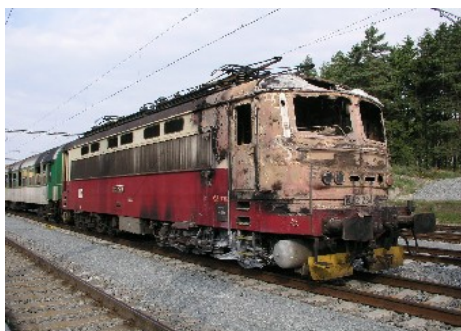
Grade:	accident
Date and time:	30th July 2008, 22:29 (20:29 GMT)
Occurrence type:	fire in rolling stock of fast train No. 766
Description:	fire of fast train No. 766 (locomotive + first carriage) within the run
Type of train:	fast train No. 766
Location:	open line between Pnovany and Vranov u Stribra stations, km 374,100
Parties:	Ceske drahy, a. s. (RU) Sprava zeleznicni dopravní cesty, s. o. (IM)
Consequences:	no fatality no injury total cost CZK 7 326 528,40 (cca EUR 293 061)
Direct cause:	rolling stock (locomotive) / on train equipment / equipment failure
Underlying cause:	maintenance planning and organisation
Root cause:	organisation of work / safety policy
Recommendations:	1) Addressed to Ceske drahy, a. s.: <ul style="list-style-type: none"><li>• In the interest of railway safety it is recommended to make maintenance organisation rules compliant with valid national legislation and rolling stock manufacturers' recommendations.</li><li>• It is recommended to take measures preventing managers from ordering staff to break the rules.</li></ul> 2) Addressed to The National Safety Authority (Drazni urad): <ul style="list-style-type: none"><li>• It is recommended to check whether railway undertaking meets safety requirements each time they report any change to parameters which are relevant to safety certification process.</li></ul>
