Doc. number A-96/13

NIB ANNUAL REPORT 2012

Swedish Accident Investigation Authority SWEDEN

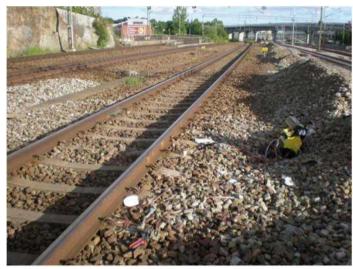
RJ 2012:01 Near-collision between two trains at Nyhem interlocking area, Jämtland County, 9 June 2011.

On Thursday, 9 June 2011, a near-collision occurred between two freight trains on the Nyhem - Grötingen section.

Train 42059 got a 'proceed' at intermediate signal Ny 2/5 and exit block signal Ny L1, though the section towards Grötingen was not free of trains. This was because the block system's track circuit dependencies were partly out of operation owing to a switch in the telecommunications cable between Nyhem and Grötingen. Exit block signal Ny L1 did not show 'stop' until the approaching train, 4004, tripped the track circuit immediately outside the interlocking area boundary in Nyhem. The driver of train 42059 noticed that a stop lamp had gone to 'stop' and then stopped the train within the Nyhem interlocking area.

The direct cause of the incident was that a function was moved from one wire pair to another in a copper cable and the new wire pair was not connected to the functions required for the signal installation to have the fully secure and intended functionality.

An underlying cause of the incorrect switching is that the telecommunications technician lacked knowledge and experience of the Swedish Transport Administration's telecommunications system and its applications, despite the fact that he/she had completed the qualification test with good results.

Recommendation RJ2012:01 R2	The Swedish Transport Agency is recommended to conduct an inspection of the Swedish Transport Administration to examine how the Administration's safety management system ensures that safety-critical work is carried out correctly and by personnel who have the right skills.

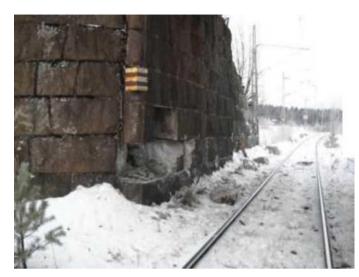
RJ 2012:04 Impact incident involving personnel working in the track at Skavstaby interlocking area, Stockholm County, 17 November 2010

On 17 November 2010, there was an impact incident involving two people who were working in the track at Skavstaby interlocking area. Skavstaby lies between Upplands Väsby and Rosersberg in Stockholm County.

Two track workers, involved in green zone working, were installing snow protection on a point when a passenger train approached on the track in which they were working. The passenger train driver sounded the horn and the two persons jumped out of the track just before the train passed the point on which they had been working.

The direct cause of the train being able to pass the spot where the work was being performed was that the proceed signal could be shown because the track circuit was not shorted. Underlying causes of the incident include Infranord's failure to plan the work in accordance with the procedures in BVF 923 for protection and safety planning. The work was also arranged as directly planned green zone working even though the work was known within Infranord and direct planning of a job may only be used for emergency repairs. The supervisor and head supervisor did not notice in their discussions on coordination and starting permission that they planned the work for different areas.

• The Swedish Transport Agency is recommended to analyse and evaluate the oversight practices applied in order to improve capacity to uncover the types of deviations that the Agency has not been able to pick up in its oversight of safety management systems (see section 2.3.1), for example, an infrastructure manager that does not follow the requirements for work in the track environment (see section 3.2.2), BV-FS 2000:3 regarding competency requirements for persons working in safety services (see sections 2.2.2 and 3.2.2), and BV-FS 2000:4 regarding medical examinations conducted before returning to work (see section 2.6.2) (RJ2012:04 R1).
