Federal Ministry of Transport
and Digital Infrastructure

Management of the Federal Railway
Accident Investigation Office

ANNUAL REPORT

2013

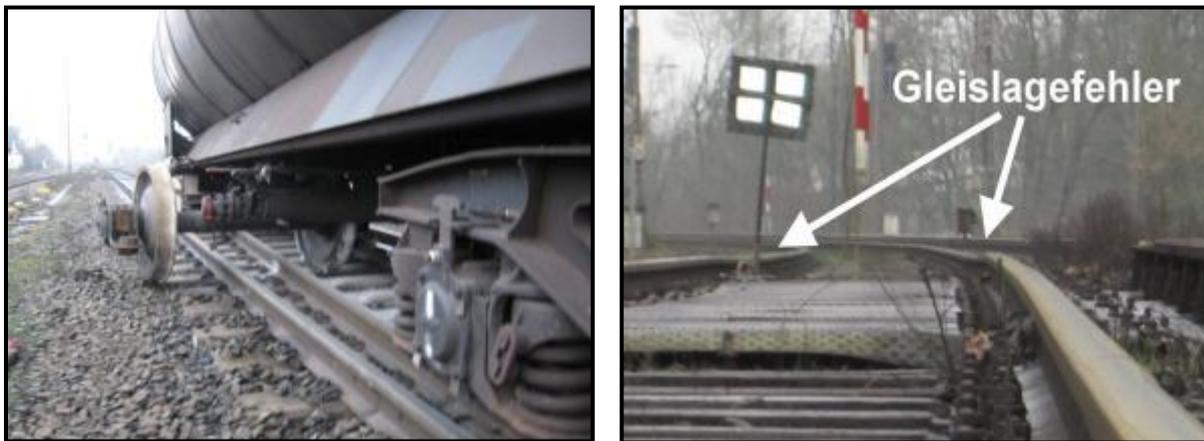
Figure 7: Train derailment in Recklinghausen Ost

After the DGS 95748 passed the entry signal showing 'line clear' points 58W201, 58W202, 58W204, 58W205, and 58W207 were forced open. There was no leak of hazardous material.

The present stage of the investigation indicates that track geometry faults caused the derailment.

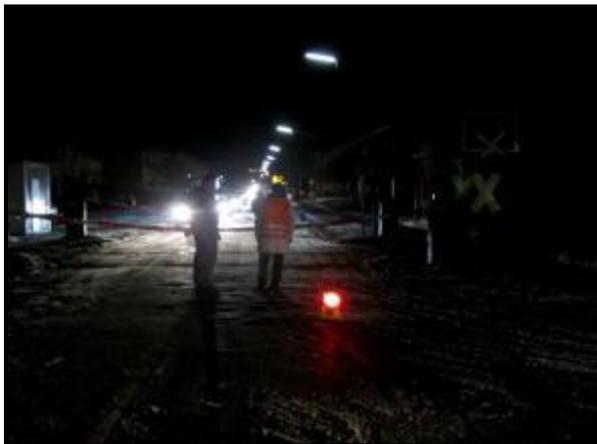
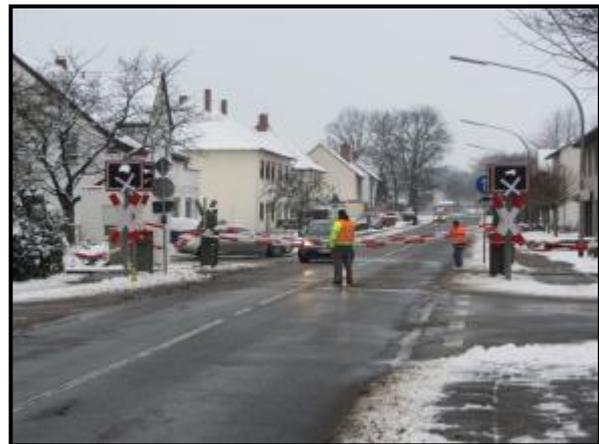
Figure 8: Railway crossing accident between Lübbecke (Westphalia) and Espelkamp

One person was killed and two people seriously injured in the accident. The two employees used as attendants suffered shock. Damage to property estimated at approximately EUR 170 000 was caused.

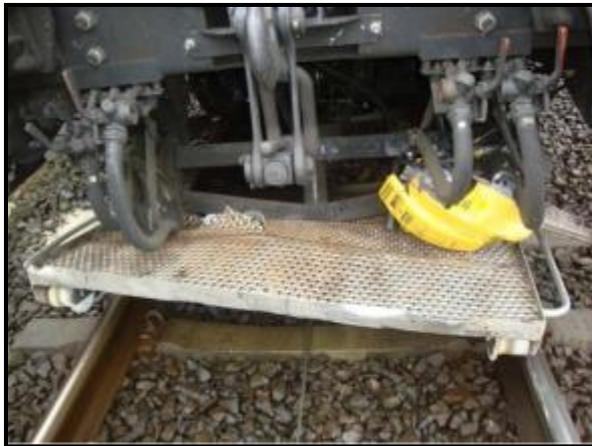
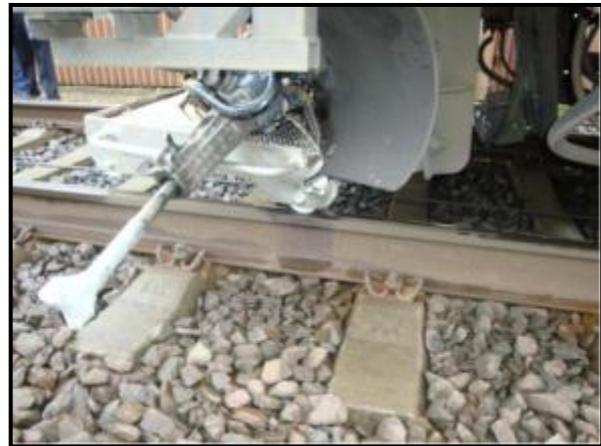
Figure 9: Train collision in Hamburg Bergedorf

During the collision the tools were thrown through the air. One person was hit by one of the flying implements and sustained fatal injuries.

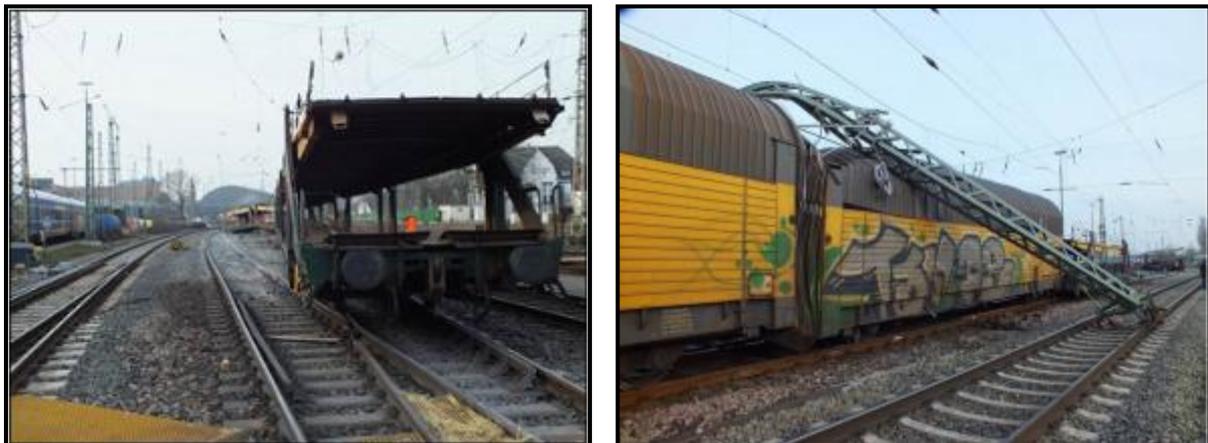
Figure 10: Train derailment between Vahr (Jct.) and Bremen Central Station

As a result of the derailment there was severe damage to track, control and safety systems and the overhead line system.

The cause was identified as a hand brake being applied in the rear wagon unit. The locking of the wheelsets led to large material loss and deposits on the running surfaces of the wheelsets. As a result the wheelsets were unable to run truly on the rails causing the wagon to derail to the right.

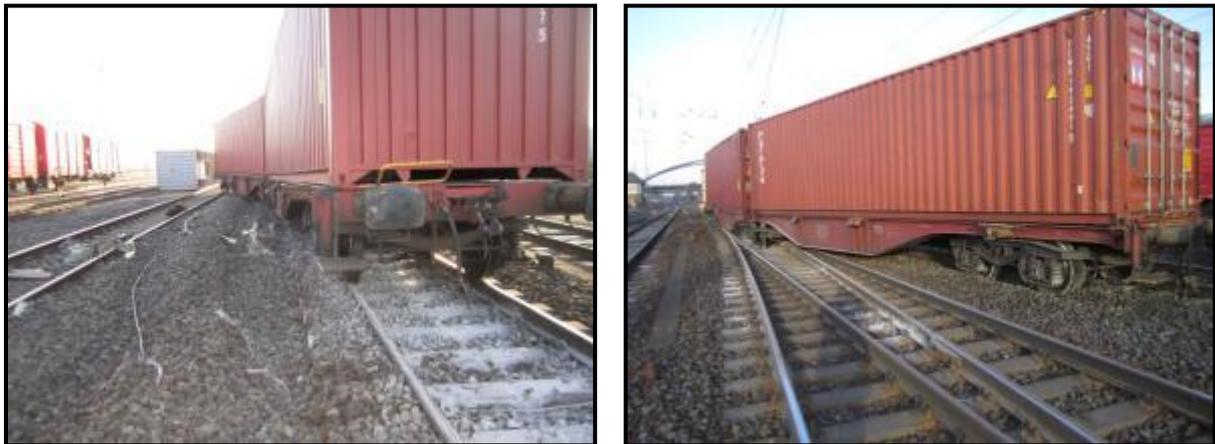
Figure 11: Train derailment in Hannover-Linden

As a result of the derailment considerable damage was caused to track, control and safety systems and the overhead line system.

The cost of the damage was estimated at approximately EUR 320 000.

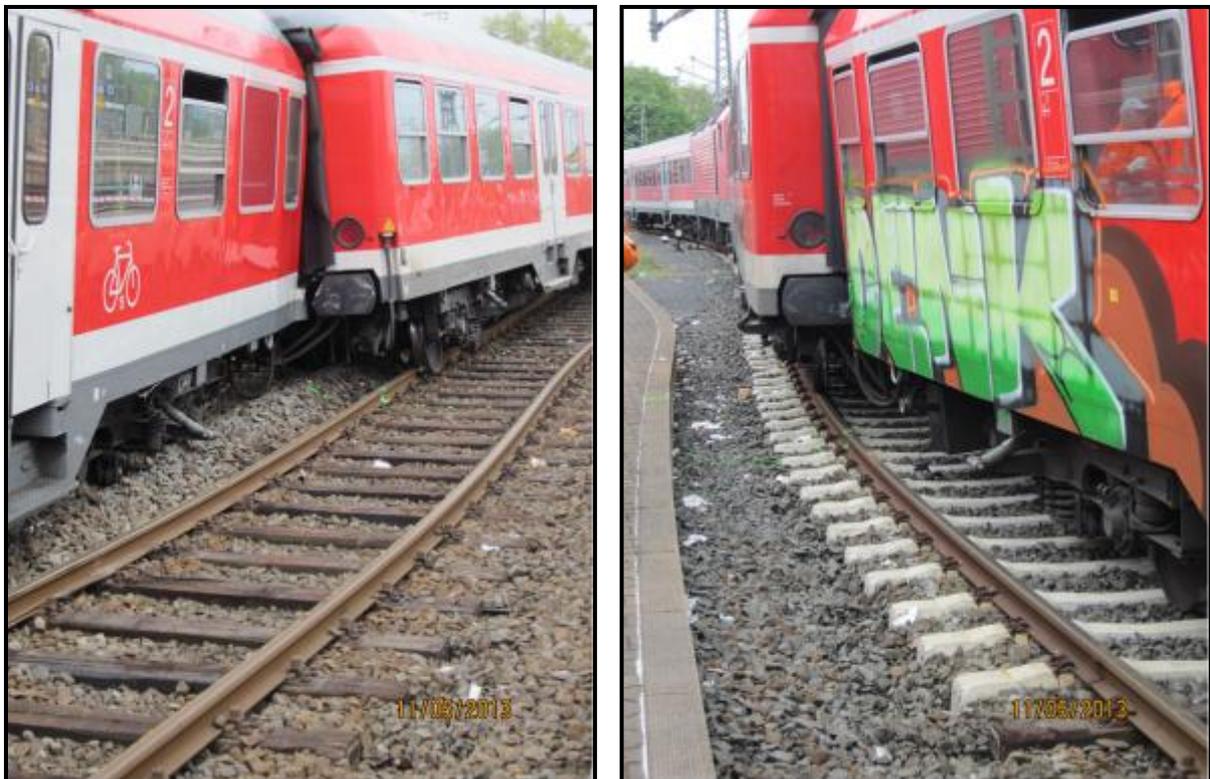
Figure 12: Train derailment in Frankfurt South

Nobody was injured. Damage to vehicles and infrastructure was caused by the derailment.

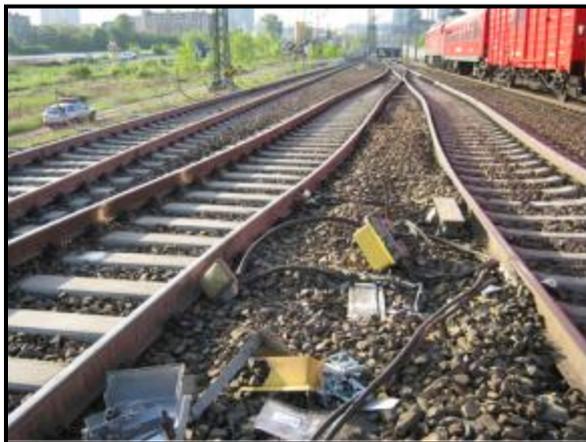
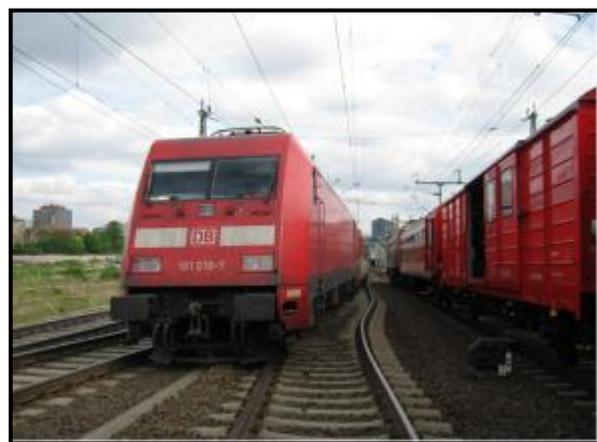
Figure 13: Train derailment in Berlin Central Station

The train driver was slightly injured (shock). Nobody else was injured.

The cost of the damage was approximately EUR 770 000.

LPF 178 derailed as it was passing over point 51W102 while this was changing from the right position to its normal position (left position). This was caused by a premature release of the section of signal 51ZU5 with destination 51LUMA6.

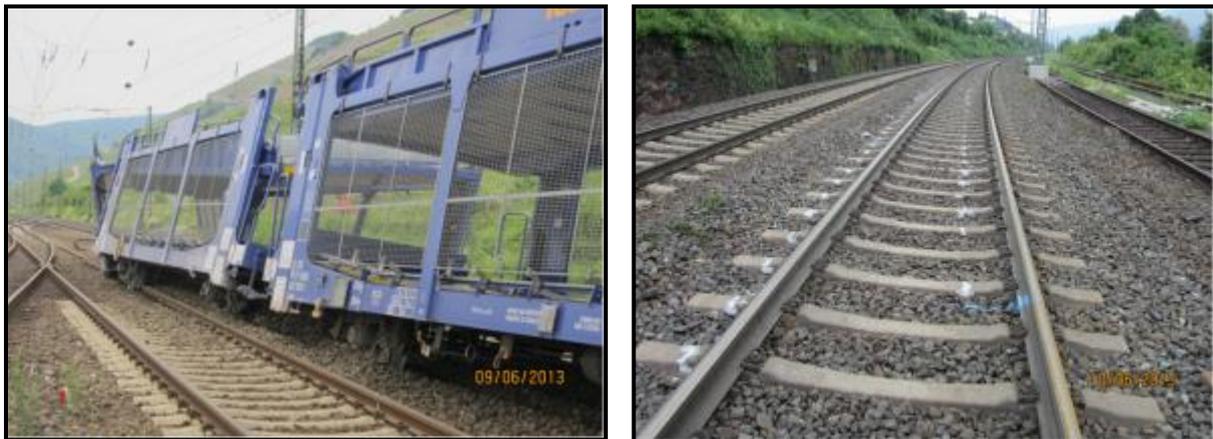
Figure 14: Train derailment between Lorch (Rh.) and Rüdeshheim (Rh.)

As a result of the derailment the track at Üst Lorch and the entrance to Rüdeshheim (Rh.) Station and the signalling equipment, overhead line systems and communication systems were severely damaged over a distance of approximately 11 km. In addition, the next three following vehicles of the DGS 90636 were severely damaged in places. As a result of flying gravel cars parked next to the railway line were also damaged.

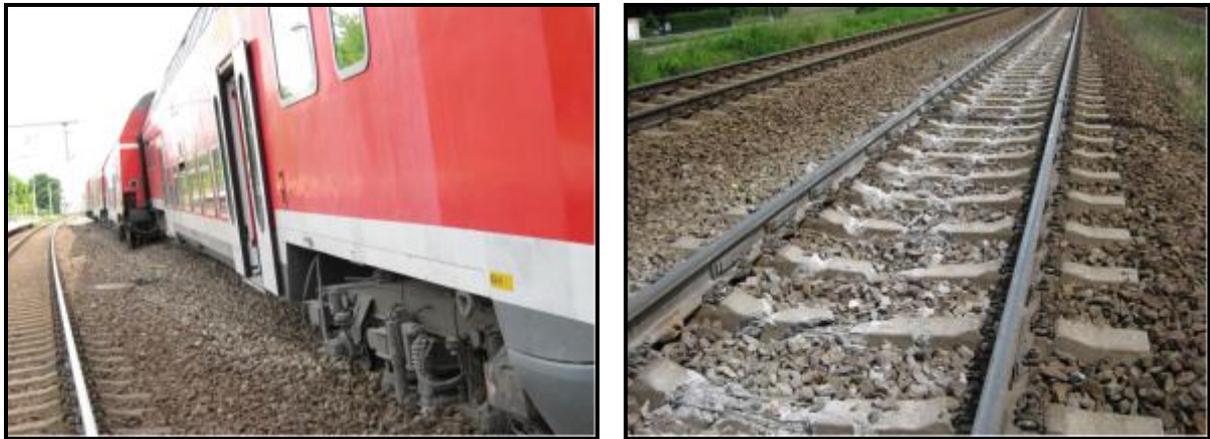
Figure 15: Train derailment in Schkeuditz

Two people were slightly injured. The cost of the damage to the infrastructure and the vehicles was estimated at a total of approximately EUR 505 000.

The derailment was caused by passing crossover 31W11/31W10 at excessive speed.

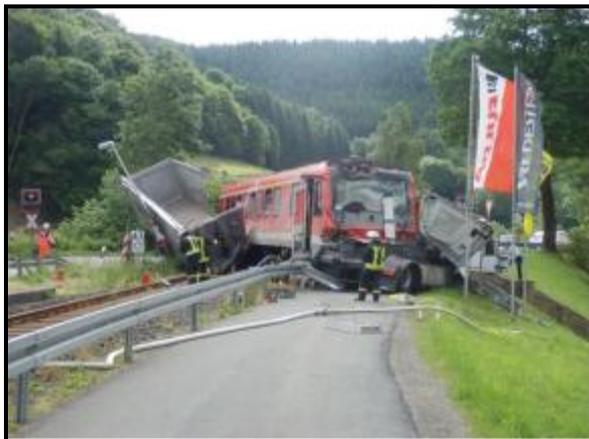
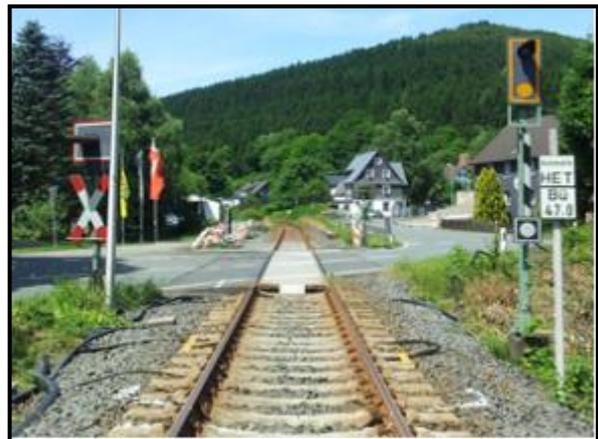
Figure 16: Railway crossing accident between Bad Laasphe and Erndtebrück
Source: Federal Police

One person was killed as a result of the collision, with one person seriously and thirty people slightly injured.

RB 23156, a class 628 railcar, derailed with two bogies. The cost of the damage was estimated at approximately EUR 600 000.

The accident was caused by the driver of the lorry who drove the vehicle over the railway crossing despite the flashing light showing.

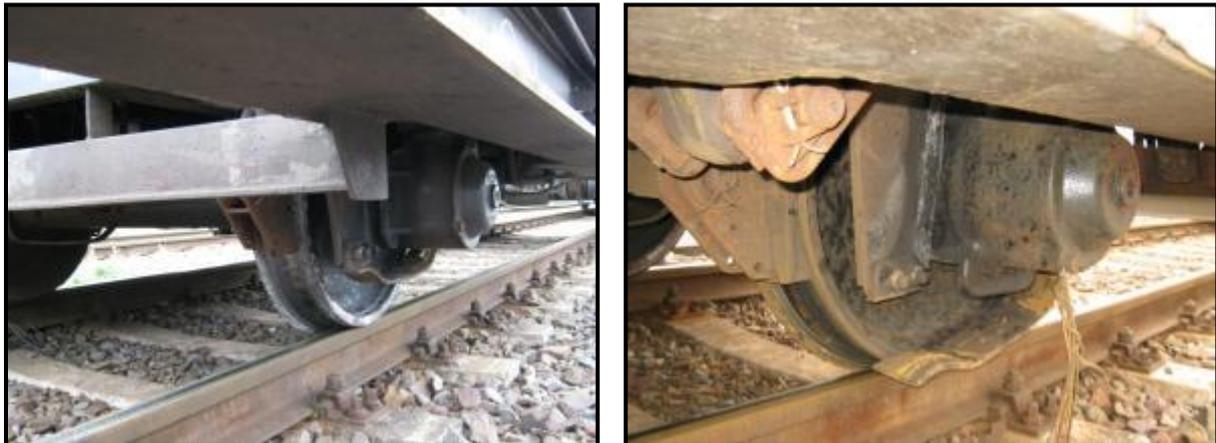
Figure 17: Train derailment between Kayhauserfeld and Oldenburg Central Station

As a result of the derailments damage was caused to the track, to the rear axle of the derailed wagon and to its axle box.

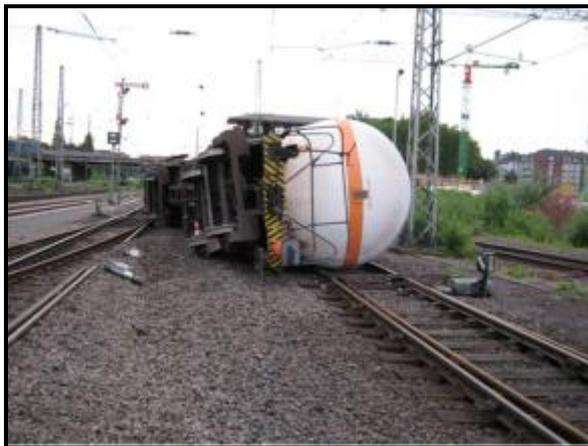
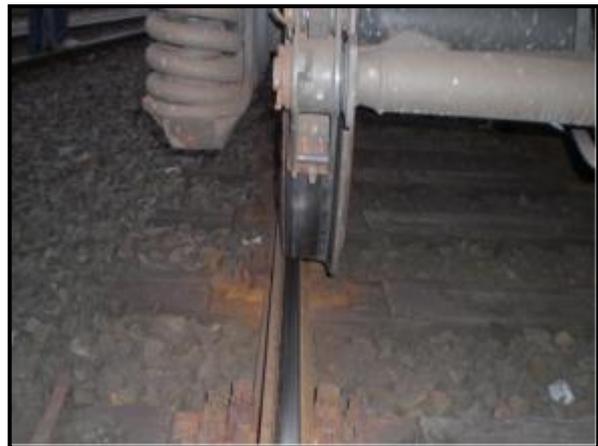
Figure 18: Train derailment in Düsseldorf-Derendorf

As a result of the derailment damage was caused to the track systems and the goods wagons. Since one of the tank cars loaded with propene overturned, until this vehicle's contents were transferred and it was placed in the upright position again, there was an increased danger of explosion, resulting in extensive safety measures being taken by the police and fire service in the station and in the surrounding urban area.

The cost of the damage was estimated at approximately EUR 650 000.

The derailment was caused by an inadmissible gauge widening, triggered by advanced biological decay of the wooden sleepers. As a result the track was no longer able to keep to gauge.

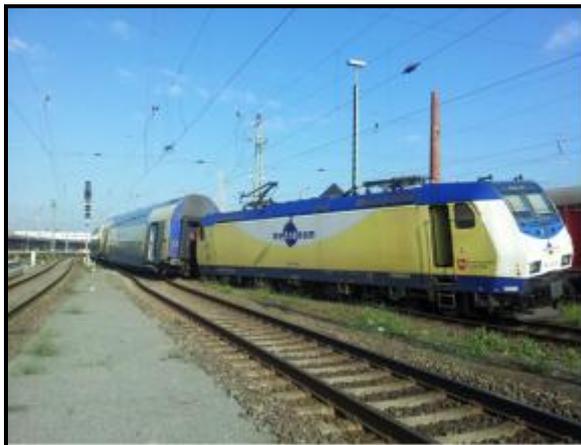
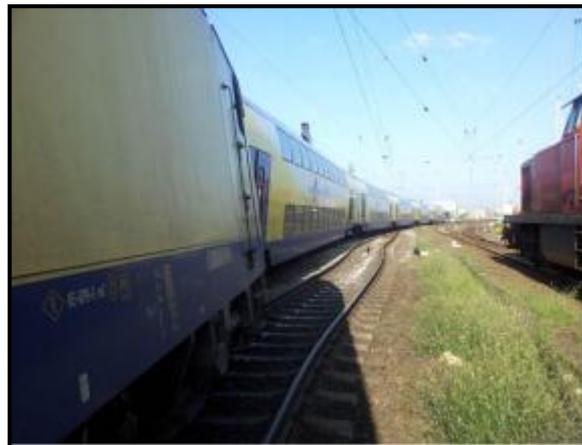
Figure 19: Train derailment on 5 September 2013 in Bremen Central Station

As a result of the derailment, track and control and safety systems were severely damaged in places over a length of approximately 100 m. According to the infrastructure manager the cost of the damage to the route was estimated at approximately EUR 150 000.

The total damage caused to the RU comprised material damage to rolling stock, making good of environmental damage and operational difficulties and was put at approximately EUR 2.5 million by the undertaking.

The derailment was caused by the throwing of point W11230 as a result of movement of the train. As a result the first bogie of the traction unit continued on the planned route to track 10. Because of the open switch points the second bogie left the guiding device and was thus in between the two stock rails.

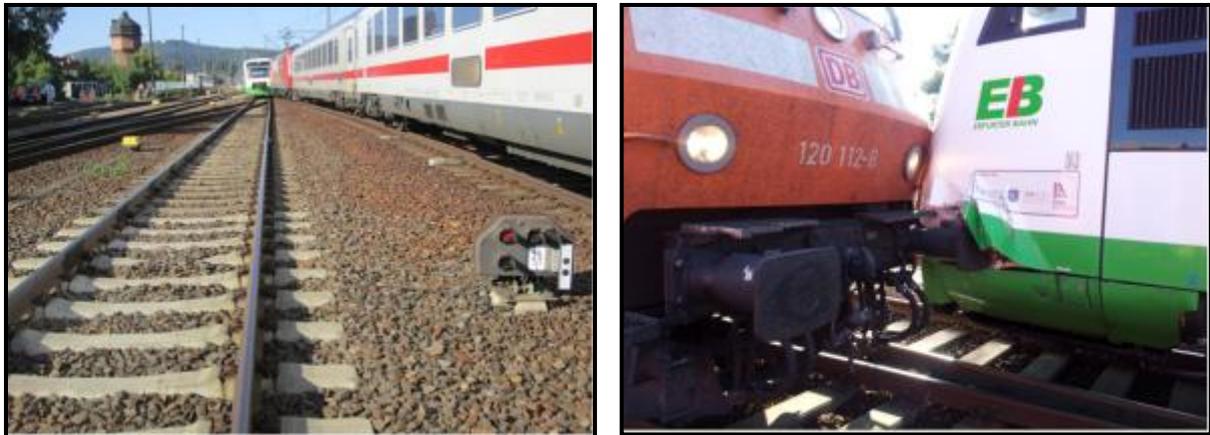
Figure 20: Train collision on 5 September 2013 in Saalfeld

Damage was caused as a result of the collision between IC 2208 and the shunting movement. The shunting movement derailed with one bogie.

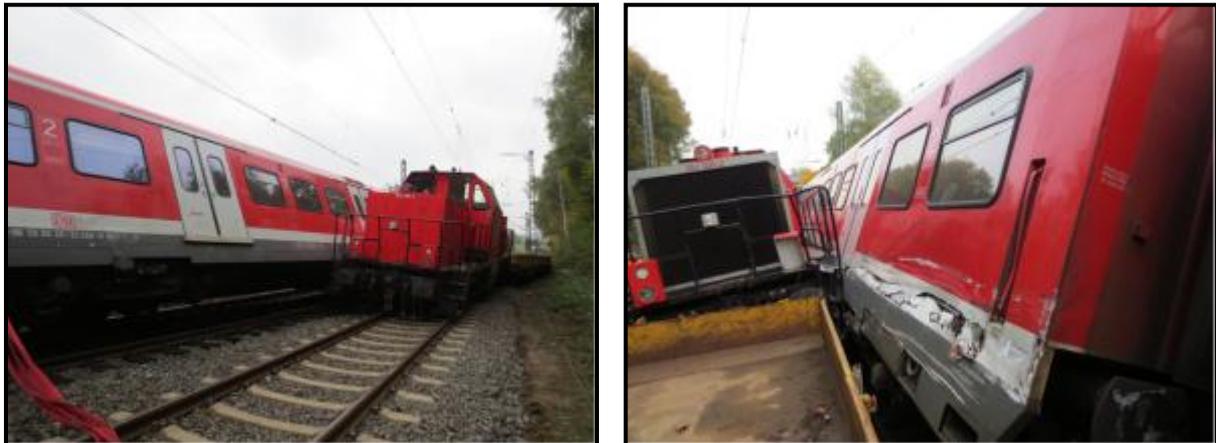
Figure 21: Train collision on 16 October 2013 in Essen-Werden

The traction unit belonging to the S-Bahn derailed with one bogie. The following wagon derailed completely and ended up in a tilted position. The work train comprising the traction unit and a pushed wagon also derailed. In total the cost of the damage was estimated at approximately EUR 700 000.

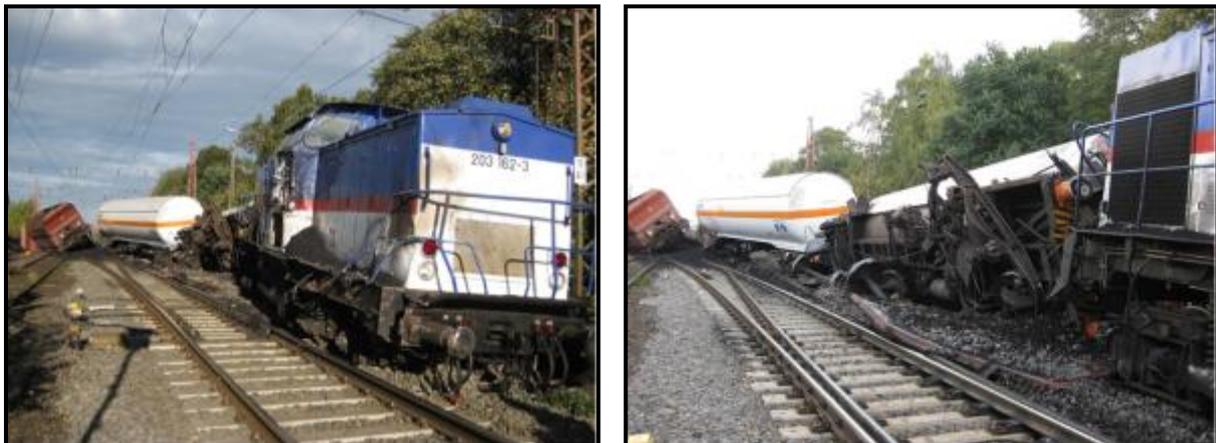
Figure 22: Train collision on 26 October 2013 in Gladbeck West

The driver of train 89025 was seriously injured in the accident. Severe damage was caused to the vehicles of both trains, to railway premises and to the control and safety systems equipment.

The cost of the damage was estimated at approximately EUR 2.2 million.

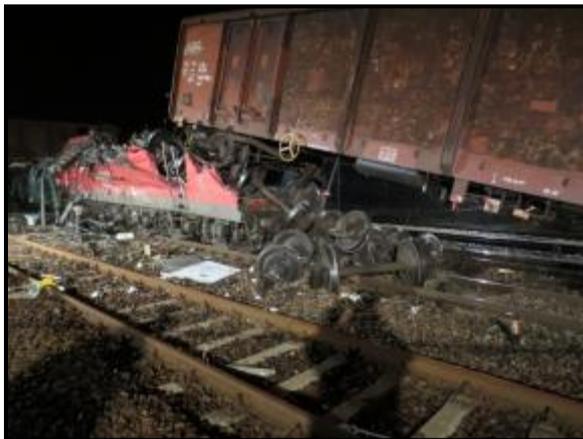
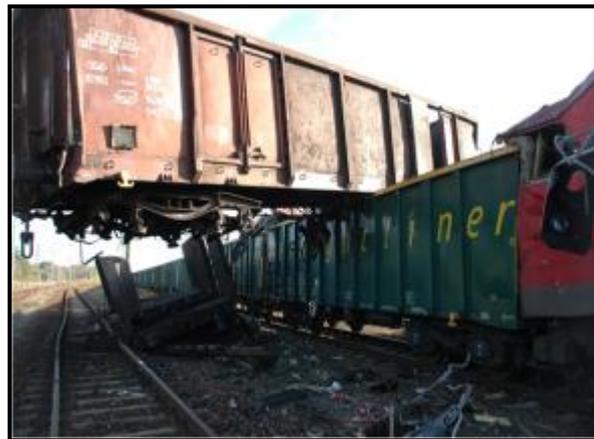
Figure 23: Train collision on 11 November 2013 in Hosena

The driver of the GM 61649 was slightly injured in the collision. The traction unit of the GM 61649 was destroyed and the following five wagons of the train derailed, toppled over and became wedged to each other.

The cost of the damage was estimated at approximately EUR 1.85 million.

The train collision in track 4 of Hosena Station was caused by the entry of train GM 61649 into the track section still occupied by train DGS 93981. This was the result of serious operational human error by local staff.
