Unit for Investigation of Railway Accidents

Annual report of railway accidents investigated in 2010

Estonia

Tallinn 2011

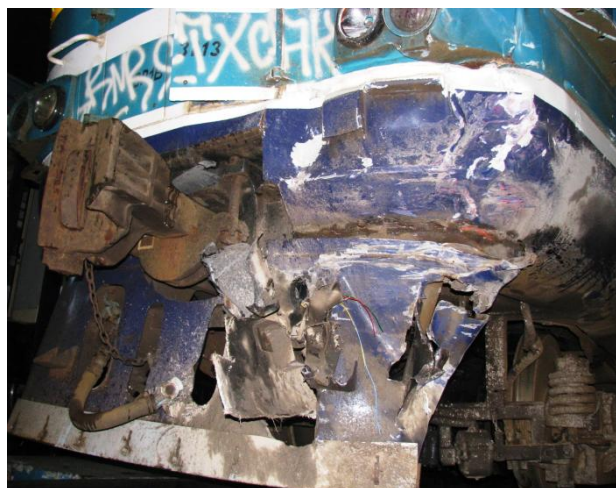
On Saturday, 21 November 2009 at 08.15am there was a collision between a passenger train and a MAZ truck on the unregulated Edelaraudtee Infrastuktuuri AS Männiku level crossing (km 14,599). The railway traffic intensity on the Männiku level crossing is less than 26 units and the highway traffic intensity less than 50 units per 24 hours. A five-car diesel train travelling from Tallinn to Viljandi as fast train No 0041 engaged emergency brakes at 82 km/h. The truck had been driving on a road parallel to the railway and immediately prior to reaching the level crossing, performed a right turn at low speed at a sharp bend as a result of which the truck did not stop at a priority sign “Stop and give way” but continued driving to the crossing at a speed less than 5 km/h. The distance of the nearest rail from the road sign was 7,9 m. Upon reaching the crossing the driver noticed the train approaching from the right

and stopped the truck on the rail tracks. Before the truck started to move it was hit from the right by the braking passenger train.

Due to the light rail traffic the truck driver, a frequent user of the Männiku crossing, had lost the sense of danger. The cause of the accident was human error on the part of the truck driver.

The truck was thrown off the road, its load of sand fell off, and the driver was killed.

The car became unfit for use. The driver of the locomotive sustained minor injuries, front of the railcar trailer DR1B-3713 of the railway rolling stock suffered damage but the railway infrastructure remained intact.

For improvement of railway traffic safety the investigation report contained altogether 7 recommendations to the IM, Safety Authority and the police for the development and equipment of the new level crossing and organisation of travel supervision.

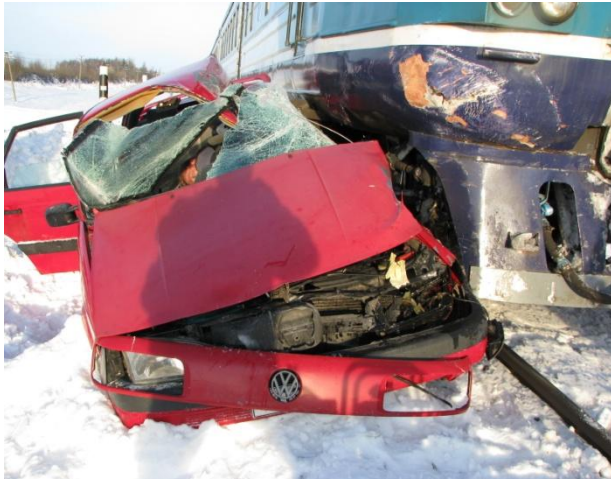
Pikkjärve 21.01.2010

On Thursday, 21 January 2010 at 09.55 am there was a collision between an express train No 0010 and a Volkswagen Passat car on the regulated AS EVR Infra Pikkjärve level crossing (km 393,3). Railway traffic intensity is 42 trains in 24 hours and highway traffic intensity is 3599 units in 24 hours. The level crossing is equipped with warning road signs, automatic barriers and crossing traffic lights.

Tallinn – Tartu five-car passenger train and the car approached the crossing at an acute angle to each other. Pikkjärve crossing was technically operational. The driver of the car who did not slow down on a sloping bend had increasing glare from the low sun in his eyes. The diesel train on the express route engaged emergency brakes at 96 km/h. The car applied the brakes only immediately before the collision with the train and it had not stopped at the prohibiting traffic light or the lowered

barrier. The road was dry but the braking took place too late. The car was wedged between the snow plough and the bogie of the train's railcar. The train dragged the car for almost a kilometre before stopping.

The driver of the car had been using the crossing over a longer period of time for journeys to work and home. While driving round a sloping bend he did not judge adequately the impact of the setting sun and the changing angle of its rays to the visibility in front. The direct cause of the accident was human error on the part of the driver of the car.

The driver of the car was killed in the accident, the passenger sustained minor injuries. Railway infrastructure suffered damages, mainly in the form of damages to the barrier. Of the railway rolling stock, the front end of the railcar trailer DR1BJ-3706 suffered damages. The Volkswagen Passat car became unfit for use.

Two recommendations were made to the IM and the road manager for improving railway traffic safety.

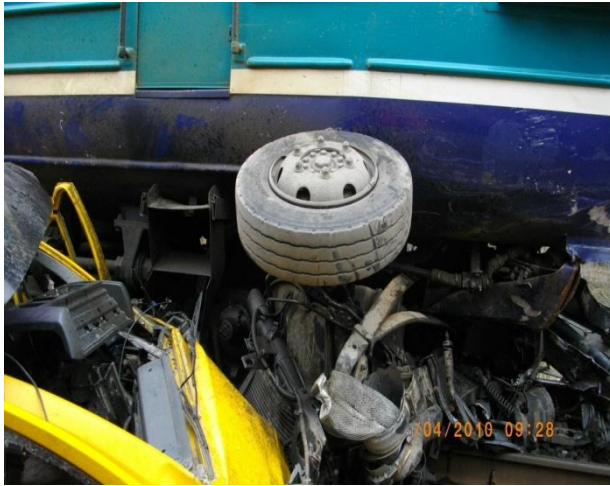
Männiku 16.04.2010

On Friday, 16 April 2010 at 08.13 am there was a collision between the passenger train No 0014 and a MAN truck at the rural automatically unregulated Edelaraudtee Infrastruktuuri AS Männiku level crossing on the Liiva - Kiisa open track (km 14,599). The road and the rail tracks run across each other at the Männiku level crossing. The crossing is equipped with a warning road sign “Level crossing” and a priority sign “Stop and give way”“.

The diesel train travelling as fast train was approaching the Männiku level crossing at a permitted speed of 85 km/h. Approximately 20 m before the nearest track the truck had performed a sharp right turn to the level crossing and might not have been parallel to the longitudinal axis of the road prior to reaching the rail tracks whereby the driver's view of the train approaching from the right was limited. The truck driver did not hear the train's second warning signal and started crossing the level crossing without

stopping. During the collision with the train the truck was hit from the right in the area between front and rear wheels. The train pushed the truck on the tracks in front of it for approximately 0,5 km until it stopped.

As a result of the accident at Männiku level crossing the truck driver was killed and one train passenger sustained minor injuries. The cause of the accident was human error on the part of the truck driver.

The front side of the body, snow plough, the beam of the automatic signalling system receiver coils, the drive of the speed recorder and the compressed air pipeline of the railcar DR1B-3703 at the head of the 5-car diesel train suffered damages, the front windscreen of the locomotive driver's cab was shattered. The railway infrastructure remained intact. The damage to the train made it impossible for the train to continue its scheduled journey. Following the inspection the train was moved back to the depot with the aid of the railcar at the other end of the train.

The MAN truck had broken into three separate parts which where the container, cab and chassis of the truck. The cab and the chassis were completely deformed and had become unfit for use.

Five recommendations were made to the IM and local government for improving railway traffic safety.
