Federal Ministry of Transport,
Building and Urban Development

Railway Accident Investigation

ANNUAL REPORT

2009

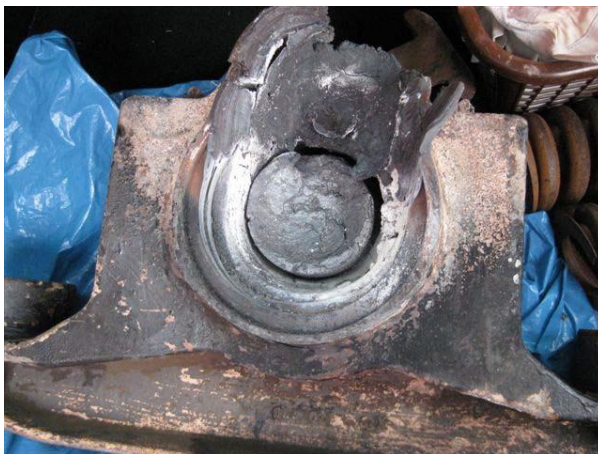
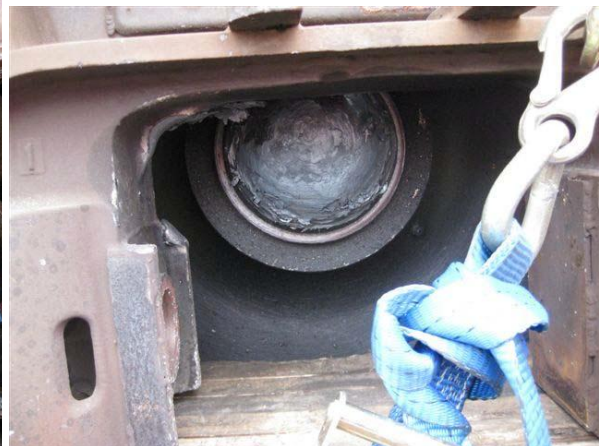
2.1.3 Derailment on the Bünde (Westphalia) to Bruchmühlen line on 17 July 2009

A hot box on train 61084 was detected at about 00:20 on 17 July 2009 between Bruchmühlen and Bünde (Westphalia) on the line from Löhne to Rheine at km 102.190. The train came to rest at km 99.2 after it was stopped by the signaller at Bünde.

After investigating, the driver confirmed that the leading bogie of the sixteenth wagon, loaded with fuel oil, had derailed.

There was no personal injury nor did any dangerous goods escape. The permanent way was severely damaged.

The investigations carried out to date show that the derailment is to be attributed to a broken axle, itself the result of an axle box running hot.

'The following rolling stock-related measures are currently recommended to avoid further axle failures caused by hot boxes:

- replace riveted brass cages by plastic bearing cages;
- investigate whether fitting further derailment detectors and/or hot box detectors could contribute to preventing derailments.'
