TRANSPORTATION SAFETY
BUREAU

ANNUAL REPORT 2009

Transportation Safety Bureau

Hungary

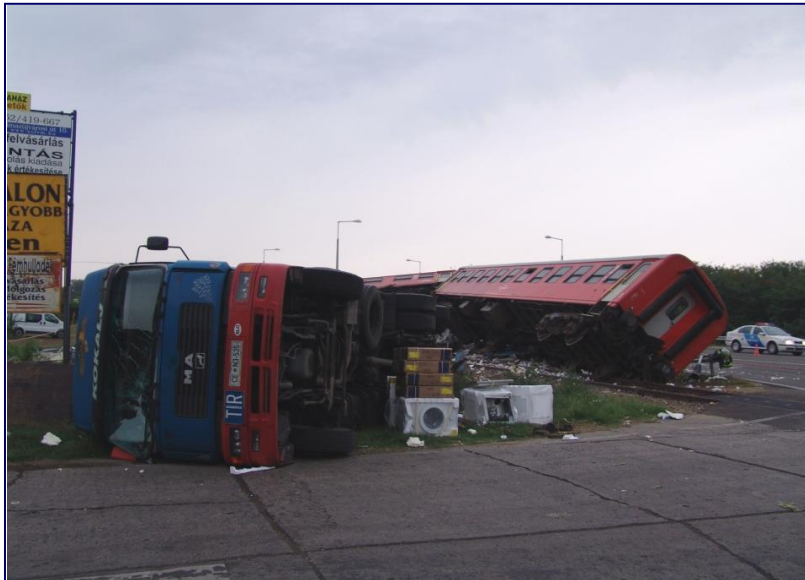
2007-323-5**2008-115-5****2008-191-5****2008-211-5****Railway accidents**

On 29th August 2007, a regional passenger train collided with a lorry at a normally operating LC - protected by warning lights - between Tócsövölgy and Balmazújváros stations. The engine-driver and three passengers suffered minor injuries as consequence of the accident. The control car of the train and one carriage derailed and toppled to its side.

(3 similar accidents - collisions - happened at the same LC during the year

2008-0191-5-01: With regard to the recurring accidents at LC AS 41, the IC recommends the National Transport Authority to review the design and construction of LC AS41 (between Tócsövölgy and Balmazújváros stations at railway section 41+16 hm) from transport safety point of view as well as to examine whether or not it would be necessary to improve the technical conditions of railway safety and to install a traffic control system which is integrated with the LC.

The IC also recommends LC AS 47 (in railway section 47+72 hm) to be reviewed as in the last 12 months there have been a number of accidents at this LC during which cars collided with trains (disregarding the Stop signal of the warning lights). On all occasions, the road vehicles involved in the accidents arrived from Debrecen direction on road no.33 - which is a slip road to M35 motorway - and turned left (from the 2x2 lane road) onto the LC (see photo above) This manoeuvre - also considering the heavy traffic on the 4-lane-road, 2 lanes in opposing direction - directs the attention of the drivers from the LC (which is signposted with one sign only), therefore they often only notice the danger when they are already on the LC. Turning from Házgyári út direction onto the main road is also difficult as the drivers have to give way not only to the trains but also to the other cars on the main road.

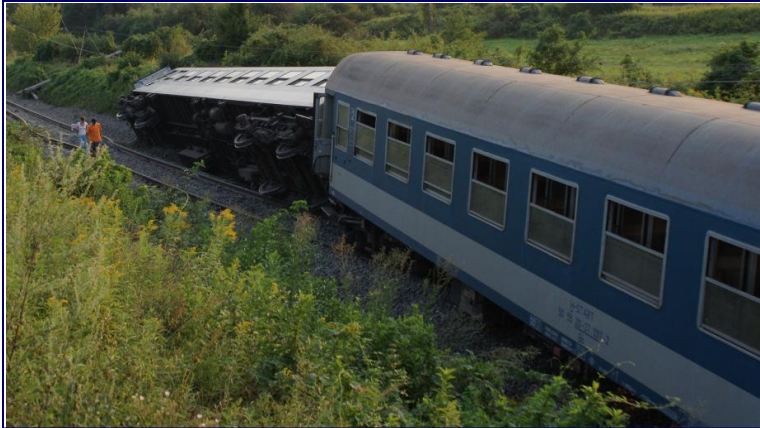
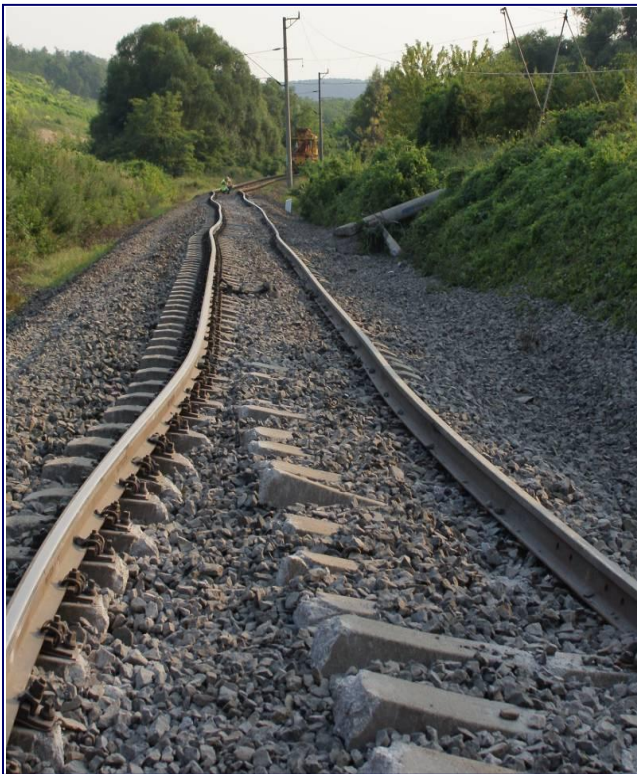
2008-335-5

On 2 August 2008, 4 carriages of a passenger train derailed between Kurd and Szakály-Hőgyész stations, one of which toppled to its side. The rail track sustained substantial damage on a 200 metre length.

- Prior to the accident, there had been more precipitation than usual, and then the weather was hot for a few days.

- There was no drainage at the site of the accident.
- The upper part of the bedding got soaked; its supporting capacity was significantly reduced.

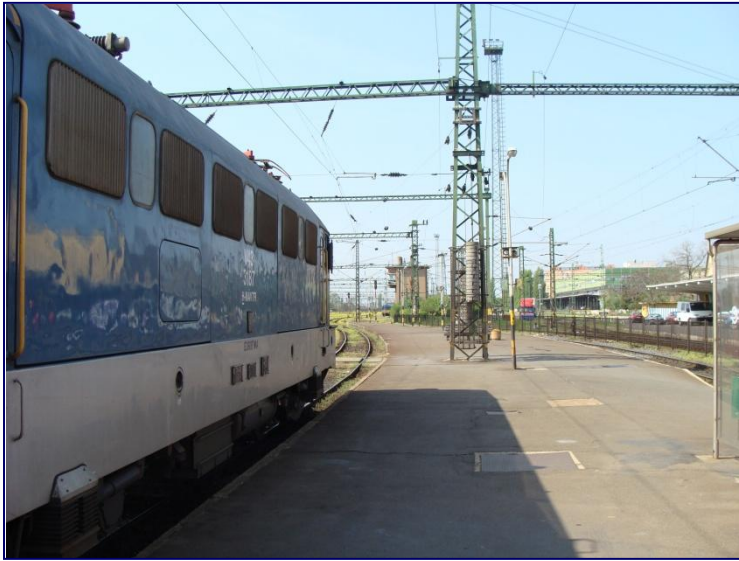
2009-148-5**Railway incident**

On 14 April 2009, scheduled Inter City train departed on permission of the controller and passed an inoperative exit signal. The train was stopped by manual signalling. There was neither injury to persons nor material damage.
