# **NIB ANNUAL REPORT 2007**

Accident Investigation Board

FINLAND

This is the annual report of railway sector of the Accident Investigation Board of Finland for calendar year 2007. This is mainly the part of the Annual Report 2007 of AIBF, which relates to railway sector. There are also some parts which have added that the report would measure up to standards of ERA.

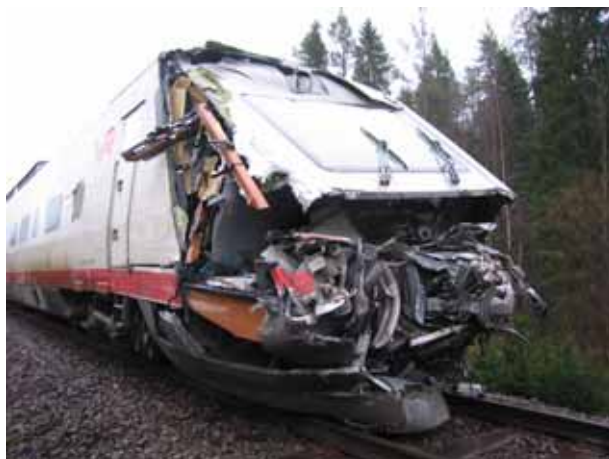
**S1/2005R**

**Safety study on level crossing accidents**

There were altogether three fatalities in the seven accidents investigated: two persons died in one accident and one person in one of the accidents. Five persons suffered mild injuries in the accidents; among them one was a train passenger and one was an engine driver. Four car passengers or drivers were unharmed. Among the accident trains, the Pendolino train was severely damaged while the other trains only suffered minor dam-

In all of the individual level crossing accidents investigated by the commission, the travelling of the road the vehicle to the level crossing without stopping was disclosed as the immediate cause of the accident. In three cases, the driver's vigilance in terms of the traffic situation was insufficient as due to his absent-mindedness. In two cases the driver essentially focussed on his manipulation of the road vehicle and in two other cases, the driver's attention was concentrated on other objects than the level crossing. Among environmental factors having contributed to the occurring of the accident, there was in four cases too high a speed limit before the level crossing, in three cases a rising gradient to the level crossing, in two cases the road and railway meeting angle, in one case insufficient visibility, in one case darkness and rain, in one case glaring sunshine, and in one case slippery road.

driver as being in a hurry. Among the environmental factors, the most general background factors included the rising gradient of the road to the level crossing, the slipperiness of the road and obstructed sightline. Among factors hampering observation, there were moreover the glare caused by sunshine, fog, darkness and the road-railway crossing angle.

In view of the removal of level crossings, the investigation commission recommends that:

- stopping should be adopted as the regular model of behaviour at unguarded level crossings where the sightline along the railway is only attained at a distance of 8 metres from the railway;
- the visual range requirements should be modified so as to also consider the possibility of crossing a level crossing without stopping;
- the perceptibility of a train and a level crossing should be improved;
- the speed limit before a level crossing should be reduced to max. 50 km/h;
- the wait platforms at level crossings in poor condition should be upgraded to meet the specifications set forth in the Track Technological Rules and Regulations (RAMO);
- maintenance instructions for level crossings should be drawn up;

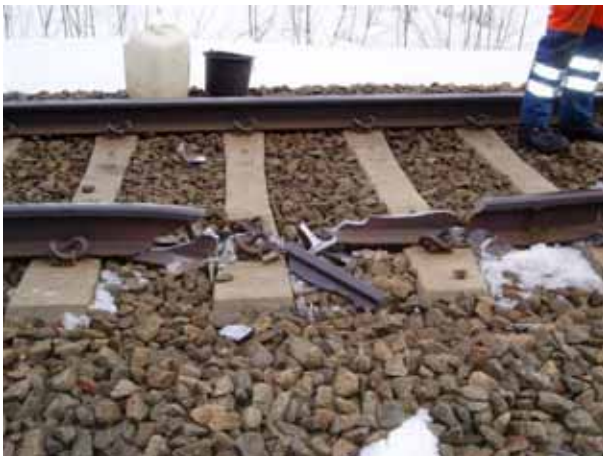
**B1/2005R**

**Passenger train car derailing between Saakoski and Jämsänköski on 30 March 2005**

The remote control operator contacted the engine driver of the passenger train, by line radio and told him of the observations and experiences of the drivers of the two previous freight trains and of the broken rail. The remote control operator told the engine driver to run over the place in question at a reduced speed and to inform the remote control operator of his relevant observations. As the train approached the breakage point, the driver reduced the speed from 118km to 87km/h. When the locomotive passed the rail breakage point, the driver heard a bump. The conductor in the fourth car heard a loud bang as the car ran over the breakage point. By using his interphone, the conductor advised the driver of his observation. The driver viewed the rear end of the train in the mirror and saw a big cloud of dust behind the train and sparks flying beside the train. The driver started to brake and notified the conductor of the sparkling. When the train had come to a full stop, the conductors went out to check the situation. The front bogie of the second last car of the train had derailed.

The immediate cause of the incident was the rupture of the rail that had broken just a moment earlier, under the weight of the cars of the train. The rupture of the rail was probably due to the combined effect of a poor finishing of the hole drilled in the rail and the local characteristics of the rail steel. Moreover the important stress of the rail possibly also contributed to the rupture.

The rail breakage resulted in the incident as due to an incorrect reaction thereto. The drivers of the two freight trains had perceived the bang caused by the rail breakage but the traffic control unit had failed to appraise the situation as hazardous enough to generate derailment.

As a result of the incident, the Finnish Rail Administration decided to replace the rails on this particular section of line over the summer 2005. Furthermore VR Ltd introduced a modification in its traffic control instructions: should the remote control operator receive a notice of a bang or a swing from the engine driver, he shall regularly introduce a speed limit of max. 50km/h at the location in question. The Central Finland Emergency Response Centre has adopted in its data systems the track-km localization data of the sections of line of the region.

In order to prevent similar accidents in the future, the Accident Investigation Board of Finland recommends that the instruction on a 50km/h speed limit to be introduced in unclear situations as specified in the Traffic Control Operator's Manual of VR Ltd, be also adopted and included in the Train Safety Regulations. VR Ltd should moreover introduce a modification in its emergency situation instructions: in addition to a notice addressed to the traffic control unit from the railway accident or incident scene, also an emergency response centre should be directly contacted in case urgent help is needed from a rescue service. The Emergency Response Centre Administration should ensure the compatibility of the data system of the Emergency Response Centre Agencies with the localization data used by the railway.

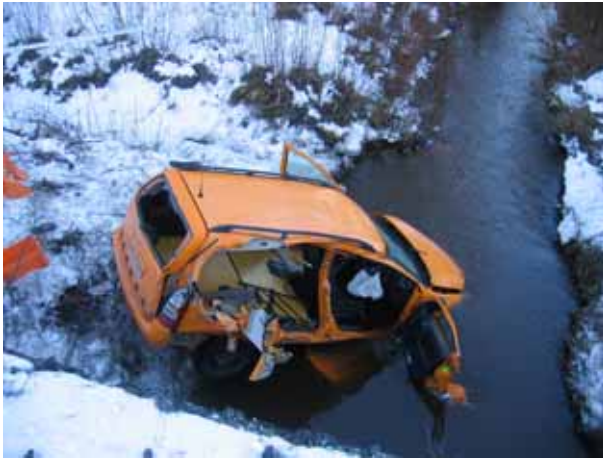
**B1/2007R**

**Fatal level crossing accident in  
Närpiö on 17 January 2007**

On Wednesday 17 January 2007 at 10.50 a.m. an accident occurred in Närpiö in which a train carrying lumber on its way from Seinäjoki to Kaskinen collided with a van at an unprotected level crossing. The van driver perished in the accident, and the van was wrecked beyond repair, while the front of the locomotive suffered only minor damage.

The accident was caused by the van driver not driving clear of the train travelling from the right. It is obvious that the driver either did not look towards the approaching train or did not notice it.

To prevent similar accidents, the Accident Investigation Board of Finland recommends that delivery services and their planning aim to avoid unprotected level crossings. Furthermore, level crossing warnings placed between the delivered material and the use of a GPS device notifying of level crossings would improve safety. The Investigation Commission also recommends that the use of safety belts be extended to apply to delivery vehicle drivers and passengers irrespective of the driving distance. In addition, the Investigation Commission would reiterate its recommendation, S1/05R/S216, regarding the lowering of the speed limit to 50 km/h on unprotected level crossings.

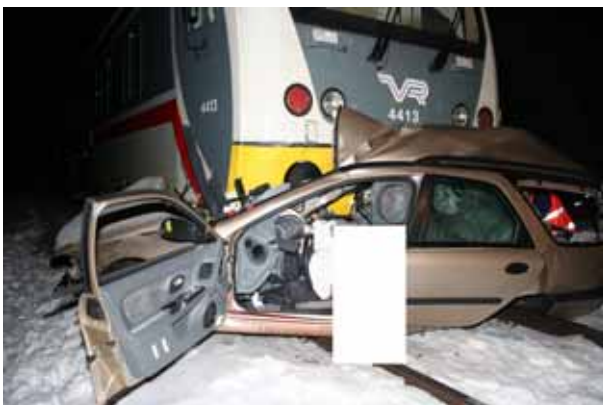
**B2/2007R**

**Fatal level crossing accident in  
Nivala on 5 March 2007**

harmed. The accident wrecked the car beyond repair, while the train suffered only minor damage. The total material costs due to the accident were approximately EUR 70,000.

The immediate cause of the accident was the passenger car driver driving onto the level crossing without stopping. Presumably, the car driver and passenger did not notice the rail bus approaching from the right. This might have been affected by the following:

- The driver was distracted by a phone call the passenger received and was possibly looking for the ringing mobile phone
- The driver's attention was focused on attaching the safety belt
- The approaching short train was in a blind spot formed by the moving vehicle's structures and the passenger
- The driver was not in the habit of stopping every time at the level crossing.

To prevent similar accidents, the Accident Investigation Board of Finland recommends that the level crossing environment be made safe for road traffic and that the unprotected level crossing of Pahaoja be equipped with a half barrier equipment. In addition, the Investigation Commission would repeat its previous recommendations on train and level crossing visibility and placing emergency calls directly from the accident location. Furthermore, the Commission would reiterate its proposals in recommendation S1/05R/S213 for improving information on level crossings, monitoring them more effectively and enhancing the related traffic offence penalties.

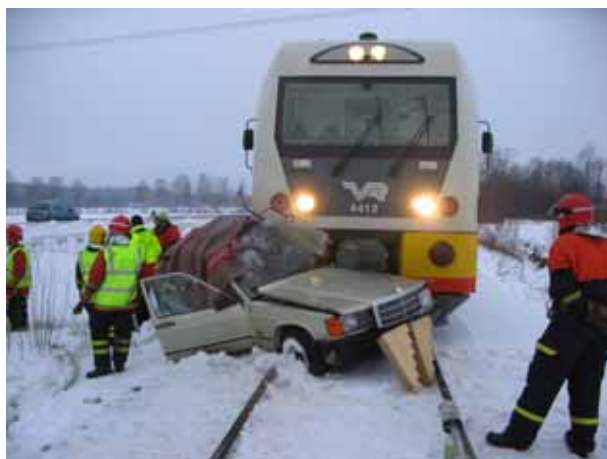
**B3/2007R**

**Fatal level crossing accident in  
Parikkala on 9 March 2007**

A level crossing accident involving a passenger car and a rail bus travelling from Savonlinna to Parikkala took place in Särkisalmi on 9 March 2007 at 4.13 p.m. The driver and passenger of the passenger car were killed but the train personnel and passengers escaped uninjured. The passenger car was completely wrecked and the train sustained minor damage.

The accident was directly due to the failure of the car driver to look carefully enough both ways as the car approached the level crossing. Another factor that may have impacted on the accident lies in the possibility that the car driver became satisfied that the level crossing was empty as the car approached the crossing on Melkonientie, run-

ning parallel with the tracks, which may have resulted in the driver failing to observe the tracks upon arriving at the crossing.

In order to prevent similar accidents, the Accident Investigation Board recommends that the Sinkonen level crossing, located in the Särkisalmi residential area, be removed.

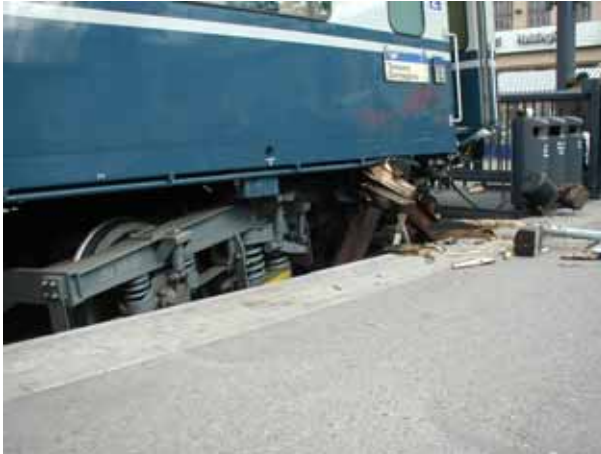
**C2/2005R**

**Collision of passenger train,  
shunted to the departure track, with  
a rail barrier at Helsinki station on  
20 April 2005**

In Helsinki on 20 April 2005 at 16.04, while being shunted to its departure track, passenger train 171 collided with a rail barrier, broke it and, having mounted it, continued for a further six metres towards the end platform. The collision caused no personal injuries. The rail barrier and the collision car were damaged and the departure of the train was cancelled due to the inspection of the cars.

The cause of the accident was that there was some kind of black spot in radio audibility, which prevented the locomotive driver from hearing the instructions given by the conductor on the escort radio, causing the train's situational speed to remain too high and braking to occur too late.

Since similar accidents have previously occurred at Helsinki Central Railway Station, the Accident Investigation Board recommends that the operation of escort radios at Helsinki Central Railway Station be examined to identify any black spots in radio audibility and any external interference. On the basis of these inspection results, an implementation solution should be elaborated to guarantee secure audibility.

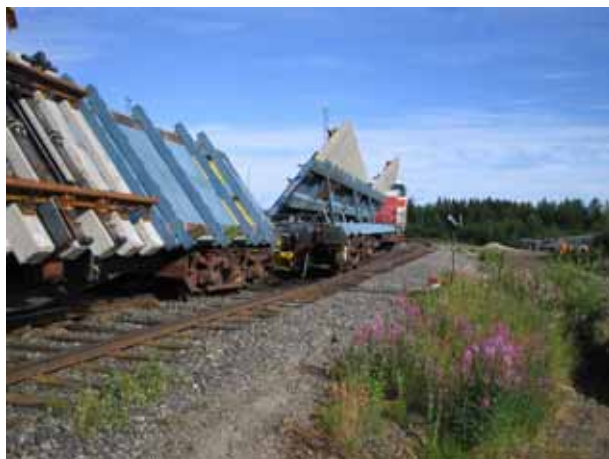
**C5/2005R**

**Derailment of two freight train cars  
on Kontiomäki railway yard on 15  
July 2005**

The incident resulted from the combined effect of the work site track and the long wagons. Between the V049 and V054 turnouts, a temporary site track had been constructed for the time of the ongoing track work. The track featured several consecutive curves. Such curves may cause running problems particularly for long wagons. When the freight train entered the track, its two long turnout-carrying wagons in front derailed. In addition, the rail packing was rather flexible, thus contributing to the occurring of the incident.

The Accident Investigation Board of Finland does not make any recommendations as based on this incident, as the risks involved remained relatively small. Nevertheless the Investigation Report includes some factors that should be paid attention to in the future, e.g. advance planning of construction work and interactive planning, building and exploitation, as well as transport operation restrictions concerning certain cases.

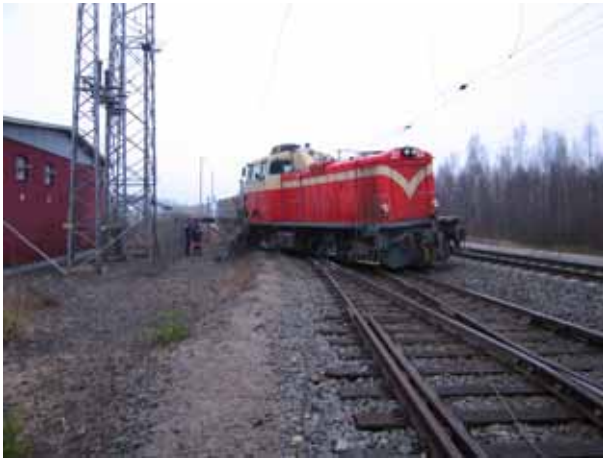
**C7/2005R**

**Locomotive and wagon of freight train derailing at Peräseinäjoki on 31 October 2005**

On Monday October 31, 2005 at 14.35 hrs at Peräseinäjoki in Finland, an incident occurred where the locomotive and one wagon of a freight train with round wood load, derailed. The train was heading toward Seinäjoki. The derailment took place when the train was leaving track 3 and entering turnout V008, where first the locomotive derailed and then the first round wood carrying wagon, that the locomotive had pulled along. The costs generated by the incident amounted to 175 000 Euros. No personal injury was caused by the incident. Both track and track equipment were damaged. In addition overhead line equipment was damaged over a distance of several hundreds of metres. As a result of the incident, the bogies and the axle control equipment of the derailed locomotive had to be replaced. Moreover the flank of the locomotive as well as its buffer and railings suffered damage. The wheelset, buffer, some handles and steps of the derailed wagon had to be replaced.

The incident was not caused by one particular factor, but by the joint effect of several circumstances. The causes of the incident included the poor condition and fastening of the sleepers, thus permitting a yielding of the rails at the turnout. The V008 turnout was worn and hence it failed to meet all of the measurement requirements set thereupon. Furthermore the locomotive displayed very worn wheelsets which again may have contributed to the wheel slipping over to the wrong side of the turnout check rail.

The Accident Investigation Board of Finland does not make any recommendations pertaining to the derailment as the V008 turnout was repaired immediately after the incident and later it was submitted to a mechanical overhaul.

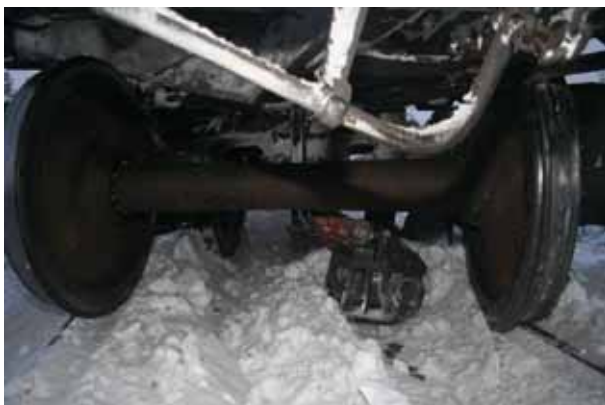
**C8/2005R**

**Detaching of traction device of locomotive and derailling of freight wagon, on section of line between Ypykkävaara and Vartius on 28 December 2005**

On Wednesday December 28, 2005, on the Ypykkävaara– Vartius section of line between Kontiomäki and Vartius in Finland, an incident took place in which the detaching of the traction equipment of a locomotive caused the derailment of the rear bogie of the third wagon of a freight train. The incident generated no personal injury. The derailed wagon damaged some sleepers. The following day the track was repaired. The detached traction device caused some damage to the two locomotives in the train. The fuel tanks of the locomotives were pierced and the fuel contained therein leaked out. The costs generated by the incident amounted to about 108 000 Euros.

The traction device of the locomotive detached as caused by the unfastening of the retention screws of the clamp disc of the traction device wedge. The clamp disc and the wedge fell off and the traction device detached from the locomotive.

In order to prevent corresponding accidents, the Accident Investigation Board of Finland recommends that the Dr16 locomotive maintenance instructions be supplemented by a checking of the fastening of the clamp disc of the traction device wedge.

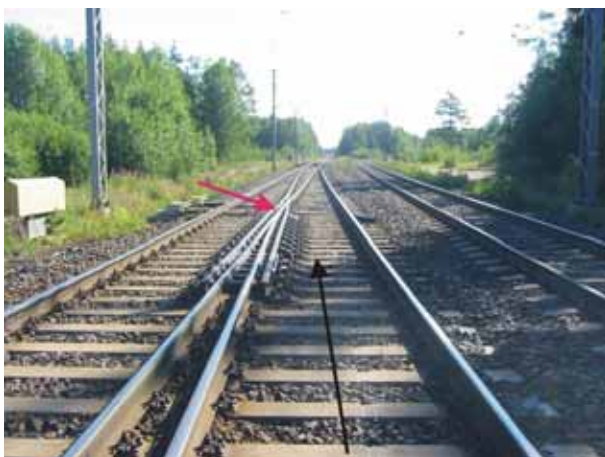
**C1/2006R**

**Derailling of locomotive and two wagons at Luumäki on 20 March 2006**

no personal injury. The derailed wagons damaged two point mechanisms of the operating switch crossing, and stretcher rods, and they caused rail fastening parts to detach.

The chain of events resulting in the derailment started from the heating fuse of the crossing with a movable frog having burnt, thus preventing an adequate heating of the crossing. When operated laterally, the crossing failed to take the detection position and the point failed to take the detection position. The incident was caused by the remote control operator and the engine driver being unable to act in an expedient manner in such an exceptional situation. Neither of them was very familiar with the high-speed turnouts with turning-point frogs at Luumäki. The remote control operator granted the train the permission to pull via a secondary track to the turnout, though the turnout had been operated to take the position toward the straight track. Having forced open the turning point frog turnout, the engine driver set out to push the wagons back.

In order to prevent such incidents in the future, the Accident Investigation Board of Finland reiterates its previously issued recommendation suggesting that the orientation training designed for dispatchers include detailed data on all stations within their respective responsibility so as to enable them to secure the safety of traffic operation.

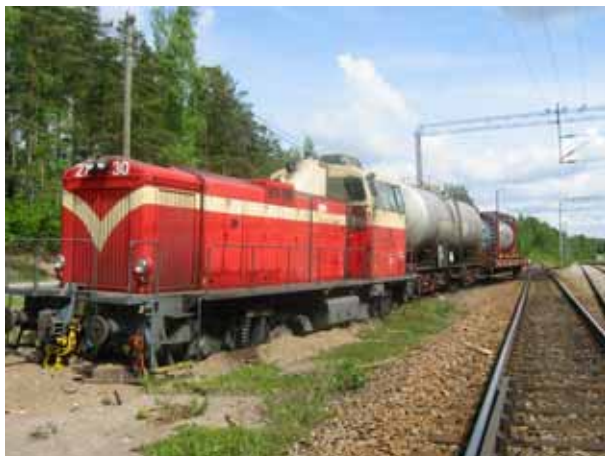
**C2/2006R**

**Freight train running through rail barrier at Karjaa on 1 June 2006**

On Thursday 1 June, 2006 an accident took place at Karjaa, Finland, where a freight train collided with a rail barrier at the end of a trap siding. The locomotive of the train derailed. As a result of the collision, the locomotive and the rail barrier were damaged.

The immediate cause of the incident was the fact that the driver of the 3046 train passed a signal in a stop position, without permission. Inadequate communication between the engine driver and the remote control operator essentially contributed to the generation of the incident. The driver of the 3046 train had advised the remote control operator of a balise failure, and the remote control operator pursued this discussion while giving another train permission to pass the signal in the stop position. The driver of the 3046 train hence firmly believed that the permission was granted to the train run by himself.

The Accident Investigation Board of Finland does not make any new safety recommendations based on this incident, but it underscores the importance of the communication

procedures as adhering to a due form specified in the Railway Signalling Regulations (Junaturvallisuussääntö, Jt).

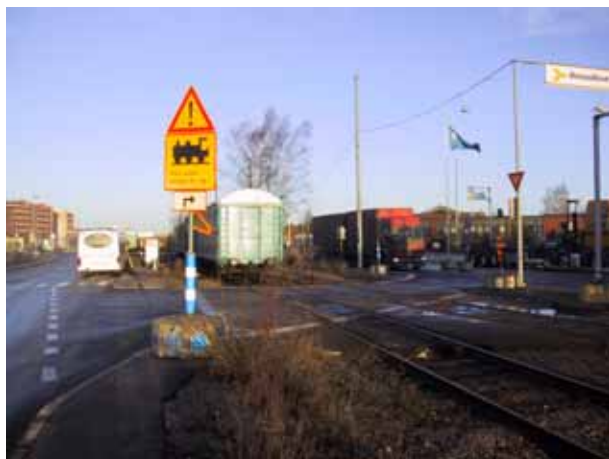
**C4/2006R**

**Collision of a shunting unit and a lorry at the level crossing in Sörnäinen on 15 December 2006**

The accident was the result of the lorry driver not paying enough attention at the level crossing. The fact that the shunting unit was to the right of the lorry driver, who was not familiar with Sörnäinen harbour, may have been a contributing factor to the accident.

The Accident Investigation Board finds no reason to make new recommendations based on this accident. However, the Accident Investigation Board points out that the necessity of having the level crossing in front of the gates to the harbour in Sörnäinen should be evaluated. Consideration should be given to replacing it with one further north.

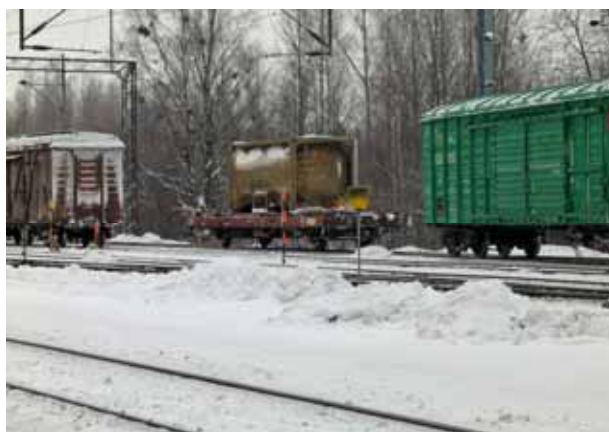
**C1/2007R**

**Accident during shunting work at the Joensuu railway yard on 2 February 2007**

The aim was to shunt a domestic container wagon equipped with a screw switch pulling device using a Russian wagon equipped with an automatic coupling. Apparently, the shunting unit foreman intervened to move the slowly moving Russian wagon's automatic coupling towards the coupling hook of the container wagon. He fell on his stomach onto the tracks, where he was run over by the wheel of the wagon coming from behind. The direct cause of the foreman's fall was not revealed by the investigations, but is likely to have been the result of slipping or being nudged by the shunting wagon.

In order to prevent similar accidents from occurring again, the Accident Investigation Board of Finland recommends that the instructions for safe working in a railway yard be supplemented to forbid employees from placing themselves between moving wagons in all situations, and improving the grip of footwear used in yard work. The Accident Investigation Board further recommends that the Emergency centre use an emergency response that corresponds to the type of accident. In urgent cases, it would be important to have a sufficient number of appropriate units attend the scene of the accident quickly. The Accident Investigation Board also repeats its recommendation issued in its investigation report B1/2005R on making the emergency call directly from the scene of the accident.
