NIB ANNUAL REPORT 2008

Accident Investigation Board

FINLAND

PREFACE TO THE REPORT

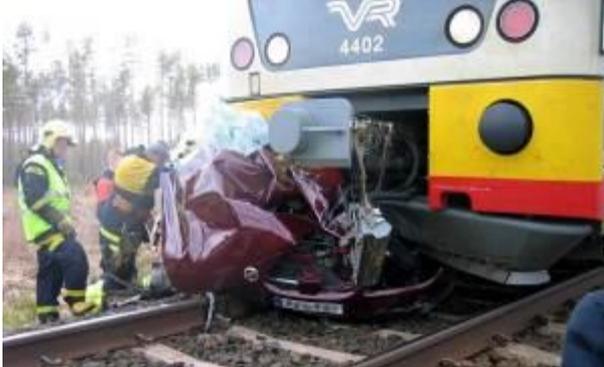
B4/2007R

**Fatal level crossing accident in
Kiuruvesi, Finland, on 6 May 2007**

The accident was caused by the car driver's failure to notice the train. The level crossing at which the accident occurred does not fulfil the determined level crossing regulations in regard to visibility and the crossing angle. Observation was hampered by the characteristics of the level crossing and, possibly, the driver's health. Familiarity with the level crossing probably diminished the driver's attentiveness.

The start of the rescue operation was delayed due to the fact that the emergency alarm call made by traffic control was routed to the wrong emergency response centre with regard to the place of the accident. There were problems with locating the place of the accident, resulting in two of the rescue units driving to the wrong level crossing.

In order to avoid similar accidents and alleviate their effects, the investigation commission recommends that the Pohja level crossing be eliminated, since the nearest overpass is located at a distance of only 300 metres. Moreover, the commission recommends that the Finnish Rail Administration analyse similar level crossings that do not entail a great level of risk but that can be removed at a minor cost. In addition, the commission calls for an improvement in the emergency call capacities of traffic control, and reiterates its previous recommendation regarding emergency alarm calls performed at the accident site.

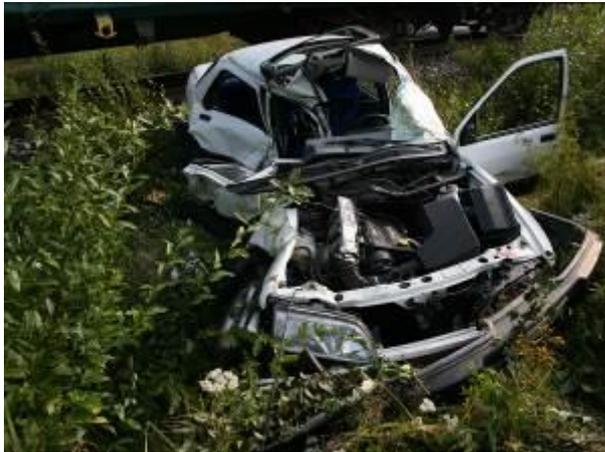
B5/2007R

**Fatal level crossing accident in
Röykkä, Nurmijärvi, Finland on
13 August 2007**

The front of the train engine suffered some damage and the car was entirely wrecked.

The direct cause of the accident was that the passenger car died in the middle of the level crossing without restarting and the train was unable to stop in time despite applying the emergency brake.

The driver of the car possibly made a mistake that led to the engine extinction on the crossing. A technical failure in the car prevented the engine from restarting. The weakening of the passenger's judgement due to intoxication also had an impact on the driver's decision not to leave the car as the train approached. Furthermore, being alarmed by the approaching train affected the decision not to leave the car.

In order to prevent similar accidents, the investigation commission recommends that the Korpi level crossing be equipped with half-barriers.

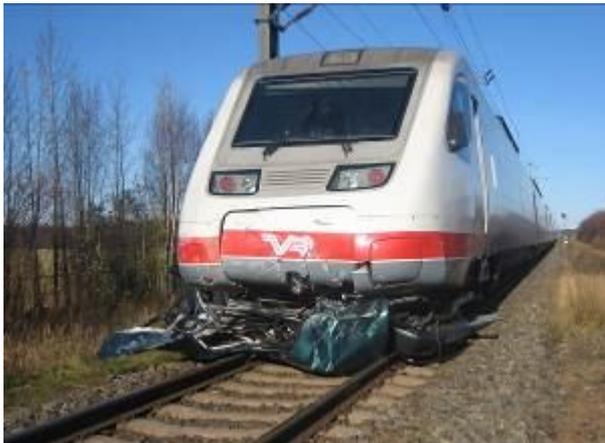
B6/2007R

Fatal level crossing accident in Perälä, Kempele, Finland, on 6 October 2007

The car was entirely wrecked and the train's front structure incurred damage. Traffic along the section of the line came to a halt from 11.40 a.m.–5.00 p.m. Train traffic between Oulu and Liminka was handled by busses while the track was closed. The accident caused damage totalling € 132,000.

The direct cause of the accident was that the car driver drove onto the level crossing without stopping. It is likely that the driver failed to make any observation of the train approaching from the left. This was probably because the driver had taken a wrong turn. Furthermore, the driver's attention was probably focused on driving in an unfamiliar environment, looking out for a place to turn around and pedestrians who were walking their dogs along the road. Sohjanantie was not equipped with appropriate warning signs either before or at the crossing. The vegetation between the road and the track also impaired the visibility of the track and the train running parallel to the road.

In order to prevent similar accidents, the Accident Investigation Board of Finland recommends the removal of the Perälä level crossing or its replacement with an interchange. Furthermore, as a derailment prevention measure, the Board recommends that the lower front structure of the train be re-designed in such a way that cars cannot be wedged underneath. In addition, the Board proposes the following actions before the implementation of the recommendations: Sohjanantie should be equipped with the appropriate warning signs, the level crossing should be equipped with portals, and undue vegetation between the road and the track should be regularly removed. The Board favours proposals for improved accident localisation with equipping locomotive with a GPS equipment and automatic locating of a mobile phone, as submitted in a statement by the Emergency Response Centre of North Ostrobothnia and Kainuu.

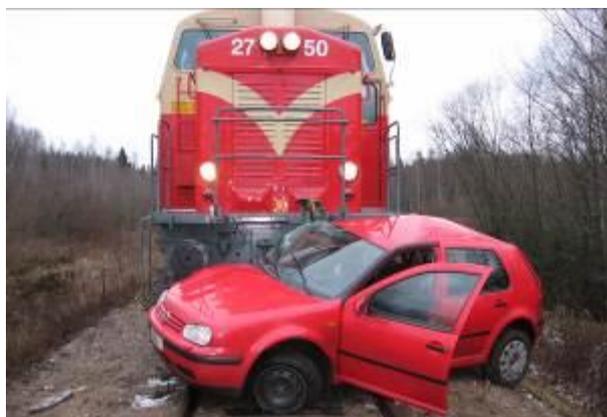
B7/2007R

Fatal level crossing accident in Lahti, Finland on 21 November 2007

Rescue operations were somewhat delayed because traffic control called the wrong emergency response centre, and not the emergency response centre that was responsible for the accident site. Further delays were caused by difficulties in locating the accident site.

To prevent similar accidents in the future, the investigation commission recommends that renovation investments planned for the track be speeded up with respect to level crossing security. Several level crossings along the Lahti–Heinola track do not have sufficient visibility, and therefore the investigation commission recommends that the track speed limit be lowered at level crossings to a level that ensures the appropriate safety level.

In order to limit the negative consequences of similar accidents, the investigation commission restates earlier recommendations concerning the ability to make a telephone call directly from the accident site, and improving the compatibility of information used by emergency response centres and traffic control to locate the accident site.

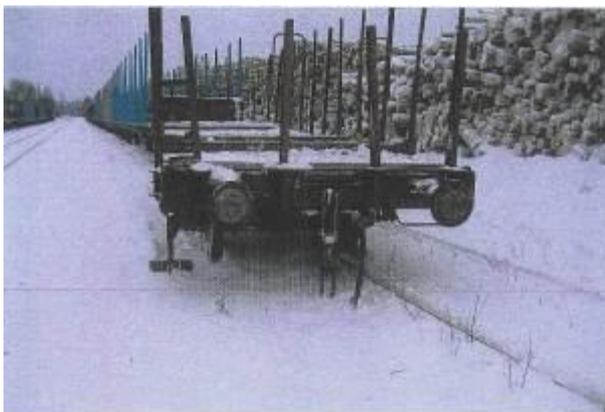
C9/2005R

Freight car derailling and member of train crew injured at Tupovaara on 31 December 2005

The accident occurred because the derailer had not been removed and the shunting foreman did not notice this in time. The non-removal of the derailer, in turn, was possible because the key could be removed from the derailer's safety lock even though the derailer had not been removed from the rail.

To prevent the occurrence of similar accidents, the Accident Investigation Board recommends that the safety lock's operation be altered in such a way that the safety key cannot be removed before the derailer has been removed from the rail. In addition, the Board recommends that greater attention be paid to safety measures for shunting workers during the ploughing of snow in rail yards.

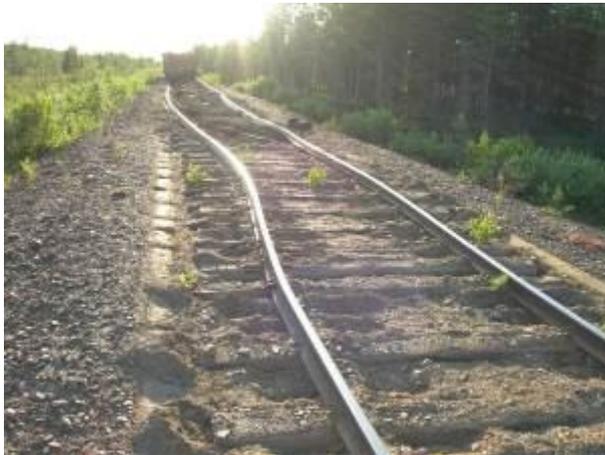
C3/2006R

**Derailment of five freight wagons
between Tupovaara and
Heinävaara, Finland, on 13 July
2006**

On Thursday, 13 July 2006, at 4:41 pm, a freight train en route from Tuupovaara to Joensuu was derailed about 10 km from Tuupovaara in the direction of Joensuu. The train was carrying timber. There were no casualties. A 100-metre stretch of track was damaged, and five wagons were partially damaged and later scrapped.

The accident was caused by the formation of a heat curve on the track. The rail buckled because it had a weak structure made of light rails, wooden railway sleepers and gravel ballast. The heat curve was released below the train and derailed the last five wagons of the train. Repair work at the scene also had a negative impact on track stability.

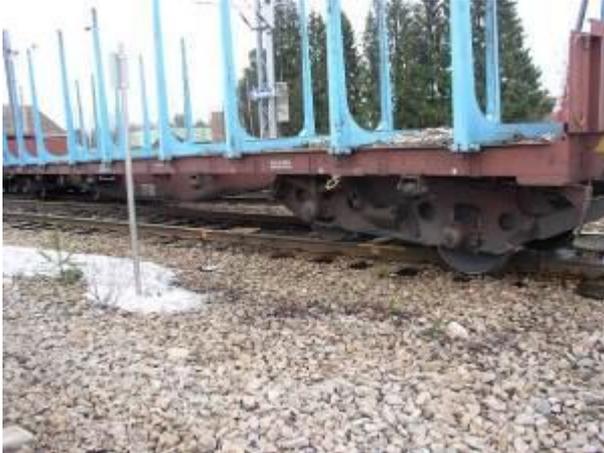
C2/2007R

**Derailment of a wagon in Ylivieska
on 21 March 2007**

The top leaf of the spring pack of the derailed wagon had broken and fallen before the derailment. In addition, a wheel bearing was broken, a wheel flat occurred, and brake triangle support screws had fallen. The wagon wheels were damaged while running on ballast, and the bogie and under frame were damaged as the bogie collided with the under frame. Also damaged were the coupling and buffer equipment of the derailed wagon and the wagons connected to it. The derailed wagon broke the electric-motor switch drive of two turnouts. Rail traffic northbound from Ylivieska was blocked for three and a half hours, and eastbound traffic for 24 hours. The total cost of the accident was 24,000 euros.

The derailment occurred because the unloaded front wheel of the front-most wheelset did not steer at the turnout, because of the missing spring pack, and therefore the bogie did not turn but tried to continue straight ahead. The spring pack had fallen because the uppermost leaf holding the pack together had broken. This was probably caused by the wheel flat and leaf fatigue. On account of its structure, a spring pack can come apart after the main leaf breaks, and the vibration caused by a wheel flat contributes to this.

The Accident Investigation Board of Finland recommends that, to prevent the occurrence of similar accidents, greater care be exercised in statutory freight train inspections, and that any flaws observed be acted upon more quickly than is currently the case. It should be ensured that the inspectors are qualified to identify damage such as that described above.

Greater care should be exercised during statutory freight train inspections, and any flaws observed should be acted upon more quickly than is currently the case. [C2/07R/S238]

In order to ensure successful inspection, it should be ensured that the inspectors are qualified to identify damage such as that described above.

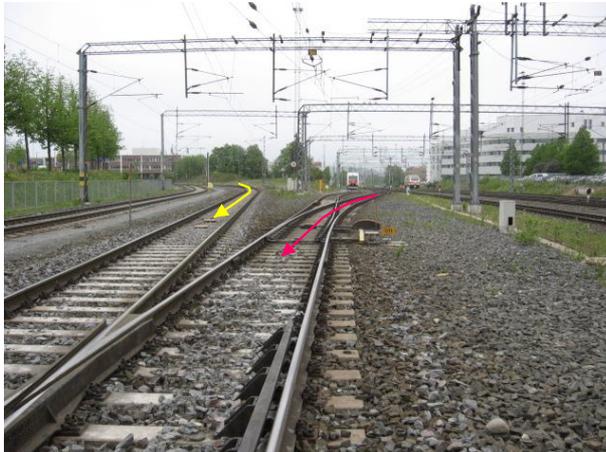
C3/2007R

**Hazardous situation in train traffic
in Tampere on 27 May 2007**

The cause of the incident was that the shunting foreman did not notice that the shunting signal was in the stop position. Locomotives engines standing on the adjacent track and their tail lights had 'blurred' the shunting foreman's vision as the shunting unit approached the point.

The Accident Investigation Board is not issuing new safety recommendations as a result of the incident but stresses that training and guidelines should emphasise the importance of providing relevant additional information during shunting work.

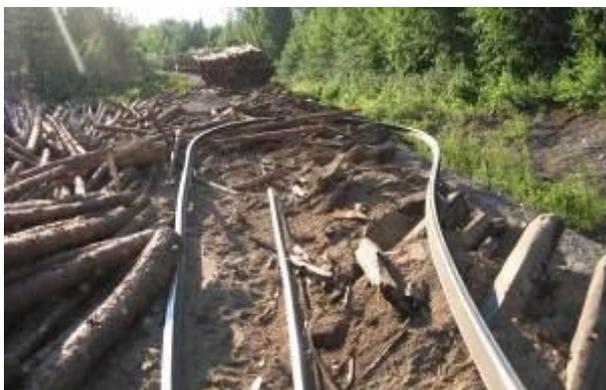
C4/2007R

**Derailment of eight freight train
wagons between Saarijärvi and
Äänekoski, Finland, on 3 July 2007**

Eight wagons of a freight train carrying wood were derailed on 3 July 2007 at 4.01 p.m. Four of the wagons incurred heavy damage, and four minor damage. About 170 metres of track were damaged.

The accident was caused by the poor condition of the track and the train's excess speed, considering the condition of the track. The first of the freight wagons (the 16th wagon), carrying pinewood, was derailed. Researches show that pinewood is heavier than spruce. As the wagon approached what was possibly the weakest point of the track, the outer rail of the track, which was on a curve, was dislocated. The distance between the rails grew to such an extent that the wagon's wheels fell between the rails. Track support work had been completed at the point of the derailing. This track work, and the small repositioning and sideways movement of the rails that this involved, reduced the stability of the track.

To prevent the occurrence of similar accidents, the Accident Investigation Board recommends that segments of the track that are in poor condition be investigated, and that a speed limit of 20 km/h be set for segments that are in poor condition for trains with an axis weight of 16–20 tons, until the necessary repairs have been completed. In addition, the Accident Investigation Board repeats recommendation S181, which it issued after the occurrence of a similar accident in Huutokoski on 31 May 2002: The track should immediately be repaired and the defective old sleepers be replaced by new ones. Replacement of spike fastening by screw fastening, replacement of the rails by heavier ones, and replacement of the gravel in the railway bed by ballast should be discussed and considered.

Track curves that are in poor condition should be identified and these curves should have a speed limit of 20 km/h for trains with an axis weight of 16–20 tons, until the necessary repairs have been completed. [C4/07R/S242]

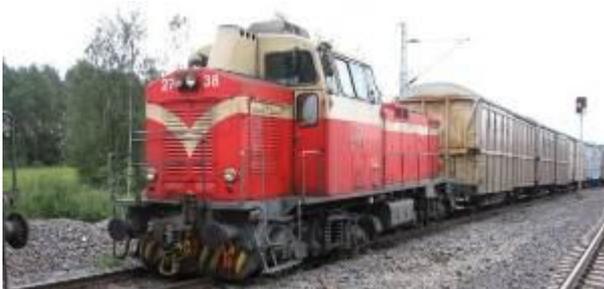
C5/2007R

Derailment of a freight train locomotive in Talviainen, Finland, on 15 July 2007

On Sunday 15 July 2007 at 6.11 p.m., one of the two locomotives of a freight train was derailed after passing a curved turnout in Talviainen station. The derailed locomotive incurred some damage.

Contributing to this was the fact that rail construction in the depot had involved deficiencies in planning and implementation. At no point during the construction project had the special features of the rail's unusual geometry been taken into account. The geometry had been called into question during planning, but the matter had not been addressed when new plans were formulated. During planning, no observations had been made that there was insufficient space to even out the cant in the turnout.

In order to prevent similar occurrences in the future, the Accident Investigation Board recommends that planning guidelines be formulated for curved turnouts and that demanding construction projects include the measurement of rail geometries with loads before commissioning, in order to ensure that limit values are met.

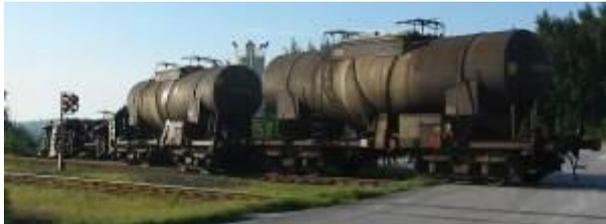
C6/2007R

Tank wagon loaded with nitric acid tipped over in Siilinjärvi, Finland, on 4 August 2007

The reason for the accident was that the derailer was not removed before shunting of the wagons and that the derailer that had been left on was not noticed in time. The shunting foreman gave order to shunt without securing the route first.

To avoid similar accidents, the Accident Investigation Board of Finland recommends that the right operation of derailleurs should always be secured so that false operation and leaving the derailer on rail could not be possible. On railway yards, where dangerous goods are handled, should always have dependence between the derailer and the turnout that leads to the rail.

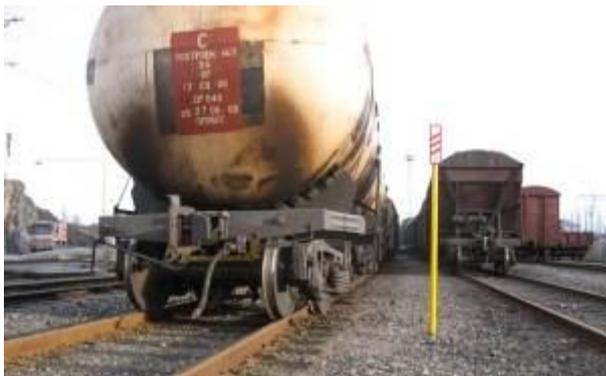
C1/2008R

Derailment of five shunting unit wagons in the Heikkilä railway yard in Turku, Finland, on 8 February 2008

On 8 February 2008 at 9.53 a.m., three Russian tank wagons and two Russian covered wagons were derailed during shunting in the Heikkilä railway yard in Turku. The track was damaged for about 70 metres.

The direct cause of the occurrence was that the track, which was in poor condition and fastened by rail spikes, gave way under the heavy tank wagons. In addition, the dry, non-greased bogie pivots of the wagons placed additional pressure on the track curve.

In order to prevent similar occurrences, the Accident Investigation Board of Finland recommends that a 20 km/h speed limit be set for wagons transporting dangerous goods on spike-fastened secondary tracks. In addition, track and railway yard condition monitoring and rail fastening work should place special emphasis on routes and tracks used for the transport of dangerous goods.

Track and railway yard condition monitoring and rail fastening work should place special emphasis on routes and tracks used for the transport of dangerous goods. [C1/08R/S246]

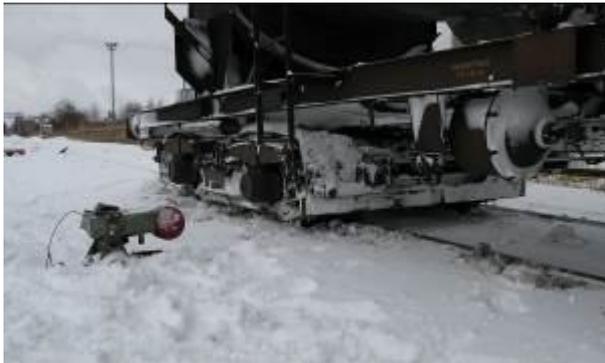
C2/2008R

Derailed wagon carrying phosphoric acid in Ykspihlaja, Kokkola, Finland, on 1 March 2008

The incident occurred because the shunting unit did not stop in sufficient time before the derailer. This was due to an error of judgement made by the shunting foreman and a lack of communication between the shunting foreman and engine driver. Furthermore, snow and ice had accumulated on the brakes of the wagons, thereby weakening the power of the breaks.

In order to prevent the occurrence of similar incidents, the Accident Investigation Board of Finland recommends that engine drivers be clearly informed of any blocks (e.g. derailleurs) along the track during shunting operations. In addition, the Board emphasises that unnecessary risks should be avoided when approaching derailleurs or other blocks.

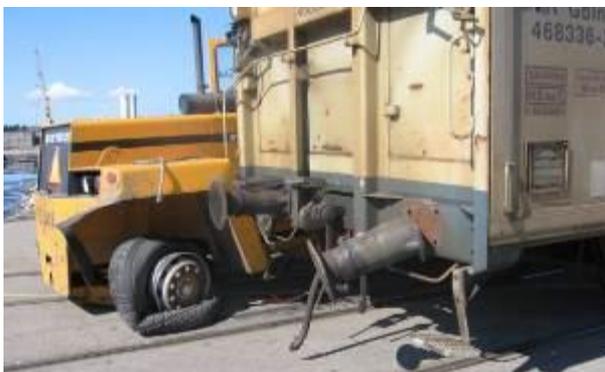
C3/2008R

Collision of a shunting unit and a forklift truck on the Syväsatama port track in Joensuu, Finland, on 30 April 2008

jured. One of the freight wagons incurred minor damage and the forklift truck was badly damaged.

The accident occurred because the forklift driver did not observe the approaching shunting unit before turning or when turning to cross the track. The driver noticed the shunting unit only upon the collision. In order to fulfil his lookout duty, the shunting foreman was standing on the buffer step on the right side of the first wagon in the direction of travel, which contributed to the injury. He was unable to stand on the corner step because of a high loading platform on the right side of the track.

In order to prevent the occurrence of similar accidents, the Accident Investigation Board of Finland recommends that storage containers should be placed further away from the track so that they do not impede visibility. No other recommendations have been issued because actions have been taken to improve port safety with the installation of warning lights indicating that a shunting unit is moving along the tracks. In addition, the loading platform next to the track should be dismantled if it is no longer in use.

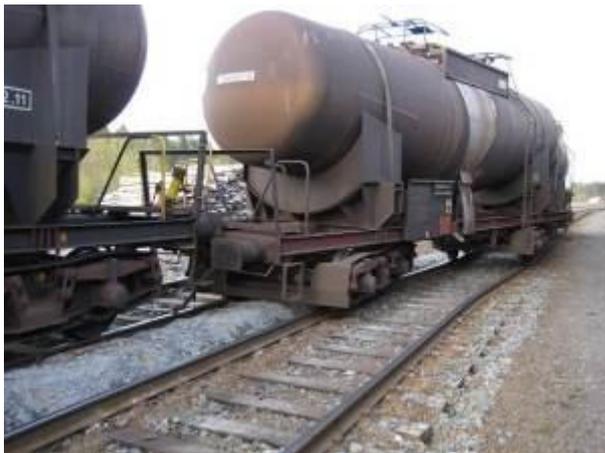
C4/2008R

Derailment of a tank wagon during shunting work in Ykspihlaja, Kokkola, Finland, on 15 May 2008

On Thursday 15 May 2008 at 5.28 p.m., one tank wagon carrying a sulphuric acid consignment was derailed in Ykspihlaja in Kokkola. After the shunting unit started pulling the wagons, the last bogie of the second last wagon carrying sulphuric acid moved onto the wrong track. Three wagons incurred damage as a result of the derailment. The track and the turnout were also damaged in the derailment area. The derailment did not cause disorder to the other train traffic.

The cause of the incident was forcing open the turnout when shunting wagons. The opened forced turnout switched to its initial position while pulling underneath the wagon and the wagon's other bogie were directed onto the other track. The wagon derailed as a result of directed to two tracks. When shunting the wagons, the lookout was not conducted in sufficient way.

The Accident Investigation Board of Finland is not issuing new recommendations as a result of the incident, but reminds operators that a lookout should be placed on the steps of the last wagon when several wagons are being shunted, if the wagon allows for this. If
