# **NIB ANNUAL REPORT 2013**

Safety Investigation Authority

This is the annual report of railway sector of the Safety Investigation Authority, Finland for calendar year 2013.

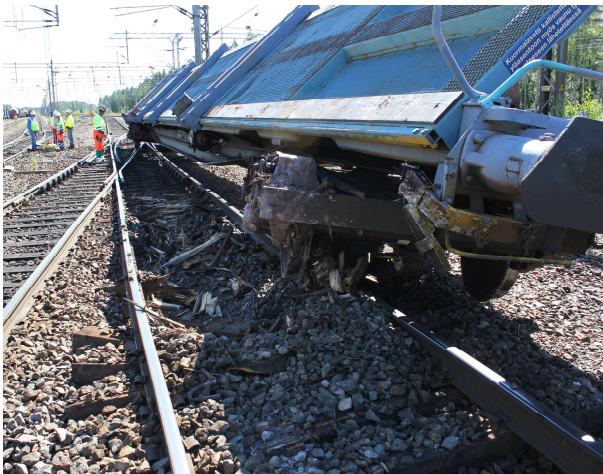
R2012-02

**Derailement of turnout transport wagons in the Riihimäki railway yard on 22 May 2012 and Kouvola railway yard on 28 June 2012**

Imbalanced loading caused the sideways load balance distribution of the turnout transport wagon to be very uneven. The wheel-weight ratio was 1:1.96, meaning that wheels on one side were carrying almost double the load compared to wheels on the other side. This caused the frame of the wagon to lean heavily on the side bearer blocks placed on top of the bogies. Due to the remarkable imbalance, significant friction was generated between the frame and side bearer block. This friction made it difficult for the bogies to turn when travelling on curves and through turnouts.

The wagon's bogie pivot centres were also rather dry and somewhat rusty. This required the use of more force for turning the bogie.

In the Riihimäki accident, the head of the rail was cracked at the spot where the derailment occurred. In Kouvola, the turnout at the derailment spot was in poor condition, featuring wear exceeding the allowed measurement values. Moreover, the track featured dents of varying depth around the turnout. These flaws and wear contributed to the wheel flange rising on top of the rails. Similar turnout transports with imbalanced loads have been previously carried out without any problems. This fact supports the notion that wear and flaws in the track played a key role in the accidents.

- The risk assessment element of the safety management system should also extend assessment to existing standardised activities.
- In the turnout condition monitoring system, turnouts that have been found to be in poor condition should be repaired or replaced to ensure that they fulfil the measurement values and other requirements set for turnouts.

- Unambiguous operational instructions regarding maintenance and traffic limitations should exist for cases in which the measurement values and acute limits determined for turnouts are exceeded.

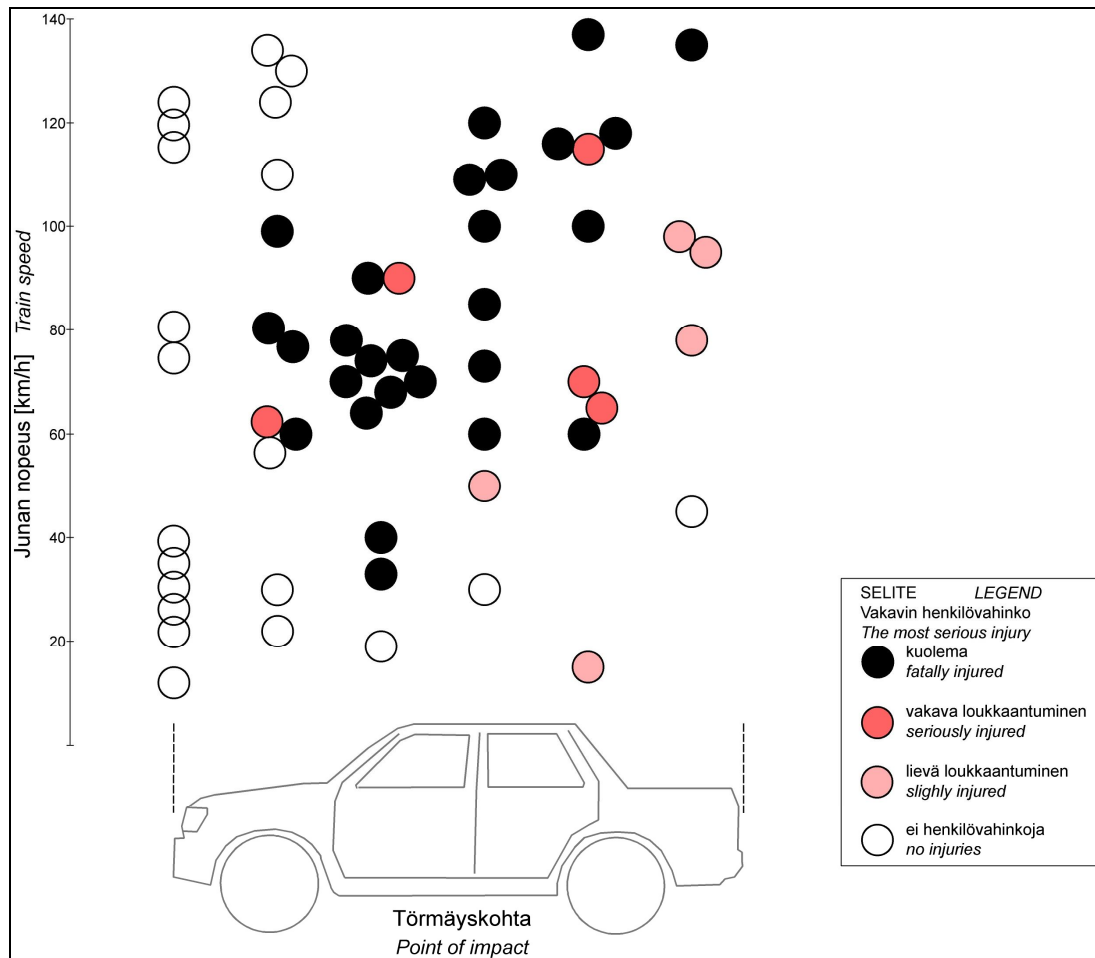
*Seriousness of personal injury in level crossing accidents, categorised by point of impact and train speed. (Leading to deaths 2007–2012, others 2012.)*
