# **NIB ANNUAL REPORT 2014**

Safety Investigation Authority

This is the annual report of railway sector of the Safety Investigation Authority, Finland for calendar year 2014.

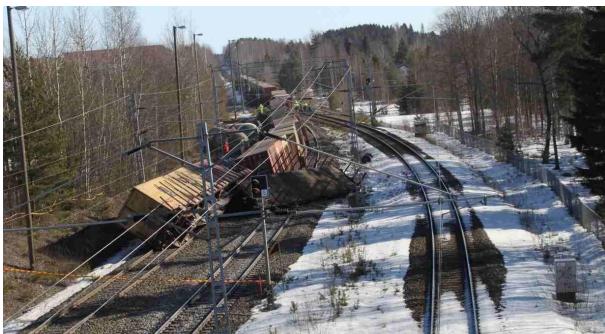
R2013-01

**Derailment of 13 wagons of a freight train at Vammala station on 6 April 2013**

There were no personal injuries. A total of 13 wagons derailed during the accident. Two Russian tank wagons were damaged beyond repair after they had derailed and tipped over. The intermediate wagon following the tank wagons, and a wagon loaded with empty containers that came after the intermediate wagon, were badly damaged. The damage caused to the other nine derailed wagons was not as extensive. Tracks were damaged at a distance of 177 metres and the concrete sleepers of one track were damaged at a distance of 249 metres. A small amount of crude tall oil leaked onto the ground from one of the tank wagons that tipped in the accident. The total costs caused by the accident were €940,000.

The derailment was caused by the switch turning underneath the train. The train caused the open switch blade to move, resulting in the opening of the switch lock, which allowed the switch to turn. When an open switch blade is subjected to vibration or sufficiently powerful impacts, a switch lock that allows trailing may become unlocked. As a result, the closed switch blade opened and the wagon wheels fell between the switch blade and the stock rail.

Vibration affecting the open switch blade was caused by several factors. The Railex locking device had been adjusted eccentrically, in deviation from the specifications in such a manner that the gap between the open switch blade and the stock rail was 10 mm too small. This allows the inner surface of the flange of a train wheel to impact against the open switch blade. This is more likely in the case of Russian rolling stock, in which the distance between the inner surfaces of the wheel flanges is 5 mm less than in Finnish rolling stock.

In order to avoid similar accidents in the future, the Safety Investigation Authority, Finland recommends that the Finnish Transport Safety Agency (Traf) ensure the implementation of the following new recommendations:

- The installation, inspections and maintenance of switches and their components should be seamlessly documented. [B5/09R/S293]

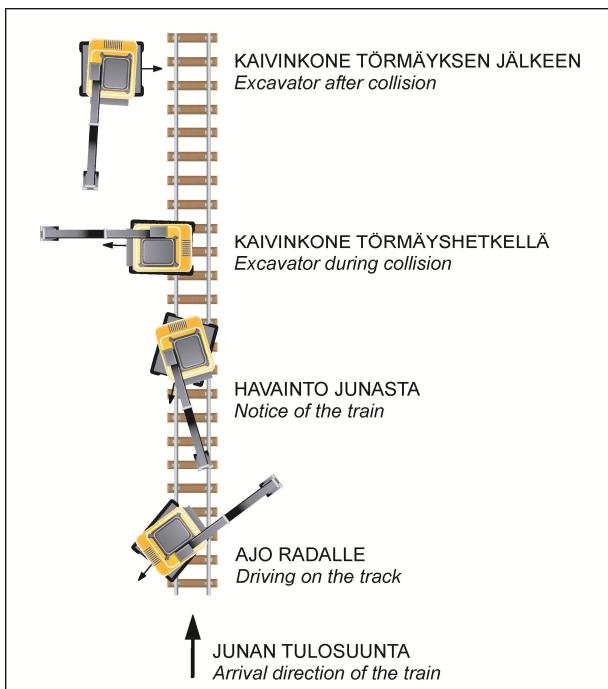
R2013-03

**Collision of a freight train with an excavator on the Pännäinen–Kolppi section on 7 November 2013 and other occurrences and incidents in 2013**

The excavator driver sustained minor injuries in the collision. The freight train had two Dv12 locomotives. The collision caused a hole into the fuel tank of the first engine, and fuel leaked onto the track. The left steps of both engines were either bent or broken. The excavator was damaged beyond repair. The track and track equipment did not suffer damage. Traffic at the accident site

The immediate cause of the accident was attributed to incorrect or unclear communication regarding the trackwork permission given during a conversation between the trackwork supervisor and the excavator driver. The confusion was caused by the permission given by the traffic controller and and wording "behind the train", and the trackwork supervisor's location at Pännäinen Station without visual contact with the excavator. Works permission practices had developed between the traffic controllers and trackwork supervisors that expedited trackwork but contributed to hazards. Short-circuit conductors were not used for securing the construction site. The root cause of the accident was a prolonged exceptional situation at Pännäinen Station, which was attributed to the trackwork contract and its delay. The traffic controller and the trackwork supervisor were overloaded with work. The delay in the contract was caused by several factors, such as employee incompetence and problems in communication, management and monitoring.

In order to avoid similar accidents in the future, and to improve trackwork safety, the Safety Investigation Authority, Finland recommends that the Finnish Transport Safety Agency (Trafi) ensures the implementation of the following new recommendations:
