# ANNUAL REPORT

of the Rail  
Accident and Incident  
Investigation Unit

## 2020

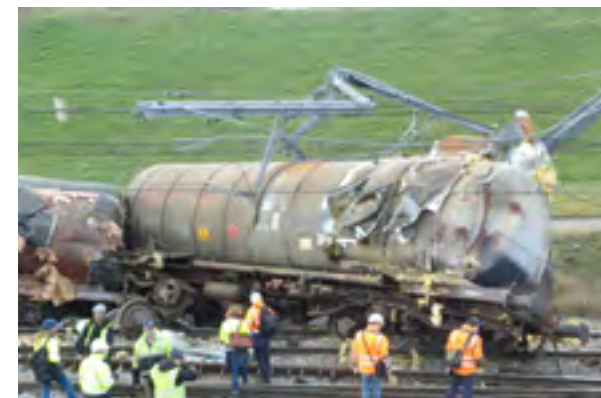
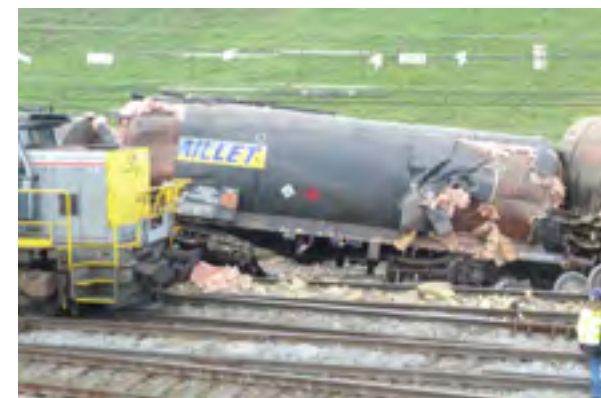
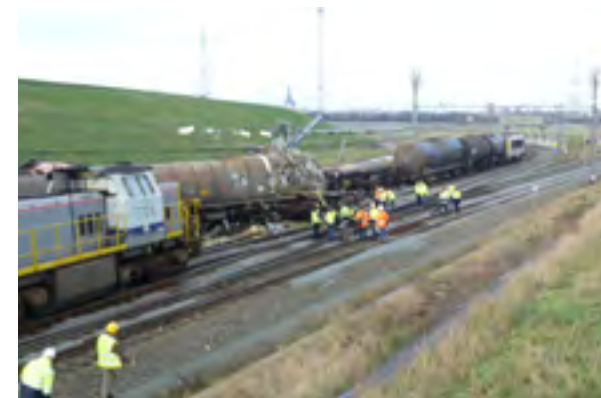
Upon impact, six wagons of the E49826 train derail. Wagon number four separates and overturns completely. The residue inside the wagon leaks out. There is no immediate fire risk. Wagons number five and six partially overturn, derail towards the verge and

start jack-knifing. Upon impact, the LZ70080 train's diesel tank also starts to leak. The first engine's driver's cab is severely damaged.

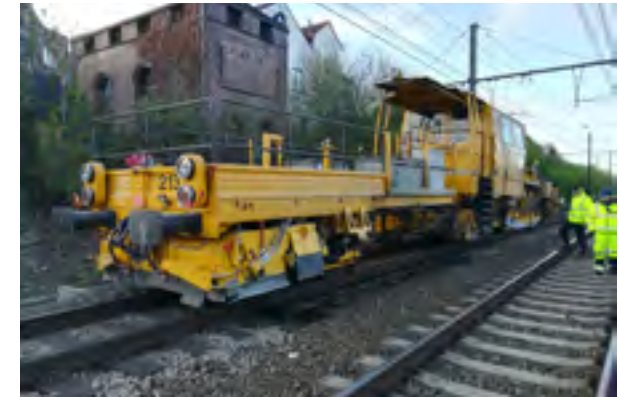
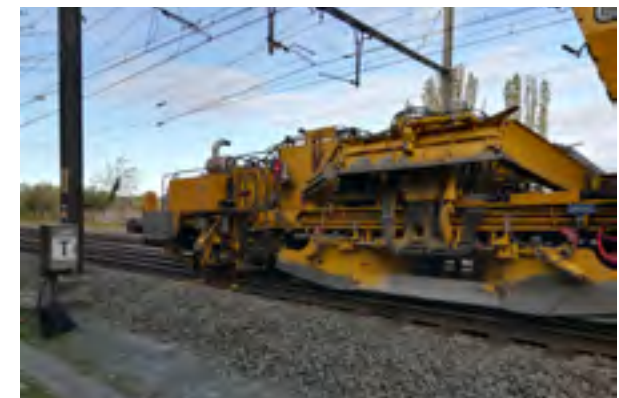
The derailment caused damages to the infrastructure and the ballast regulator, as well as a stoppage of rail traffic for more than six hours.

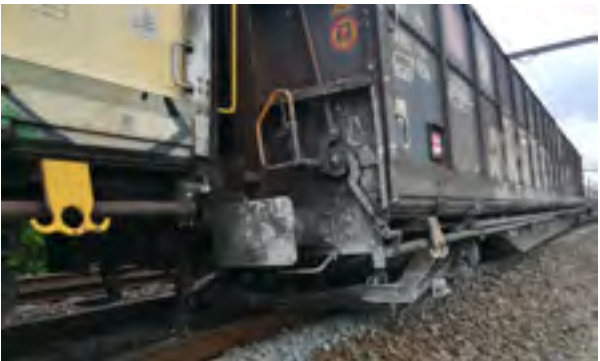
The derailment of wagon 31 80 2772 112-1 resulted from the breakage of the first axle of the leading bogie (in the direction of traffic).

As a result of the breakage, the first bogie of the wagon derailed. The train continued its route: the first signs and damage to the infrastructure caused by the derailed wagon were found at kilometre marker 26.667 and the train stopped at kilometre marker 30.100.

- the axle breakage does not seem to be caused by a track component: the first signs of damage to the infrastructure were found in open track, in a straight track section without points and crossings;

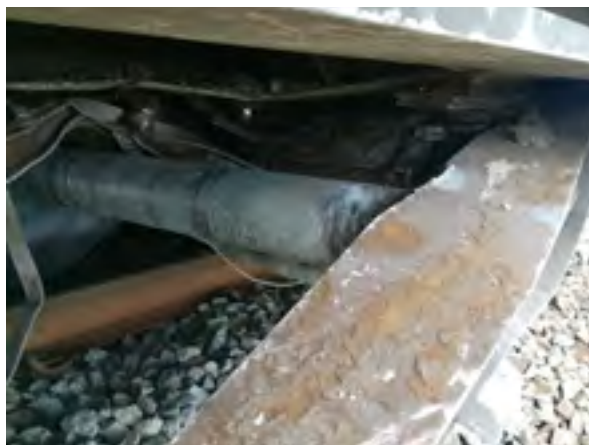
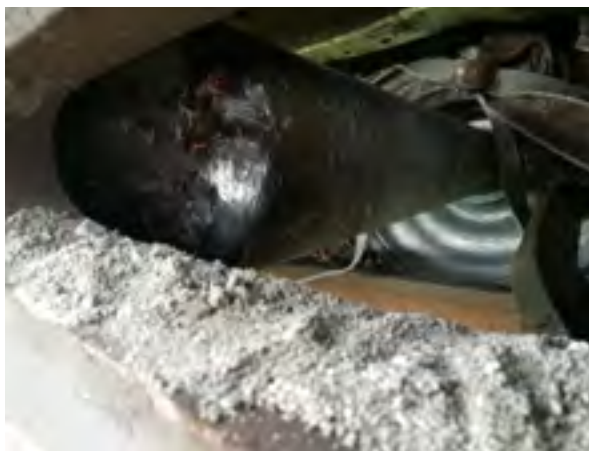
- driving actions do not seem to have resulted in the axle breakage: locomotive records indicate that traction was active and that no braking action was performed;
- the load mass carried on the day of the accident does not seem to have caused the axle breakage: the load mass of the wagon exceeds the mass indicated on the consignment note by 1564 kg, but does not exceed the maximum allowable mass for the wagon load.
- the blow found very close to the initiation point appears to be a consequence of the accident.

The axle failure is a fatigue failure, which is believed to be caused by the corrosion of the area identified as the failure initiation area, which is also subjected to high mechanical stress.

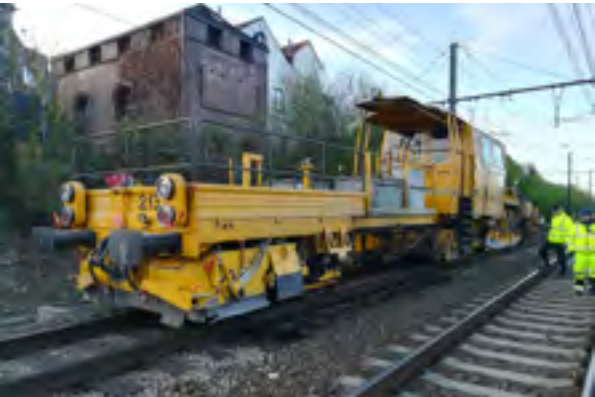
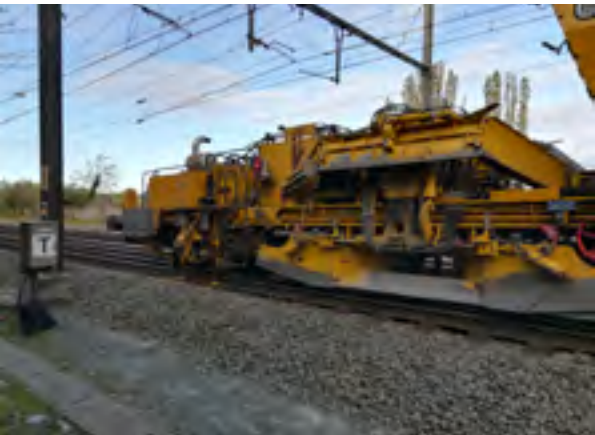
The direct cause of the derailment of the ballast regulator at switch 02C was the movement of the switch point of switch 02C while being traversed by the ballast regulator, as a result of the switch not being locked after a manual operation on a track taken out of service for work.

A screwdriver, which is less burdensome than the emergency crank, is regularly used by track officers and is available on site. But the use of this tool does not comply with the procedure established by the manager.
