MINISTRY FOR  
INNOVATION AND TECHNOLOGY  
TRANSPORTATION SAFETY BUREAU

# **ANNUAL REPORT 2019**

## **Transportation Safety Bureau**

### **Hungary**

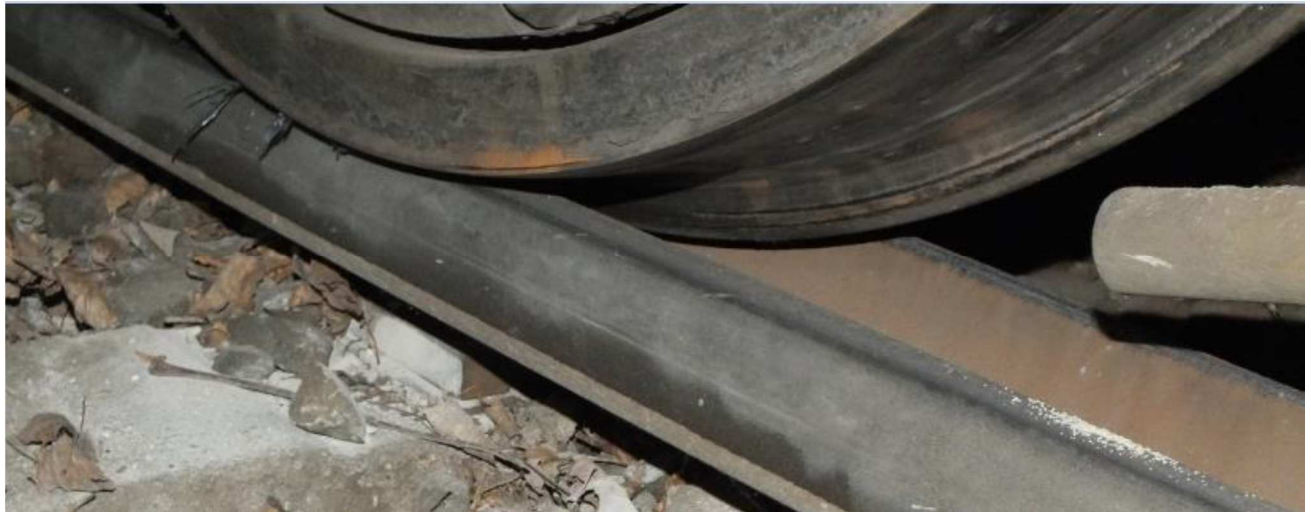
Based on investigation of the scene of the accident, the IC found that the accident was caused by technical characteristics relating to the rail track (inadequate transverse strength). Due to cracks in their cross sections, the outdated rail fittings were not able to provide sufficient counterforce to the transverse forces evoked by the arriving train, and thus, breaking out of the fittings, the rails of the track tipped on their sides.

**Figure: A wheel of the derailed vehicle on the rail which had tipped to its side**

According to the IC, the cause of the accident was the worn-out state of the track, especially the outdated rail fittings. The mechanical strength of the transversely cracked rail spikes provided no sufficient downforce to the rails which then tipped to their sides under the weight of the arriving train and caused derailment of the rolling stock.

The inspection and measuring procedures applied during track supervision could not provide data relating to the process of impairment of the rail fittings therefore the wears and cracks of the rail spikes could remain unrevealed for some time.

**Transportation Safety Bureau recommends Railway Authority Division, Ministry for Innovation and Technology to consider reviewing in the safety management system of MÁV Zrt. why the shortcomings revealed by track supervision are not followed by action, and taking action as necessary.**

**Transportation Safety Bureau recommends Railway Authority Division, Ministry for Innovation and Technology to consider reviewing the procedures applied in the track supervision system of MÁV Zrt. to see to what extent such procedures ensure detection of hidden corrosion and thinning of rail spikes, and taking action as necessary for modification of such track supervision procedures.**

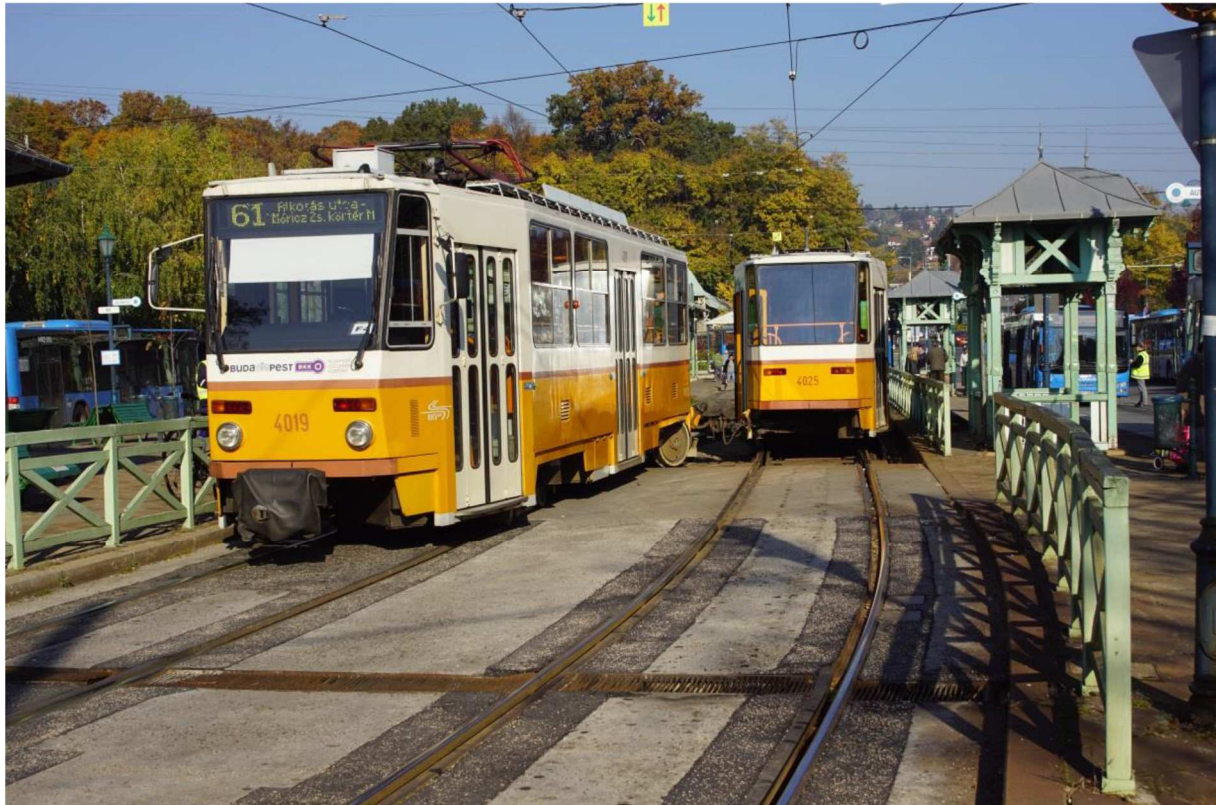
During the investigation at the scene, the IC found that the cause of derailment was the loose state of the straight switch tongue caused by breaking of the pull rod.

**Figure: The derailed tram**

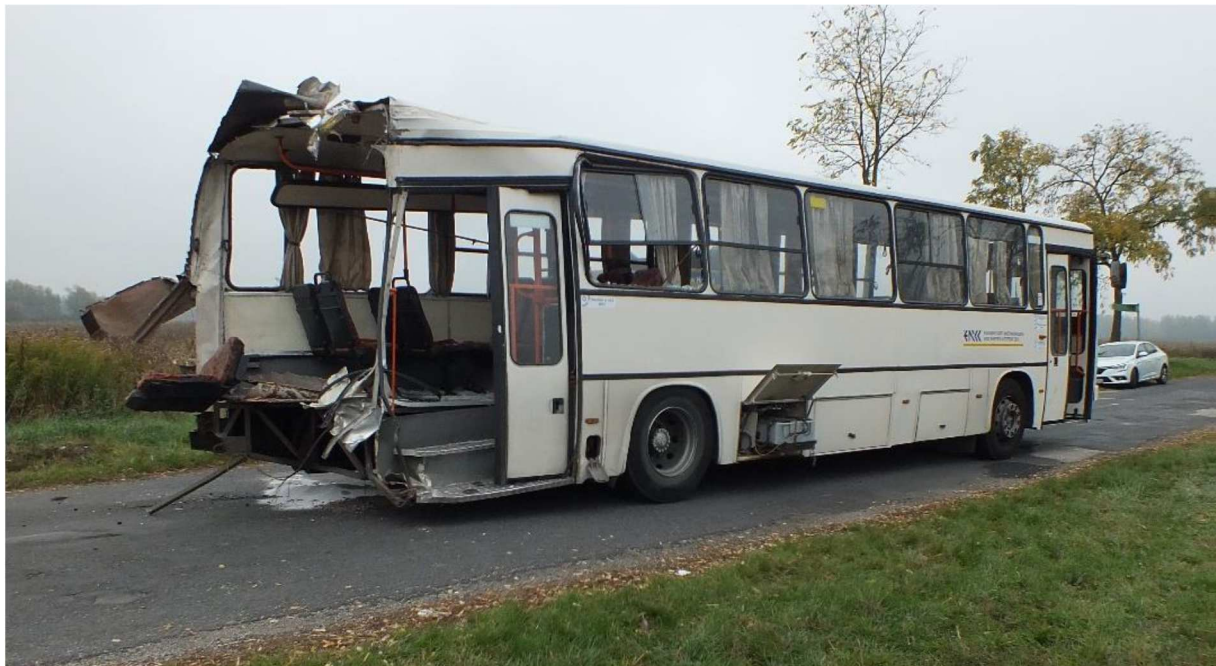
When the train moved over the point of action of the barrier installations it was not detected by the track circuits, and the red signal was displayed on the warning lights when the train reached the terminal release point and caused break-down state, and the “extended red” function of the installation switched the warning lights to flashing red.

**Figure: Damages to the bus**

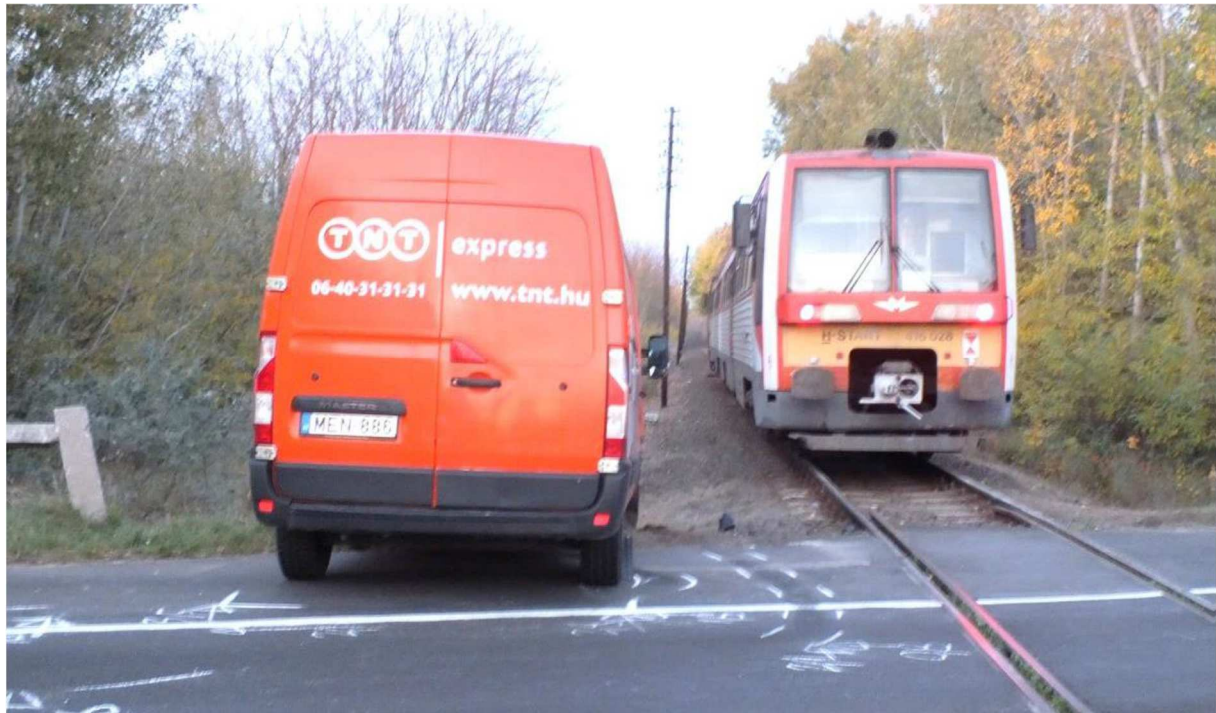
According to the IC, the cause of the accident was the dark state of the road barrier and a human factor on the part of the driver of the automobile.

**Figure: Positions of the vehicles following the collision**

The IC proposes a safety recommendation relating to the occurrence so that the locomotive driver approaching a level crossing in break-down state can be notified of a situation which is potentially dangerous for the train and can control the speed of his train accordingly.

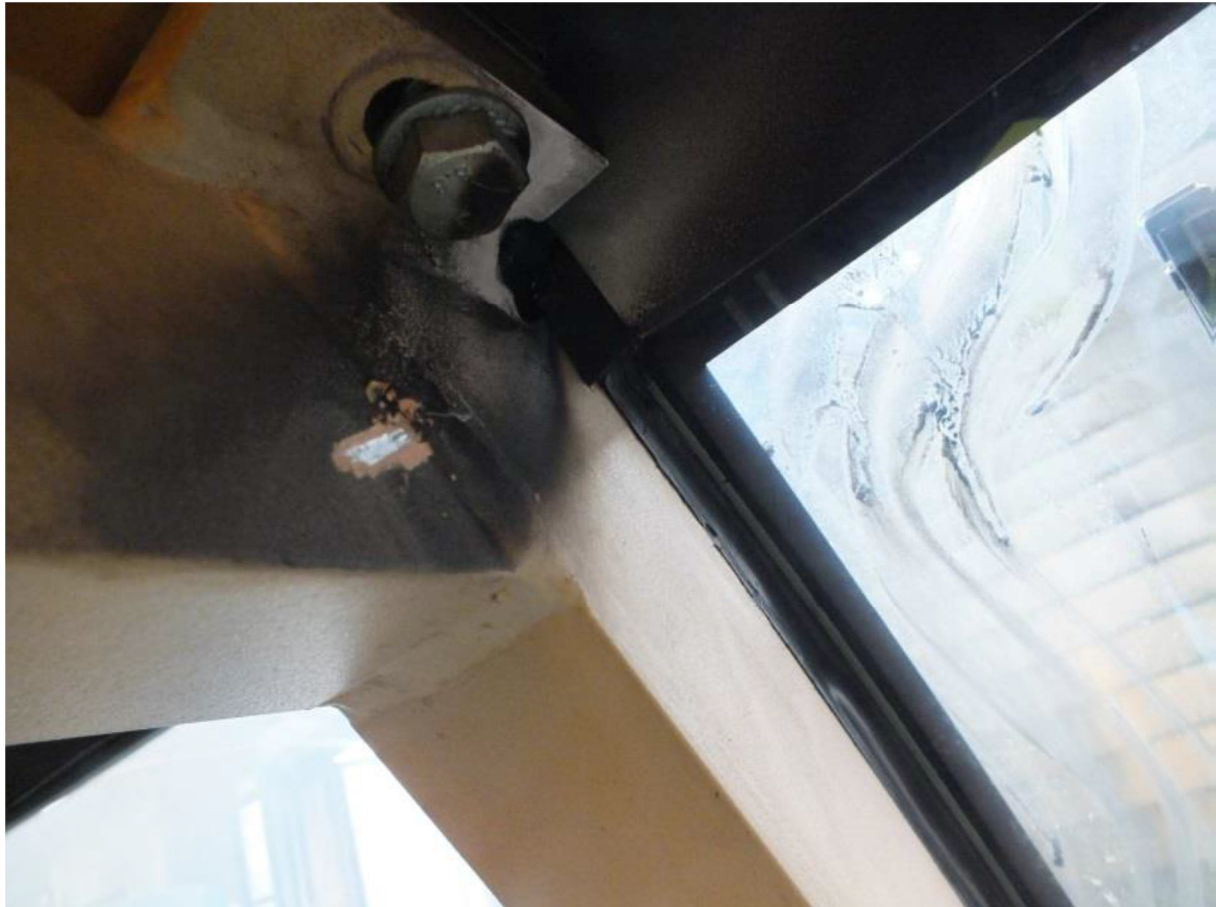
As a result, an electric arc was generated between the contact wire and the middle column of the windscreen of the locomotive, and drops of molten aluminium and glue got in the air in the driver's cab. The hot particles caused burn injuries to the locomotive driver.

**Figure: Marks of an electric arc in the driver's cab**

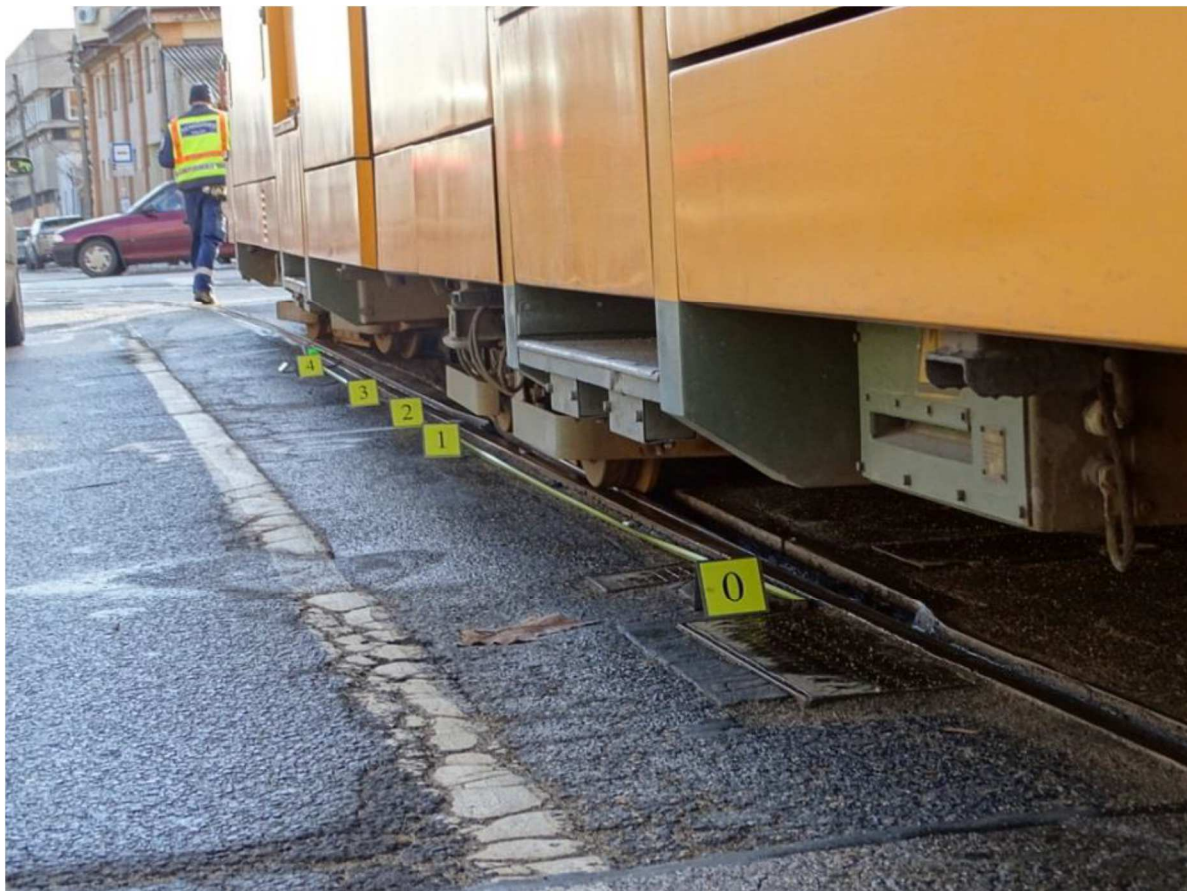
**Figure: The tram which derailed in December 2018**

**Transportation Safety Bureau recommends Budapesti Közlekedési Zrt. to consider reviewing the harmony of the technical solutions and rules of signalling applied with the switchpoint lights along the tram network of the Company, and to take action to reach harmony between the rules and the capabilities of available technical equipment.**

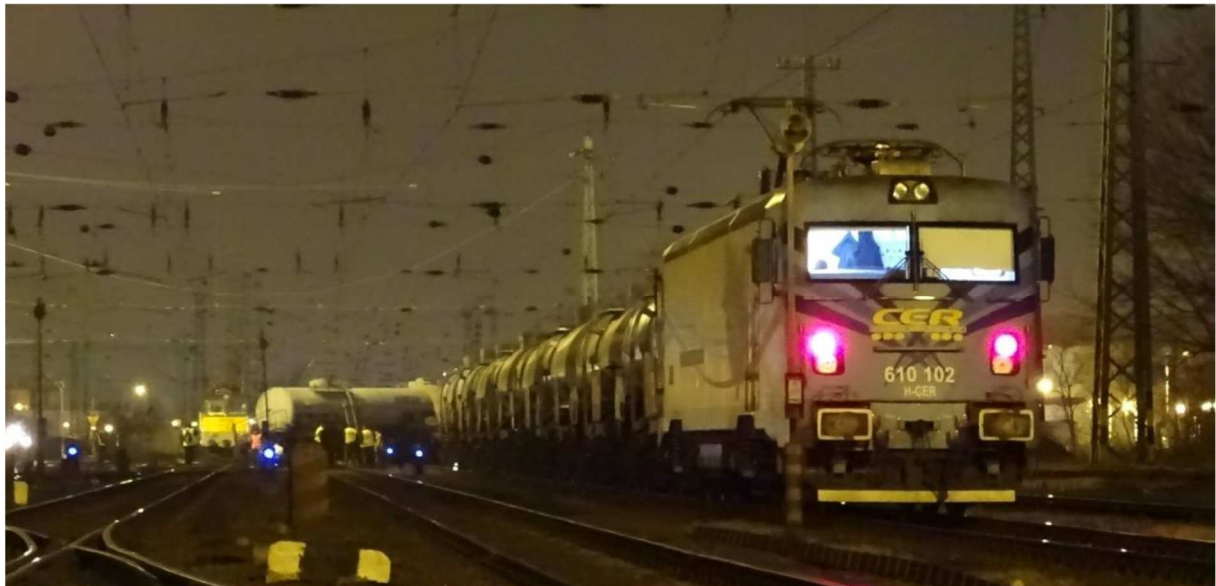
The cause of the loosening of the wheel rim could not be established clearly, but probably the decrease (approaching the lower limit) of the thickness of the wheel rim largely influenced the loosening of the wheel rim, and the lack of combined marking of the two pieces hindered the detection of the beginning dislocation.

**Figure: The freight train and the derailed wagon**

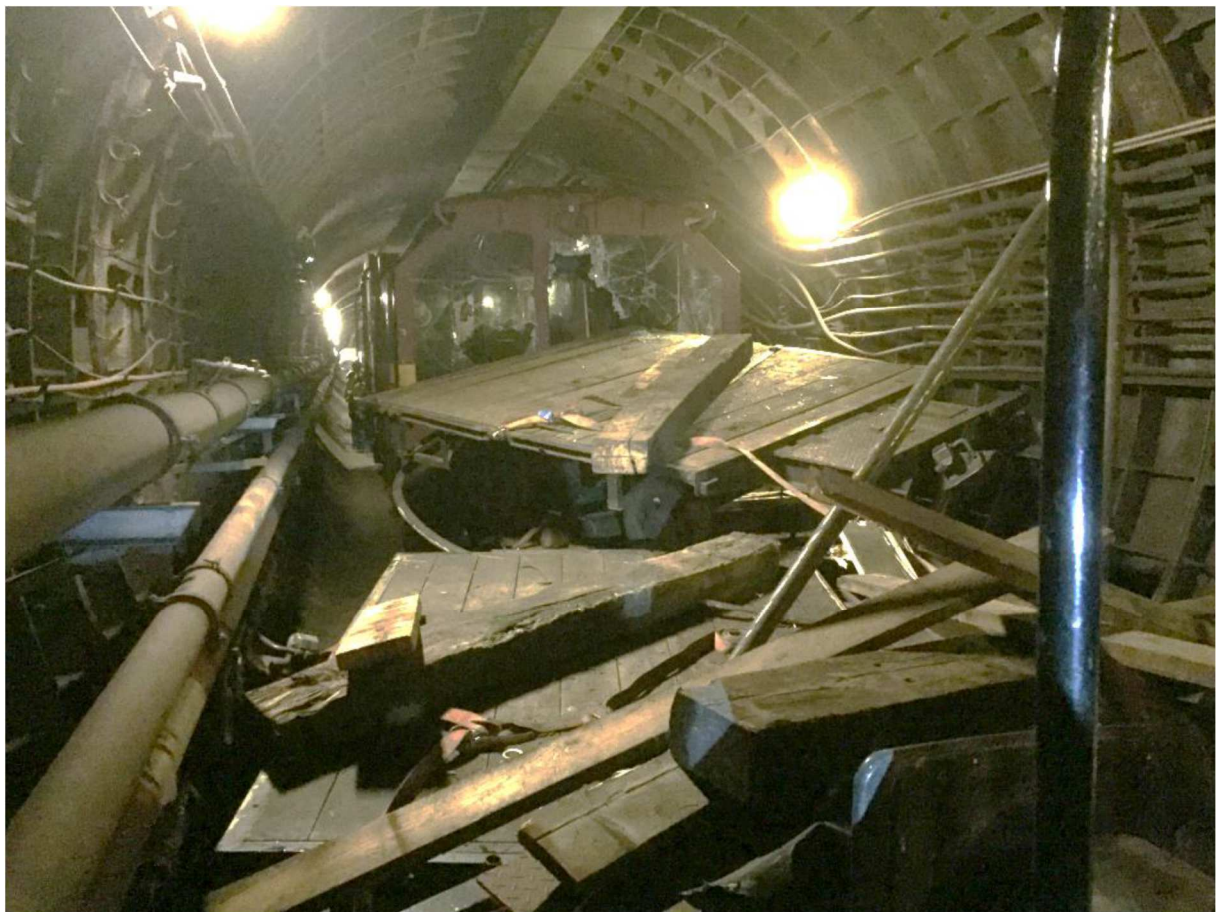
**Figure: Scene of the accident (Photo: BKV Zrt.)**

Therefore TSB issues a safety recommendation relating to the practice of managerial inspection of the company involved.

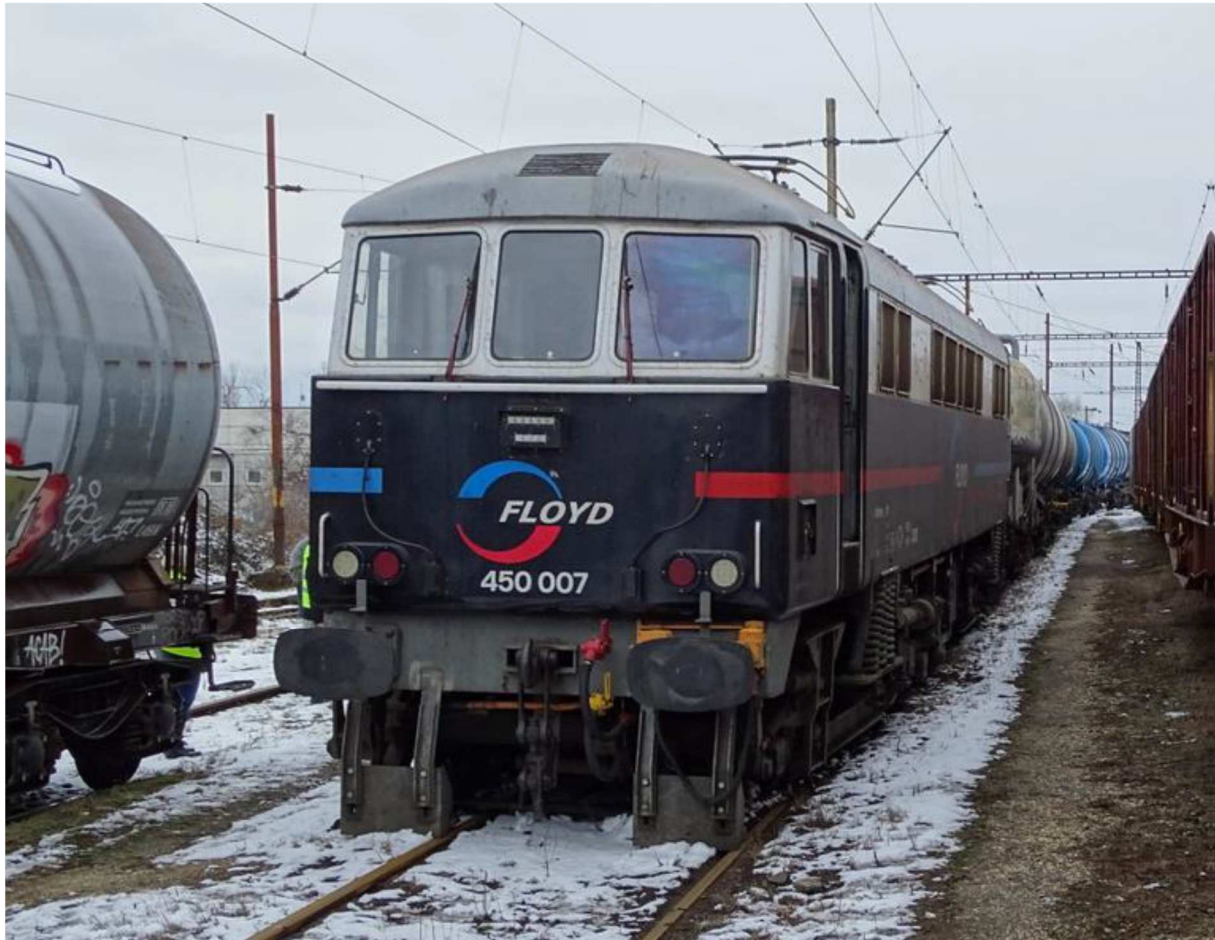
The IC attributes the occurrence to the worn-out condition of the track. In addition, the axle load of the locomotive slightly exceeded the limit for the given track, which cannot be directly related as cause to the occurrence, but increases safety risk.

**Figure: The locomotive which derailed**

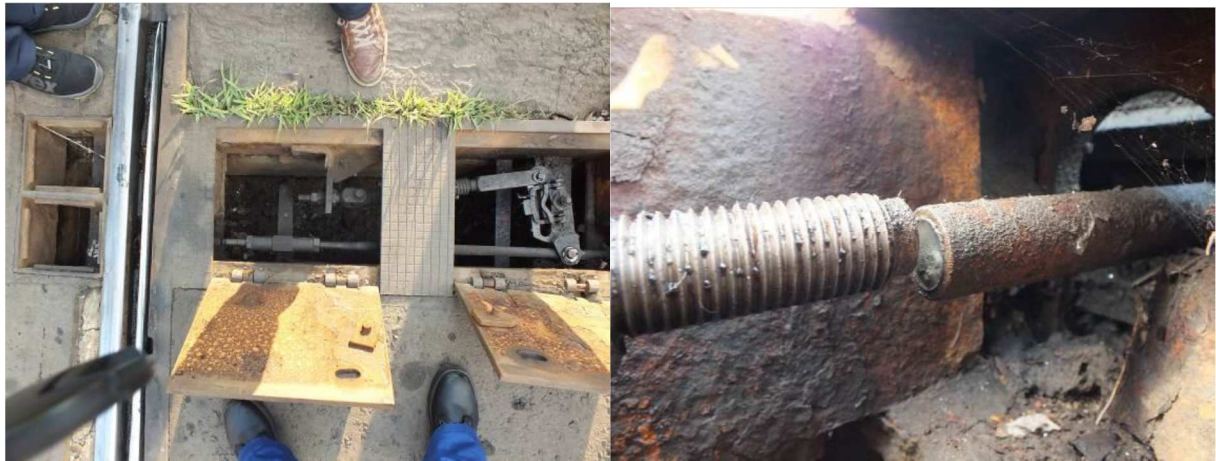
The IC attributes the occurrence to a fatigue fracture of the pull rod in the switch, which took place when the tram was rolling over the switch. The fastening of the switch tongue was loosened by such fracture, so the third bogey of the tram went on straight, unlike the others ahead of it, and the vehicle derailed due to the resulting forces of stress.

Possible cracks of the pull rods cannot be identified by visual inspection, and a crack testing would be disproportionately costly. The safety risk caused by the lack of testing is low, i.e. acceptable. A BKV Zrt. intends to prevent similar occurrences by replacing similar switches by modern devices (in which the likelihood of similar defects is lower) in more frequented, heavy-duty areas.

**Figure: Fracture of the short pull rod**

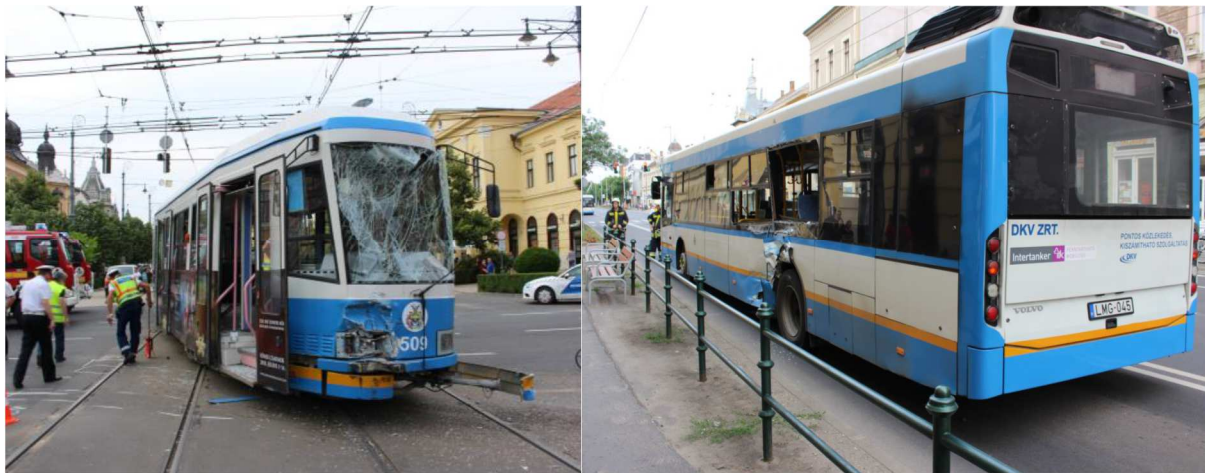
The IC also found that the phase layout of the traffic lights did not take into account the technical parameters of the vehicles using the affected intersection.

**Figure: The derailed tram (source: Police), and the pulled-over bus**

Therefore the IC proposes a safety recommendation for Ministry for Innovation and Technology to initiate modification of GKM Regulation 41/2003. (VI. 20.) GKM in such manner that phase layout of traffic lights should also take into account the parameters of those vehicles which typically participate in traffic.

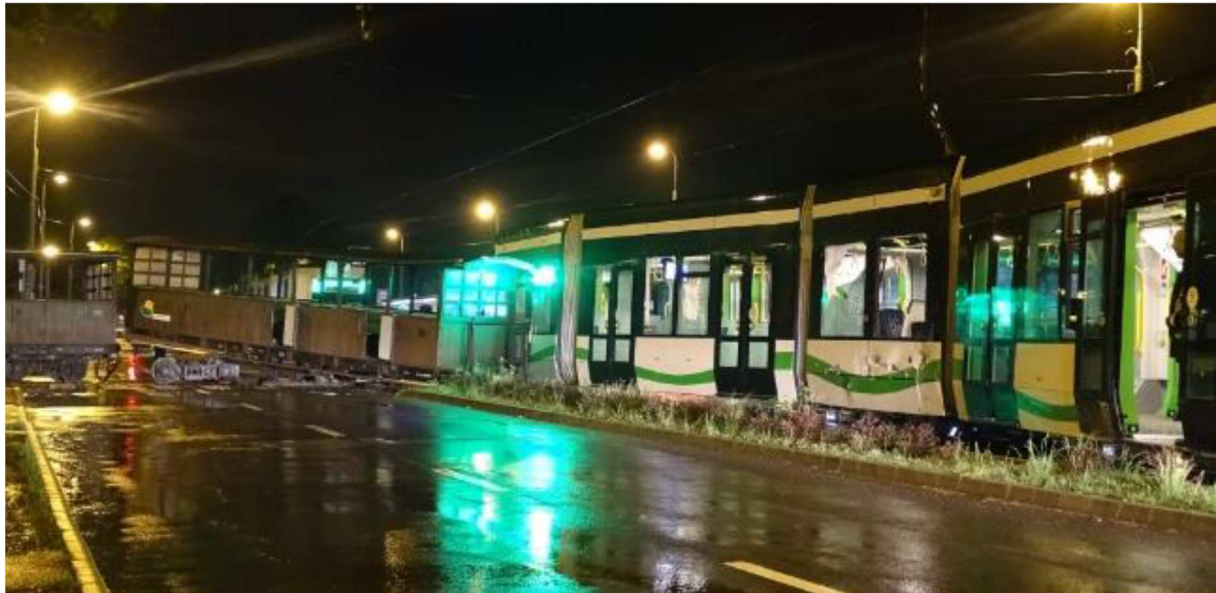
The shortcomings of the management's activity may be related to overload of the staff as well as to earlier changes to the staff of the railway company, and also to the low level of cooperation within the management.

**Figure: View of the wrecks at the scene of the collision**

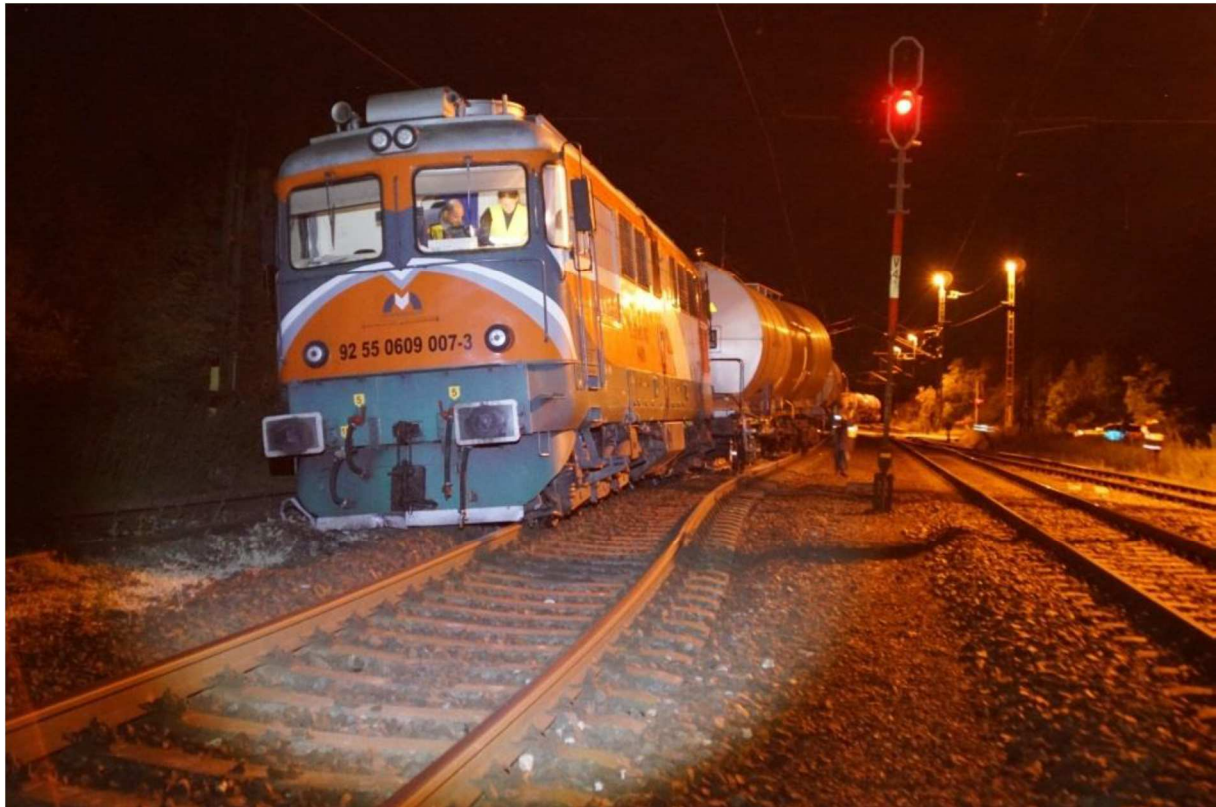
The IC analysed the movement of the train № MRN-2 (during which the switch № 9 had been burst open) as other risk factor.

**Figure: The derailed train**

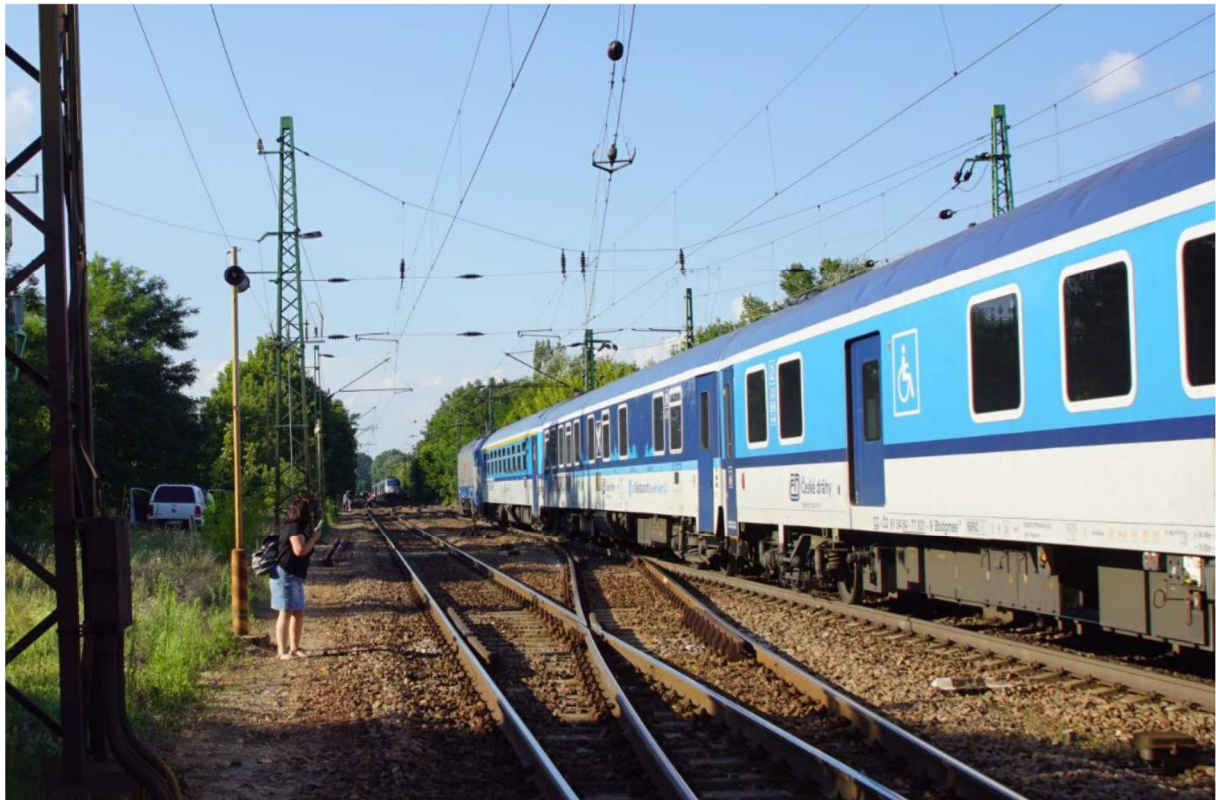
It contributed to the occurrence that other activities (closing the entry door, sitting down and getting settled) distracted the locomotive driver’s attention after departure, and that the senior ticket inspector did not observe the exit signal either before giving authorisation to the locomotive driver to start.

**Figure: Positions of the two trains relative to each other after the occurrence**

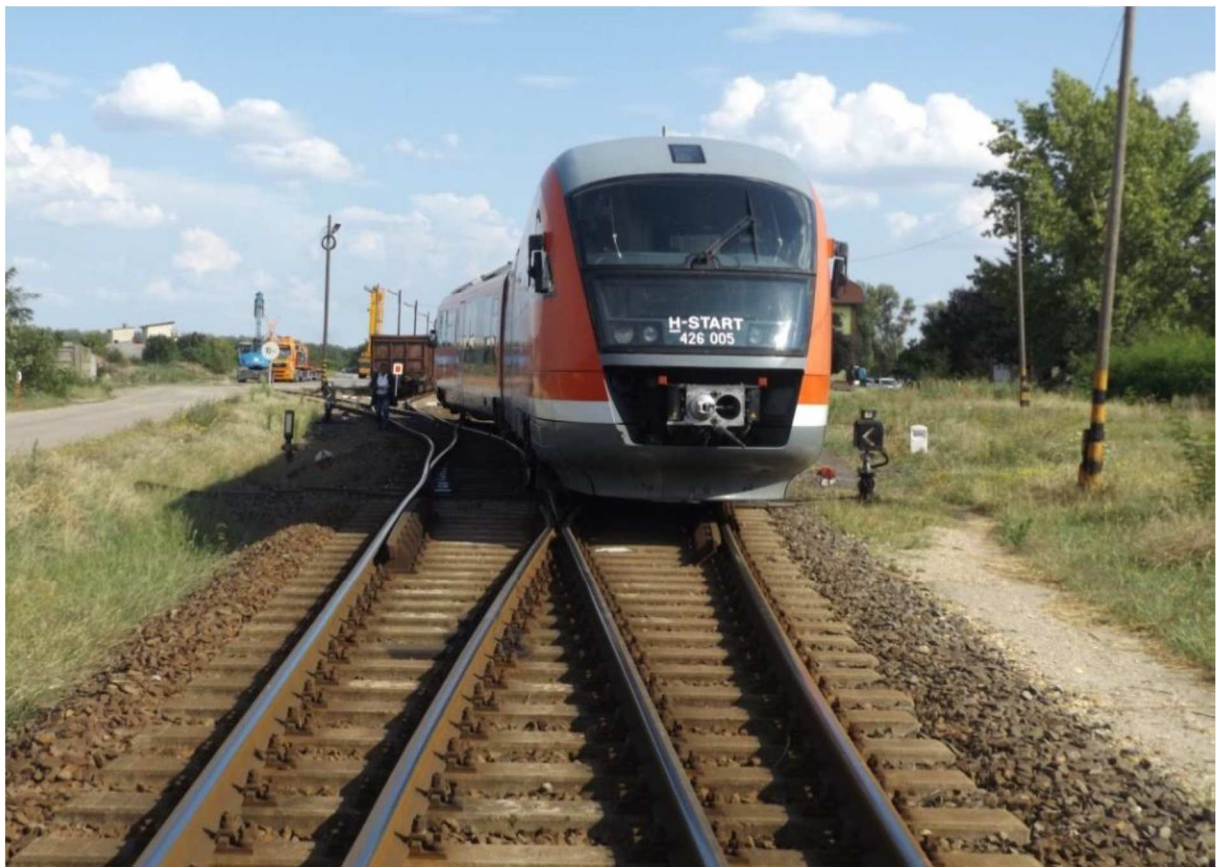
While positioning the hand-operated switch, the pointsman did not realise that both the straight and the curved switch tongues were lying against the stock rail.

**Figure: The derailed motor train set**

TSB maintains its Safety Recommendation issued relating to the occurrence of 8 June 2017 at Ferencváros Station and investigated by TSB under № 2017-0720-5: is the reliability of the switch tongue – point rod – control rod connection sufficient or is it necessary to integrate the inspection thereof into the rules of the safety management system. An appropriate addition would considerably improve detection of similar defects and prevention of similar occurrences.

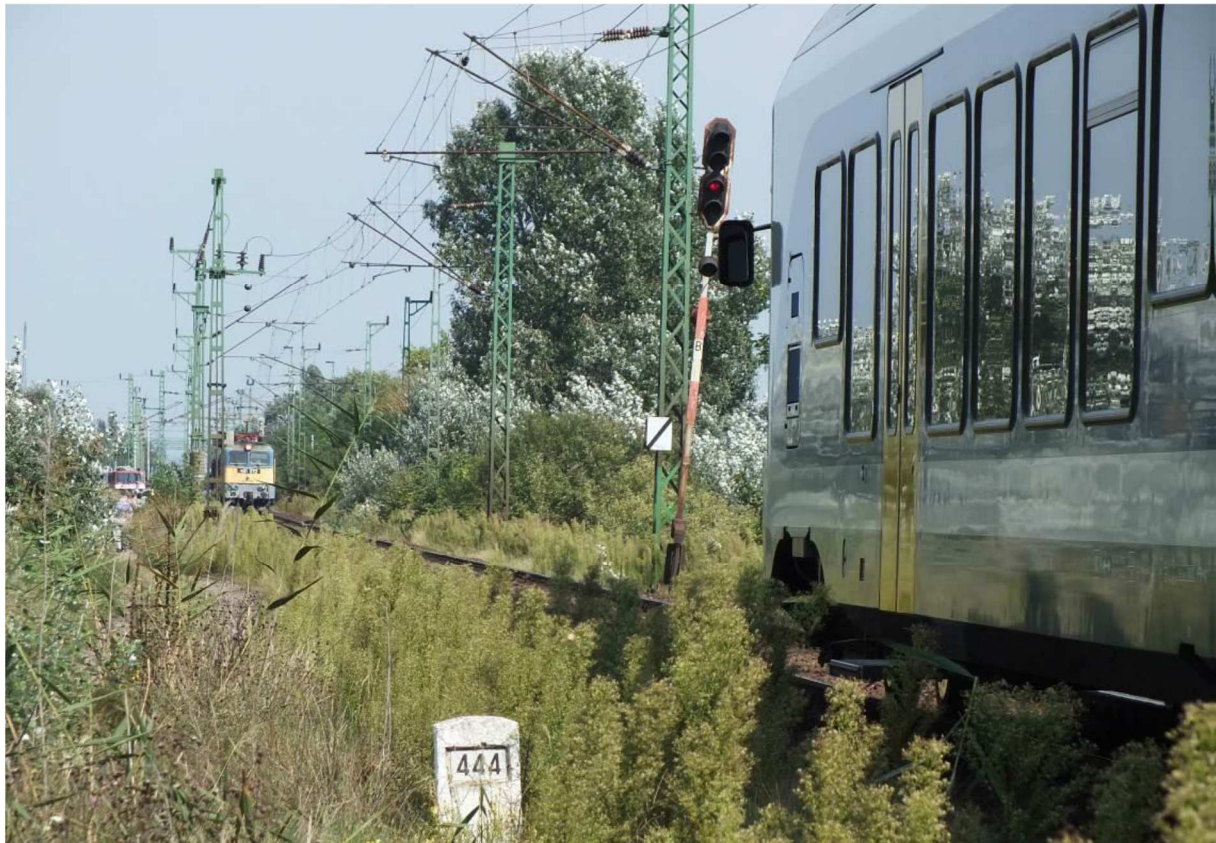
At Dömsöd station, the train № 343-2, which was moving through according to schedule, passed the V3 signal at danger without authorisation, then burst the switch № 1 open, and stopped 62 metres after the switch. The train № 7927, coming from the direction of Kunszentmiklós-Tass and approaching the down-side entry signal of the station stopped before such entry signal; the distance between the two stopped train was 380 metres.

The IC attributed the occurrence to human factors on the part of the locomotive driver, but misleading, attention-diverting circumstances were also found.

**Figure: The trains after they stopped**

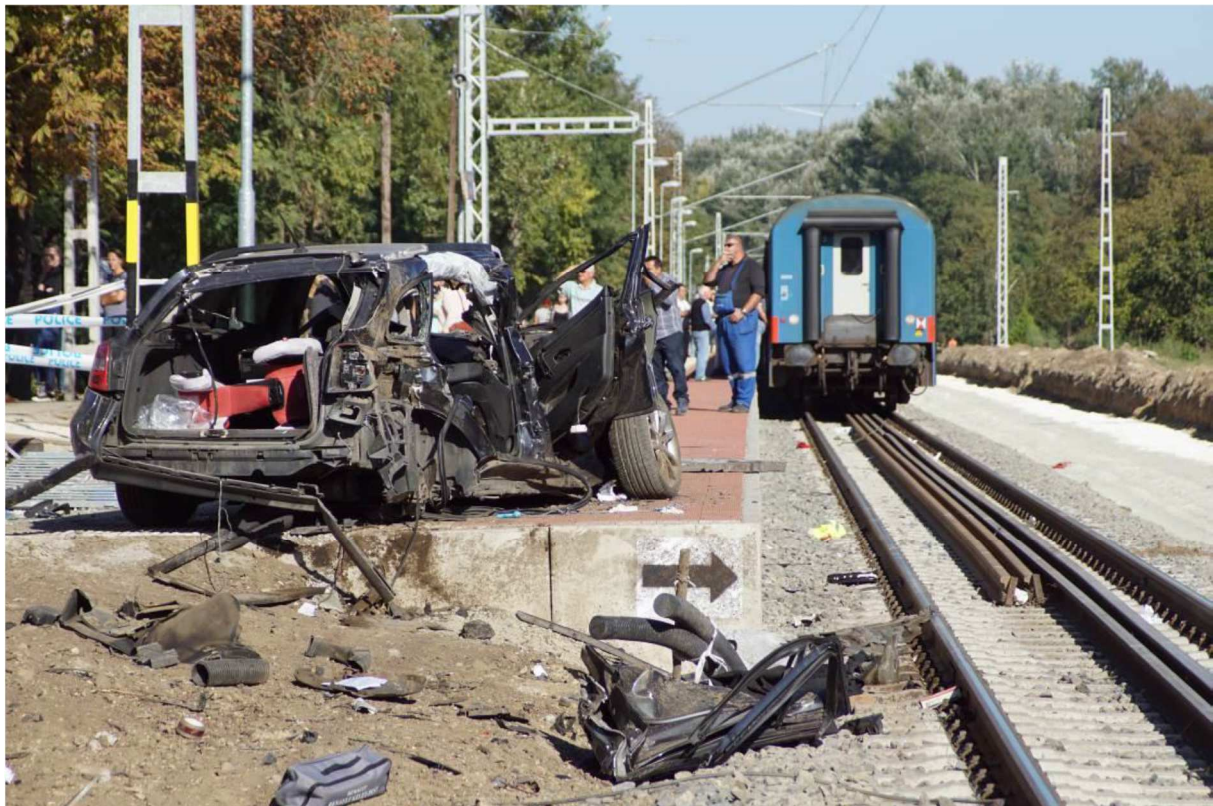
**Figure: The wreck of the car with the train in the background**

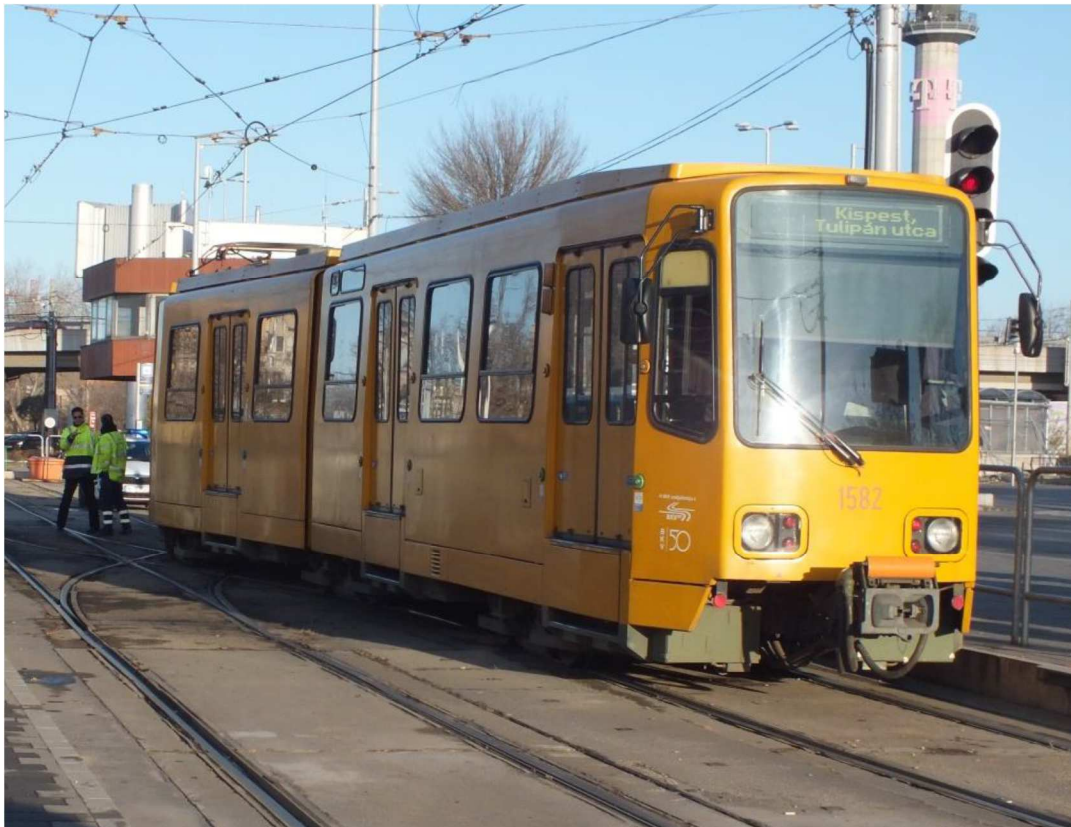
According to investigation findings, the main signal displayed 'End of movement authority' to the tram before it moved onto the switch. The control panel operator did not notice the unauthorised signal passed at danger, and, during the route setting initiated by him, the switch was changed to turnout direction while the tram was moving over on it.

The IC attributed the occurrence to the design of the signal system at the terminal station and to human factors on the parts of the tram driver and the control panel operator.

**Figure: The derailed tram**
