MINISTRY FOR
INNOVATION AND TECHNOLOGY
TRANSPORTATION SAFETY BUREAU

ANNUAL REPORT 2020

Transportation Safety Bureau

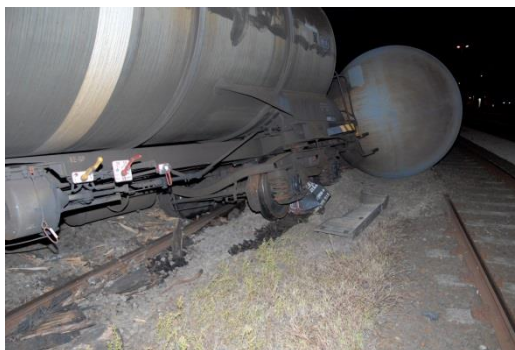
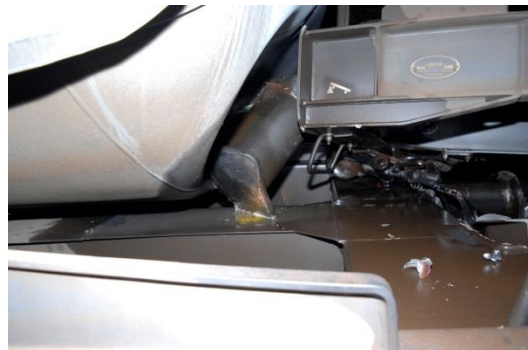
A freight train from the direction of Szombathely was approaching through several switches in diverging direction to Track V at Vép station when seven of its tank-cars derailed, two tipped over to the side, and one got back on track. Two tank-cars were damaged to such extent that their consignment (ca. 100 m³ diesel oil) spilled on the ground.

The track and the derailed tank-cars were badly damaged. A large quantity of top soil had to be replaced due to the damage to the environment.

The investigation found that the poor condition of the track played a direct role in the accident; the track supervision system had known of the problem, but no effective action was taken before the accident.

The derailed wagons and the spilled oil

- a) the rail surface defect of the turnout located just before the location of the derailment might have increased the swaying of the vehicle and its load;

- b) although the track supervision were aware of the defect of the track they took no action and the track was used a holding siding;
- c) it could not be proved nor excluded that, because of low level of loading, the tank-cars exposed the considerably worn-out track to harmful forces; however, crosswise sloshing of the liquid cargo must have caused measureable forces.

In November 2017, after the occurrence, the head of the infrastructure division ordered an extraordinary review of curves of small radius. The works recommended as an outcome of such review were carried out by the track maintenance section in 2018.

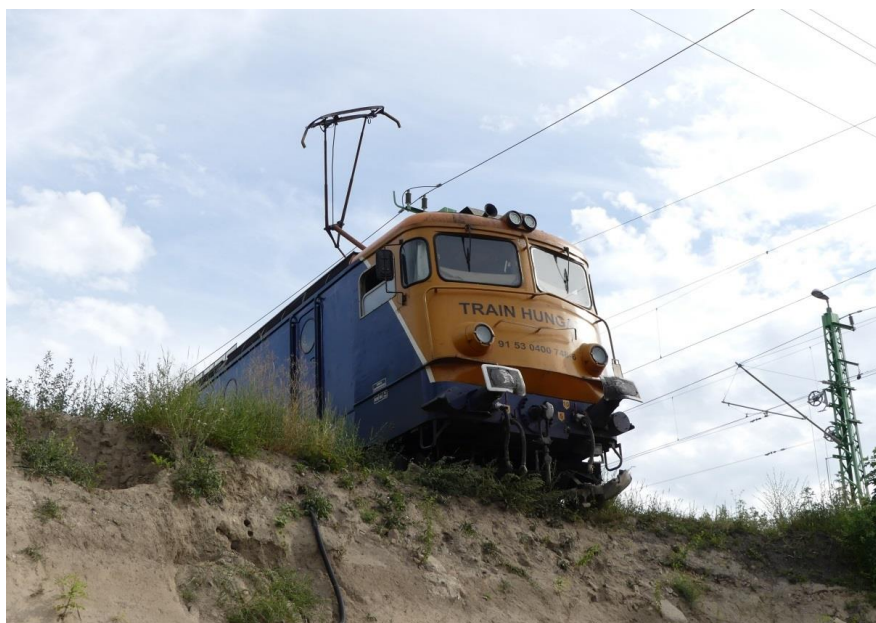
During the investigation, doubts emerged in connection with the reliability of the train control system, even the possibility of its deactivation was raised, but, neither the tests nor data from the data recorder confirmed any error or erroneous management which would have affected the occurrence.

It is not related to the occurrence, but the IC found erroneous data in the locomotive's licence from the transport authority related to the brake type of the locomotive, and such error affects the method of operation of the brake as well.

The final stop point above the road

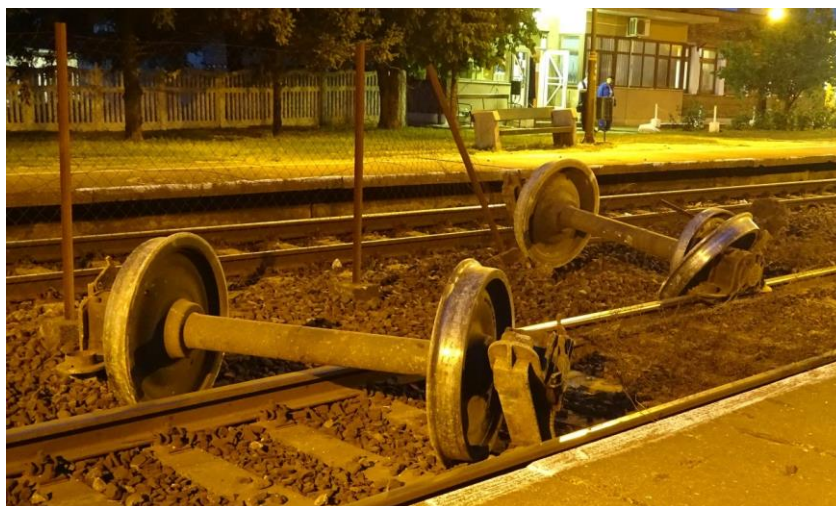
The cause of loosening of the rim wedge was not clearly identified, but it was probably influenced by the fact that the thickness of the wheel rim was close to the relevant lower limit.

Wear-out of the wheel rim may lead to loosening of the rim wedge rarely, but it may be identified by following the relevant inspection methods therefore the IC does not find it necessary to issue a safety recommendation.

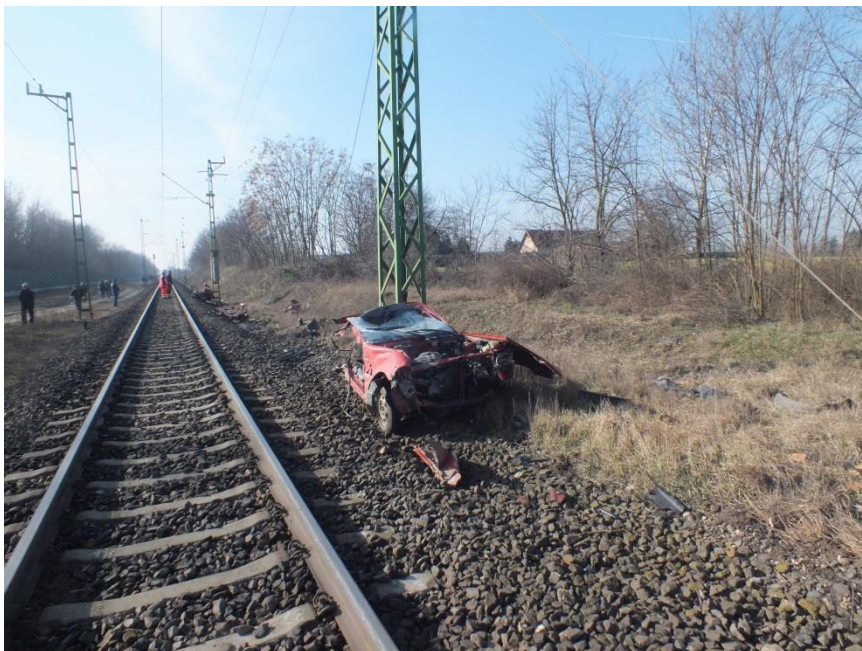
On 16 February 2020, the train № 712 collided with an automobile at the level crossing (SR1) protected with serviceable warning lights at Katonatelelep station. Two children, as passengers of the automobile died on the spot, and the driver of the car was injured seriously.

The investigation found that the warning lights had worked correctly, showing alternating red warning lights in the direction of the road at the time of the accident.

The IC attributes the occurrence to human factors on the part of the driver of the car, and found that the car had entered the level crossing despite the alternating red signal of the correctly working warning lights (SR1).
