MINISTRY OF  
TECHNOLOGY AND INDUSTRY

**ANNUAL REPORT 2021**  
**Transportation Safety Bureau**  
**Hungary**

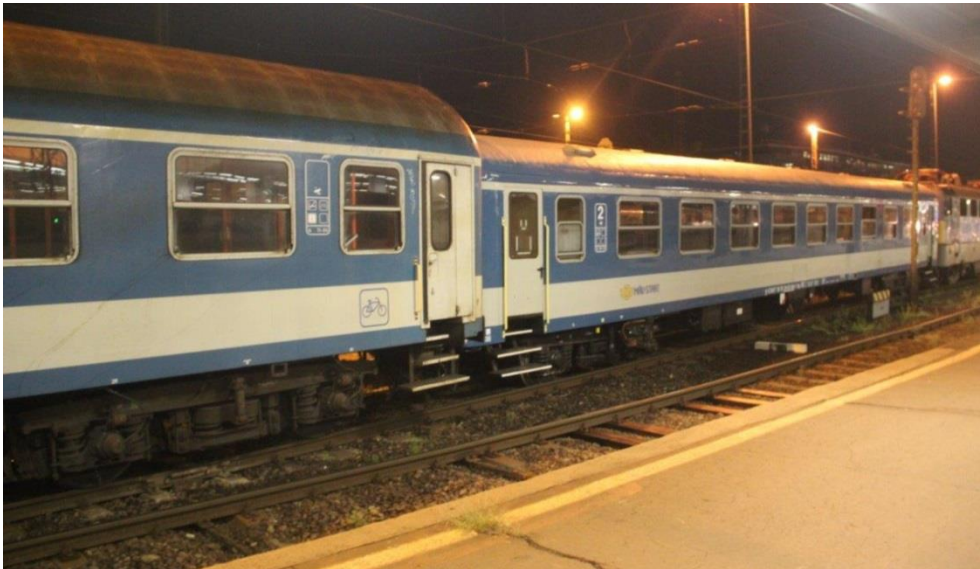
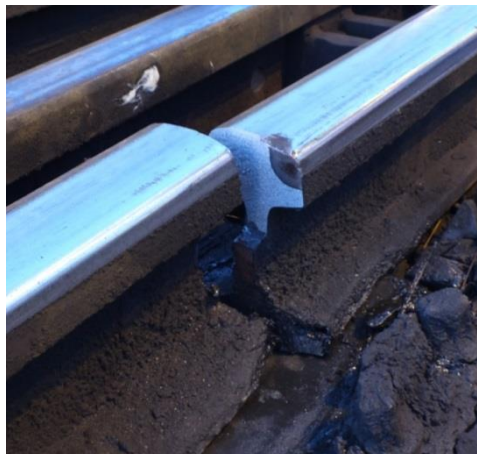
<i>Grade:</i>	<i>Railway accident</i>
<i>Date and time:</i>	<i>10 September 2019</i>
<i>Location:</i>	<i>Budapest-Nyugati (station)</i>
<i>Occurrence type:</i>	<i>Train derailment</i>
<i>Movement type:</i>	<i>Passenger train</i>
<i>Description:</i>	<i>The second bogie of the first wagon of the arriving train no. 22629 derailed on the switch no. 19/a at Budapest-Nyugati station.</i>
<i>Consequences:</i>	<i>0 fatality / 0 serious injury Total damage &lt; EUR 150,000</i>
<i>Parties:</i>	<i>MÁV Zrt. (IM) MÁV-START Zrt. (RU)</i>
<i><u>Direct cause(s):</u></i>	<ul style="list-style-type: none"><li>• <i>one of the tongue rails of the switch fractured under the incoming train, causing the derailment of second bogie of the first wagon</i></li></ul>
<i><u>Contributory factor(s):</u></i>	<ul style="list-style-type: none"><li>• <i>due to poor prop up of the track, the rail was exposed to loads that led to fatigue fractures in the long term</i></li></ul>

<i><u>Underlying cause(s):</u></i>	<ul style="list-style-type: none"><li>• <i>the railway track in the area of Budapest Nyugati station is in a significantly degraded condition, the track maintenance system is not able to reduce the degradation process</i></li></ul>
<i><u>Recommendation(s):</u></i>	<i>none</i>

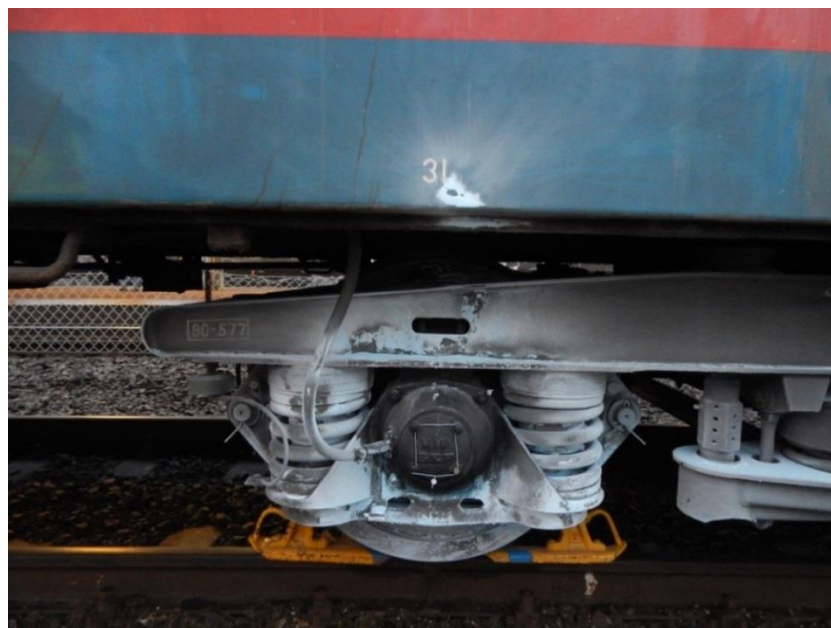
<i>Grade:</i>	<i>Railway accident</i>
<i>Date and time:</i>	<i>15 January 2020</i>
<i>Location:</i>	<i>Mende (station)</i>
<i>Occurrence type:</i>	<i>Fire in rolling stock</i>
<i>Movement type:</i>	<i>Regional passenger train</i>
<i>Description:</i>	<i>A bearing of a wagon of passenger train no. 3330 caught fire, then the train was stopped at Mende station and the fire was extinguished with a fire-extinguisher.</i>
<i>Consequences:</i>	<i>0 fatality / 0 serious injury Total damage HUF 522,011 ( &lt; EUR 150,000)</i>
<i>Parties:</i>	<i>MAV Zrt. (IM) MAV-START Zrt. (RU)</i>
<u><i>Direct cause(s):</i></u>	<ul style="list-style-type: none"> <li><i>the bearing was stucked, probably due to mechanical damage from fatigue fracture; the rolling elements and the inner ring have stopped rotating, the withdrawal sleeve rotated on the shaft journal and on the inner ring of the bearing</i></li> </ul>
<u><i>Contributory factor(s):</i></u>	<ul style="list-style-type: none"> <li><i>due to high friction, the heat generated ignition of the lubricant (grease)</i></li> <li><i>the bearing had already reached the end of its fatigue lifetime, but this was not detectable due to the nature of the maintenance system</i></li> <li><i>there is a manufacturer's recommendation for the lifetime of the bearing, but the maintenance system does not adapted it to the operating conditions and does not specify an expected lifetime period, so there is not a known maintenance requirement to replace the bearing before the end of its life</i></li> </ul>

<u><i>Underlying cause(s):</i></u>	<ul style="list-style-type: none"> <li><i>none</i></li> </ul>
<u><i>Recommendation(s):</i></u>	<i>Transportation Safety Bureau recommends to MAV-START Zrt. to consider introducing a procedure in its passenger car maintenance system that takes into account the manufacturer's recommendations on bearing lifetime and requires bearings to be replaced before the end of their expected lifetimes.</i>

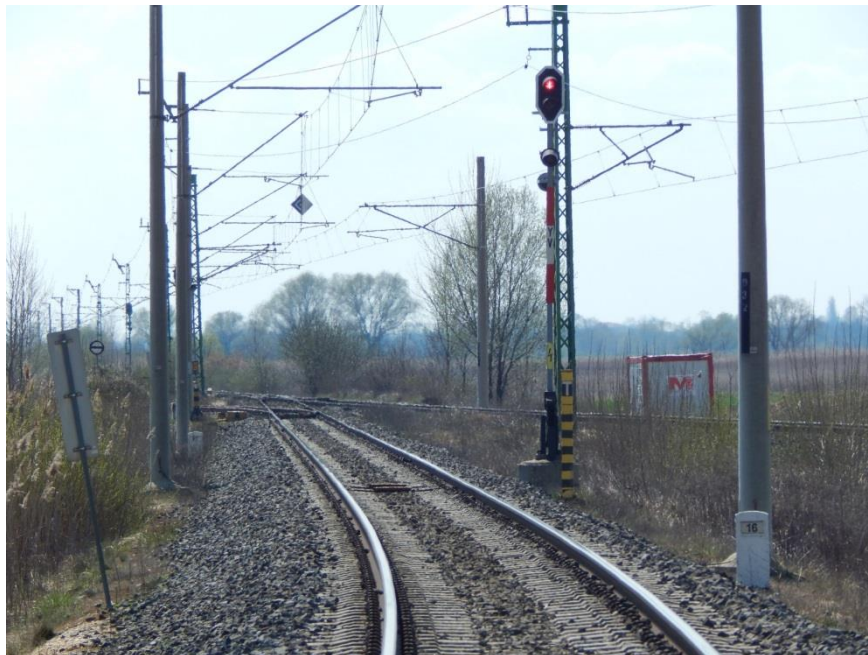
<i>Grade:</i>	<i>Railway incident</i>
<i>Date and time:</i>	<i>28 January 2020</i>
<i>Location:</i>	<i>Jánosháza elágazás (junction)</i>
<i>Occurrence type:</i>	<i>Signal passed at danger</i>
<i>Movement type:</i>	<i>Long distance passenger train</i>
<i>Description:</i>	<i>The passenger train no. IC952 passed the signal of Jánosháza-elágazás at danger. The train was stopped by the engineer 149 metres behind the signal.</i>
<i>Consequences:</i>	<i>0 fatality / 0 serious injury No damage (EUR 0)</i>
<i>Parties:</i>	<i>MÁV Zrt. (IM) MÁV-START Zrt. (RU)</i>
<u><i>Direct cause(s):</i></u>	<ul style="list-style-type: none"> <li><i>the driver did not check the aspect of the warning signal and did not expect a “Danger” aspect on the “YV” signal and therefore did not apply the brakes in time</i></li> </ul>
<u><i>Contributory factor(s):</i></u>	<ul style="list-style-type: none"> <li><i>the driver’s attention was distracted from checking the pre-indication signal by making the necessary switches to cross the phase boundary located in front of the signal</i></li> <li><i>the line-side of this section of the railway is not equipped for continuous train control system operation</i></li> </ul>

<u><i>Underlying cause(s):</i></u>	<ul style="list-style-type: none"> <li><i>during the training of locomotive drivers, it is possible that they acquire certificate of knowledge of a line section without having actually travelled on certain parts of it</i></li> <li><i>within the infrastructure managing entity, the incident was not initially handled in accordance with its real safety risk and the relevant legislation and instructions, and therefore its immediate reporting to the TSB was delayed and the scene of the accident was disrupted without authorisation</i></li> </ul>
<u><i>Recommendation(s):</i></u>	<i>none</i>

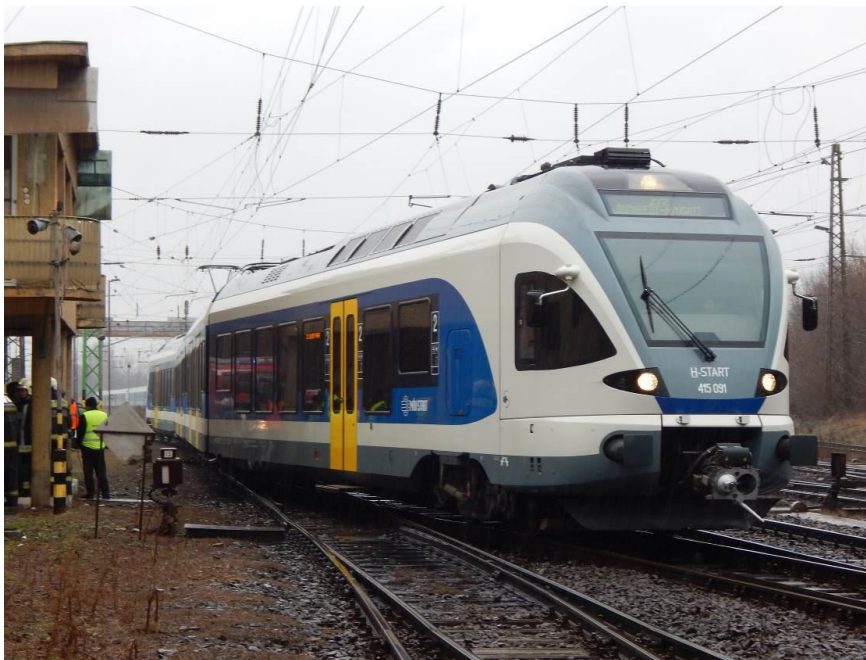
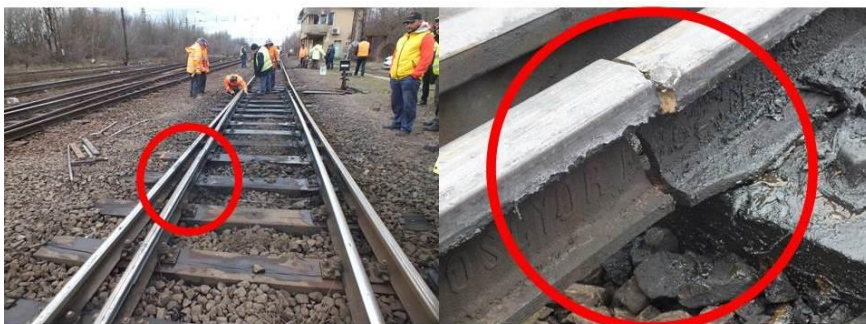
<i>Grade:</i>	<i>Railway accident</i>
<i>Date and time:</i>	<i>4 February 2020</i>
<i>Location:</i>	<i>Rákosrendező (station)</i>
<i>Occurrence type:</i>	<i>Train derailment</i>
<i>Movement type:</i>	<i>Commuter train</i>
<i>Description:</i>	<i>The passenger train no. 2067 derailed on the switch no. 11 at Rákosrendező station.</i>
<i>Consequences:</i>	<i>0 fatality / 0 serious injury Total damage HUF 37,430,000 ( &lt; EUR 150,000)</i>
<i>Parties:</i>	<i>MÁV Zrt. (IM) MÁV-START Zrt. (RU)</i>
<u><i>Direct cause(s):</i></u>	<ul style="list-style-type: none"> <li>during the train's approach, the switch tongue in the diverging direction fractured, causing the derailment of the leading bogie of the train</li> </ul>
<u><i>Contributory factor(s):</i></u>	<ul style="list-style-type: none"> <li>none</li> </ul>
<u><i>Underlying cause(s):</i></u>	<ul style="list-style-type: none"> <li>the cycle time for ultrasound rail testing (which can detect hairline cracks in the web and the foot of the rail) is much longer than the time needed by the processes leading to similar fractures (from the formation of detectable hairline cracks to the final fracture), therefore fractures cannot always be prevented</li> </ul>

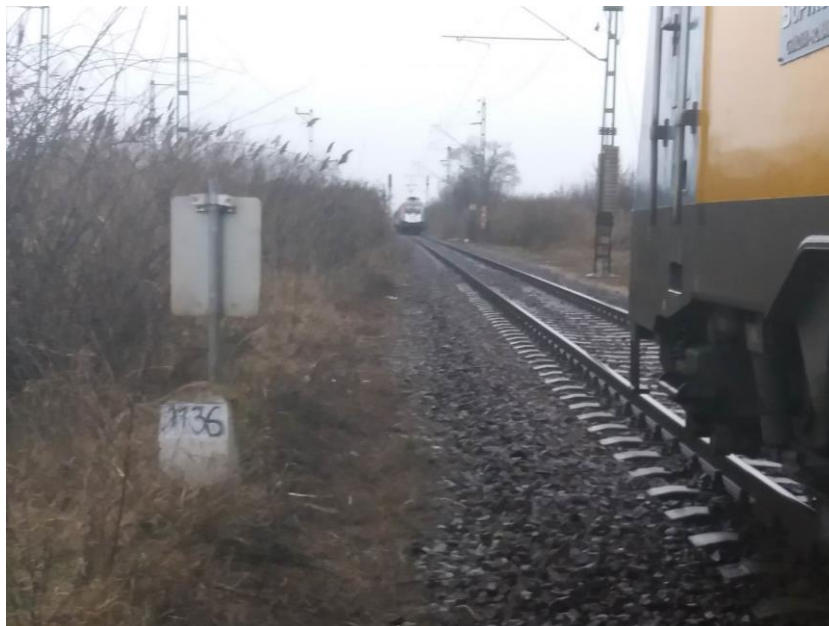
<i>Grade:</i>	<i>Railway incident</i>
<i>Date and time:</i>	<i>21 February 2020</i>
<i>Location:</i>	<i>Lőkösháza (station)</i>
<i>Occurrence type:</i>	<i>Signal passed at danger</i>
<i>Movement type:</i>	<i>Locomotive running solo</i>
<i>Description:</i>	<i>The train no. 27355 passed the signal of Lőkösháza station at danger. Eventually the train was stopped by the engine driver before leaving the station. The passenger train what was coming from the opposite direction (no. 7504), stopped before reaching the entry signal of the station.</i>
<i>Consequences:</i>	<i>0 fatality / 0 serious injury No damage (EUR 0)</i>
<i>Parties:</i>	<i>MÁV Zrt. (IM) CER Hungary Zrt. (RU) MÁV-START Zrt. (RU)</i>
<i><u>Direct cause(s):</u></i>	<ul style="list-style-type: none"> <li>• <i>the driver remembered incorrectly the aspect of the entrance signal which also gave pre-indication for the exit signal</i></li> <li>• <i>the locomotive driver was late in checking the aspect of the “K2” exit signal</i></li> <li>• <i>the driver's work was interrupted by a telephone conversation with the dispatcher of the railway company and then by the receive of the journey documents</i></li> </ul>

<i><u>Contributory factor(s):</u></i>	<ul style="list-style-type: none"> <li>• <i>the driver was also distracted by the fact that, after a phone call with the dispatcher, he was already planning the rest of the work to be done at Szolnok station when he got back on the locomotive and departed</i></li> <li>• <i>the locomotive driver's concentration may have been reduced by the fact that he has had to leave home quite early, about four hours before the start of the service</i></li> </ul>
<i><u>Underlying cause(s):</u></i>	<ul style="list-style-type: none"> <li>• <i>none</i></li> </ul>
<i><u>Recommendation(s):</u></i>	<i>none</i>

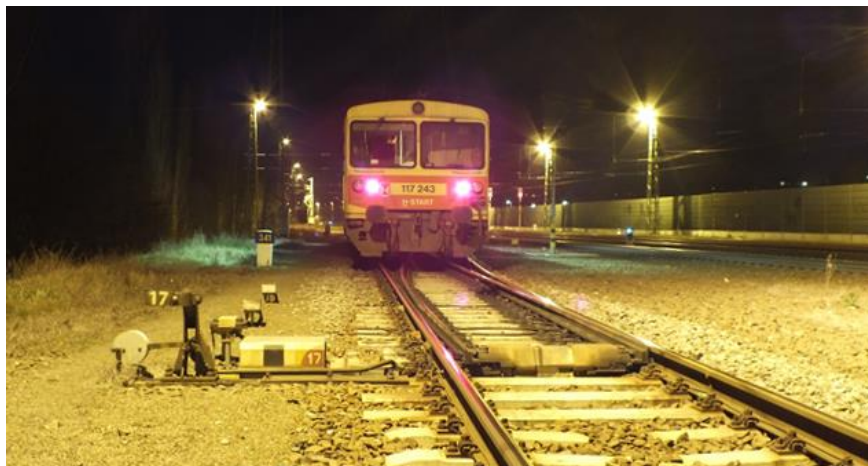
<i>Grade:</i>	<i>Railway incident</i>
<i>Date and time:</i>	<i>15 March 2020</i>
<i>Location:</i>	<i>Vác (station)</i>
<i>Occurrence type:</i>	<i>Signal passed at danger</i>
<i>Movement type:</i>	<i>Regional passenger train</i>
<i>Description:</i>	<i>For the passenger train no. 32228 the route was set incorrectly by the signaller from track no. 4b instead from track no. 3b at Vác station. The train left the station this way: passed a signal at danger and opened up a switch.</i>
<i>Consequences:</i>	<i>0 fatality / 0 serious injury No damage (EUR 0)</i>
<i>Parties:</i>	<i>MÁV Zrt. (IM) MÁV-START Zrt. (RU)</i>
<u><i>Direct cause(s):</i></u>	<ul style="list-style-type: none"> <li><i>the traffic controller in the computer did not lock the proper track route for the train that was actually departing, and then gave instructions to his co-worker to authorise the train driver verbally, without ensuring that the track route had actually been formed, because he was not staying at his place of work</i></li> <li><i>the external traffic controller, on the basis of receiving an incorrect verbal instruction, authorised the locomotive driver without checking the aspect of the exit signal</i></li> <li><i>under the influence of the authorisation and the signal from the exit signal of the adjacent track allowing the train to proceed, the driver started his train without checking the signal concerning his train, and did not check the signal either while moving towards it</i></li> </ul>

<u><i>Contributory factor(s):</i></u>	<ul style="list-style-type: none"> <li><i>after a change of direction, continuous train controlling does not work on the train until the new track route setting is made, so the more frequently given vigilance alert does not help the driver detect the situation, nor does the emergency brake apply when passing a signal at danger</i></li> <li><i>because of the spatial position of the signals, their apparent order due to the curve in the track causes problems when checking them</i></li> <li><i>the movement inspector on the platform was accustomed to the fact that in daylight the signals were not clearly visible, so he did not even attempt to check them by stepping back from the train in the dark, nor did he ask about the aspect of the exit signal by radio</i></li> </ul>
<u><i>Underlying cause(s):</i></u>	<ul style="list-style-type: none"> <li><i>none</i></li> </ul>

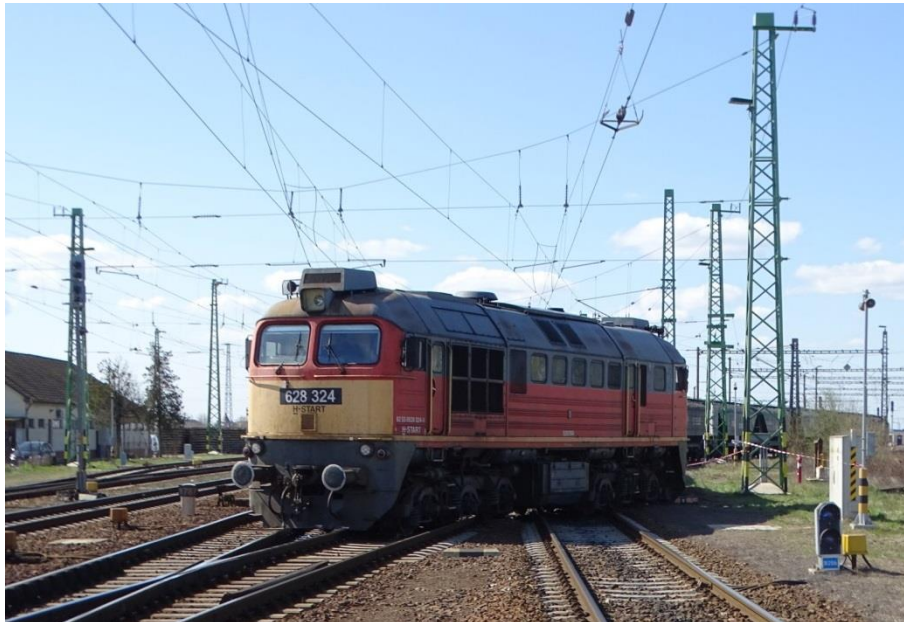
*Grade:* *Railway accident*  
*Date and time:* *22 March 2020*  
*Location:* *Püspökladány (station)*  
*Occurrence type:* *Train derailment*  
*Movement type:* *Freight train*  
*Description:* *The freight train no. 47481-2 derailed at Püspökladány station.*  
*Consequences:* *0 fatality / 0 serious injury*  
*Total damage HUF 91,000,000 HUF (EUR 150,000 – 2,000,000)*  
*Parties:* *MÁV Zrt. (IM)*  
*Rail Cargo Hungaria Zrt. (RU)*

- *a rail of the track fractured under the load of the locomotive, after wear-and-tear may have caused cracks on the surface when contacting the wheel flange*
- *the driver exceeded the speed limit in the situation by 75%*

- *the set of points involved in this case (type: 'Group B') is not subject to the eddy current inspection procedure that would be appropriate to detect the rail defect that caused the present accident*

*Recommendation(s):* ***Transportation Safety Bureau recommends the Railway Authority Division, Ministry of Technology and Industry (as National Safety Authority) carrying out a risk analysis as part of the operation of the safety management system to assess whether surface crack detection should be extended to lower class sidings or to a defined group of sidings based on operational conditions (e.g. frequency of use, load, time spent since installation, etc.) and that the track inspection system should be amended accordingly as necessary.***

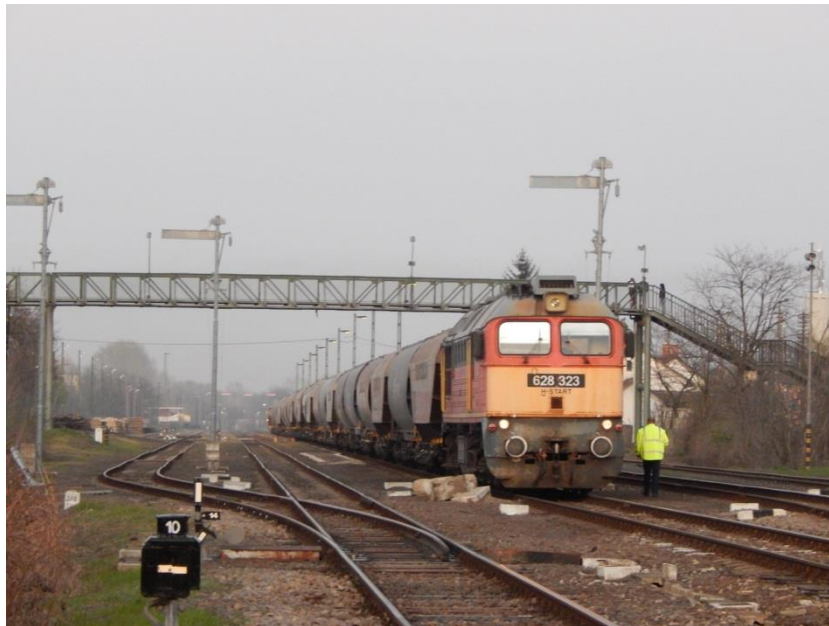
<i>Grade:</i>	<i>Railway incident</i>
<i>Date and time:</i>	<i>7 April 2020</i>
<i>Location:</i>	<i>Nyírbátor (station)</i>
<i>Occurrence type:</i>	<i>Signal passed at danger</i>
<i>Movement type:</i>	<i>Freight train</i>
<i>Description:</i>	<i>The freight train no. 68001 passed the signal of Nyírbátor station at danger. Eventually the train was stopped by the engine driver before leaving the station. The passenger train what was coming from the opposite direction (no. 6316), stopped before reaching the entry signal of the station.</i>
<i>Consequences:</i>	<i>0 fatality / 0 serious injury No damage (EUR 0)</i>
<i>Parties:</i>	<i>MÁV Zrt. (IM) Rail Cargo Hungaria Zrt. (RU)</i>
<i><u>Direct cause(s):</u></i>	<ul style="list-style-type: none"><li><i>the locomotive driver did not stop his train at the shunting limit signal at the station, contrary to the train's timetable</i></li></ul>
<i><u>Contributory factor(s):</u></i>	<ul style="list-style-type: none"><li><i>the exit signal "K3" involved in the route had not been repaired in six months following a previous accidental damage and was not standing in place at the time of the incident</i></li><li><i>the man-portable 'Stop' sign previously placed in place of the "K3" sign was removed within a short time</i></li><li><i>the permanently changed traffic conditions at the station have not been modified in the Station Instructions, nor in the Route Book</i></li></ul>

<i><u>Underlying cause(s):</u></i>	<ul style="list-style-type: none"><li><i>the replacement of the signal was not seen as a safety issue but as a financial one</i></li><li><i>the station staff and area managers, who were uncertain about the applicable procedures, received only informal guidance on the interpretation of the applicable rules from the management</i></li></ul>
<i><u>Recommendation(s):</u></i>	<i>none</i>

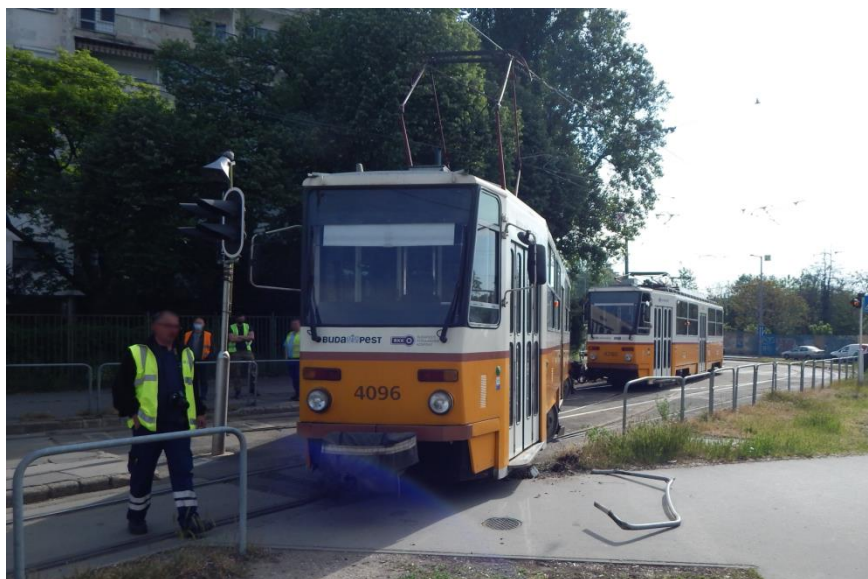
*Grade:* Tramway accident  
*Date and time:* 27 April 2020  
*Location:* Budapest, Lehel tér (station)  
*Occurrence type:* Train derailment  
*Movement type:* Tramway  
*Description:* The tram no. 14 derailed on the switch of the terminus Budapest, Lehel tér.  
*Consequences:* 0 fatality / 0 serious injury  
 Total damage HUF 149,400 ( < EUR 150,000)  
*Parties:* BKV Zrt. (IM)  
 BKV Zrt. (RU)

- several human factors identified during the investigation indicate the presence of a low level of safety culture, which implies a higher safety risk in adverse operational and traffic conditions

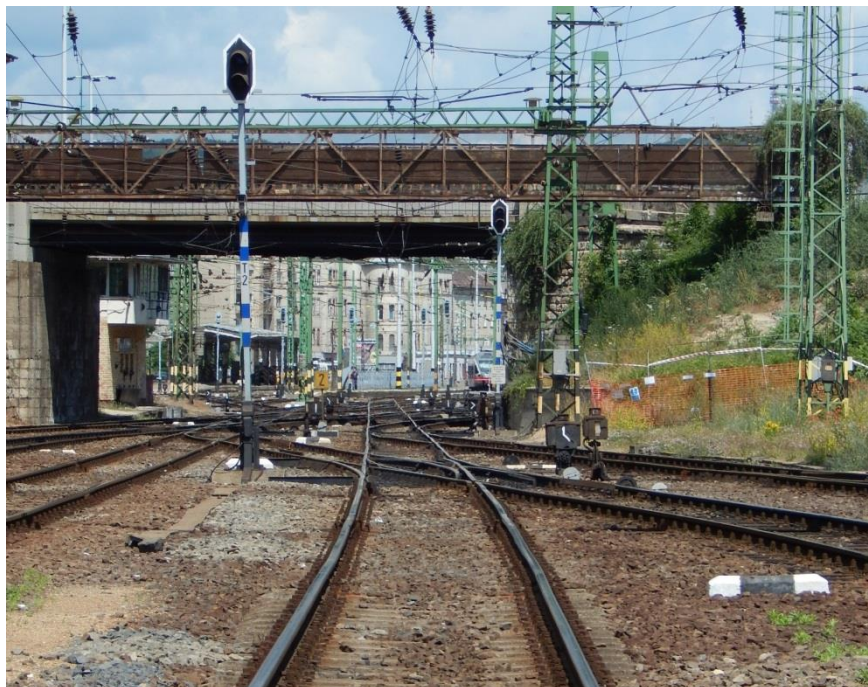
<i>Grade:</i>	<i>Railway incident</i>
<i>Date and time:</i>	<i>29 April 2020</i>
<i>Location:</i>	<i>Budapest-Déli (station)</i>
<i>Occurrence type:</i>	<i>Signal passed at danger</i>
<i>Movement type:</i>	<i>Locomotive running solo</i>
<i>Description:</i>	<i>The train no. 20348-1 passed the signal at danger at Budapest-Déli station and opened up a switch. Eventually the train was stopped by the engineer.</i>
<i>Consequences:</i>	<i>0 fatality / 0 serious injury No damage (EUR 0)</i>
<i>Parties:</i>	<i>MÁV Zrt. (IM) MÁV-START Zrt. (RU)</i>
<i><u>Direct cause(s):</u></i>	<ul style="list-style-type: none"> <li>• <i>the locomotive driver did not stop at the shunting limit signal at the end of the 'T4' track</i></li> <li>• <i>the yard foreman did not meet the train in front of the signal box 'B' and did not give the train the 'Slow down!' and 'Stop!' handsignals as it is required by the Station Instructions</i></li> </ul>

<i><u>Contributory factor(s):</u></i>	<ul style="list-style-type: none"> <li>• <i>the driver did not have a professional, substantive route knowledge relating to the station's storage sidings and tracks</i></li> <li>• <i>the driver was busy with a protracted operational telephone call</i></li> </ul>
<i><u>Underlying cause(s):</u></i>	<ul style="list-style-type: none"> <li>• <i>the volume of work load concerning for staff working as yard foremen at the station may mean that they are not always able to carry out their duties fully</i></li> <li>• <i>having a legally valid route knowledge licence for locomotive drivers does not guarantee that their real knowledge is in fact adequate and up-to-date, and the associated risk is not managed by the safety management system</i></li> </ul>
<i><u>Recommendation(s):</u></i>	<i>none</i>

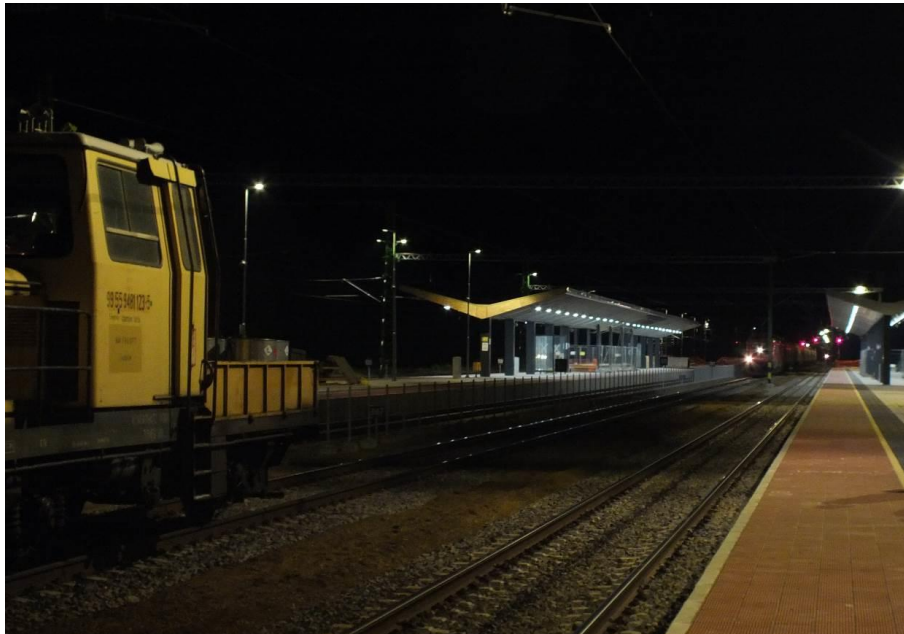
<i>Grade:</i>	<i>Railway incident</i>
<i>Date and time:</i>	<i>27 May 2020</i>
<i>Location:</i>	<i>Kaba (station)</i>
<i>Occurrence type:</i>	<i>Signal passed at danger</i>
<i>Movement type:</i>	<i>Locomotive running solo</i>
<i>Description:</i>	<i>The train no. 14566 (work train) passed the signal of Kaba station at danger and moved on towards the oncoming freight train no. 48911. Eventually the two trains stopped 200 metres away from each other.</i>
<i>Consequences:</i>	<i>0 fatality / 0 serious injury No damage (EUR 0)</i>
<i>Parties:</i>	<i>MÁV Zrt. (IM) MÁV FKG Kft. (RU) Rail Cargo Hungaria Zrt. (RU)</i>
<u><i>Direct cause(s):</i></u>	<ul style="list-style-type: none"> <li>• <i>both the driver (who is presumed to have fallen asleep) and the second attendant failed to detect the 'Danger' aspect of the second entry signal 'C' and neither of them stopped the vehicle before the signal</i></li> </ul>

<u><i>Contributory factor(s):</i></u>	<ul style="list-style-type: none"> <li>• <i>the driver and the second employee on watch had spent a large part of their time on night duty, which led to long-term fatigue</i></li> <li>• <i>the vehicle with registration number 99 55 9481 123-5 was not fitted with vigilance equipment that would have stopped the train if the driver had failed to react</i></li> </ul>
<u><i>Underlying cause(s):</i></u>	<ul style="list-style-type: none"> <li>• <i>the employees' need for resting periods was not taken into account in the scheduling of their working hours</i></li> </ul>
<u><i>Recommendation(s):</i></u>	<i>none</i>

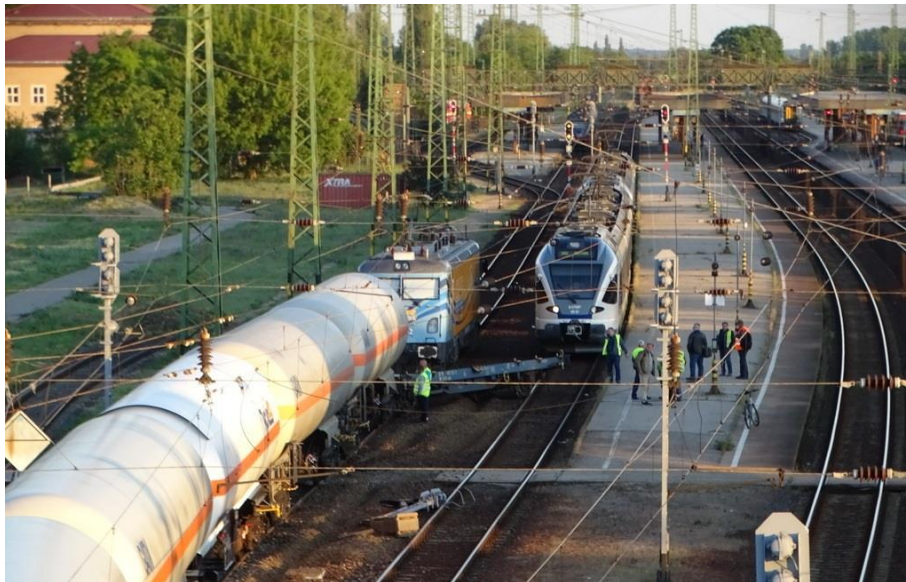
*Grade:* *Railway accident*  
*Date and time:* *2 June 2020*  
*Location:* *Hatvan (station)*  
*Occurrence type:* *Train derailment*  
*Movement type:* *Freight train*  
*Description:* *The freight train no. 45290-1 derailed on the switch no. 33 at Hatvan station.*  
*Consequences:* *0 fatality / 0 serious injury*  
*Total damage HUF 6,600,000 ( < EUR 150,000)*  
*Parties:* *MÁV Zrt. (IM)*  
*CER Hungary Zrt. (RU)*

- Direct cause(s):*
- *there was a rapid loss of gauge in the curve of № 33 set of points, which was not detected by the track supervision system and therefore was not corrected*

- *at the front of the train, a light wagon was inserted as a guard wagon, which was more sensitive for the trajectory error*
  - *the causes implied by the technical condition of the derailed wagon could not be investigated, but could not be excluded either*

*Recommendation(s):* ***The TSB recommends the Railway Authority Division, Ministry of Technology and Industry (as National Safety Authority) considering to review the safety management system and operation of MÁV Zrt. to ensure that it adequately provides for immediate corrective action to be taken in response to identified risks and that the company operates its safety management system accordingly.***

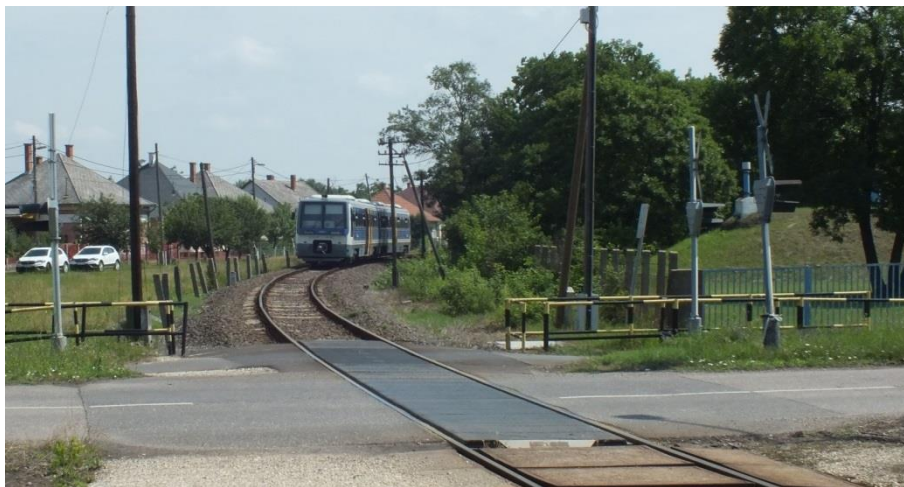
<i>Grade:</i>	<i>Railway incident</i>
<i>Date and time:</i>	<i>14 June 2020</i>
<i>Location:</i>	<i>Püspökladány (station)</i>
<i>Occurrence type:</i>	<i>Signal passed at danger</i>
<i>Movement type:</i>	<i>Regional passenger train</i>
<i>Description:</i>	<i>The passenger train no. 6417 could not stop thus passed the signal of Püspökladány station at danger. Eventually the train could stop 2,6 kilometres away from the station.</i>
<i>Consequences:</i>	<i>0 fatality / 0 serious injury No damage (EUR 0)</i>
<i>Parties:</i>	<i>MÁV Zrt. (IM) MÁV-START Zrt. (RU)</i>
<u><i>Direct cause(s):</i></u>	<ul style="list-style-type: none"> <li><i>a glide on an electrical cable has slipped off the electro-pneumatic brake valve connector on side A, causing the brake valve to fail</i></li> <li><i>the driver did not recognise the brake valve failure during troubleshooting and therefore did not apply the relevant rules</i></li> <li><i>the locomotive driver started the train after manual release of the brakes, despite the main pipeline pressure was 0 bar</i></li> <li><i>the locomotive driver had severe deficiencies in his knowledge of the type of locomotive and was therefore unable to activate the independent braking devices</i></li> </ul>

<u><i>Contributory factor(s):</i></u>	<ul style="list-style-type: none"> <li><i>the glides of the electrical wires connected to the brake valve were not the fixing lock type and were able to slip off the connector and cause the electro-pneumatic brake valve to fail</i></li> <li><i>the DMU train set does not have a main line pressure switch to prevent traction when the main brake line is empty</i></li> <li><i>the driver did not use the direct engine brake, even in an emergency, because he thought that it could lead to a technical failure</i></li> </ul>
<u><i>Underlying cause(s):</i></u>	<ul style="list-style-type: none"> <li><i>locomotive drivers' current knowledge of the type and decades of driving experience do not necessarily reflect their confidence in handling vehicles, and their knowledge is not always at a skill level</i></li> <li><i>the DMU train set was not overhauled within the required time</i></li> </ul>

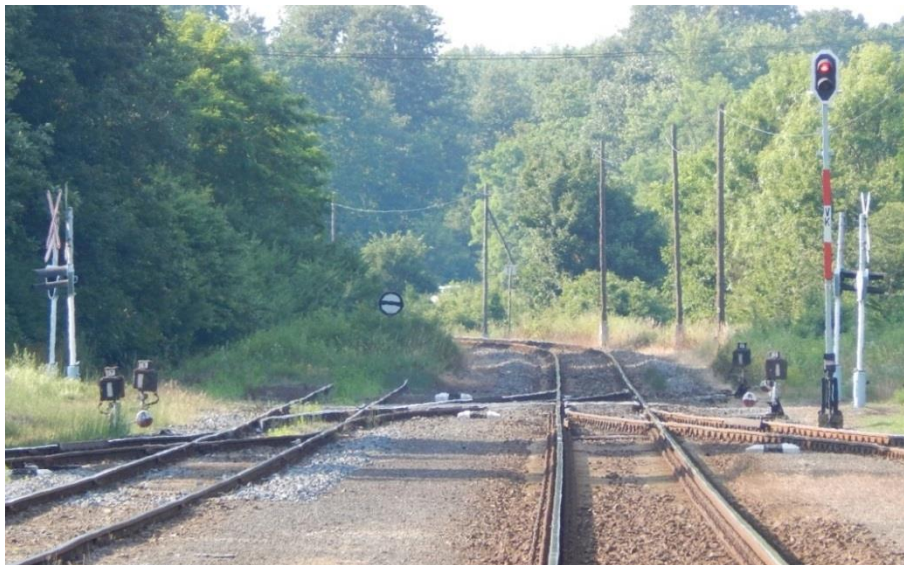
<i>Grade:</i>	<i>Railway incident</i>
<i>Date and time:</i>	<i>27 June 2020</i>
<i>Location:</i>	<i>Uzsa (station)</i>
<i>Occurrence type:</i>	<i>Signal passed at danger</i>
<i>Movement type:</i>	<i>Regional passenger train</i>
<i>Description:</i>	<i>The train no. 9694 passed the signal of Uzsa station at danger. Eventually the train was stopped by the engine driver.</i>
<i>Consequences:</i>	<i>0 fatality / 0 serious injury No damage (EUR 0)</i>
<i>Parties:</i>	<i>MÁV Zrt. (IM) MÁV-START Zrt. (RU)</i>
<u><i>Direct cause(s):</i></u>	<ul style="list-style-type: none"> <li><i>instead of passing through, as it was in the timetable of the train, the signaller wanted the train to stop at the station, but the locomotive driver did not intend to stop at the station and therefore did not apply the brakes in time</i></li> <li><i>the locomotive driver did not check the aspect of the level crossing protecting signal at the other end of the station and did not miss the authority (hand signal) to pass the station from the signaller</i></li> <li><i>the signaller did not meet the train at the trackside and did not give the “Slow down” hand signal because he was on the phone with the line traffic controller</i></li> </ul>

<u><i>Contributory factor(s):</i></u>	<ul style="list-style-type: none"> <li><i>the chief ticket inspector was staying in the driver’s cabin</i></li> <li><i>the pintsman did not stop the train at the entry signal</i></li> <li><i>the signaller prioritised his tasks incorrectly</i></li> <li><i>the line traffic controller changed the trains’ meeting point several times and issued his last order too late</i></li> </ul>
<u><i>Underlying cause(s):</i></u>	<ul style="list-style-type: none"> <li><i>the audit by the station master did not take action to address the poor practices identified after a previous similar incident at the station what are also relevant to this incident</i></li> </ul>
<u><i>Recommendation(s):</i></u>	<i>none</i>

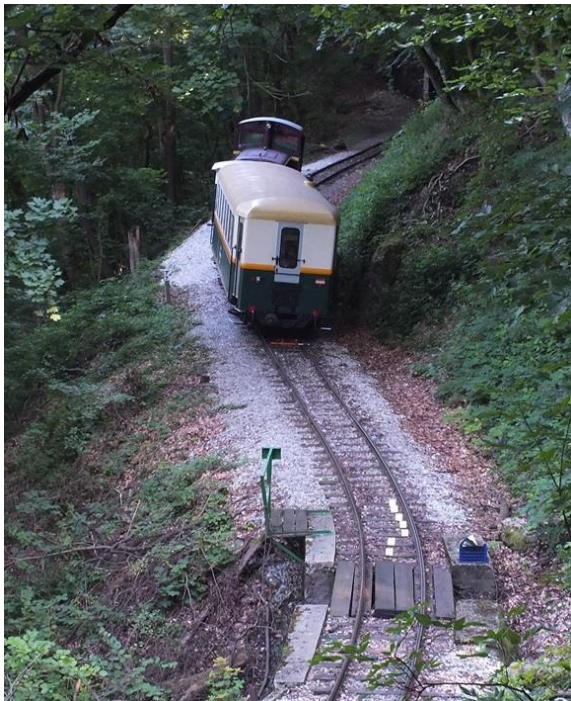
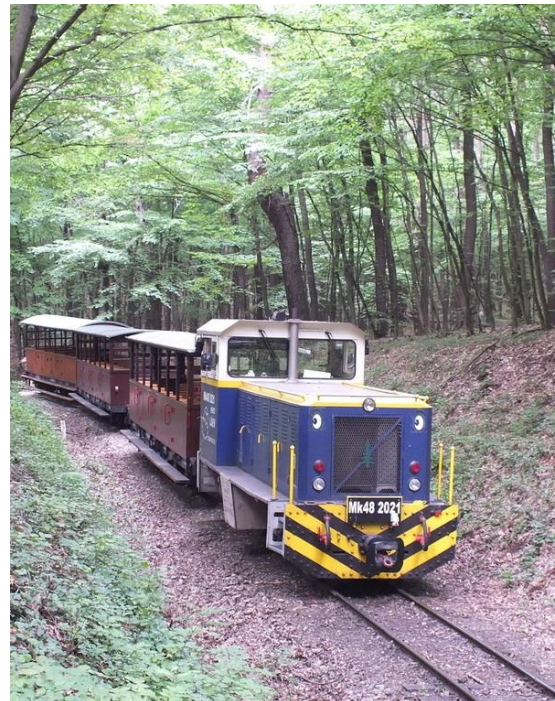
<i>Grade:</i>	<i>Heritage railway accidents</i>
<i>Date and time:</i>	<i>24 June 2020 / 10 July 2020 / 14 July 2020</i>
<i>Location:</i>	<i>Papírgyár - Puskaaporos, km 4,3 (line) / Lillafüred - Fazolakohó, km 7,7 (line) / Papírgyár - Puskaaporos, km 4,3 (line)</i>
<i>Occurrence type:</i>	<i>Train derailment</i>
<i>Movement type:</i>	<i>Heritage passenger trains</i>
<i>Description:</i>	<i>Three passenger trains derailed on the network of LÁEV narrow-gauge railway.</i>
<i>Consequences:</i>	<i>0 fatality / 0 serious injury Total damage &lt; EUR 150,000</i>
<i>Parties:</i>	<i>Északerdő Zrt. (IM) Északerdő Zrt. (RU)</i>

<u><i>Direct cause(s):</i></u>	<ul style="list-style-type: none"> <li>• <i>direct technical causes:</i> <ul style="list-style-type: none"> <li>○ <i>low wheel flange angles of derailed vehicles, which is a normal consequence of the overhaul</i></li> <li>○ <i>high friction between the wheel and the rail, which can be traced back to</i> <ul style="list-style-type: none"> <li>– <i>the high proportion of vehicles that are refurbished, and</i></li> <li>– <i>the lack of rail lubrication;</i></li> </ul> </li> <li>○ <i>high guiding force on the derailed wheels, which is due to</i> <ul style="list-style-type: none"> <li>– <i>in track section 43, the modified coupling of the wagon turned the bogie out</i></li> <li>– <i>in track section 77, the car could not follow the change of the track curve due to the sliding plate being jammed and there was too little superelevation of the outer rail of the track</i></li> </ul> </li> <li>○ <i>wagon 012 had a low wheel load because the wagon did not tolerate the track distortion</i></li> </ul> </li> <li>• <i>additional causes:</i> <ul style="list-style-type: none"> <li>○ <i>high percentage of refurbished vehicles on the line</i></li> <li>○ <i>the incorrectly modified coupling design</i></li> <li>○ <i>the overall quality of the refurbishment of the wagon № 012 was poor, the refurbisher did not have sufficient railway experience and was not officially licensed</i></li> <li>○ <i>application of standards and regulations that are not appropriate to the railway system</i> <ul style="list-style-type: none"> <li>– <i>in the absence standards for own and forest railways</i></li> <li>– <i>over-reliance on similar specifications from other railway companies</i></li> </ul> </li> </ul> </li> </ul>

***The TSB recommends to Északerdő Zrt. to develop standards for coupling devices for all (applicable) types used, ensuring safe coupling and/or imposing application restrictions, with the involvement of similar railway companies.***

***The TSB recommends to Északerdő Zrt. to clearly identify the person responsible for making technical decisions in the ongoing vehicle renewal (and the planned track renewal) project.***

***The TSB recommends the Rail Technical Committee to develop technical rules for narrow gauge railways with the meaningful involvement of the narrow gauge rail industry, with regulatory requirements proportionate to the risks and opportunities of these railways.***

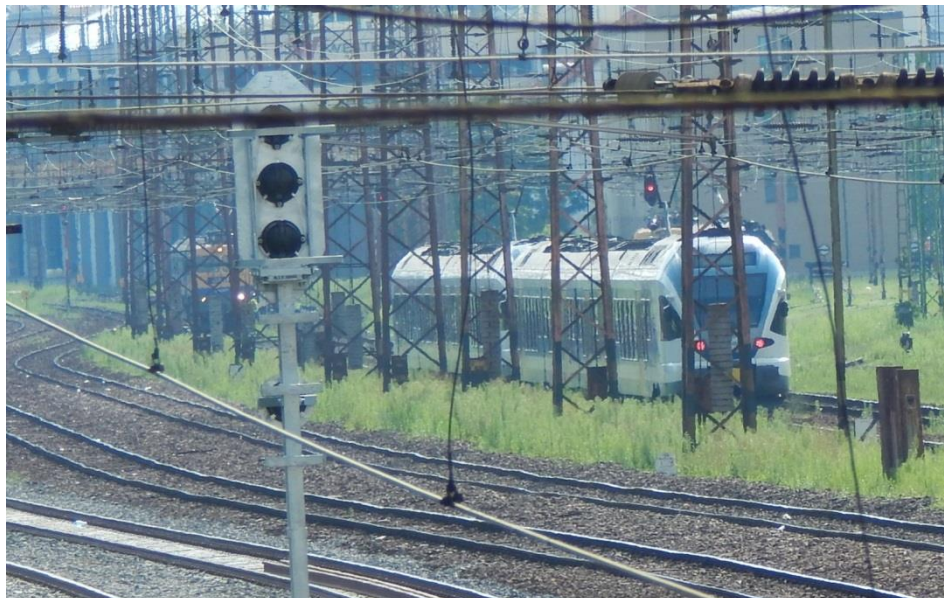
<i>Grade:</i>	<i>Railway incident</i>
<i>Date and time:</i>	<i>23 July 2020</i>
<i>Location:</i>	<i>Budapest-Nyugati (station)</i>
<i>Occurrence type:</i>	<i>Signal passed at danger</i>
<i>Movement type:</i>	<i>Locomotive running solo</i>
<i>Description:</i>	<i>The train no. 22425 passed the signal „G” of Budapest-Nyugati station at danger and moved on towards the oncoming passenger train no. 2346. Eventually the two trains stopped 288 metres away from each other.</i>
<i>Consequences:</i>	<i>0 fatality / 0 serious injury No damage (EUR 0)</i>
<i>Parties:</i>	<i>MÁV Zrt. (IM) MÁV-START Zrt. (RU)</i>
<u><i>Direct cause(s):</i></u>	<ul style="list-style-type: none"> <li>• <i>after the train № 2036 (moving in the opposite direction) had passed, the locomotive driver of train № 22425 departed without authorisation and without observing (or after not observing it carefully enough) the aspect of signal "G" which was in 'Danger'</i></li> </ul>

<u><i>Contributory factor(s):</i></u>	<ul style="list-style-type: none"> <li>• <i>the 75 Hz continuous signal transmission for train control systems is not installed at the location of the occurrence, so active train control is not available there</i></li> <li>• <i>the personnel of the traffic-regulating signal box № 2 did not notice that train № 22425, which had been waiting in their area, started to move without authorisation, passed the area of the train-regulating signal box № 2 and then entered the track which lead towards signal box № 1, and so did not take any action to stop the dangerous movement(s)</i></li> </ul>
<u><i>Underlying cause(s):</i></u>	<ul style="list-style-type: none"> <li>• <i>the train protection system based on 75 Hz track-circuit signals is not suitable to prevent head-on traffic when it is only partially installed</i></li> </ul>
<u><i>Recommendation(s):</i></u>	<i>none</i>

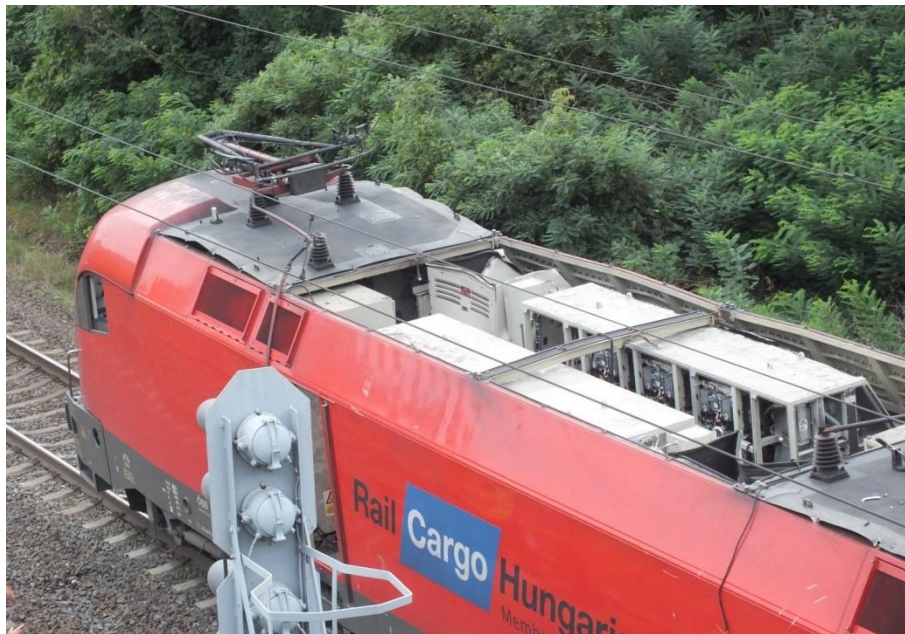
<i>Grade:</i>	<i>Railway accident</i>
<i>Date and time:</i>	<i>14 August 2020</i>
<i>Location:</i>	<i>Biatorbágy (station)</i>
<i>Occurrence type:</i>	<i>Fire in rolling stock</i>
<i>Movement type:</i>	<i>Freight train</i>
<i>Description:</i>	<i>There was an explosion inside the electric-engine of the freight train no. 92905 and the roof of the engine fell down onto the second track, where the oncoming passenger train no. IC910 collided with the pieces of it.</i>
<i>Consequences:</i>	<i>0 fatality / 0 serious injury Total damage EUR 150,000 – 2,000,000</i>
<i>Parties:</i>	<i>MÁV Zrt. (IM) Rail Cargo Hungaria Zrt. (RU) MÁV-START Zrt. (RU)</i>
<u><i>Direct cause(s):</i></u>	<ul style="list-style-type: none"> <li>• <i>one capacitor of the locomotive was overheated, and produced a combustible gas which inflamed, because</i> <ul style="list-style-type: none"> <li>– <i>the materials of the capacitor decompose as a result of heat and</i></li> <li>– <i>the detection and venting of such gases is not ensured</i></li> </ul> </li> <li>• <i>the failure can be traced back to the capacitor's manufacturing de-fect, or possible overvoltage</i></li> </ul>

<u><i>Contributory factor(s):</i></u>	<ul style="list-style-type: none"> <li>• <i>the locomotive driver did not respond adequately to the fire alarm that had appeared, because sometimes false fire alarms do occur</i></li> </ul>
<u><i>Underlying cause(s):</i></u>	<ul style="list-style-type: none"> <li>• <i>the failure of the capacitors had been a known phenomenon, but its safety risks were underestimated</i></li> </ul>
<u><i>Recommendation(s):</i></u>	<i>none</i>

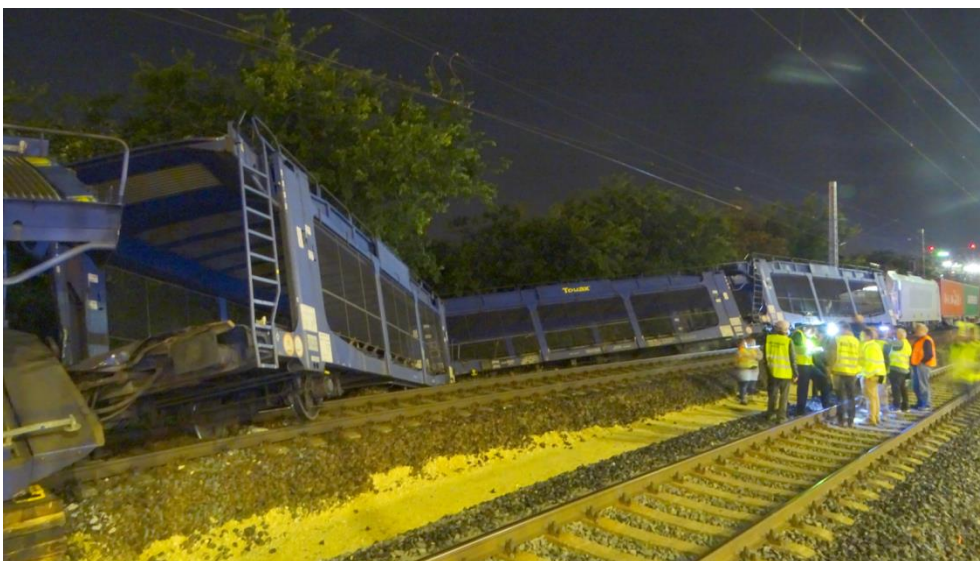
<i>Grade:</i>	<i>Railway accident</i>
<i>Date and time:</i>	<i>7 October 2020</i>
<i>Location:</i>	<i>Ferencváros - Kelenföld, km 8,2 (line)</i>
<i>Occurrence type:</i>	<i>Trains collision</i>
<i>Movement type:</i>	<i>Freight train</i>
<i>Description:</i>	<i>The freight train no. 42000-1 passed the section signal '83a' at danger and collided with the end of the freight train no. 47141 which was standing 21 metres behind the signal. The last 2 twin-wagons of the train no. 47141 derailed, the engine of the train no. 42000-1 was damaged.</i>
<i>Consequences:</i>	<i>0 fatality / 0 serious injury Total damage HUF 15,000,000 ( &lt; EUR 150,000)</i>
<i>Parties:</i>	<i>MÁV Zrt. (IM) METRANS Danubia Kft. (RU) LTE Hungária Kft. (RU)</i>
<u><i>Direct cause(s):</i></u>	<ul style="list-style-type: none"> <li><i>the locomotive driver did not apply the brake in time because he did not scan the 'Danger' signal he was approaching</i></li> <li><i>the locomotive driver was occupied by handling an error message which had appeared on the display when he ought to have been prepared for stopping the train</i></li> <li><i>the train control system in use at the time of the occurrence is not suitable for avoiding similar cases</i></li> </ul>

<u><i>Contributory factor(s):</i></u>	<ul style="list-style-type: none"> <li><i>while the vehicle was in motion, the locomotive driver opened a description of tasks to do at standstill, related to the error message</i></li> <li><i>the description was unprofessional</i></li> <li><i>this error message occurs frequently, and if it is handled inappropriately, it may be necessary to restart the locomotive, which is a time-consuming process; the locomotive driver was aware of it, which resulted in him a stressful situation</i></li> <li><i>the use of short blocks increases the risk of collision in cases of signal overrun</i></li> </ul>
<u><i>Underlying cause(s):</i></u>	<ul style="list-style-type: none"> <li><i>none</i></li> </ul>
<u><i>Recommendation(s):</i></u>	<i>none</i>
