Railway Accident Investigation Unit Ireland

Annual Report
2021

Summary

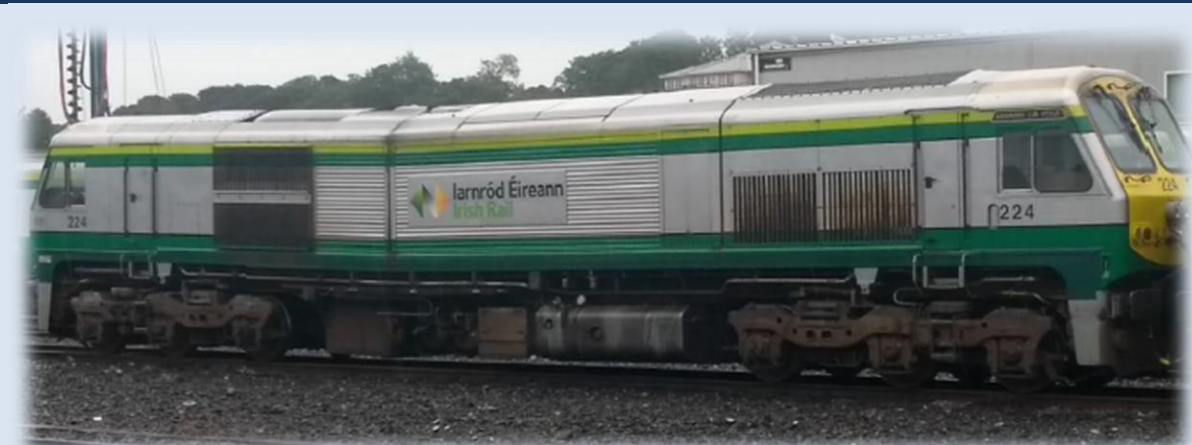
Chassis Plate Fracture on General Motors Class 201, Locomotive 224, 7th July 2020

IE 201 Class Locomotives were manufactured by General Motors in Canada and entered service in 1994. Locomotive 224 had its engine and generator removed in 2010 and 2019 for maintenance. When the engine and generator was removed cracks were identified in the Bed Plate (non-structural component) between the two Chassis Plates (structural component) of the Locomotive. IE carried out weld repairs to the Bed Plate but the weld repair did not conform to the EN15085 2007 standard series, entitled, "Railway applications - Welding of railway vehicles and components" or any IE approved written specification; and, on one occasion (in 2010 or 2019) the weld repair was unnecessarily continued from the Bed Plate into the Chassis Plate.

On the 7th July 2020, while Locomotive 224 was at Heuston Station awaiting transfer to Inchicore Works, a driver observed the body of Locomotive 224 was sagging near the centre point and reported it to his supervisor who in turn alerted the relevant parties. On inspection, by the Chief Mechanical Engineer's (CME) Department's maintenance staff a main frame crack was identified. Locomotive 224 was then shunted to Inchicore Works for a more thorough examination. The Locomotive's engine and generator were removed to give a clear view of the damage. The crack was examined by IE's Chief Chemist and Metallurgist, who was independently supervised by a metallurgist specialist, contracted by the RAIU. The metallurgical investigation identified that the failure occurred in the weld repair of the Bed Plate that was continued into the Chassis Plate.

In service, cyclic loading, particularly bending stress on the underside of the Chassis Plate (that had high residual tensile stresses generated from within the repair weld), resulted in multiple fatigue initiation sites developing and merging into a common crack that propagated through the Chassis Plate during the journey causing the Chassis Plate to fracture. The loss of integrity to the structure of Locomotive 224 resulted in a coolant pipe been disturbed and subsequent leak and the misalignment of the generator resulting in and electrical shut down fault.

- The flat Bed Plates were not replaced with cupped Bed Plates when Bed Plate cracks were identified as set out in the Original Equipment Manufacturer (OEM) Service Advisory SA 08-007;
- During a weld repair of the Bed Plate, the Bed Plate was unnecessarily welded to the Chassis Plate.

- IÉ-RU CME should review all weld repairs carried out to structures of all rolling stock to assess the risk posed by such weld repairs and mitigate against the failure mode;
- IÉ-RU CME should develop a procedure for evaluating maintenance advice received from OEMs or other railway organisations to determine applicability to IÉ fleets and assess any associated risks.

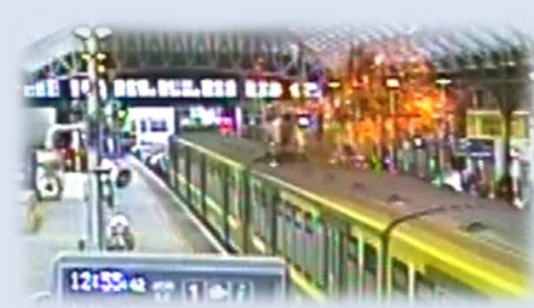
Overhead Line detachment, Pearse Station, 1st October 2020

At approximately 12:55 hrs on the 1st October 2020, the 12:04 hrs IE DART service from Greystones to Howth (Train E920) was coming to a stop in Pearse Station when the second pantograph (Pantograph 396) of the train set (Unit 8128) lost contact with the Contact Wire of the Overhead Line Equipment (OHLE). The Pantograph Head and Upper Arm lowered rapidly resulting in the Pantograph

Lower Arm extending to its maximum reach and contacting the OHLE. This action caused the Pantograph Lower Arm to flip, driving the Upper Arm and Pantograph Head on to the roof of the train resulting a short circuit and a large flashover. The short circuit caused a loss of power to the OHLE in the section. Train E920 coasted before being brought to a stop, on Platform 1, by the driver (Driver E920).

- The short circuit between the Pantograph Head and the roof of the train caused the Catenary Wire to overheat, reducing its strength, detaching and falling onto Platform 1;
- The OHLE in Pearse Station is positioned at 4.46 m above the rail allowing the Pantograph Lower Arm to strike the OHLE in the event of a Pantograph elbow chain failure;
- The elbow chains on Pantograph 396, on EMU 8128, failed due to excessive wear of the chain pins and chain link holes over a period of time due to the lack of lubrication;
- The failure of Pantograph 396's elbow chains resulted in the Lower Arm rising and the Upper Arm and Head lowering; providing an electrical path for a direct connection between the OHLE and the train body;
- The High Speed Circuit Breaker Auto-Reclose restored power to the failed section.

- The pantograph planned preventative maintenance regime did not identify the deterioration in the chains of Pantograph 396 or the poor condition of the grease that had previously been applied;
- The information contained in the IÉ CME-TMS-316 Department Engineering Change files for the extension of the pantograph overhaul from three to five years does not substantiate the conclusion reached, highlighting a lack of governance in the outsourcing of the overhaul of EMU pantographs;
- The compliance checks on the EMU fleet did not include the checking of pantographs.

- IÉ-RU CME should in conjunction with the OEM develop a maintenance regime for the pantographs, taking into consideration the operational conditions and traceability of safety critical components;

- IÉ-RU CME should carry out, in conjunction with the OEM, a condition assessment to determine the correct period for the overhaul of the IÉ-RU pantographs;

- IÉ-RU CME to include requirements to check pantograph maintenance activities in the Compliance Coordinators documentation records / check sheets;
- IÉ-IM SET should evaluate the auto-reclose function of the OHLE control system on the DART network to ensure the safe operation in the event of failures which could expose staff and passengers to live OHLE.

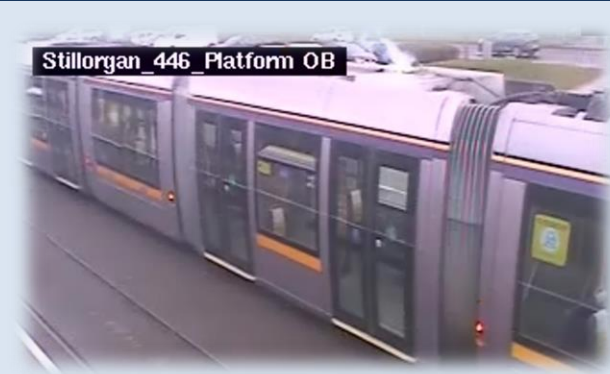
Luas Overhead Line Failure, Stillorgan, 2nd November 2020

On 2nd November 2020 the 14:31 hrs Luas Service 65 (operated by Tram 5010) from Brides Glen to Broombridge served Stillorgan inbound platform before moving forward to Signal B11. The driver of Tram 5010 (Driver 5010) noticed the Main Circuit Breaker (MCB) had opened in the driving cab (the MCB opened due to its failure to detect 750 volts (V) Direct Current (DC) from the Overhead Contact

The Traffic Supervisor viewed the images from the CCTV cameras located at the Stillorgan Stop and saw the OCS had broken and was lying across the top of Tram 5010, the outbound track and platform. The Traffic Supervisor instructed Driver 5010 not to open the passenger doors and to keep all passengers inside the tram until otherwise advised. The Supervisory Control And Data Acquisition (SCADA) system indicated that the section in the area of Stillorgan was de-energised.

A systemic factor identified that the OCS inspection regime was not robust and failed to identify OCS wire necking, as evidenced at numerous locations on the Green Line.
