MINISTERUL TRANSPORTURILOR ȘI INFRASTRUCTURII
AGENȚIA DE INVESTIGARE FERROVIARĂ ROMÂNĂ - AGIFER

ROMANIAN RAILWAY INVESTIGATION AGENCY - AGIFER -

ANNUAL REPORT

2022

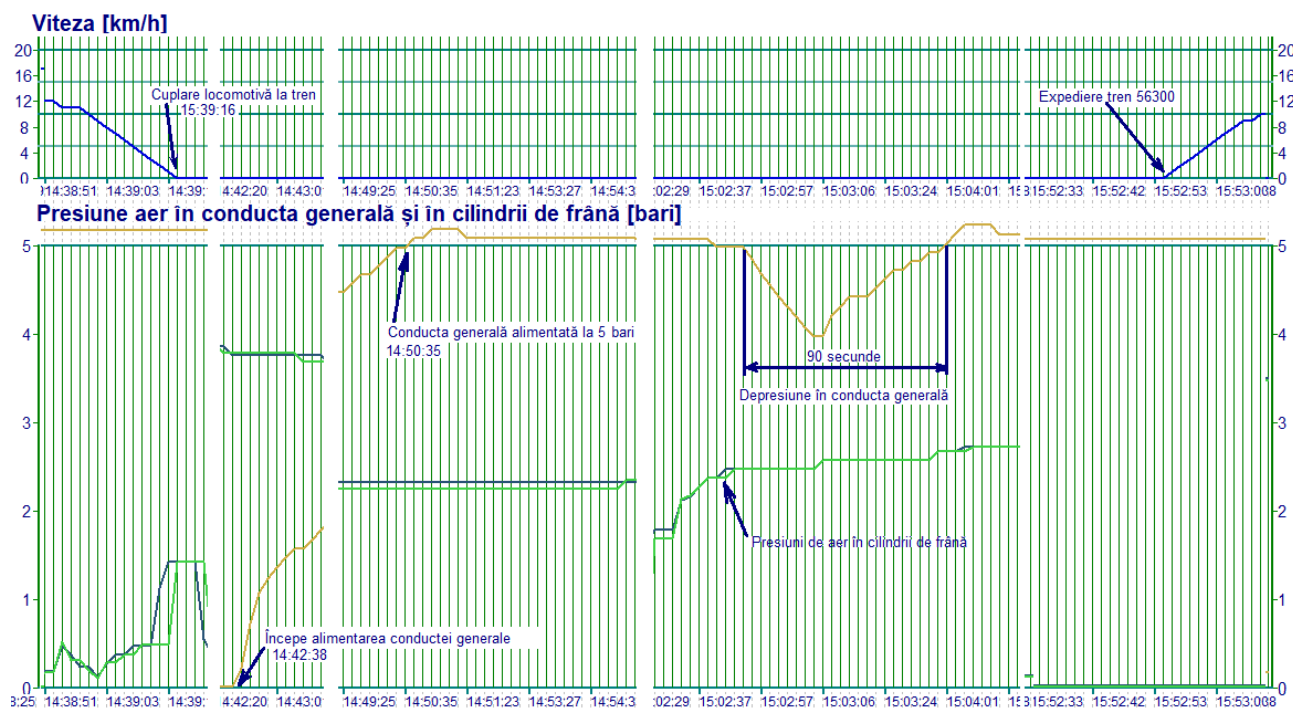
Figure no.5 - Air pressure into the general pipe and into the brake cylinders in the railway station Crivina.

Likewise, the slight increases of the pressure into the brake cylinder are due to some air losses at the triple valve of the locomotive and these pressures were removed periodically by the operation of the release valve by the driver. The investigation commission concluded the effectiveness of the automatic brake was not tested after the dispatching of the train 56300-1.

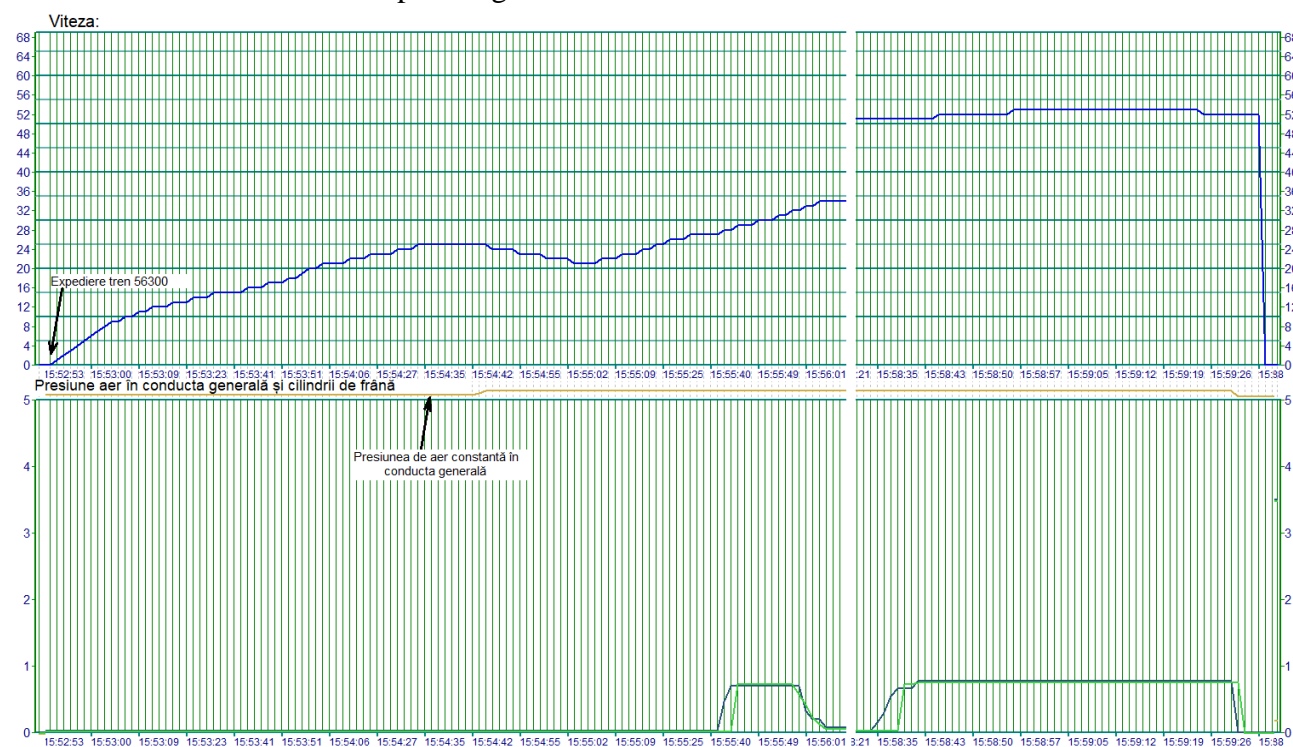
Figure no.6 – Air pressures into the general pipe and into the brake cylinders after the dispatching of the freight train no.56300-1 from the railway station Crivina.
