MINISTERUL TRANSPORTURILOR ȘI INFRASTRUCTURII
AGENȚIA DE INVESTIGARE FERROVIARĂ ROMÂNĂ - AGIFER

ROMANIAN RAILWAY INVESTIGATION AGENCY - AGIFER – ANNUAL REPORT

2020

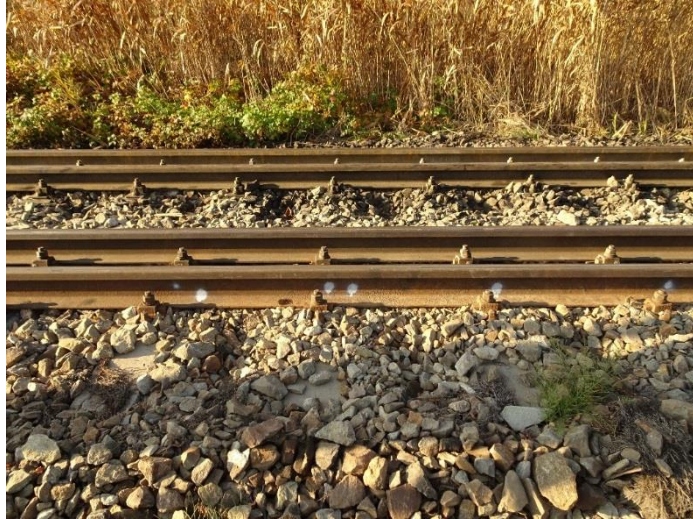
photo no.18

- on the walked distance, the superstructure of the mixed track consisted in rails type 49 fitted on the reinforced concrete sleepers type T19A, non-welded track;
- the head of District no.4 Dornești had made an inventory of the sleepers, the improper sleepers to be replaced of emergency I and II being marked properly on the common-crossing of the rail, right rails (in the direction of the track km) (photo no.18);

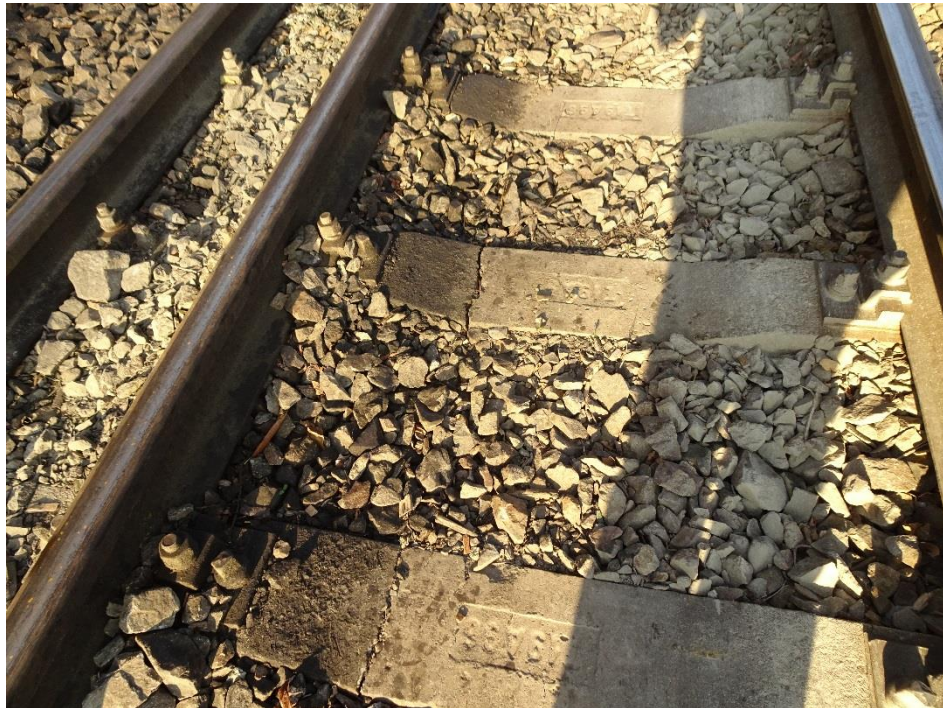
photo no.19

- concrete sleepers T19 A with transversal cracks close to the block (photo no.19);

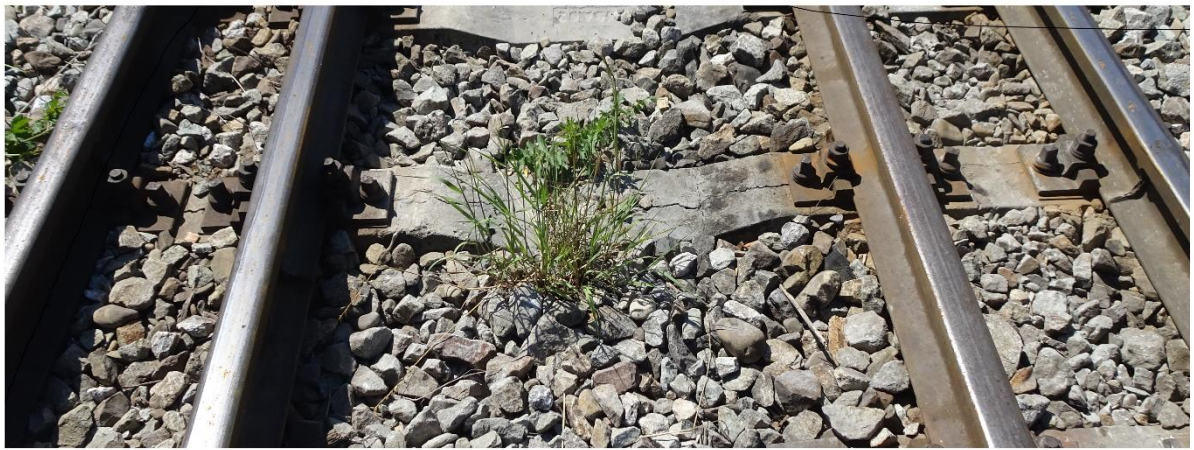
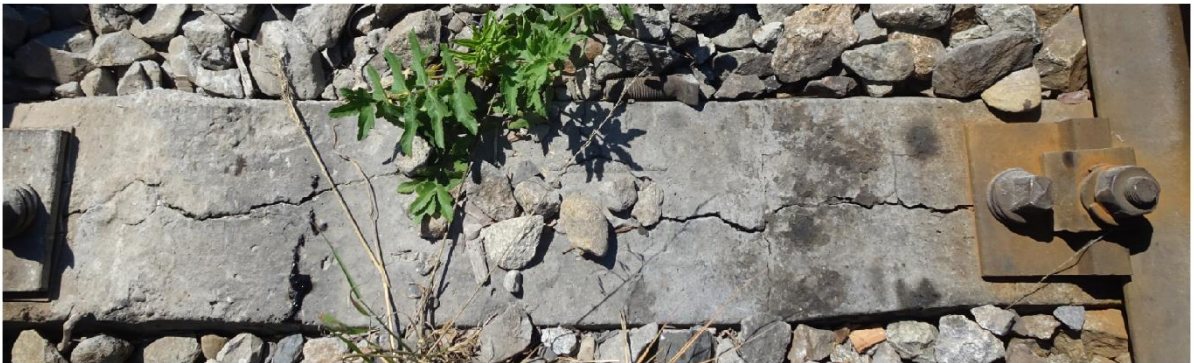
photo no. 20

- concrete sleepers T19 A within the track length with longitudinal cracks (photo no.20);

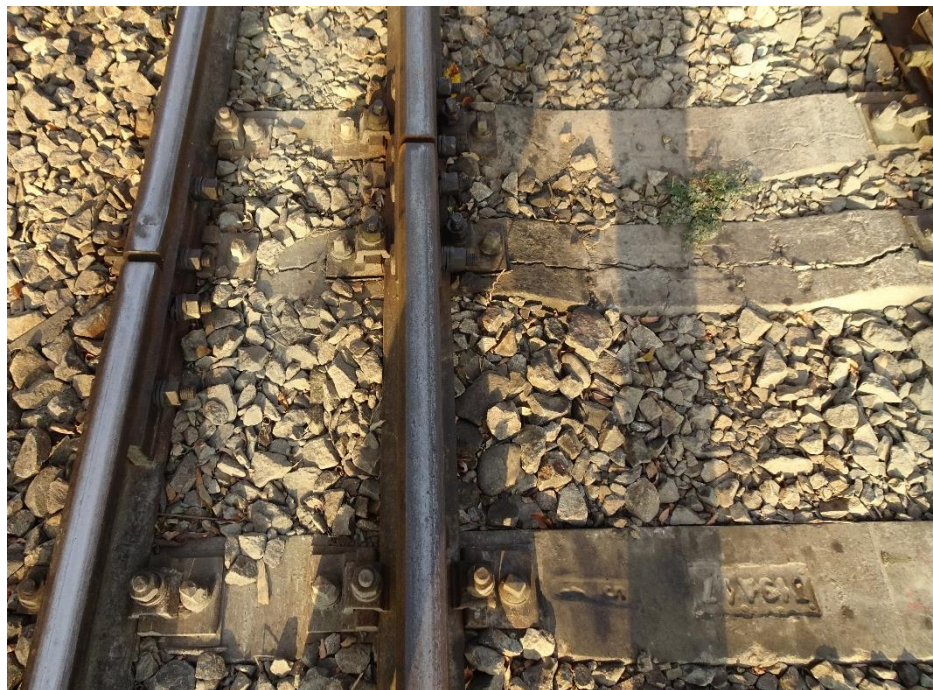
photo no.21

- joints that do not meet with the instruction, without special sleepers for joints. Because of it, in some situations the metallic plates cannot be fitted, or if these can be fitted, then it is not possible the fastening of the rail bases using clips type K, following the position of the horizontal screws for the fastening of the joint fish plates. All of these generate the destruction of the sleepers from the joints (photos no.21, 22);

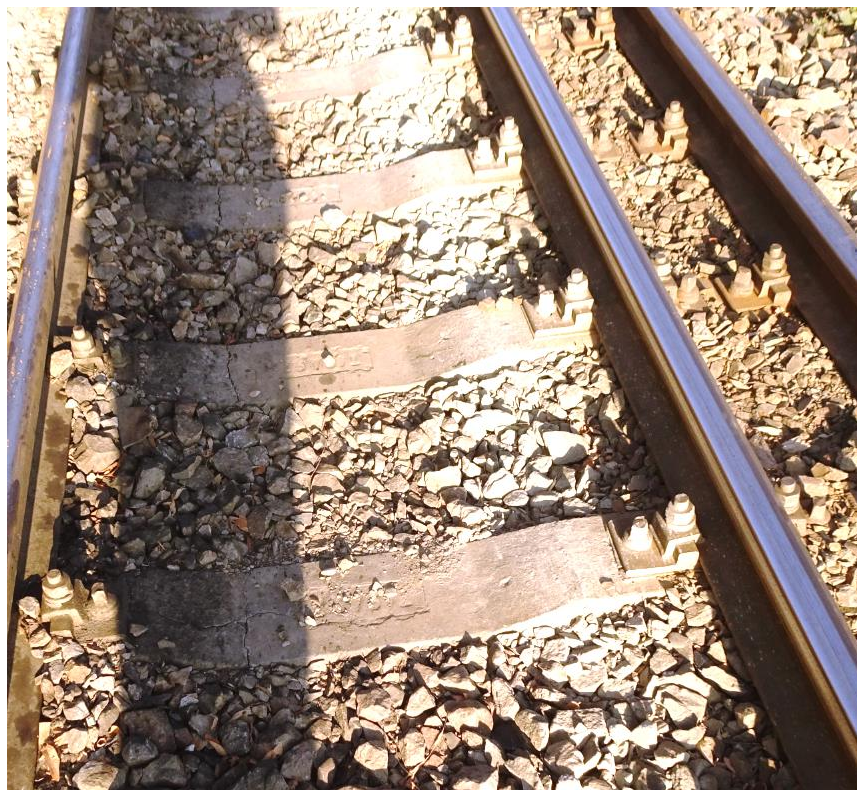
photo no. 23

- consecutive sleepers with cracks and ruptures (photo no.23).
