AIR, MARITIME AND RAILWAY ACCIDENT AND INCIDENT INVESTIGATION UNIT

ANNUAL REPORT OF THE INVESTIGATION BODY FOR RAIL TRANSPORT OF THE REPUBLIC OF SLOVENIA FOR 2019

Ljubljana, 18 September 2020

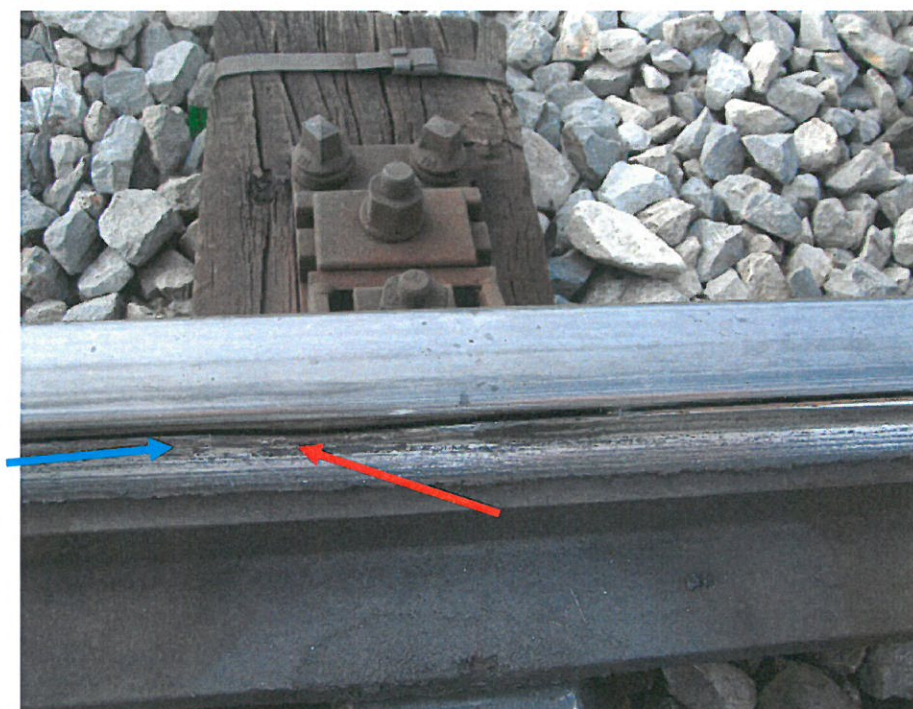
Photo 1: The red arrow points to the site of the flange of the left wheel of the first axle of locomotive no. 363-031 of train no. 93724 climbing onto the right damaged blade of point no. 49 above sleeper 3, while the blue arrow points in the direction of travel.

It was determined during the investigation that the direct cause for the derailment of the locomotive of train no. 93724 at point no. 49 of Sežana station on 20 September 2018 at 13:58 was the exceptionally poor condition of the right diverging blade which was severely worn out in the length of 2.5 metres from the top of the blade.

Indirect cause could be attributed to the poor stability of the point being used since 1973. Despite regular maintenance (mechanical regulation, replacement of worn-out elements), the stability of the point degrades over the years due to burdening.

Indirect cause could also lie in the travelling dynamics of the train along the section of the track that makes an 'S' curve directly before the point and that means that the resistance of the track is increased and more traction is required to overcome it.

- establish a register of hazardous points and a plan of examining such points, which must be adjusted to the time of exploitation of points and the weight of good transported over these points. The points being used longer and those that are more heavily burdened must be examined at more frequent intervals;
- produce limit values of wear for individual point elements with an emphasis on the wear of diverging blades;

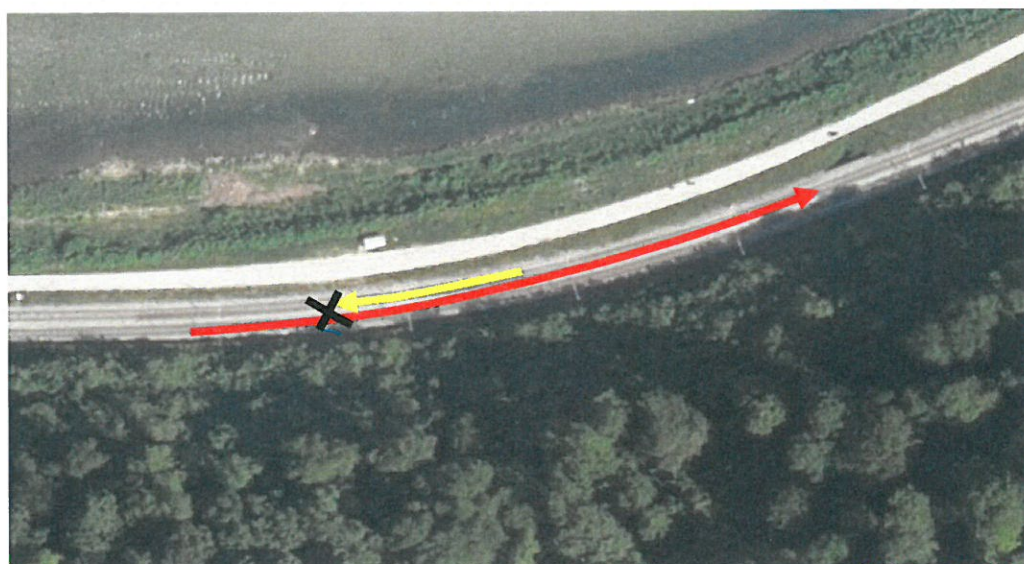
Photo 2: The red arrow shows the direction of movement of train no. 18, and the yellow the direction of travelling the motor railway vehicle. The black cross shows the site of scraping.

It was established during the investigation that the direct cause of scraping IC train no. 18 against the element for connecting machines to the drilling machine on steel caterpillar tracks, Comacchio MC 600, on 23 November 2018 at 14:32, was the extension of the drilling machine of the subcontractor, Geokop inženiring, which was loaded onto the wagon of the contractor, Tegrad, during drilling on the outer side of the closed left track into the normal clearance profile of the right track.

During the works performed on the left track, the drill was occasionally in the gauge of the neighbouring right track where the transport of trains took place between Laško and Celje stations in both directions. At the time when the drilling machine was in the gauge of the neighbouring track, the basic safety provisions stating that the traffic on the neighbouring track must be stopped unconditionally in such cases were not observed.

Indirect cause may lie in the inappropriately secured work site at the time of drilling. To ensure safer work of workers and machines along the working track, the normal clearance profile of the transport track would have to be marked in the area of works by installing a warning tape on corner profiles that are attached under the foot of the nearby track of the working track as prescribed in point 19 of the Safety plan study.

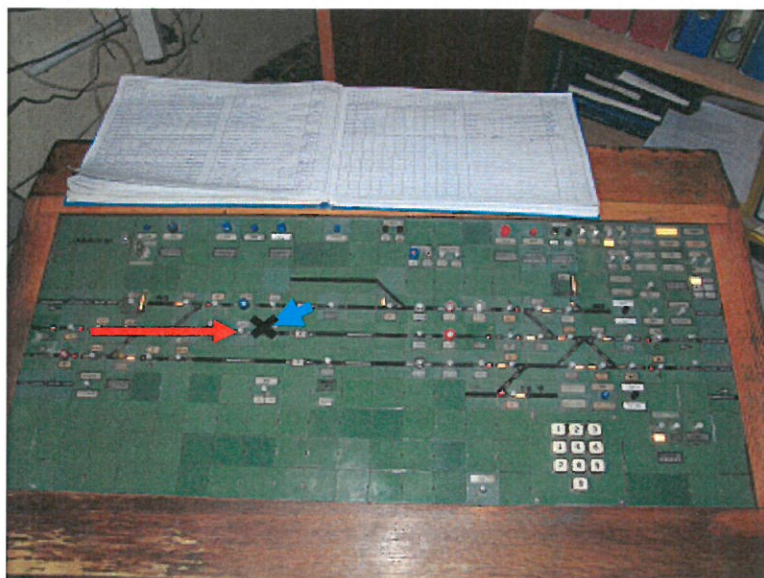
Photo 3: The red arrow on the control panel of the relay signalling and safety device of Kresnice station shows the route of passenger train ICS no. 20, the blue arrow shows the worker's movement towards the clearance profile of track no. 2, and the black cross marks the site of collision between the train and the worker.

It was established during the investigation that the direct cause of the collision of passenger train ICS no. 20 with the worker who performed finishing works of the investment maintenance of track no. 3 at Kresnice station in a supervised group on 26 November 2018 at 15:30 was the worker's entry into the hazardous area of the neighbouring track despite warnings from the working group's watchman.

The indirect cause of the accident was the omission of the work-site protection as prescribed in point 2.7. Protection method – work in the railway area of the Safety plan study.

It is also probable that one of the indirect causes for the collision of train no. 20 and the worker who was approaching the hazardous area while moving backwards in the clearance profile of track no. 2 between track nos. 2 and 3 of Kresnice station lies in the worker's confusion due to the noise caused by the company, Industrija apna Kresnice, which is situated in the immediate vicinity of the site of accident.

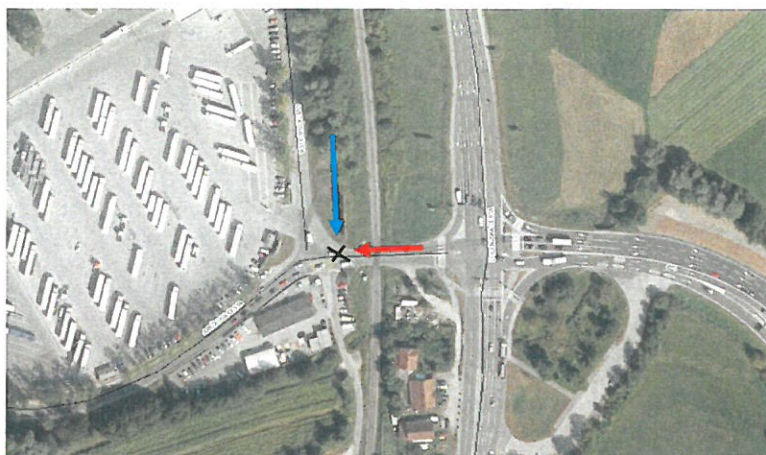
Photo 4: The red arrow shows the route of the goods road motor vehicle on Jurčkova cesta road from Dolenjska cesta road in the direction of the Rudnik shopping centre, the blue arrow shows the travelling direction of passenger train no. 3281, which drove from Ljubljana to Novo mesto, and the black cross marks the site of collision.

The direct cause of collision between local passenger train no. 3281 and the goods road motor vehicle located on the railway track at the level crossing of a road and railway at the moment when the train switched on the device for protecting the level crossing was the positioning of the goods road motor vehicle on the hazardous area of the track. When the half barriers were descending, the goods road motor vehicle was unable to move from the hazardous area of the track in time due to condensed road traffic.

The indirect cause lies in the stopping of goods road motor vehicles at the entrance to the car park of Viator&Vektor, which resulted in the road traffic congestion at the crossroads and consequently at the level crossing.

Another indirect cause is also low visibility of the track due to trees and bushes growing along the track, which obstructed the view.

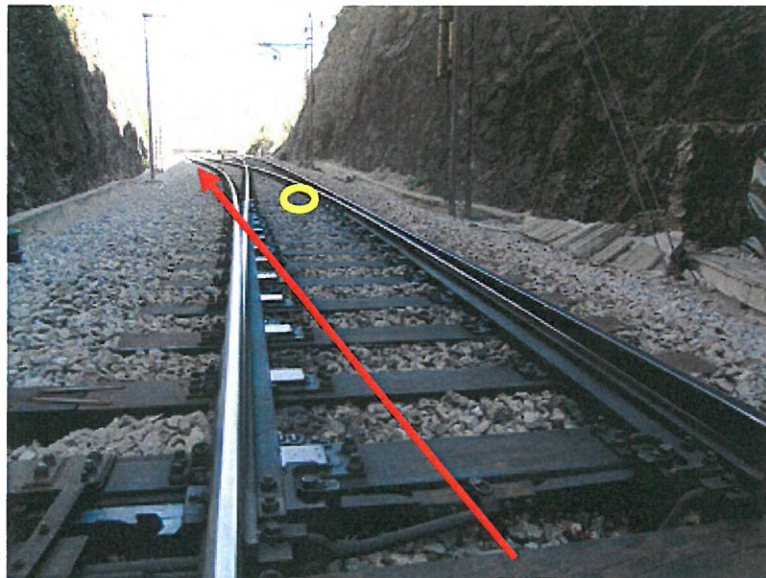
Photo 5: The red arrow shows the travelling direction of train no. 47913 over point no. 1, while the yellow circle shows the break point of the right blade. The blade broke between sleepers 11 and 12.

The direct cause of the accident of train no. 40882 on 25 June 2019 at 14:40 lies in the moving along right broken point blade no. 1 in deviation when leaving Hrastovlje station on track no. 2 towards Divača station.

The reason for the breaking of the right blade when train no. 47913 travelled towards the blade in deviation when entering track no. 2 on 25 June 2019 at 11:44 was insufficient rigidity of the blade's support (sleepers), which caused greater subsidence of the blade resulting in the break. Since stability of the ballast and substructure was not ensured at point no. 1, subsidence was too great at certain sections of the blade, causing the occurrence of micro-fractures in the blade, which advanced to the point of instantaneous break.

The result of the right blade breaking was the derailment of six carriages/tank wagons of train no. 40882, on one of which the tank shell cracked when sliding along the circumference of the tunnel. Some 7,611 litres of flammable liquid (aviation fuel/kerosene) were discharged into the ground of the tunnel. The escaped liquid posed a significant environmental hazard because the area of the accident is located in the area of drinking water catchment for the Primorska coastal region.

- draft a list of points as per their risk exposure and adjust accordingly the monitoring cycle which must be dependent on the age of the point and its burdening (if the point is older and more burdened, the inspections must be more frequent);
- the cycle of point maintenance must be adjusted to their age and burdening (if the point is older and more burdened, maintenance cycles must be more frequent), and the regulation and replacement of worn parts, e.g. sleepers, sliding plates, track fastening material, etc., must be implemented more frequently;
- the circumference of the tunnel must be treated so that the surface is smooth with no sharp edges or protruding rocks.

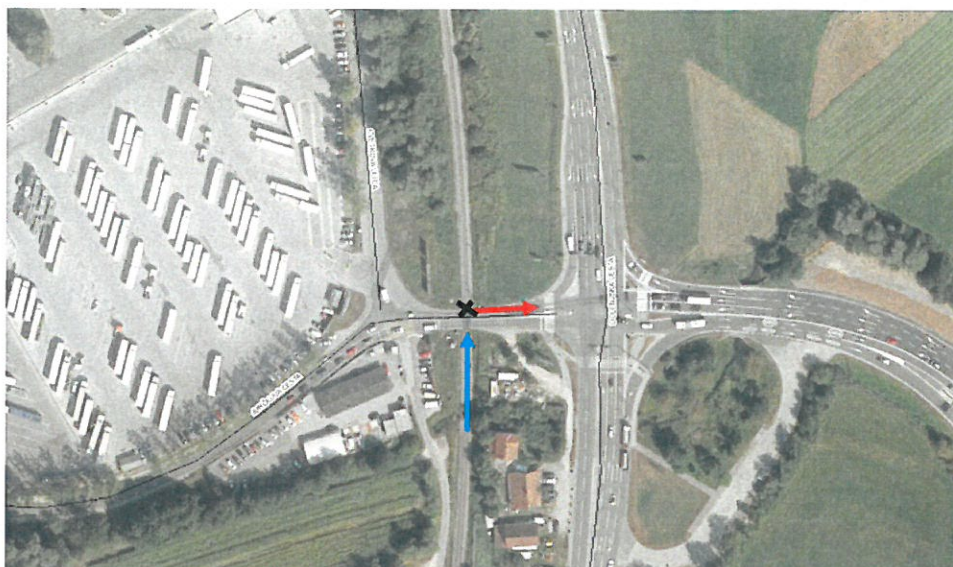
Photo 6: The red arrow shows the route of the semi-trailer on Jurčkova cesta road from the Rudnik shopping centre in the direction of Dolenjska cesta road, the blue arrow shows the travelling direction of passenger train no. 3220, which drove from Novo mesto to Ljubljana, and the black cross marks the site of collision at the level crossing.

The direct cause of collision between local passenger train no. 3220 and the rear end of the semi-trailer located on the railway track at the level crossing of a road and railway at the moment when the train switched on the device for protecting the level crossing was the positioning of the semi-trailer in the hazardous area of the track. When the half barriers were descending, the goods road motor vehicle was unable to move in time from the hazardous area of the track because the road traffic was stationary.

The indirect cause of the accident lies in the density of road and railway infrastructure in a relatively small area. Road congestion occurs as road traffic is regulated by traffic lights at the crossroads of Jurčkova cesta road and Dolenjska cesta road, the access to the southern Ljubljana bypass and the dynamics and density of road traffic in the area of the level crossing, which frequently results in incorrect assessment of the drivers' available space at the crossing.

Another indirect cause is also low visibility of the track due to trees and bushes growing along the track, which obstructed the view.

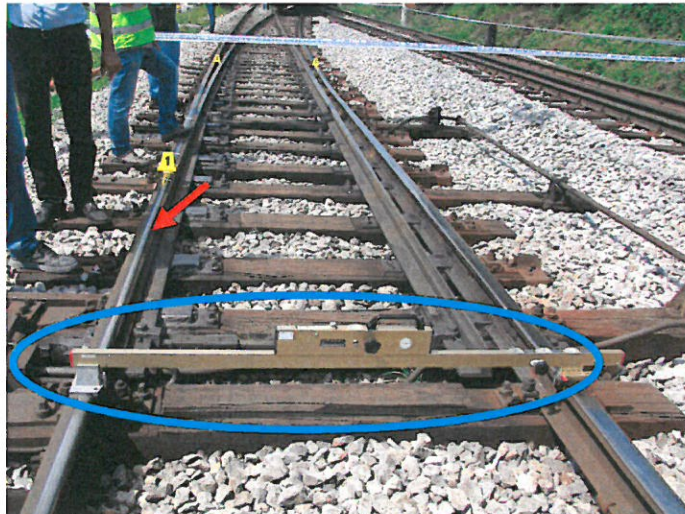
Photo 7: The red arrow shows the start of climbing of left wheels of both axles of the first carriage's second bogie and the blue ellipse shows the measuring device for performing measurements on point no. 1 when inspecting the site of the accident.

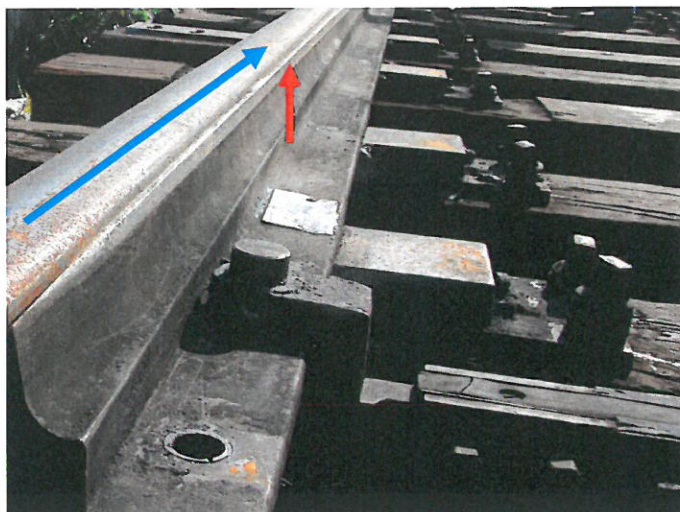
Photo 8: The red arrow shows the start of climbing of the flanges of the left wheels onto the left blade railhead of point no. 1 between the second and third sleepers, and the blue arrow points in the direction of movement of train no. 41914.

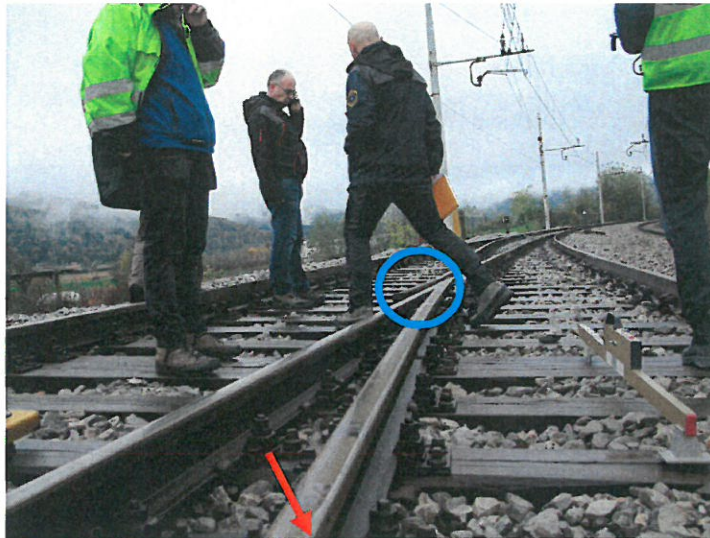
Photo 9: The red arrow shows the traces of the start of the climbing of the left wheel before the frog of point no. 9 and the blue circle shows initial traces of the left wheel derailment.
