NIB ANNUAL REPORT 2010

Accident Investigation Board

FINLAND

This is the annual report of railway sector of the Accident Investigation Board of Finland for calendar year 2010.

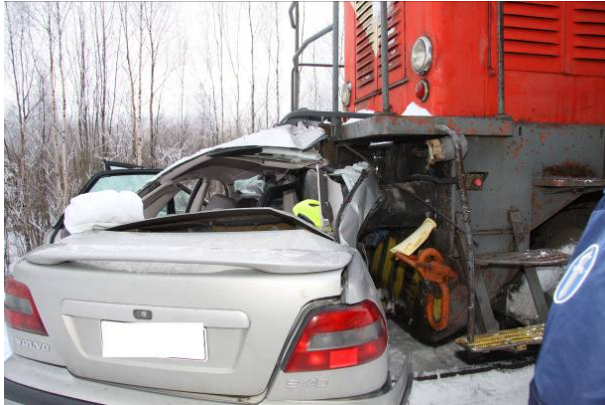
B1/2009R

The accident was caused by the car driver noticing the train too late and not having time to stop or otherwise prevent the accident. Underlying factors for this were:

- The level crossing was familiar to the driver, which in most cases decreases carefulness
- The level crossing did not feature any alarm devices
- The level crossing did not have proper wait platforms and the slope to the crossing was so steep that drivers try to avoid stopping, particularly in slippery conditions
- Visibility to the left was worse than in the direction of the train to the right, and an imbalance such as this tends to increase detection errors in the region of the better-visibility area
- An embankment over a district-heating pipe decreased the visibility of the train
- The car driver was fairly inexperienced, and the day in question was a special festive day related to studying
- Driving on the narrow private road with icy ridges was already occupying the driver's attention.

To prevent similar accidents, the Investigation Commission recommends that the unprotected level crossing of Teurastamo on the Pikakyläntie road be removed. The level crossing could be removed with minor costs by digging ditches on both sides of the track – continuing the current ditches – at the site of the road and by removing the planking. Should the level crossing be kept, it should be repaired in accordance with instructions equipped with a warning installation with half-barriers, and the embankment on the district-heating pipes should be lowered.

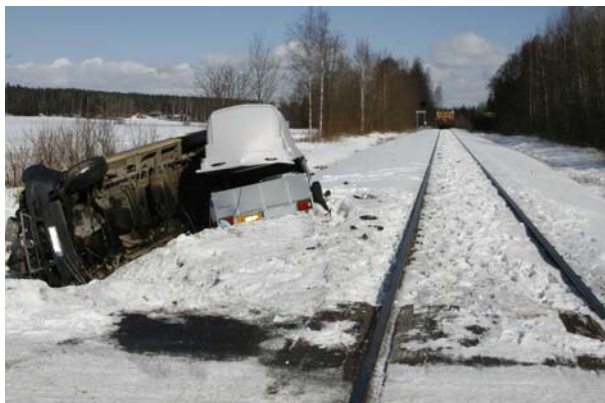
B2/2009R

**Fatal level crossing accident in Nurmijärvi
on 25 March 2009**

On Wednesday, 25 March 2009, a level crossing accident involving a van and a freight train occurred on the Hyvämäki level crossing in Nurmijärvi. The accident was fatal to the van driver. The engine driver, the shunting foreman and two shunters who were on the train came through the accident uninjured. The van was wrecked beyond repair. The train sustained minor damage.

The direct cause of the accident was the driver of the van advancing onto the level crossing without stopping at the STOP sign. It is likely that the driver of the van completely failed to notice the freight train approaching from the right. This may have been due to the following:

In order to prevent similar accidents, the Investigation Commission recommends that the wait platforms of the Hyvämäki level crossing be renovated and that nearby road junctures be relocated at a sufficient distance from the crossing. The level crossing should also be equipped with a warning installation with half-barriers. Due to difficulties experienced in locating the level crossing after the accident, the investigation commission reiterates recommendation S143: *Level crossings should be equipped with signboards displaying at least the name of the level crossing and its location in coordinates, and the relevant track-km. The signboard should be clearly visible in both directions in which the road runs.*

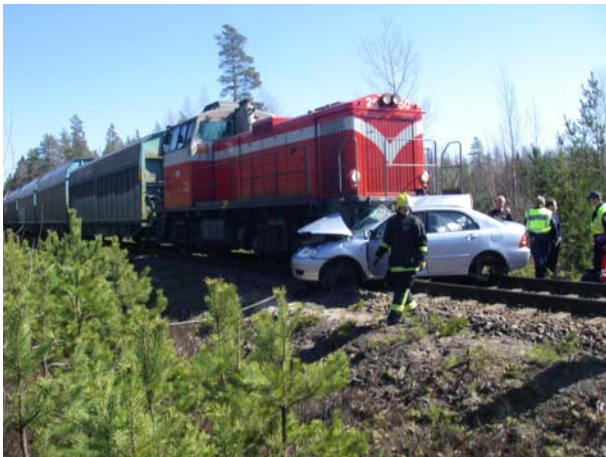
B3/2009R

Fatal level crossing accident in Mustio, Raasepori on 25 April 2009

At 1:08 p.m. on Saturday 25 April 2009, a level crossing accident occurred in Mustio in Raasepori involving a car and a freight train en route from Kirkniemi to Karjaa. The accident proved fatal to the car driver, while the engine driver escaped uninjured. While the car was wrecked beyond repair, the train sustained only minor damage.

The direct cause of the accident lay in the car's driving onto the level crossing while the freight train was approaching simultaneously from the right. It has not been ascertained why the car driver drove onto the level crossing. The following may have played a role in this decision:

In order to prevent similar accidents, the investigation commission recommends that the Ingvaldsby unprotected level crossing be removed. In addition, the investigation commission reiterates recommendation S211 concerning the establishment of a direct mobile phone connection from accident scenes to the emergency response centre. Recommendation S211 is also supported by the Ministry of the Interior Rescue Department and the Emergency Response Centre Administration. Furthermore, the Emergency Response Centre Administration recommends that VR Group equip all trains with the appropriate GPS devices, allowing the relay of accident location information to the emergency response centre clearly and without delay.

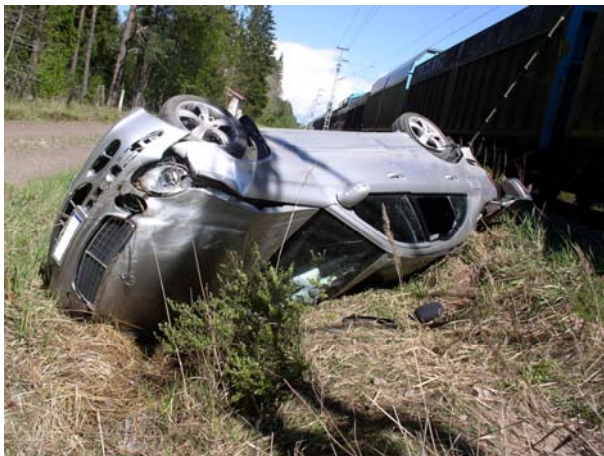
B4/2009R

On Sunday, 24 May 2009, at 2:28 p.m., a fatal level-crossing accident occurred on the Köykäntie unprotected level crossing in Eurajoki. The accident occurred when a car en route from Lapijoki village to the centre of Eurajoki drove onto the level crossing in front of a freight train en route from Rauma to Tampere. The only person in the car was the driver, who died from his injuries despite first aid. Damage caused by the accident to track equipment amounted to some € 5,000.

In order to prevent similar accidents, the Investigation Commission recommends that the Köykäntie level crossing be removed. Alternatively, the level crossing should be equipped with a warning installation with half-barriers.

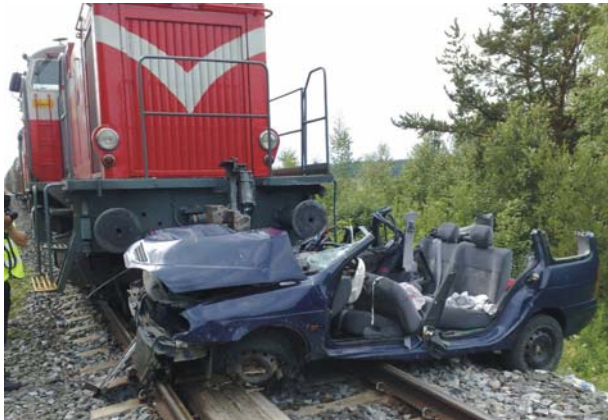
B6/2009R

Fatal level crossing accident in Vihti on 14 July 2009

At 11:17 a.m. on Tuesday 14 July 2009, a fatal level crossing accident occurred on the Kotkaniementie unprotected level crossing in Ojakkala in Vihti. The accident occurred when a car travelling along Kotkaniementie road drove without stopping in front of a freight train en route to Riihimäki. A nine-year-old girl in the car was fatally injured. The car was wrecked beyond repair. Damage totalling €6,000 was caused to the rolling stock and to the track.

The cause of the accident lay in the car driver's completely failing to observe the approaching freight train.

Considering that the Kotkaniementie road is busy with domestic and international traffic, and that no other route to the Kotkaniemi area is available, the investigation commission recommends that the Kotkaniemi 1 level crossing be equipped with half-barriers.

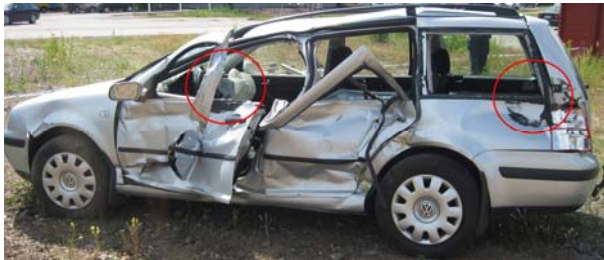
B7/2009R

**Fatal level crossing accident in Loviisa on
17 July 2009**

The most probable cause for the accident was the elderly driver's failure to perceive the approaching train. Other underlying causative factors in the accident may include the driver's familiarity with the level crossing and the fact that his physical capabilities were diminished through illnesses and impaired eyesight.

In the investigation, it also emerged that the relevant parties hold divergent views on the duty to clear the sightlines at level crossings. The Investigation Commission recommends that the Ministry of Transport and Communications ensure that such consistent guidelines on the duty to clear the sight lines be issued as are acceptable to all parties.

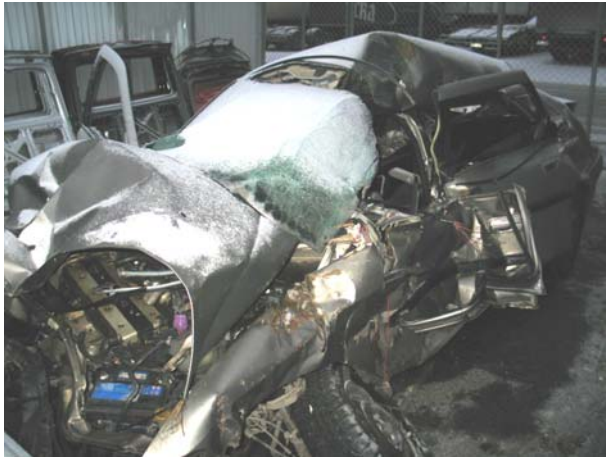
B8/2009R

**Fatal level crossing accident in Seinäjoki
on 3 December 2009**

On Thursday 3 December 2009 at 4.05 a.m., a fatal level crossing accident occurred at the Teppo level crossing in Seinäjoki. The level crossing was equipped with half barriers. A passenger train en route to Helsinki collided with a car which was at a halt on the crossing. The collision caused immediate to the car driver.

The cause of the accident lay in the train colliding with the car, which had come to a halt on the crossing. Due to issues that became apparent during the investigation, the investigation commission will not issue any recommendations as a result of the accident.

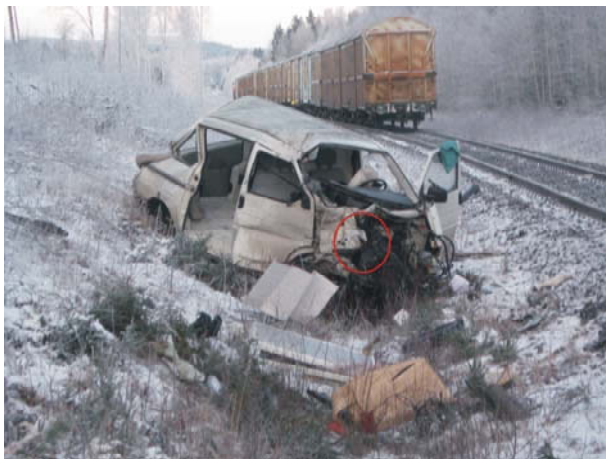
B9/2009R

**Fatal level crossing accident in Laukaa on
16 December 2009**

On Wednesday 16 December 2009 at 13:26 p.m., a fatal level crossing accident occurred on the Lemettilä unprotected level crossing in Laukaa municipality. The accident occurred when a van with a couple inside drove in front of a freight train en route from Jyväskylä to Äänekoski. The van's driver and passenger died immediately from the injuries received. The damage caused by the accident to rolling stock amounted to € 1,300.

The cause of the accident was that the van driver drove onto the level crossing without apparently observing the train approaching from the right. A contributing factor was the fact that, when approached, the crossing looks safe, rendered observation more difficult. Special care should

have been exercised, however, considering that the road slopes downwards before the level crossing, that there is a road crossing close to the level crossing and that the sun was shining directly towards the approaching van.

In order to prevent similar accidents, the investigation commission recommends the removal of the Lemettilä unprotected level crossing. Alternatively, the level crossing should be equipped with a half-barrier installation.

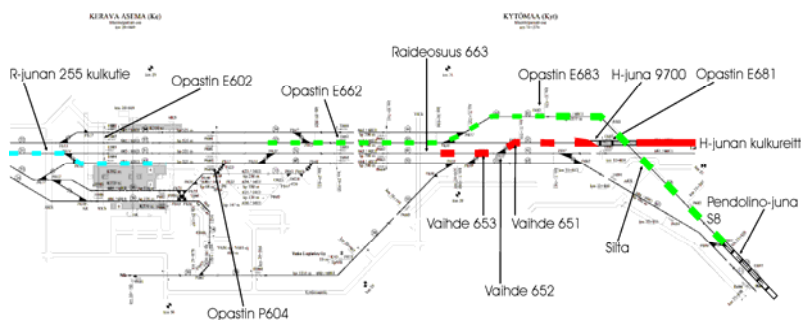
C6/2008R

Train traffic incident in Kerava on 20 October 2008

- the engine driver was used to driving the train according to the instructions provided by the automatic train running control (ATC) and to trusting the route monitoring it provided
- the signal for the H train (E681) was set to be proceed even though the distant signal after Kyrölä was in the wait/stop position
- the stop position of the main signal (E681) is not easy to observe, because its visibility can be obstructed by bridge structures and the specially built catenary suspension
- the construction area set for the automatic train running control (ATC) was too extensive
- the advance notification provided did not give sufficient information to the engine driver
- the automatic train running control (ATC) does not notify the train driver strongly enough that the train is in a construction area and that the train must proceed according to the visible signals

In order to prevent the occurrence of similar incidents, and therefore possible accidents, the Accident Investigation Board recommends that signal E681 be placed in a more visible spot, that construction areas for automatic train running control (ATC) not be set too broadly, that advance notifications provided to train drivers be more specific about ATC construction area conditions, and that train running control monitors and the information displayed there be improved in such a way that they better indicate the necessary information during exceptional circumstances.

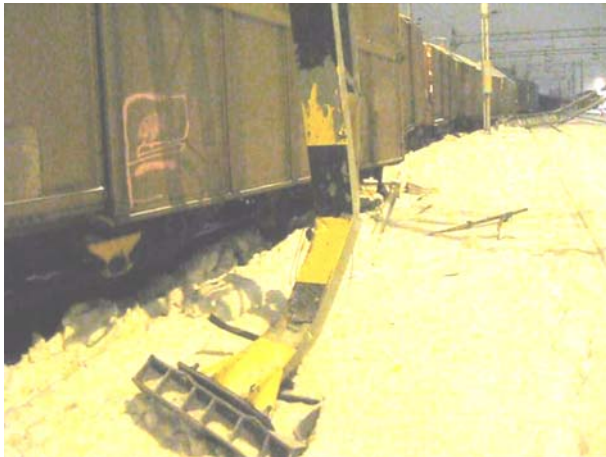
C2/2009R

**Derailment of six wagons of a freight train
at the Lahti railway yard on 9 March 2009**

Traffic on the main tracks in Lahti was badly disrupted, because the toppling of the signal portal caused the contact wires of several tracks to come down. Because of the falling of the north main track's contact wire, passenger train traffic from the east had to be stopped, and passengers had

The accident was caused by the wheel flanges of the first derailed wagon rising over the ice packed in the flangeway between the crossing frog and the check rail, and further off the rails. As the wagon, which had a light axle weight, arrived at the crossing, its front bogie was turned, by the fully frozen crossing and chunks of ice and snow, far enough to cause the wheel flange to rise over the wingrail, causing the derailment of the wheelset. There were many snow and ice chunks in the vicinity of the turnout crossing, at least some of which had likely fallen from the inner surface of the buffer plate of the locomotive of a departing train.

In order to prevent similar accidents, the Accident Investigation Board of Finland recommends that the work instructions for turnout cleaning related to winter maintenance be specified, with special attention paid to ice removal.

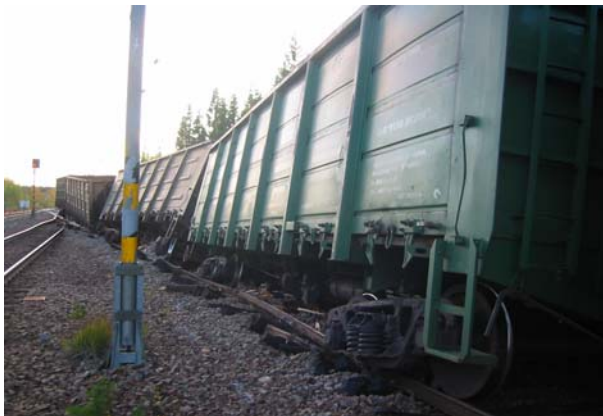
C3/2009R

**Derailement of five freight train wagons in
Kilpua station on 17 September 2009**

On Thursday 17 September 2009 at 13:13 p.m., five Russian pellet-carrying wagons were derailed at Kilpua station on the Oulu-Ylivieska section of line. The derailment occurred at the southern end of the station, when a pellet train en route from Oulu to Kokkola departed from track three towards the main track after giving way to an oncoming train. When the train's rear section was still on track 3, the train driver felt an abrupt jerk and noticed the brake pipe loosening. The train driver immediately stopped the train and went outside to inspect the situation. Although the last three of the train's eight wagons were still on the track, five had been derailed. The train had a total of 45 wagons. Being able to disengage the train at the point where the first wagon had derailed, the driver moved the wagons at the front to Oulainen for further inspection. The total costs of the incident amounted to 112,000 euros.

The incident occurred because the heavy pellet train was directed onto a sidetrack which was in poor condition. Due to oncoming traffic, the remote controller was forced to direct the freight train onto Kilpua's track three.

along the train. Combined with the stiff bogies, of the wagons' longitudinal force caused the outer rail to give way at a curve, with the result that the wheels on the inside of the curve were derailed.

In order to prevent similar incidents from occurring, the Accident Investigation Board recommends that the Finnish Transport Agency review the actual condition of station sidetracks and their ability to handle heavy, Russian freight train traffic. The Accident Investigation Board also reiterates its earlier recommendation concerning the condition inspection and greasing of pivots on Russian wagons.

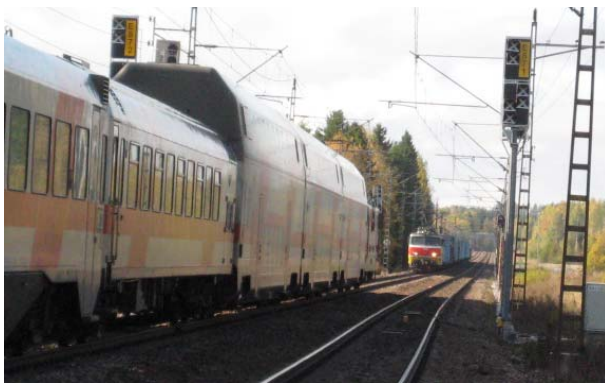
C4/2009R

A passenger train ended up on the wrong track in Koria on 1 October 2009

The immediate cause of this incident was the transverse route set for freight train ahead of the passenger train by the traffic controller. The traffic controller's situation awareness was not up to date, as a result of which his perception of the location of the passenger train was incorrect.

To prevent similar situations from occurring, the investigation commission recommends that safety planning should be enhanced during transitional stages.
