**Railway Accident  
Investigation Unit  
of Ireland**

### **Annual Report 2012**

Report number: 2013-AR2012

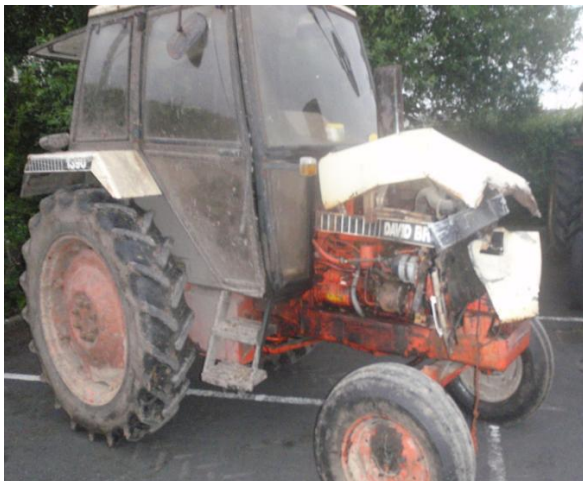
On the 20<sup>th</sup> June 2012 at 14:50 hours the 14:15 hours passenger train travelling from Limerick to Galway was involved in a collision with a tractor at level crossing number XE020 which is located close to Cratloe, County Clare on the R462. The driver of the train was initially unaware of the collision and continued to Sixmilebridge Station. The tractor driver although shocked was uninjured and the tractor sustained frontal damage.

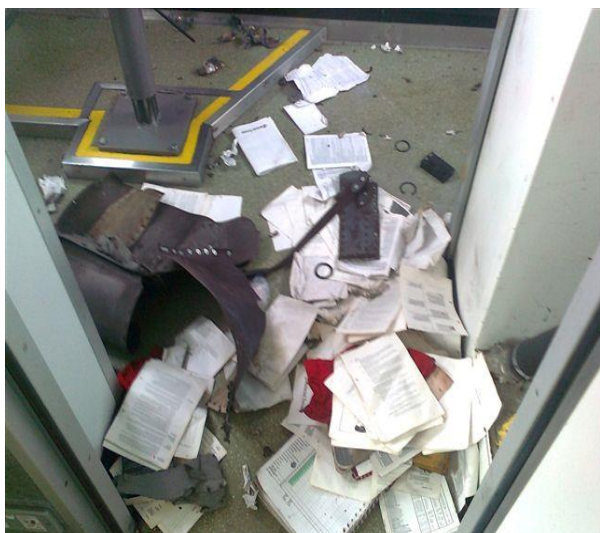
Figure 4 – Damage to drivers' bag and cab

As the driver placed his leather drivers' bag on the floor of the DART cab, eleven of the twelve Railway Fog signals that he was carrying in the bag exploded. The driver sustained injuries to his hand and suffered some temporary loss of hearing. The interior of the cab was superficially damaged.

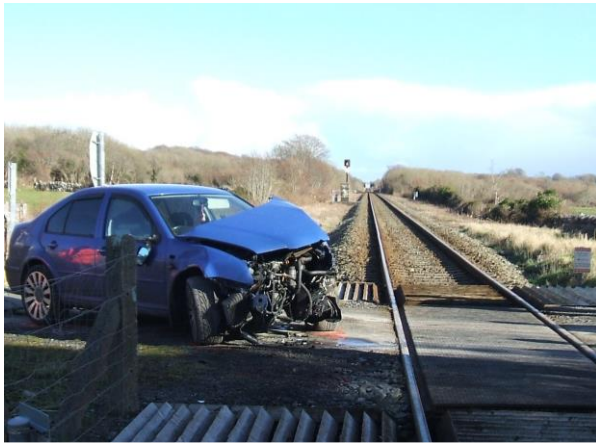
**Figure 5 – Car strike at XG173**

At approximately 12:00 hours on Monday 14<sup>th</sup> February a waste collection vehicle crew, who regularly used the Morrough level crossing (XG173) to collect waste from the private residence, Murrough House, opened the gates of the level crossing and passed over the level crossing. The crew left the level crossing gates open while they collected waste, a task that usually took only a few minutes. At approximately 12:13 hours a car approached the level crossing with the gates still open. The car slowly drove onto the level crossing. At approximately the same time, the 09:30 hours passenger service from Heuston to Galway approached the level crossing. On seeing the car, the train driver sounded the horn twice and applied the emergency brake. The train struck the car as the car's driver was attempting to reverse off the level crossing. Both occupants of the car were treated for their injuries at the local hospital and released later the same day.

- IÉ should review the suitability of the signage at user worked crossings on public and private roads, ensuring that human factors issues are identified and addressed;
- IÉ should liaise with local authorities where private road level crossings can be accessed from a public road to ensure there is advance warning to road users;
- IÉ should ensure that they adopt their own standards in relation to design changes to any plant, equipment, infrastructure or operations that have the potential to affect safety;
- The Railway Safety Commission should ensure that they adopt a formal approach to submissions made by IÉ in relation to design changes to any plant, equipment, infrastructure or operations that has the potential to affect safety.

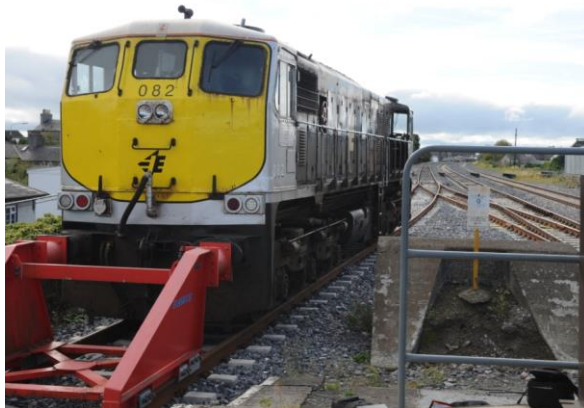
**Figure 6 – Runaway locomotive**

There were no passengers or other crew members on the locomotive and nobody was injured as a result of the occurrence. There was no damage to the locomotive or buffer stop as a result of the accident.

The immediate cause of the locomotive running away, whilst left unattended on a gradient, was the gradual release of the brakes. This was as a result of the following causal factors, which were necessary for the accident to occur:

- An air leak in part of the braking system;
- The train driver did not fully comply with the instructions for vacating and occupying locomotive cabs, set out in Iarnród Éireann's Drivers' Manual.

- IÉ should review their Vehicle Maintenance Instructions for locomotives to ensure that there are adequate braking tests at appropriate intervals;
- IÉ should adopt a quality control system, for the introduction of new maintenance procedures for locomotives;
- IÉ should review their system for introducing new train drivers' manuals, to ensure that train drivers are fully trained and assessed in all aspects of these manuals;
- IÉ should review their competency management system for train drivers to ensure that all driving tasks are routinely assessed.

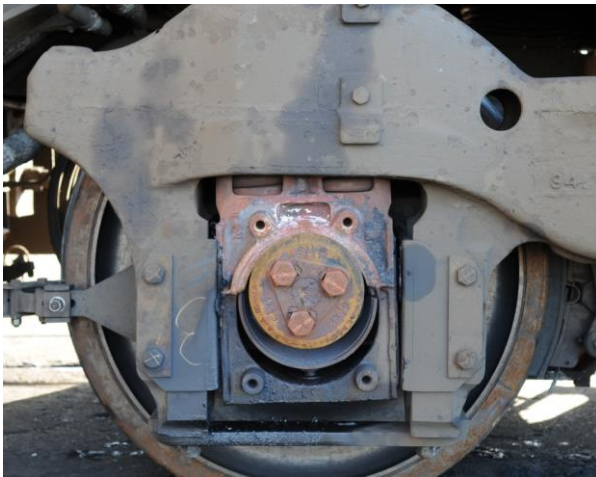
**Figure 7 – Failed bearing on locomotive 233**

The train was then allowed to continue its journey to Connolly Station. When the train arrived at Connolly Station it was inspected by a member of maintenance staff, one of the axleboxes on the locomotive was found to be red hot and smoking. An axle journal bearing on the locomotive, which was positioned at the rear of the train, had failed.

The immediate cause of the bearing failure could not be determined due to the extensive damage to the bearing, which can occur following substantial overheating and deformation of the material as in this case.
