# **NIB ANNUAL REPORT 2011**

Safety Investigation Authority

FINLAND

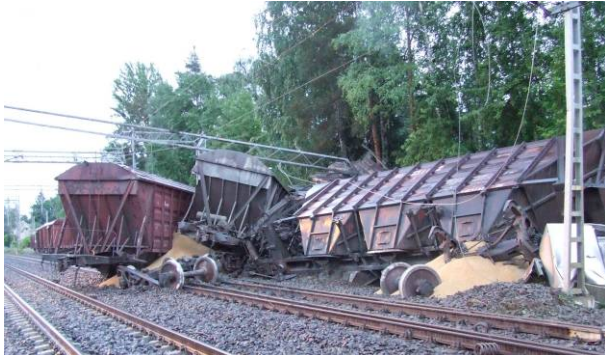
**B5/2009R**

**Derailment of ten wagons of a freight train  
in Toijala, Finland on 16 June 2009**

Ten wagons of a freight train on its way from Turku to Tampere were derailed in Toijala on 16 June 2009 at 8:51pm. Five of the wagons tipped over. The derailed wagons were the 17<sup>th</sup>–26<sup>th</sup> wagons of the total 30 wagons in the train. The speed of the train at the moment of derailment was 70km/h. Safety equipment, parts of the track, and electric railway equipment were damaged in the accident. Safety device and communications connections were disrupted in Toijala and in the nearest operating points.

The derailment of the freight train was caused by a switch turning underneath the train. In the ensuing investigation, it was shown that it was possible to force open the switch lock by exposing the switch blade to mechanic oscillation at the frequency same as caused by the axles of the freight train in question. It also became apparent in the investigation that the Railex locking device had been adjusted eccentrically, and that the switch contactors at the locking device allowed the closed switch blade to move in excess of the reference value. The Investigation Commission considers it likely that as a combined result of track geometry, switch adjustments, the oscillatory properties of the switch, and the rolling stock passing through the turnout, the switch lock became unlocked as the train passed over it.

In order to avoid similar accidents in the future, the Accident Investigation Commission recommends the following:

- To maintain control of the overall situation, a plan of action for accidents should be drawn up by the infrastructure manager.

To deal effectively with exceptional situations, the forms of cooperation and the distribution of duties and responsibilities should be clearly defined both at national and local level.

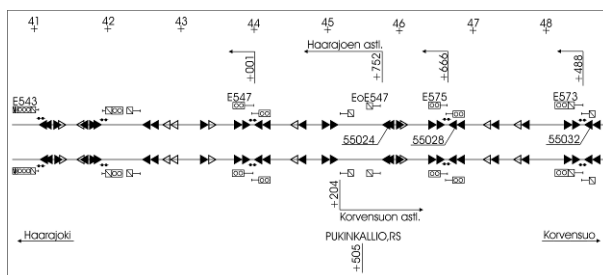
C1/2009R

### Safety failure in automatic train protection observed on 30 december 2008 on the Kerava-Lahti direction of line, Finland

The situation was temporarily fixed once the deviation had become apparent by setting an 80 km/h speed limit in the area. The Thales "Emergency Team" met on 5 January 2009 to analyse the situation. Once the reason for the irregularity was observed, a new flash card was in-

In order to prevent the installation of wrong cards, the Accident Investigation Board recommends that signal box adjustment and repair work inspections, and documentation relating to them, should be supervised and the importance of inspections should be emphasised in signal box maintenance training. In addition, component up-to-datedness should be clearly marked on the component and personnel should be made aware of what the latest version in connection with maintenance actions is.

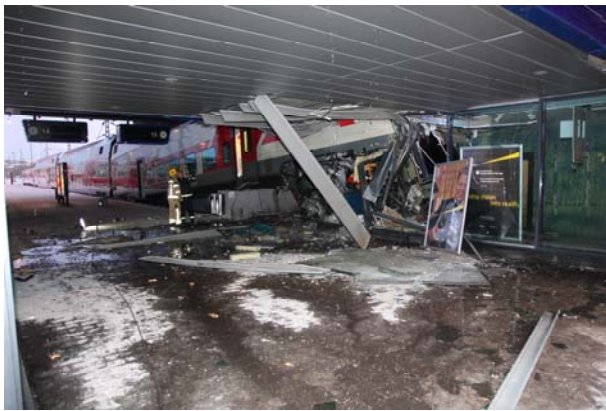
**B1/2010R**

**Collision of passenger cars with a rail barrier and eventually the wall of an office building at the Helsinki Central Railway Station, Finland, on 4 January 2010**

At 8:28am on Monday, 4 January 2010, four passenger cars that had become separated from a train collided with a rail barrier at the end of the track at the Helsinki Central Railway Station at a speed of approximately 35 km/h. The front end of the double-decker coach that was the first in the train was pushed onto the damaged rail barrier and then the concrete buffer stop at the end of the track, eventually hitting the wall of the office building at the end of the track. The car broke the wall and came to a stop partially inside the building. Pushed by a locomotive, the train was being shunted to its departure track at the Helsinki station from the Ilmala depot, 4.5 kilometres away. The security officers at the station managed to evacuate the people from the platform before the collision.

Of the three people in the cars during the collision, one was slightly injured. Having collided first with the rail barrier and then the wall of the office building, the double-decker coach was so badly damaged that it had to be scrapped. The second, third, and fourth cars in the train suffered minor damage. In the fifth car, a 1,500-volt cable and a UIC cable were broken, and a brake conduit came loose. The other cars were undamaged. The rail barrier at the end of the track was completely crushed, and the concrete buffer stop behind it suffered minor fractures in the corners. The horizontal end beam to which the contact wires are attached was torn off. The office building suffered substantial material damage. The load-bearing primary frame of the building did not suffer significant damage, but the hollow-core slabs were fractured, and they also moved slightly. A meeting room in the impact area on the second floor of the building was completely destroyed, and the street-level entrance suffered substantial damage. Additionally, the building maintenance and safety-technology-related systems in the immediate vicinity of the impact area were damaged. The total costs of the damage amounted to € 825 000.

The accident was caused by the coupling loop coming loose from the hook during the pushing movement. This caused the train to break into two, and the automatic air brakes engaged once the brake conduit had come off. The conductor released the brakes of the cars to get the train moving. He did not realise that the train had broken into two. The coupling loop came loose because, as the car buffers compressed, the coupling loop, which had frozen solid, rose off the hook. The situation was aggravated by the fact that the screw coupling had not been tightened properly. Seeing the coupling loop was difficult because of poor lighting and the ice and snow in the space between the cars. The train in question had last been de-iced nine days previously, and there was a lot of snow on the bogies and between the cars. Additionally, the water coming from the outlet pipe of the sink in the WC of the car behind the restaurant coach had increased the formation of ice in this space.

In order to avoid similar accidents in the future, the Accident Investigation Commission recommends the following:

The Investigation Commission further recommends that a preparedness plan for exceptional circumstances should be drawn up for traffic control.

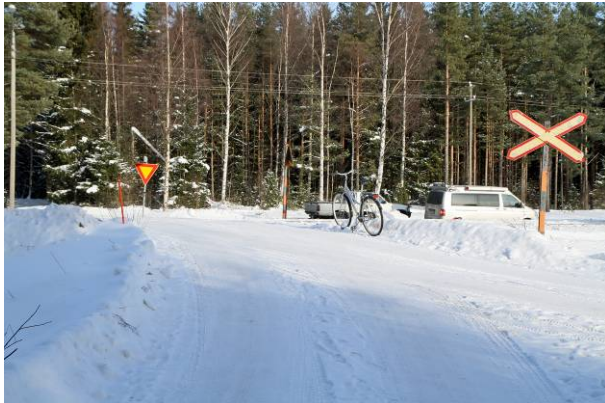
**B2/2010R**

**Fatal level crossing accident in Pori,  
Finland on 25 February 2010**

The accident occurred because the driver of the car failed to notice the approaching train in time and was no longer able to stop or otherwise prevent the collision. Factors contributing to this were:

- The crossing was familiar to the driver of the car, which is a factor that generally reduces vigilance. The driver had also driven across the level crossing in the other direction moments before the accident.
- The level crossing was not equipped with warning installations.
- The level crossing was not equipped with proper waiting platforms and the road rises before the crossing to such an extent that drivers tend to avoid stopping before the crossing, especially in wet or slippery conditions.
- The car had tyres designated for summertime use.
- For the 30 metre stretch before the level crossing, the road had two intersections with give way signs.

In order to prevent similar accidents the investigation commission recommends the removal of the Tattari level crossing and the building of an alternative route via the residential area through a protected level crossing nearby. This would direct some traffic along a route that does not require a track crossing.

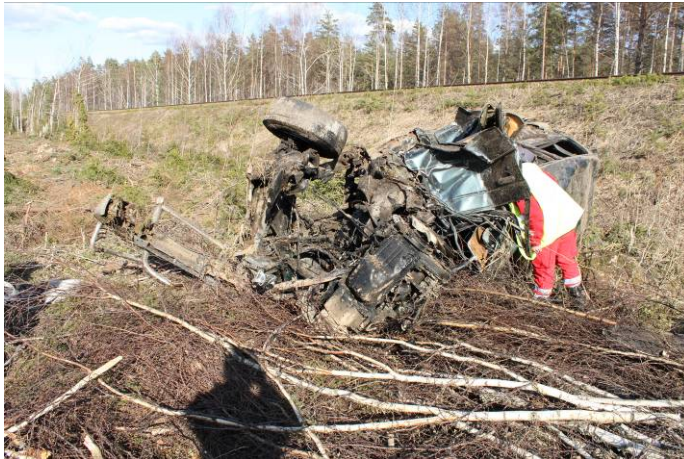
010R

**level crossing accident in Karjaa,  
and on 14 April 2010**

On Wednesday 14 April 2010 at 4.47pm, a fatal level crossing accident occurred on the Leskinen/Leppämäentie unprotected level crossing in Raasepori, Karjaa. The accident occurred when an SUV<sup>5</sup> leaving a nearby logging site collided with a commuter train (railbus) en route from Hanko to Karjaa. The only person in the SUV was the driver, who died instantly. The damage caused by the accident to track equipment amounted to € 94,500. The SUV was wrecked beyond repair.

The accident occurred because the car driver observed the approaching train too late and was no longer able to stop before the level crossing.

In order to prevent similar accidents, the investigation commission recommends that the Leskinen/Leppämäki unprotected level crossing should be replaced by an interchange. In addition, the investigation commission reiterates recommendation S211 presented in investigation report B1/2005R concerning the establishment of a direct mobile phone connection from accident site to the emergency response centre.

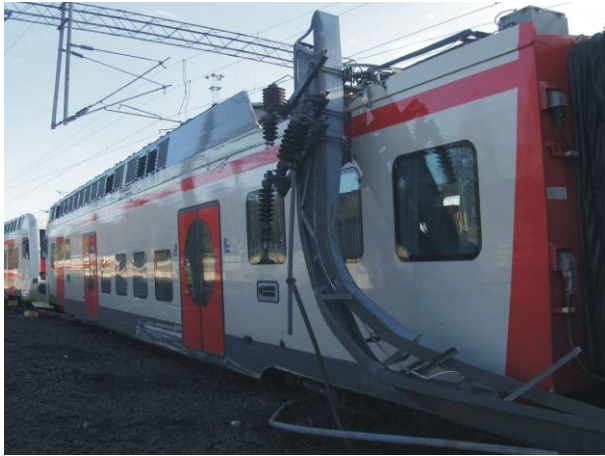
**B4/2010R**

**Derailment of a commuter train at Helsinki station, Finland on 26 April 2010**

On Monday 26 April 2010 at 5:10 pm, a commuter train was derailed in Helsinki at a turnout. The train was approaching track 6 at Helsinki station when a turnout along the route turned underneath the train causing the train to be derailed. The rearmost unit of the three-unit train derailed and collided with a catenary support, with the result that the portal fell on the train's roof causing extensive power outage at Helsinki railway yard. The derailed unit was damaged and there was also damage to track equipment. There were no personal injuries.

The cause of the derailment was that the turnout turned underneath the train. This was due to emergency commands issued from the signal box control. The traffic controller issued the commands to a turnout other than the one intended. Contributing to this was the fact that insulated track section faults had been common at Helsinki railway yard. Due to these faults, traffic control was using shunting routes for which emergency commands could be issued. This had become almost daily practice. Methods with stripped security were being used so as not to disturb the flow of traffic. Partly contributing to the accident was the fact that the traffic controller had very little experience with the task.

In order to prevent the occurrence of similar accidents, the investigation commission recommends that the party responsible for the upkeep of the track should systematically monitor and, when required, improve track maintenance and techniques for determining track availability so that security is not unnecessarily compromised. In addition, the commission recommends that traffic control job rotation should ensure that demanding posts are familiar to traffic controllers by means of training and sufficient task rotation. With regard to training in the identification and handling of disturbances, and response procedures relating to them, special attention should be given to practices that do not compromise safety.

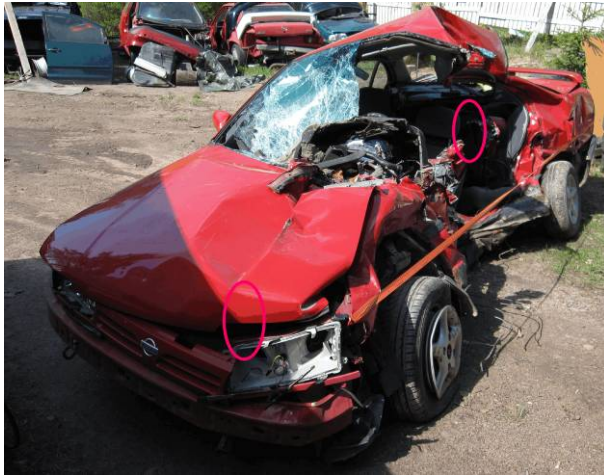
**B5/2010R**

**Fatal level crossing accident in Kokemäki  
on 16 May 2010**

On Sunday 16 May 2010 at 7.57 pm, an Sr2 electric locomotive en route from Rauma to Tampere collided with a car at the Koskinen unprotected level crossing in Kokemäki. The accident was fatal to the car driver and a passenger. A second passenger was slightly injured. The car was wrecked beyond repair and the front of the locomotive suffered minor damage.

The investigation commission is not issuing any safety recommendations as a result of the accident, but states that sightlines at the crossing should immediately be cleared in such a way that they meet regulations. In addition, the party responsible for road maintenance should reduce the speed limit to 20 km/h in the vicinity of the crossing, place warning signs on the road before the crossing and also place relevant STOP signs at the crossing. The Finnish Transport Agency should take effective action to ensure that road maintenance staff are sufficiently aware of proper level crossing maintenance as well as the installation of the relevant warning signs.

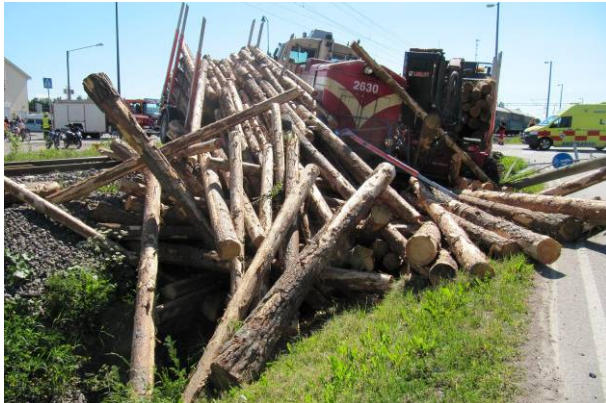
**B6/2010R**

**Level crossing accident in Kyrö, Finland,  
on 23 June 2010**

There were no serious personal injuries. Both locomotives of the train were derailed and the front and chassis of the frontmost locomotive was damaged. The articulated vehicle's trailer was damaged beyond repair. The barrier installations of the level crossing were also severely damaged. The repair costs arising from the damage to track equipment and the level crossing amounted to EUR 150,000.

The queues grew to a significant size while the barriers were lowered for too long because the engine driver did not give due regard to the signal and therefore did not notice that the remote controller had given permission to depart. Lack of formal communication between the remote controller and the engine driver led to a misunderstanding and the train did not depart as soon as permission was given. Once the alarm had been issued that the barriers had been lowered too long time, the remote controller failed to contact the engine driver or take any other action to ease the queue at the level crossing before the departure of the train.

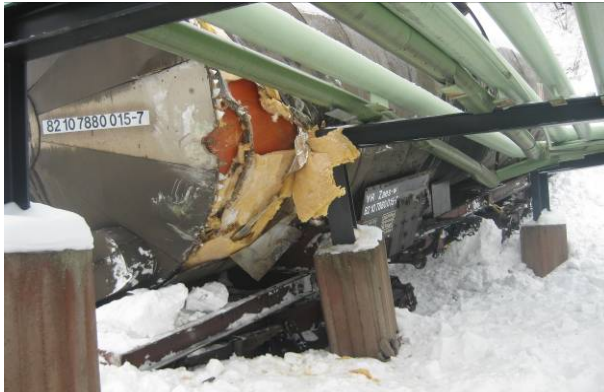
#### **C1/2010R**

#### **Derailment of five tank wagons during shunting work in Kilpilahti, Finland on 19 February 2010**

On Friday, 19 February 2010, five tank wagons pushed by a shunting unit bumped against a rail-barrier stop on track 204 at the Neste Oil Oyj unloading terminal in Kilpilahti, Finland. The first barrier wagon fell down the embankment, hitting a gas pipeline at the bottom. The second protection wagon came to a stop at the edge of the embankment, and the three Russian wagons behind it, containing industrial gasoline, were derailed. Neither the gas pipeline nor the wagons suffered any leaks. The wagons containing industrial gasoline had to be emptied before clearance work could begin.

The immediate cause of the accident was the shunting foreman's failure to escort the wagons all the way. He was under the impression that there was enough room for the wagons on the track. The shunting foreman's activities were influenced by the following factors:

- While trying to disengage the brakes, the conditions for the shunting foreman were hot. They were then cold during the long (3 km) pushing movement
- It was the foreman's third night shift in a row and he was very tired
- It was the foreman's first shift as an independent shunting foreman at Kilpilahti
- The shunting foreman had not received sufficient training to act as a shunting foreman at the unloading terminal.

To avoid similar accidents in the future, the Accident Investigation Board recommends that long and heavy rows of wagons should be pulled into the unloading terminal in Kilpilahti. It is further recommended that work orientation be carried out such that the person receiving orientation training accompanies the shunting unit as an additional crew member. This would enable the person receiving the orientation training to familiarise him or herself with the duties of a shunting foreman. An orientation plan and an orientation training card should also be provided.

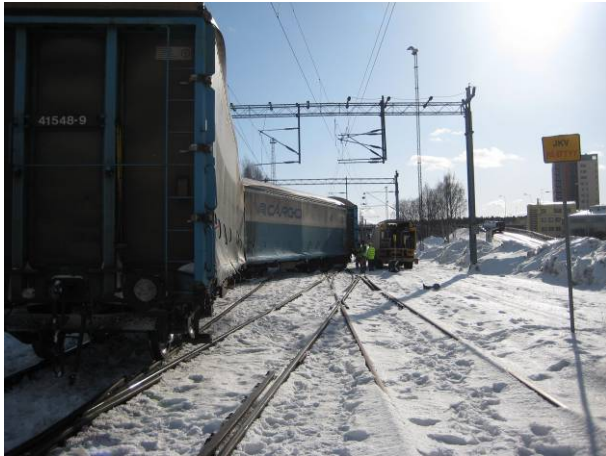
## **C2/2010R**

### **Derailment of three freight train cars at the Joensuu railway yard, Finland on 24 March 2010**

The accident damaged track over a distance of 700 metres when the derailed wagons caused damage to the sleepers and electrical cables underground. Furthermore, four turnouts were damaged in the accident and also an electric pole of railways was damaged when a derailed wagon collided with it. The accident disturbed other railway traffic for four hours. The passenger trains were replaced with bus transport during the disturbance. The total cost of the accident was 10,000 €.

The cause of the accident was that stop blocks had been left on rail when the train started moving. The underlying cause of the accident was that the brake inspector was distracted by trying to locate his radio handset, which had fallen into a brake hose pit, and, consequently, forgot to remove the stop blocks from the right-hand rail.
