The Rail Safety  
Inspection Office

## NIB ANNUAL REPORT 2025

according to Article 24(3) of Directive (EU) 2016/798

September 2026

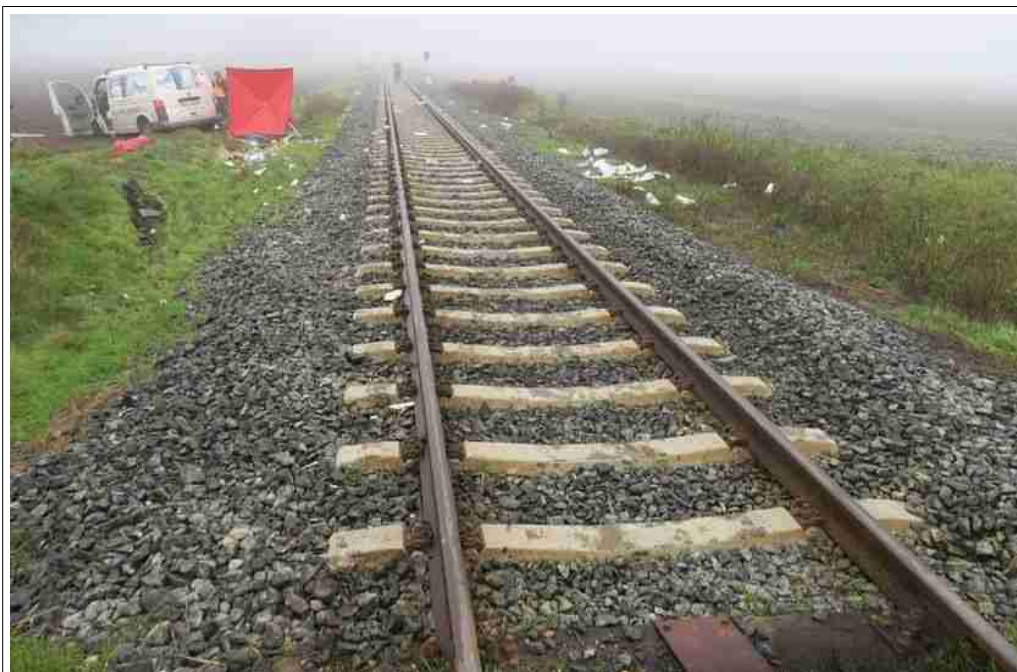
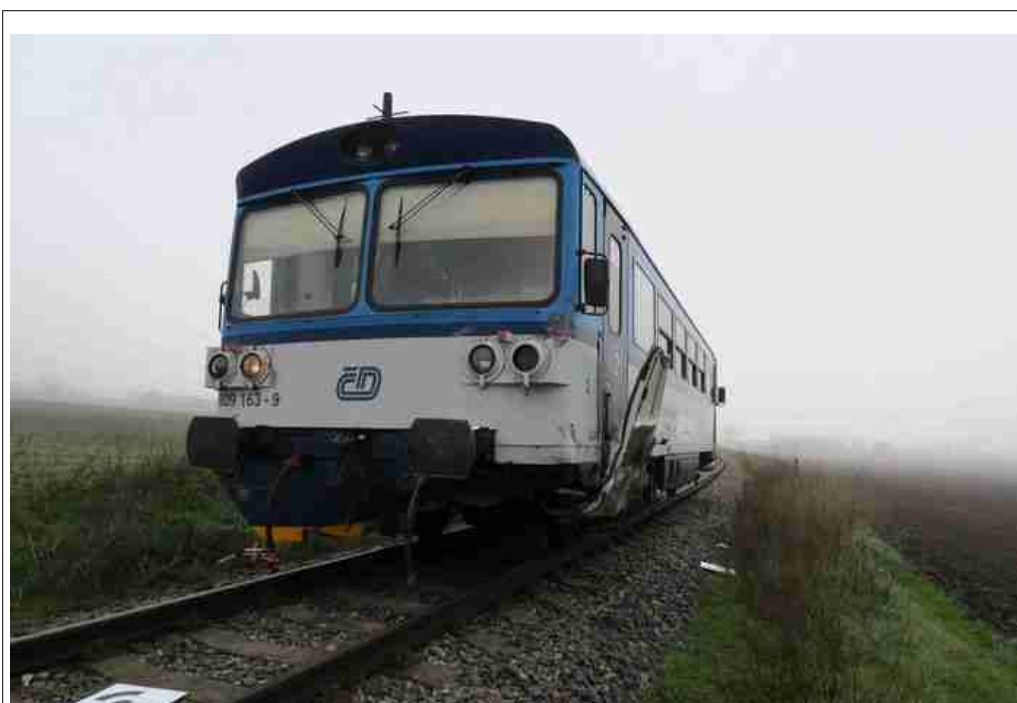
- an unauthorized entrance of the lorry at the level crossing No. P2752 at the time when the train No. 19406 was arriving, caused by behavior of the driver of the lorry, who did not make sure whether he could safely pass the level crossing.

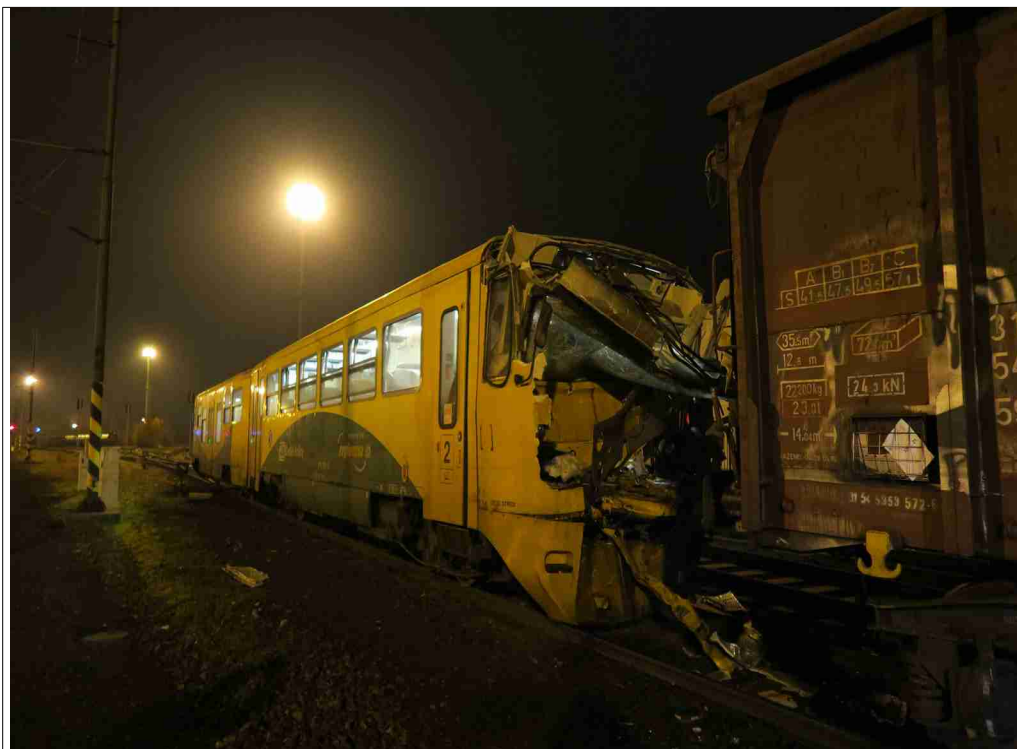
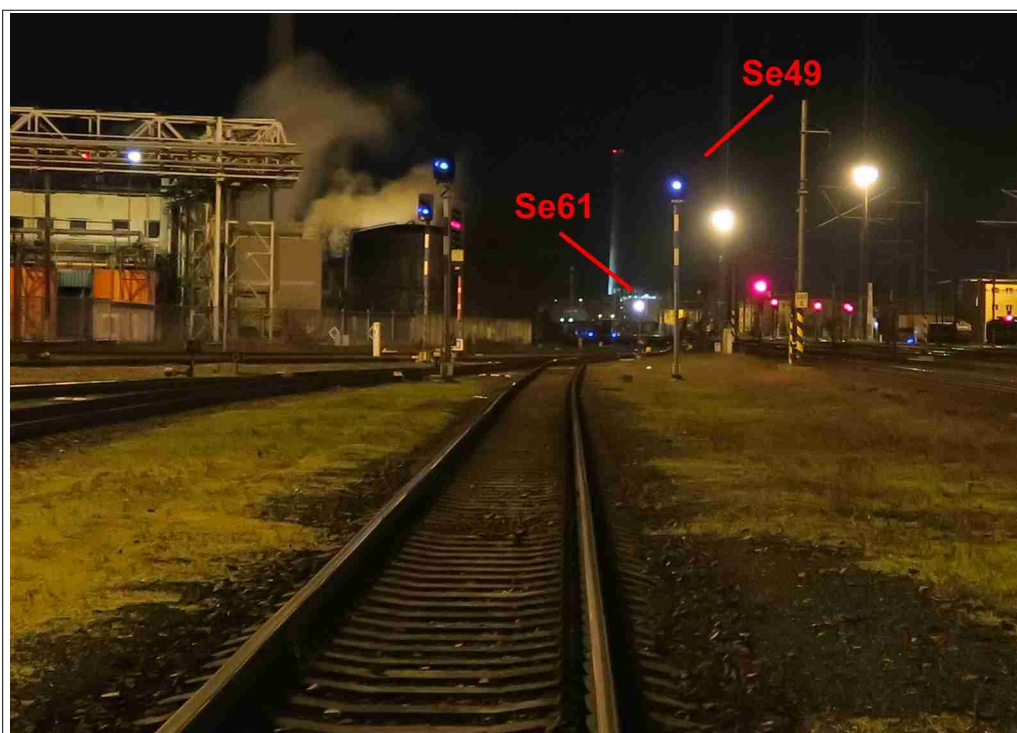
Consequences: 1 injury;  
total damage CZK 6 577 414,-

- failure to respect the signal „Shunting forbidden“ of the shunting signal device Se49 at Kolín station by the train driver of the pulling shunting set of cars.

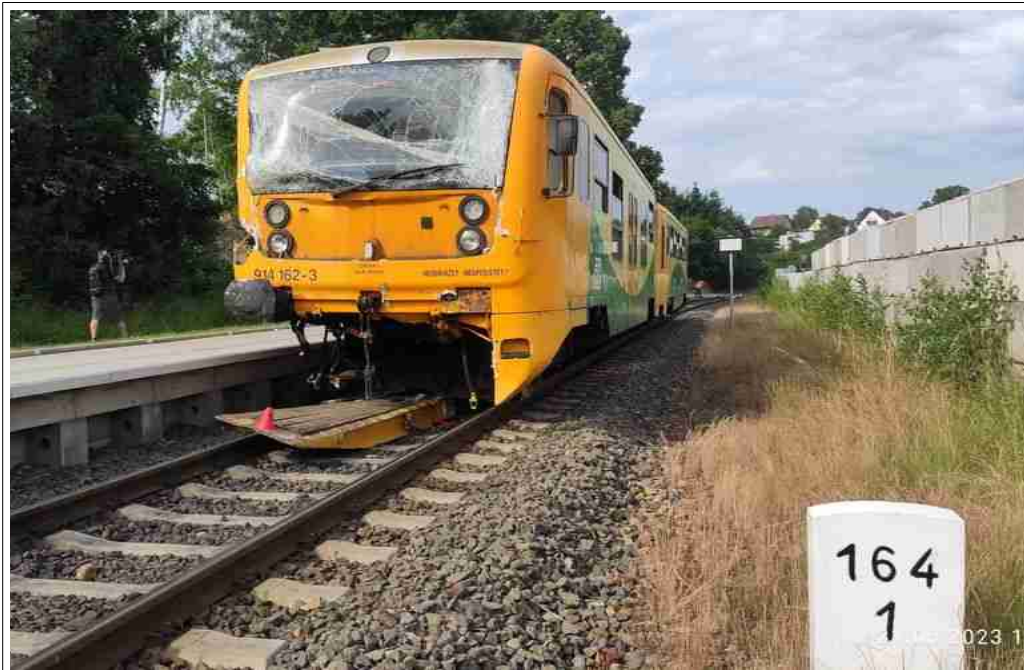
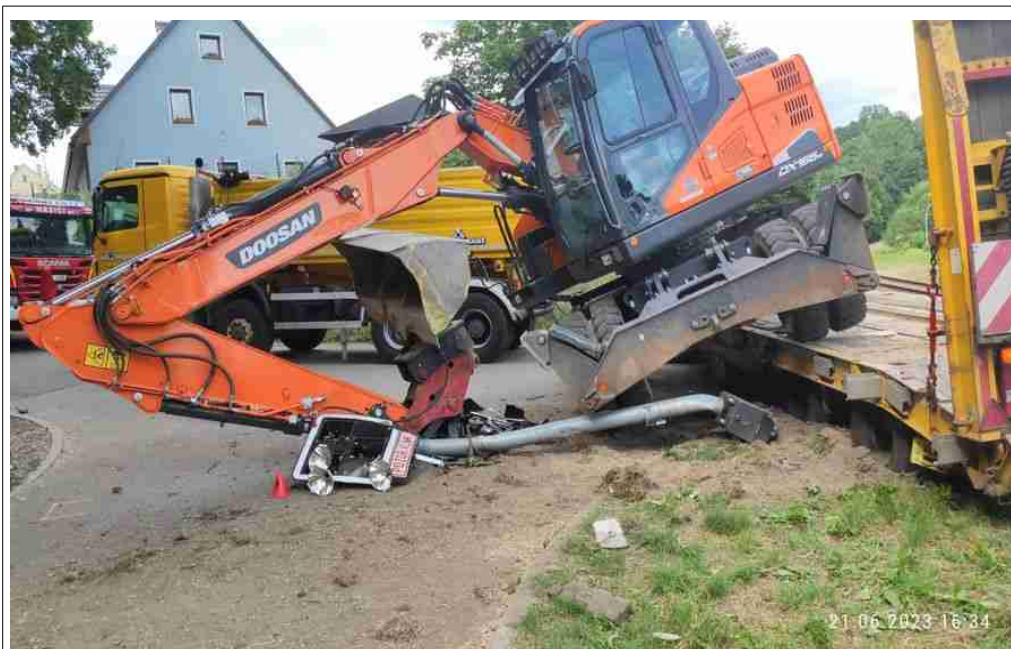
Consequences: 0 fatality, 21 injuries;  
total damage CZK 4 240 736,-

- an unauthorized entrance of the lorry with loaded trailer at the level crossing No. P2819 at the time when the regional passenger train No. 6385 was arriving, caused by behavior of the lorry driver, who did not respect the light and acoustic warning of the level crossing safety equipment and did not make sure whether he could safely pass the level crossing.

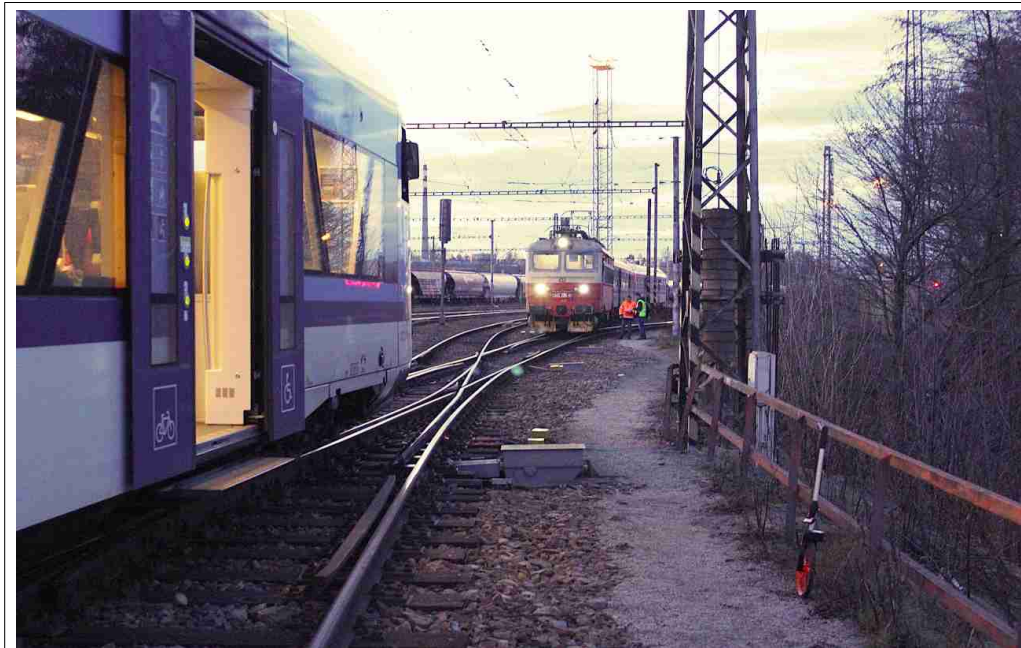
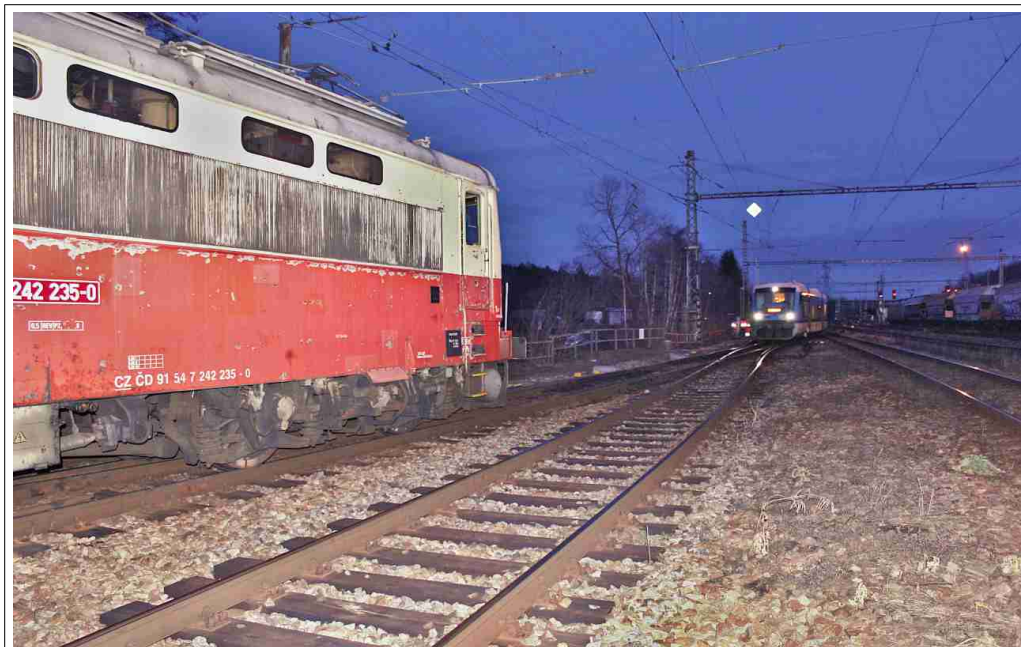
Consequences: 0 fatality, 0 injury;  
total damage CZK 204 100,-

- failure to respect the signal „Shunting forbidden“ of the shunting signal device Se12 at Havlíčkův Brod station by the train driver of the shunting operation.

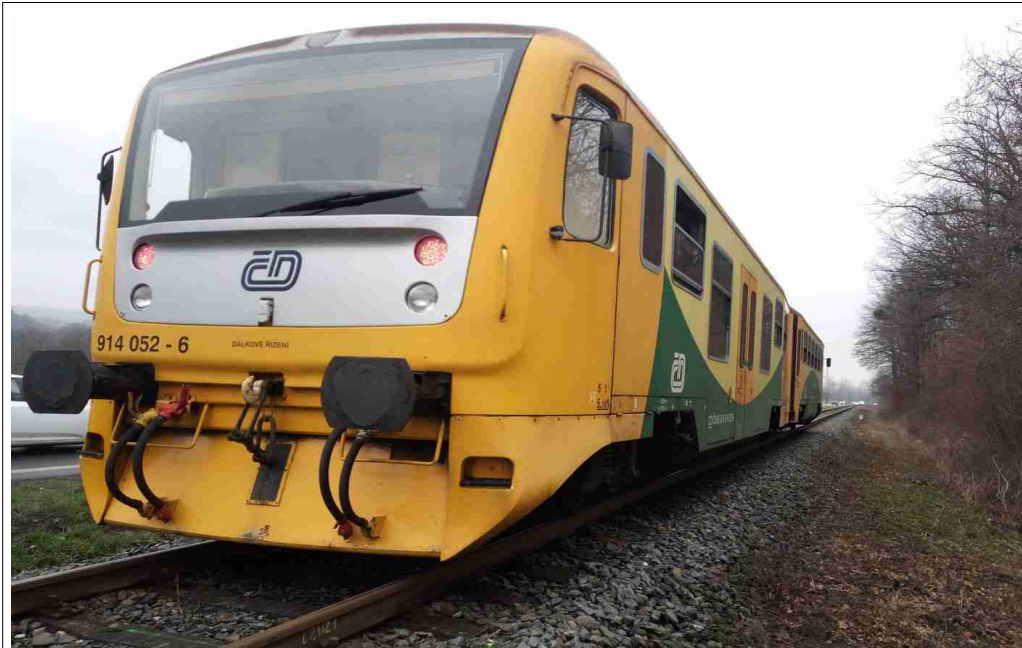
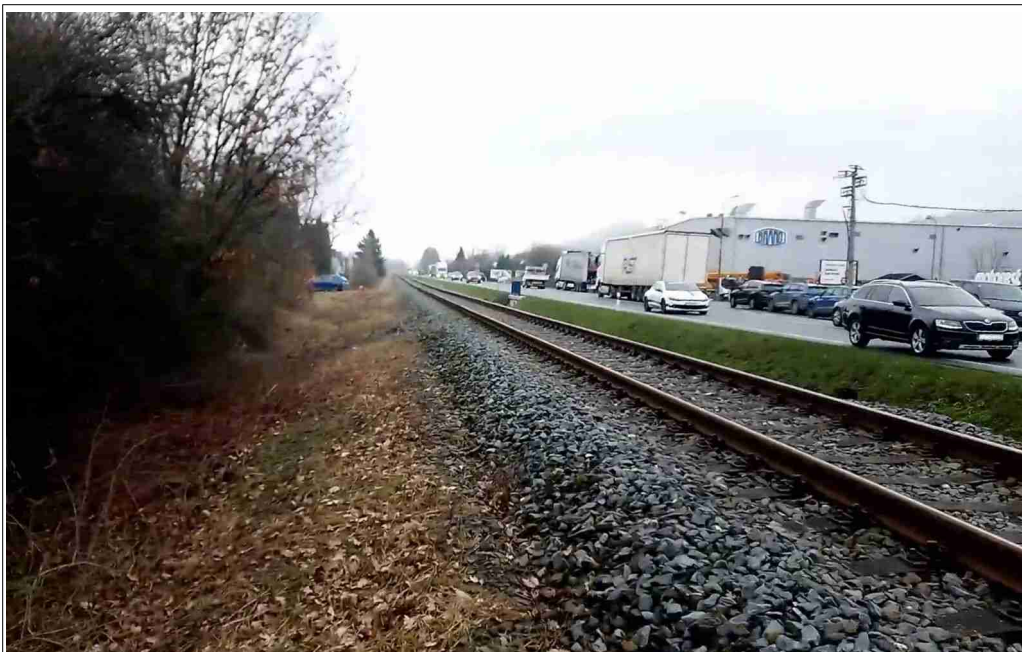
Date and time: 5<sup>th</sup> March 2024, 8:46 (7:46 GMT).  
Occurrence type: an accident to a person caused by a rolling stock in motion.  
Description: collision of the regional passenger train No. 13206 with the worker (employee of the infrastructure manager).  
Type of train: the regional passenger train No. 13206.  
Location: open line between Rožnov pod Radhoštěm and Střítež nad Bečvou operating control points, km 9,112.  
Parties: Správa železnic, státní organizace (IM);  
České dráhy, a. s. (RU of the regional passenger train No. 13206).  
Consequences: 1 fatality, 0 injury;  
total damage CZK 27 754,-

- failure to ensure own safety by the track foreman at entrance and stay in structure gauge of the track line at the time while the the regional passenger train No. 13206 was moving.

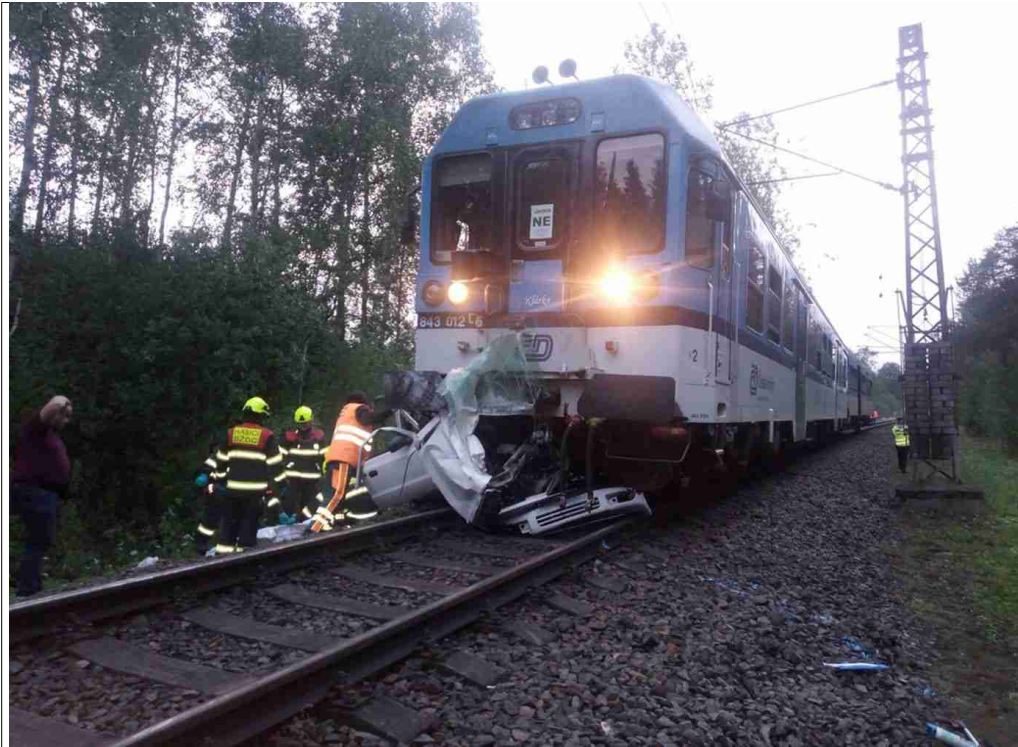
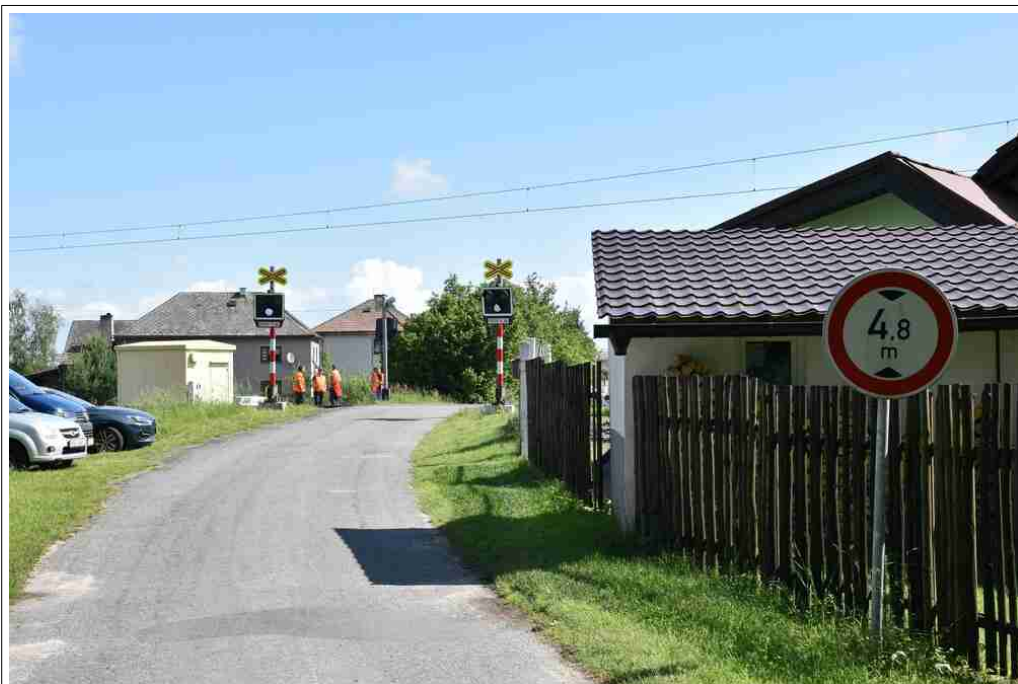
| Consequences: | 2 fatalities, 0 injury;<br>total damage CZK 484 482,- |
| Causal factor: | <ul style="list-style-type: none"><li>• an unauthorized entrance of the car at the level crossing No. P4874 at the time when the regional passenger train No. 1895 was arriving, caused by behavior of the car driver, who did not respect the light and acoustic warning of the level crossing safety equipment and did not make sure whether he could safely pass the level crossing.</li></ul> |

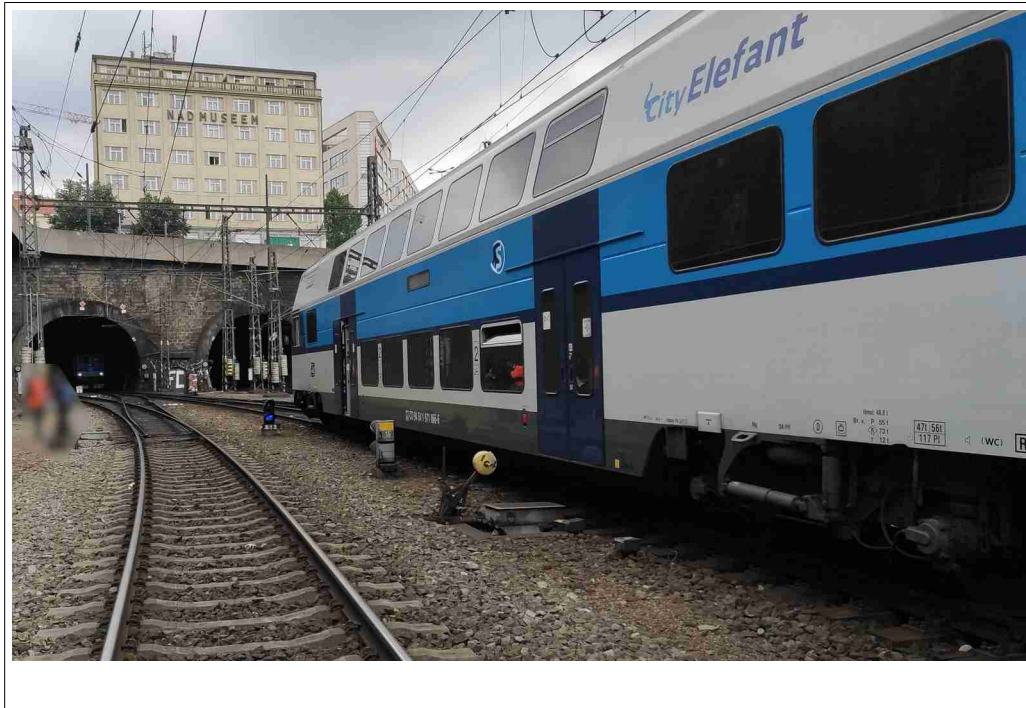
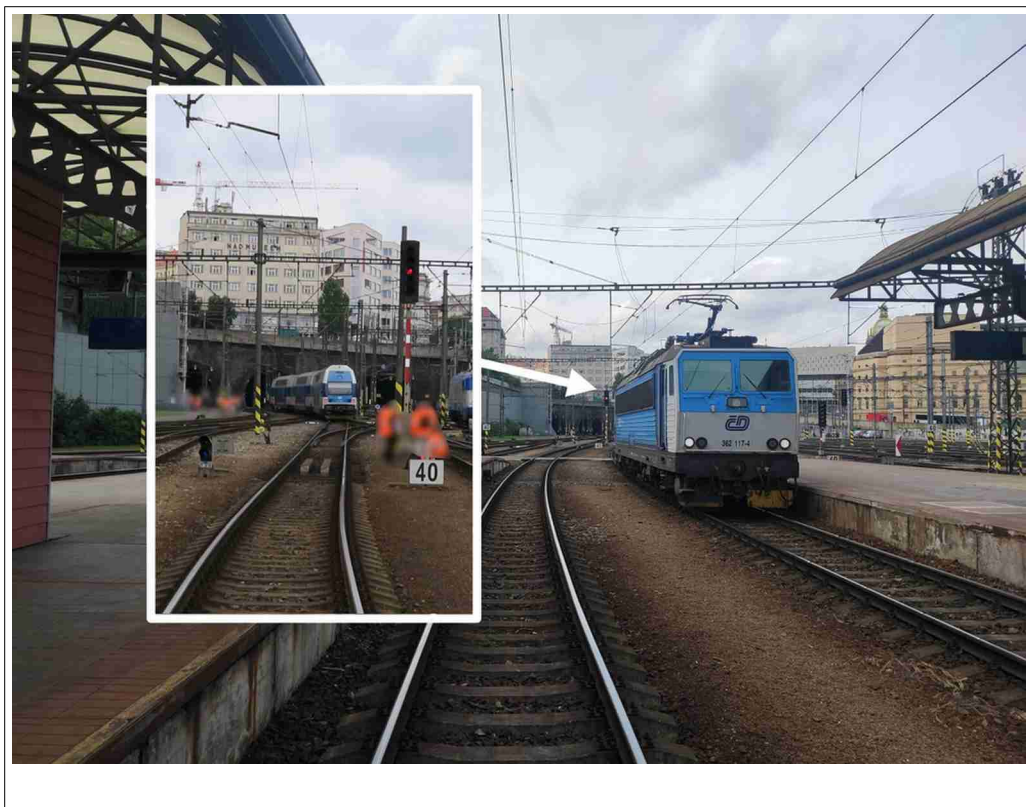
- failure to respect the signal „Stop” of the main (departure) signal device S26 at Praha hl. n. station by the train driver of the regional passenger train No. 9123 due to unconscious mistake of the train driver which manifested in the unauthorized movement of this train without dispatching from Praha hl. n. station and consequent unobservation of signal (unconviction about signal code) during ride of the train to relevant main (departure) signal device.

- non-acceptance of appropriate measure on the base previously safety recommendation which NIB recommended, that until to installation operation trains under sight European Train Control System (ETCS), to ensure to addition missing safety safeguard by technical equipment or other way, e.g. extend obligation of head of train attending crew with train with passenger transport or first person of train attending crew from front forefront of train give to train driver signal „Consent with departure” after conviction that movement of train is allow by relevant main signal device or other way.

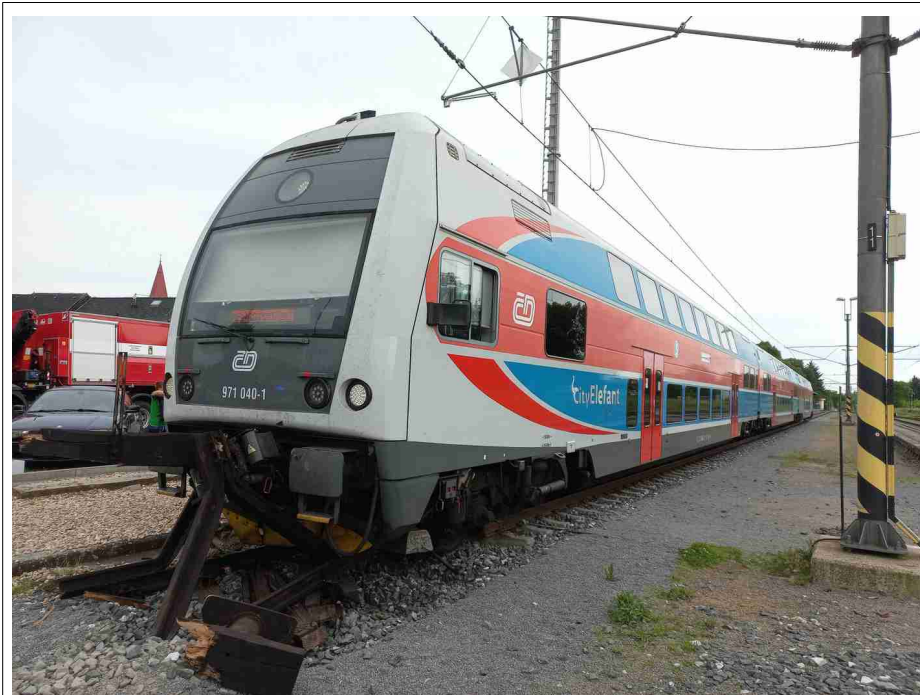
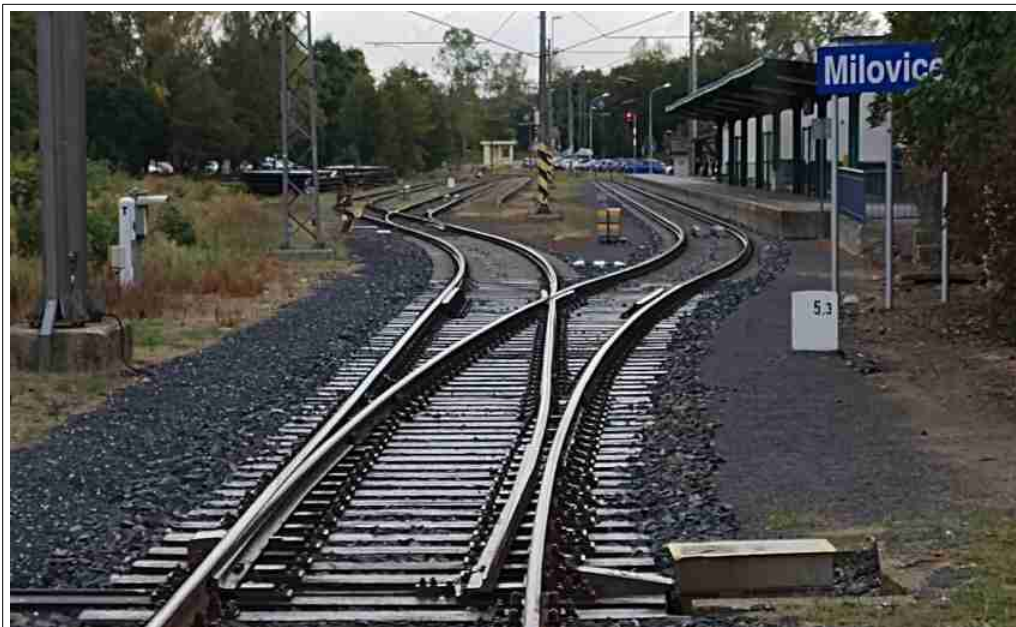
Consequences: 0 fatality, 0 injury;  
total damage CZK 3 438 527,-

- failure to stop of the regional passenger train No. 25635 in front of the main (route) signal device Sc2 with signal „Stop” at Milovice station, caused by incorrect driving style of the train driver, specifically:
  - not to start braking so, that the train safely stopped in front of the main (route) signal device Sc2 due to not to watch an operation and diagnostic monitor and a position of controller mode of ride on the control panel at a driver's footplate pointing out to deactivation of function (mode) target braking and necessity operate of brake controller.

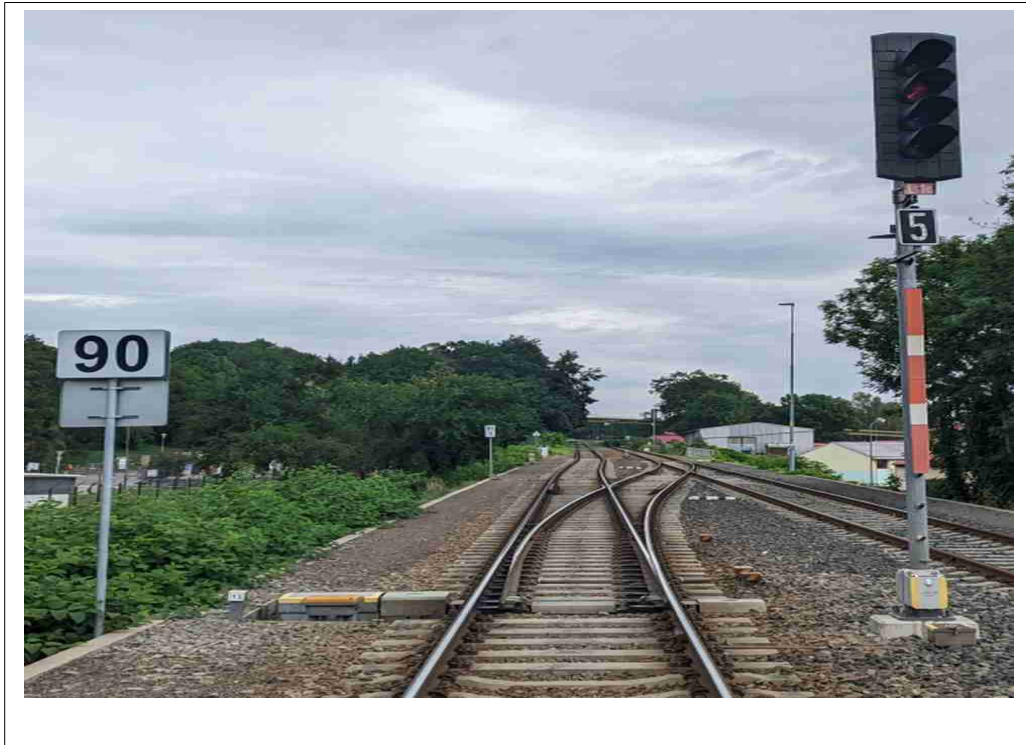
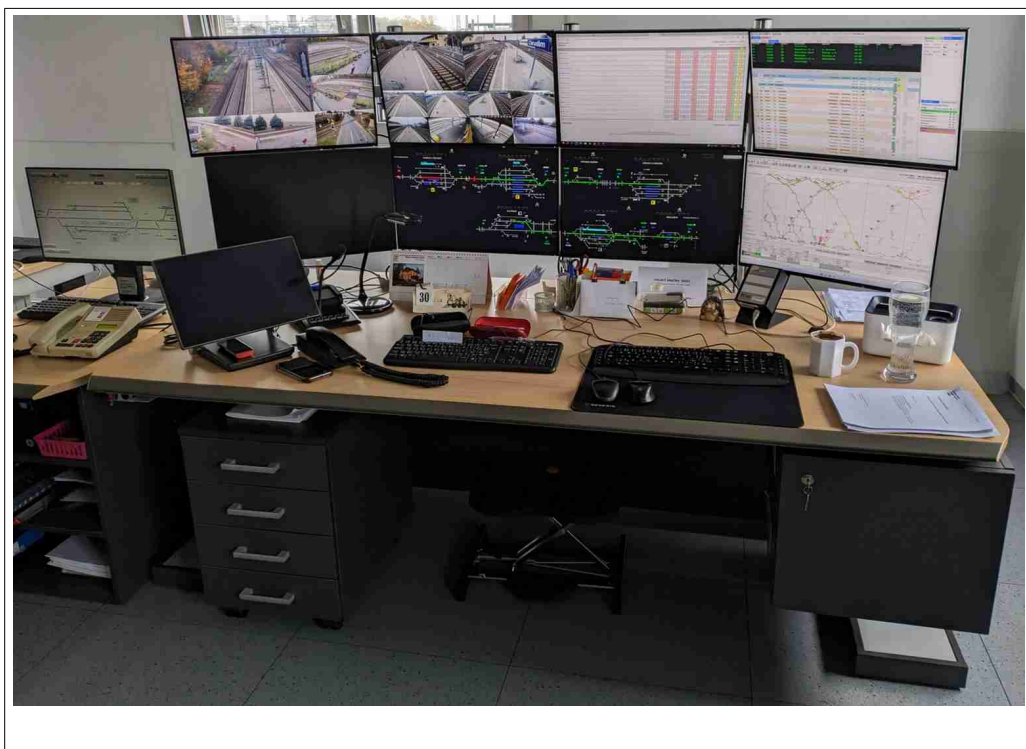
Consequences: 0 fatality, 0 injury;  
total damage CZK 0,-.

- failure to respect the signal „Stop” of the main (departure) signal device L1a at Chrudim station by the train driver of the regional passenger train No. 15186 caused by train driver’s unconscious mistake, he did not notice the signal „Stop” while driving to the signal device L1a.

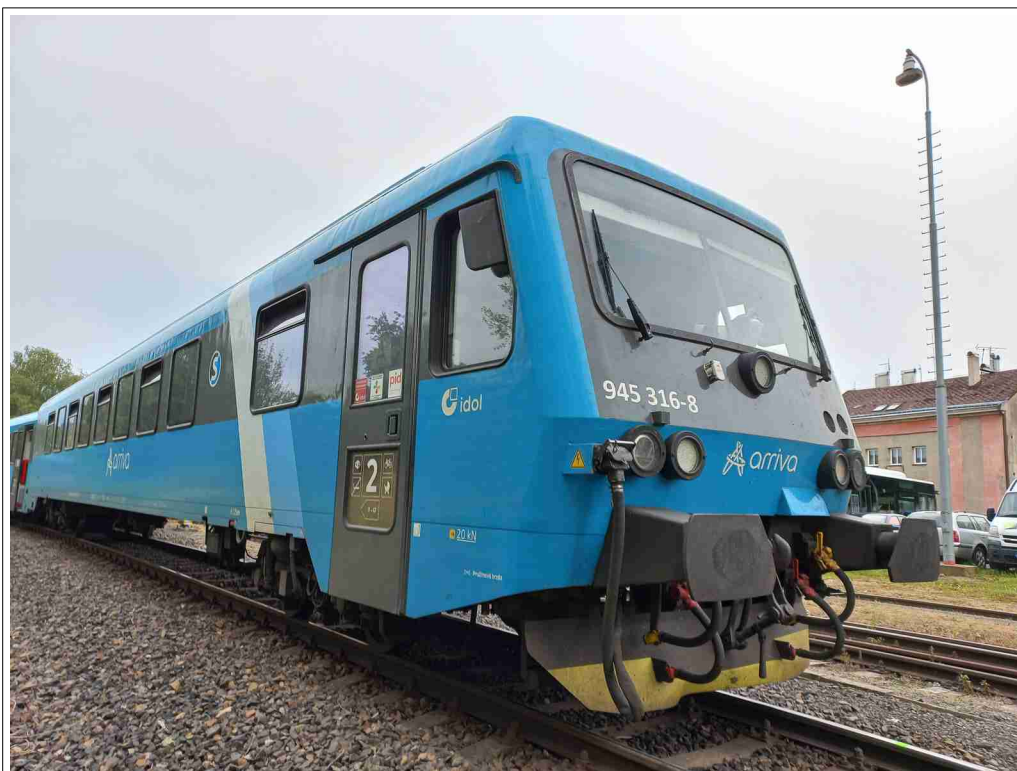
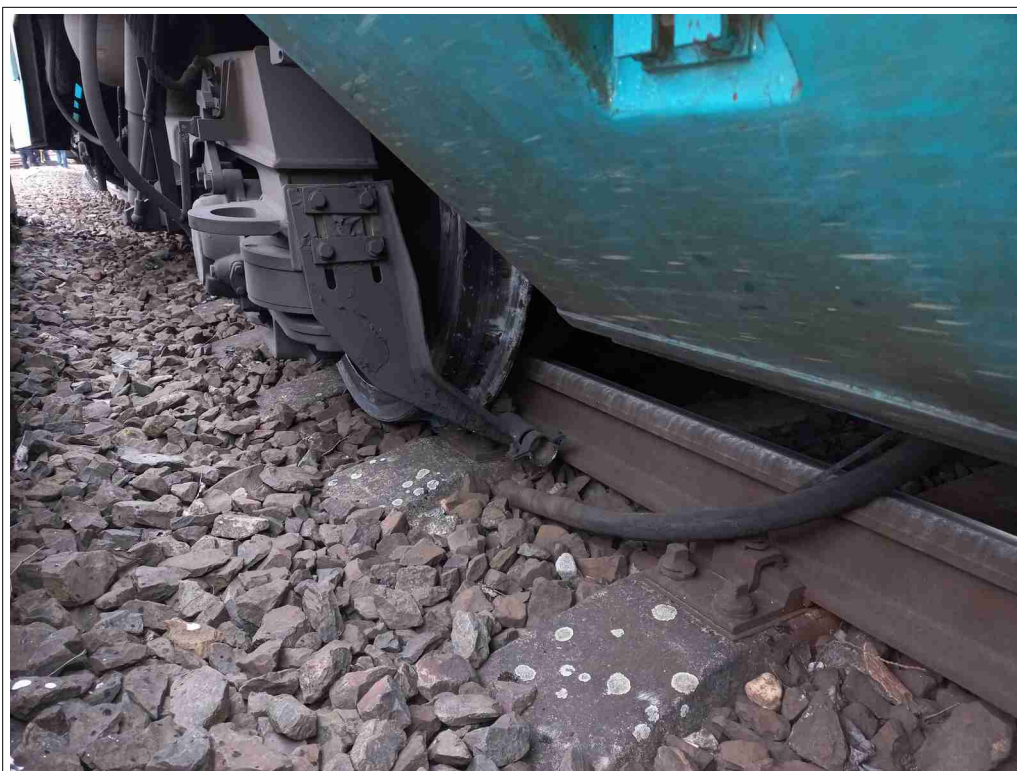
Consequences: 0 fatality, 0 injury;  
total damage CZK 1 038 055,-

- change of gauge of the third wheelset of rolling stock of regional passenger train No. 5414 caused by releasing the connection between the right wheel tyre and the wheel rim in direction of ride.

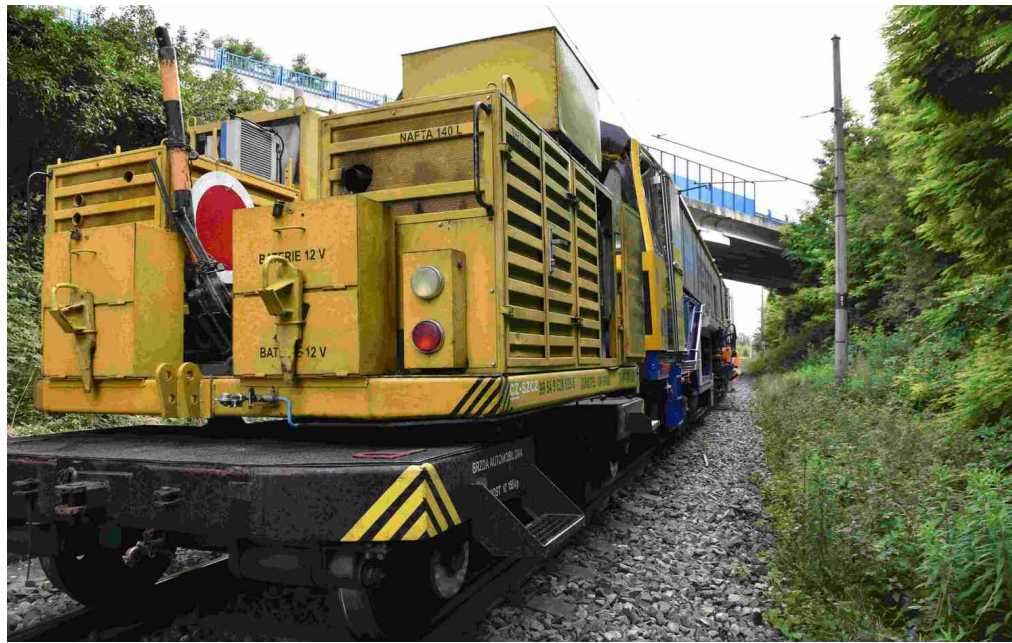
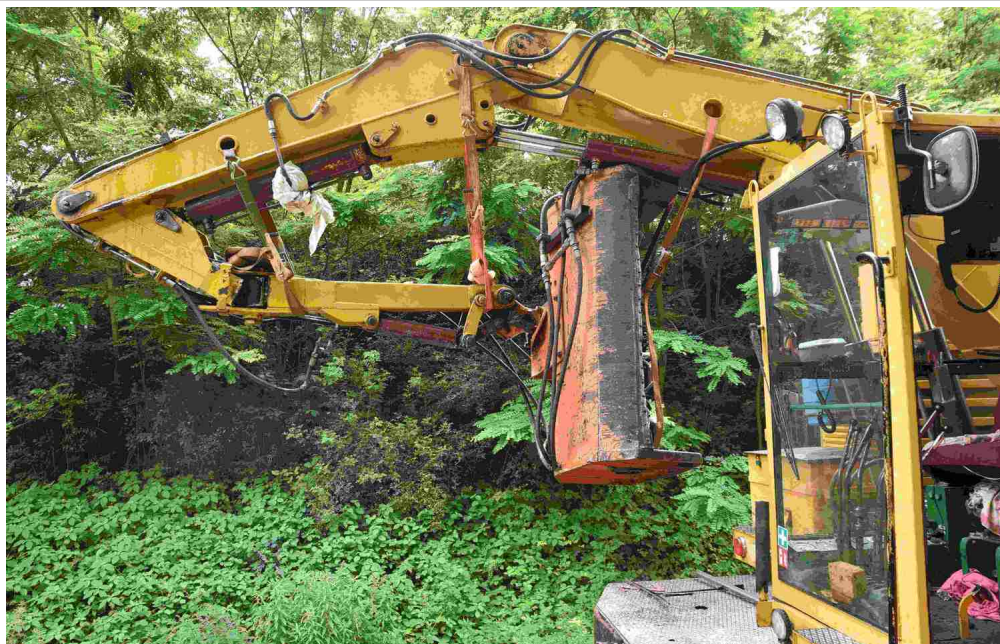
| Consequences: | 0 fatality, 1 injury;<br>total damage CZK 5 283 520,- |
| Causal factor: | <ul style="list-style-type: none"><li>failure to respect the signal „Stop” of the main (departure) signal device S1 at Holubice station by the train driver of the service train No. 52199 caused by train driver's unconscious mistake, he did not notice the signal „Stop” while driving to the signal device S1.</li></ul> |
| Contributing factor of trains collision: | <ul style="list-style-type: none"><li>muting and failure to perform a functional test of the on-board radio station located on the service train No. 52199.</li></ul> |

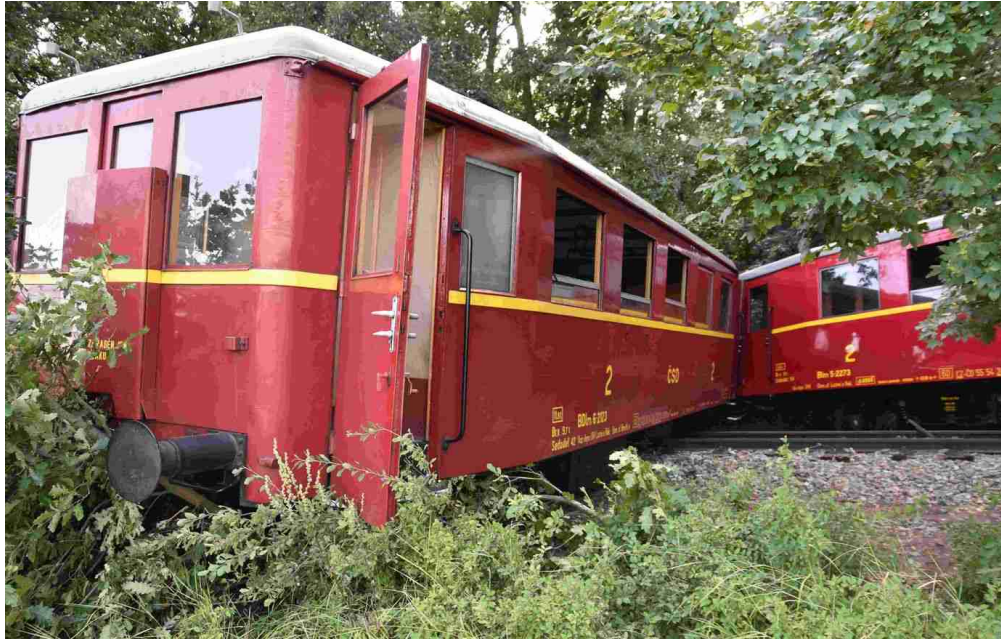
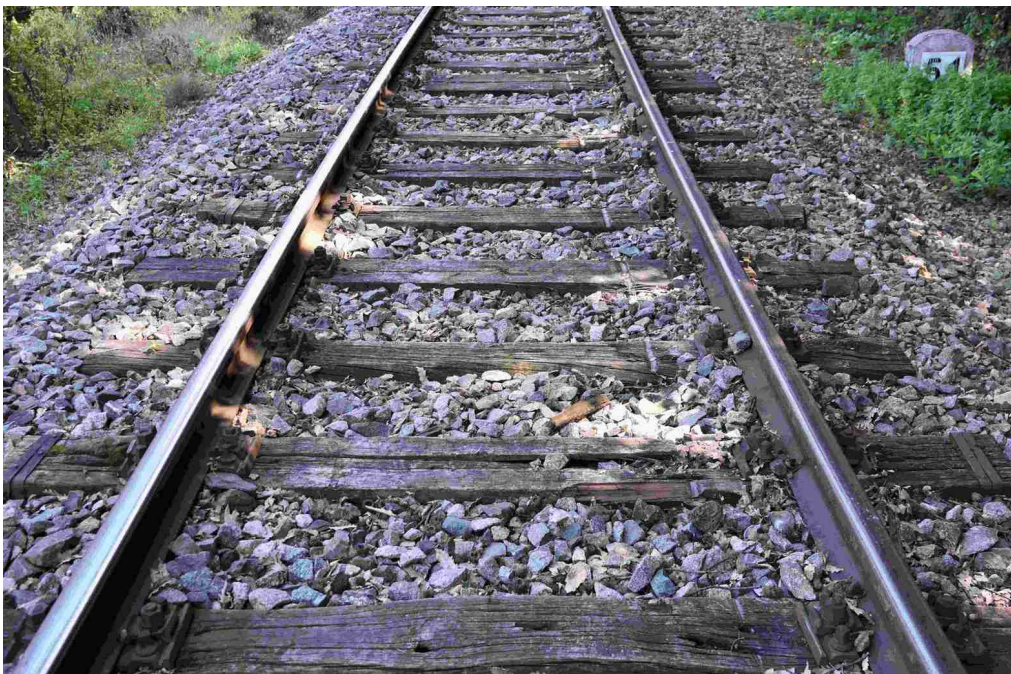
Date and time: 14<sup>th</sup> July 2024, 12:28 (10:28 GMT).  
Occurrence type: train derailment.  
Description: derailment of 2 rolling stocks of the regional passenger train No. 4583.  
Type of train: the regional passenger train No. 4583.  
Location: open line between Lednice railway stop and Boří les station, km 5,113.  
Parties: Správa železnic, státní organizace (IM);  
České dráhy, a. s. (RU of the regional passenger train No. 4583).  
Consequences: 1 injury;  
total damage CZK 3 710 619,-  
Causal factor:

- exceeding of the safety limit of track gauge and change of gauge as a result of insufficient holding of fastenings on the rotten wooden sleepers due to failure to adopt adequate measures to ensure safe guideway operating and guided transport operating.

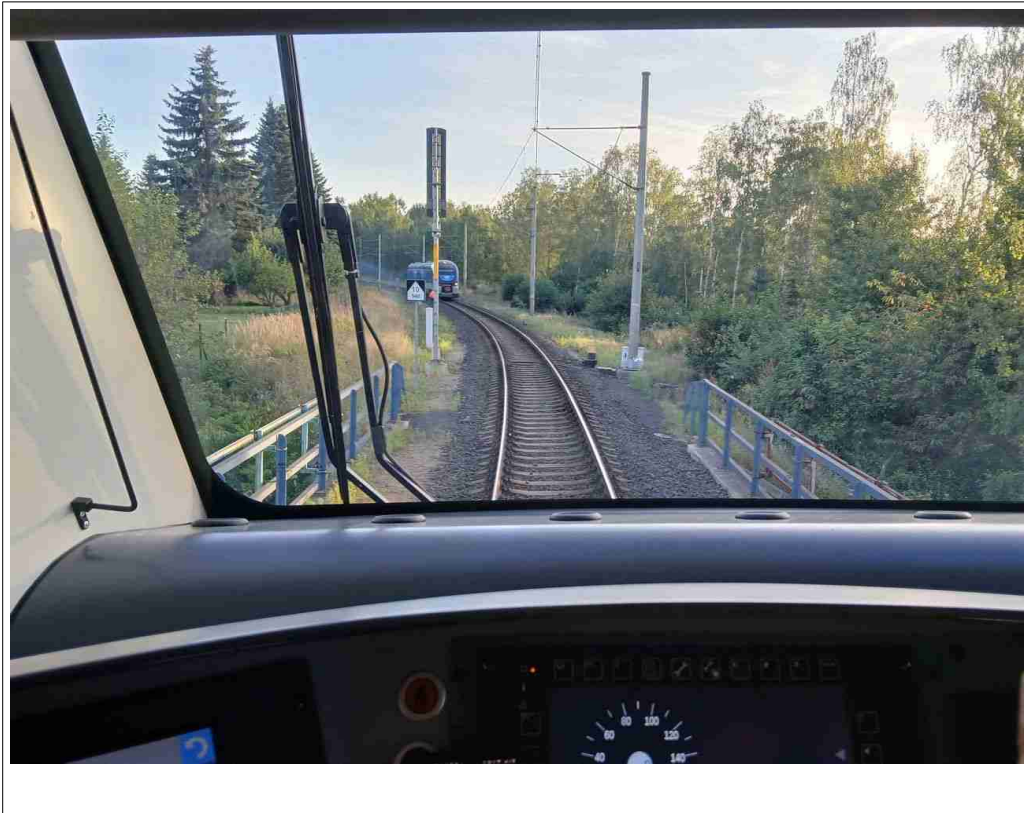
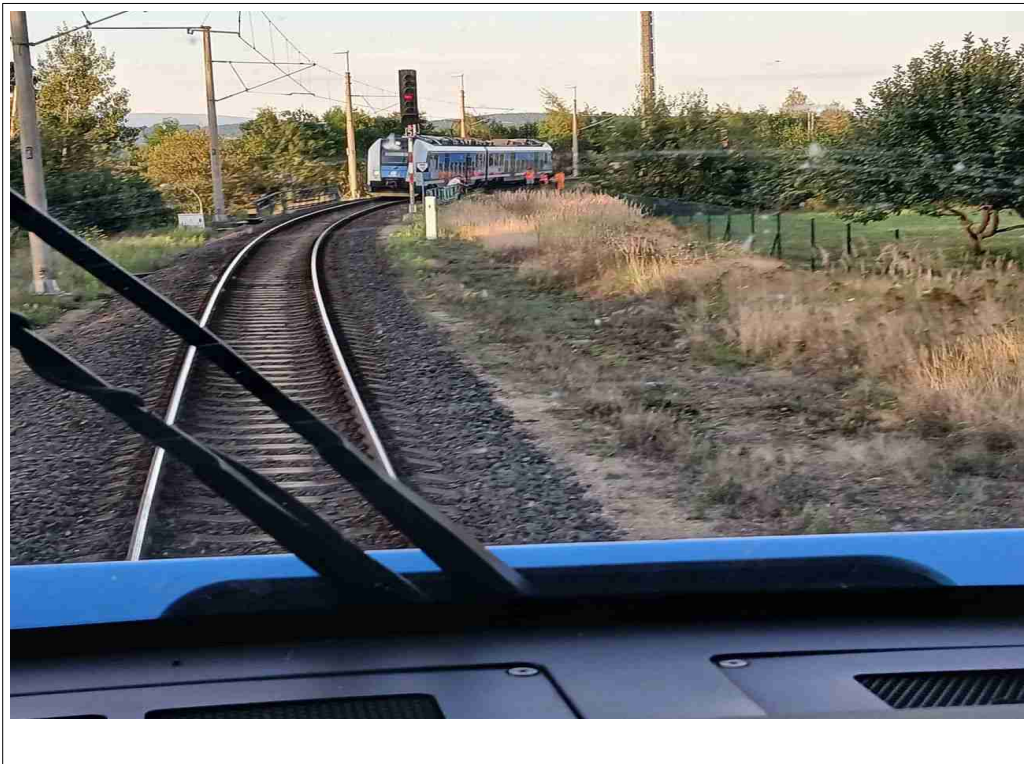
- unauthorized set the regional passenger train No. 1671 in motion and failure to respect the signal „Stop” of the main (departure) signal device L2 at Chodov station by the train driver without would:
  - it was dispatched the regional passenger train No. 1671 from Chodov station;
  - the train driver visually convinced whether the main (departure) signal device L2 at Chodov station allows movement of the train.
