The Rail Safety  
Inspection Office

## NIB ANNUAL REPORT 2025

according to Article 24(3) of Directive (EU) 2016/798

September 2026

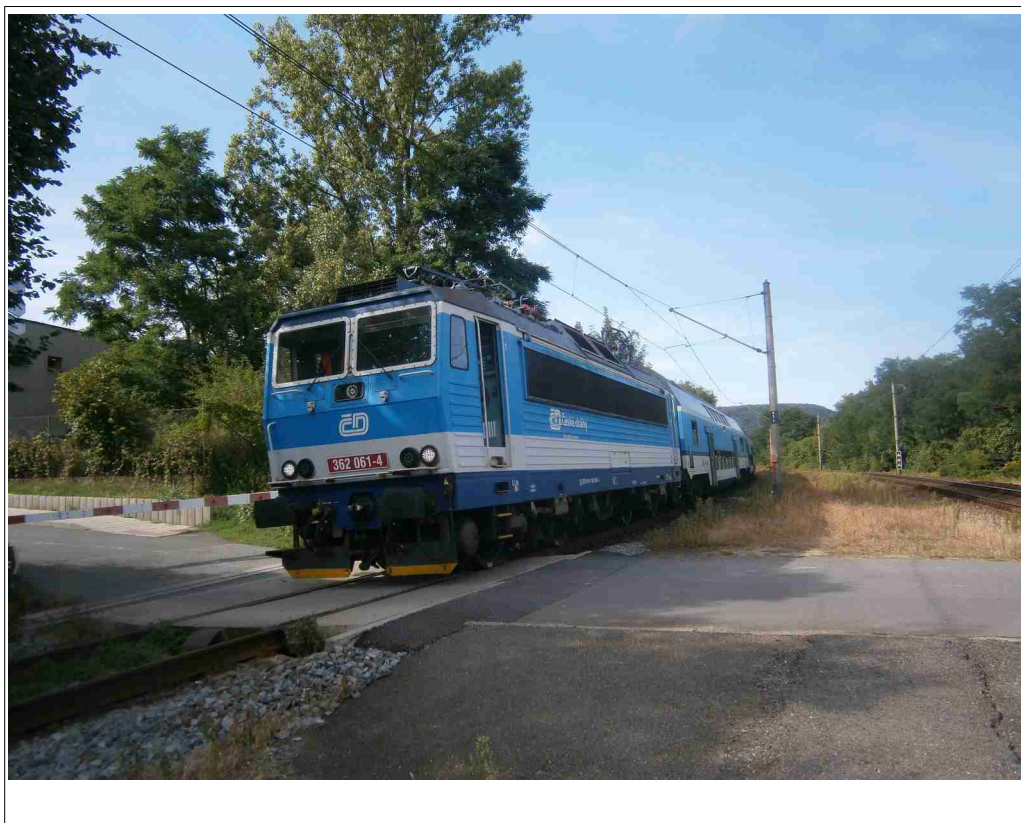
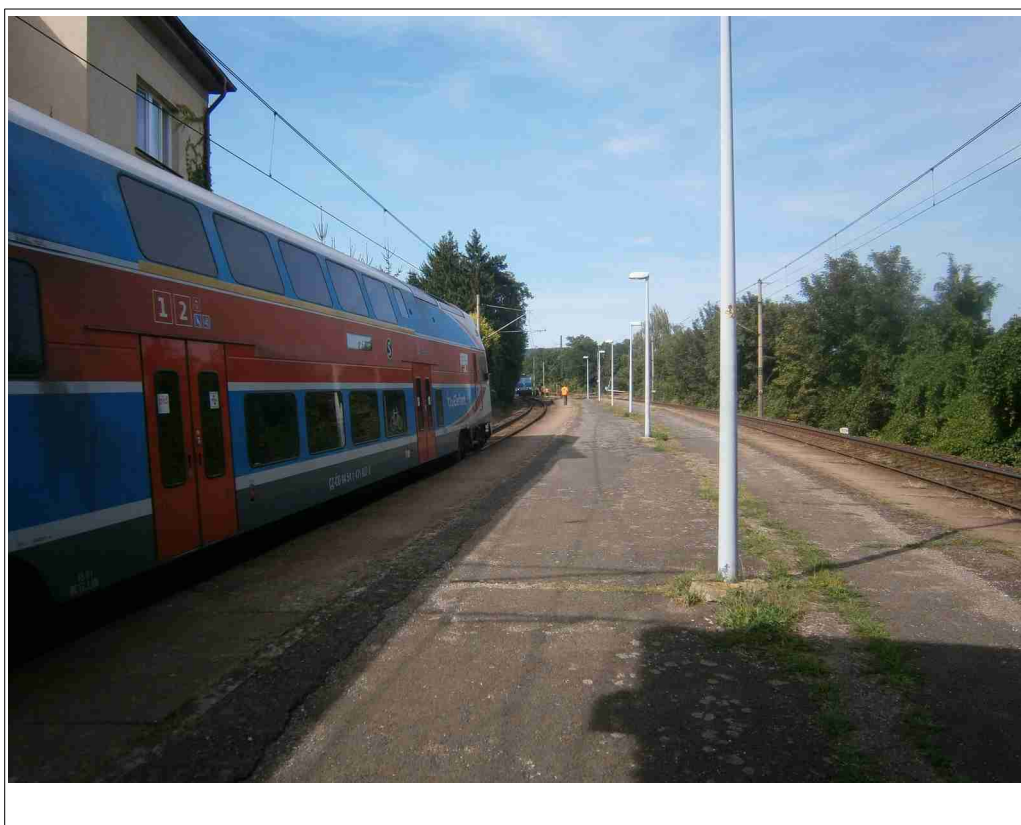
| Description: | unsecured movement of the regional passenger train No. 9940 behind the main (section) signal device of Kazín operating point with block apparatus (hereinafter signal box) into the block section which was occupied by the regional passenger train No. 8838 and consequent collision with the damage contact line. |
| Consequences: | 0 fatality, 0 injury;<br>total damage CZK 266 023,- |
| Causal factor: | <ul style="list-style-type: none"><li>• permission of ride of the regional passenger train No. 9940 by hand calling-on signal behind the main (section) signal device Lo of Kazín signal box into the block section which was occupied by the previous regional passenger train No. 8838 which caused by series of failures at performance of transport service, that:<ul style="list-style-type: none"><li>◦ the signalwoman at Kazín signal box did not continuously observe a condition of an elements of a level crossings safety installations and a line safety and signalling plant at Kazín signal box, from which were evident occupying of the block section of the line track No. 2 between Kazín and Horní Mokropsy signal boxes before the occurrence;</li><li>◦ the signalwoman at Kazín signal box did not find out (did not come to realize) that the previous regional passenger train No. 8838 already passed at signal box and on base of this mistake gave for other employees who controlled railway transport between Praha-Radotín and Dobřichovice stations (i.e. both station dispatchers and signalmán/woman at Kosoř and Horní Mokropsy signal boxes) wrong information about a position of this train at line, when she said that the train stands in front of the main (section) signal device Lo of Kazín signal box and this employees proceeded from this wrong information at their work activity;</li><li>◦ the signalwoman at Kosoř signal box did not notify other employees who controlled railway transport between Praha-Radotín and Dobřichovice stations about possible danger, when she got wrong information about the position of the previous regional passenger train No. 8838 at line from the signalwoman at Kazín signal box and she did not immediately intervene although it was located</li></ul></li></ul> |

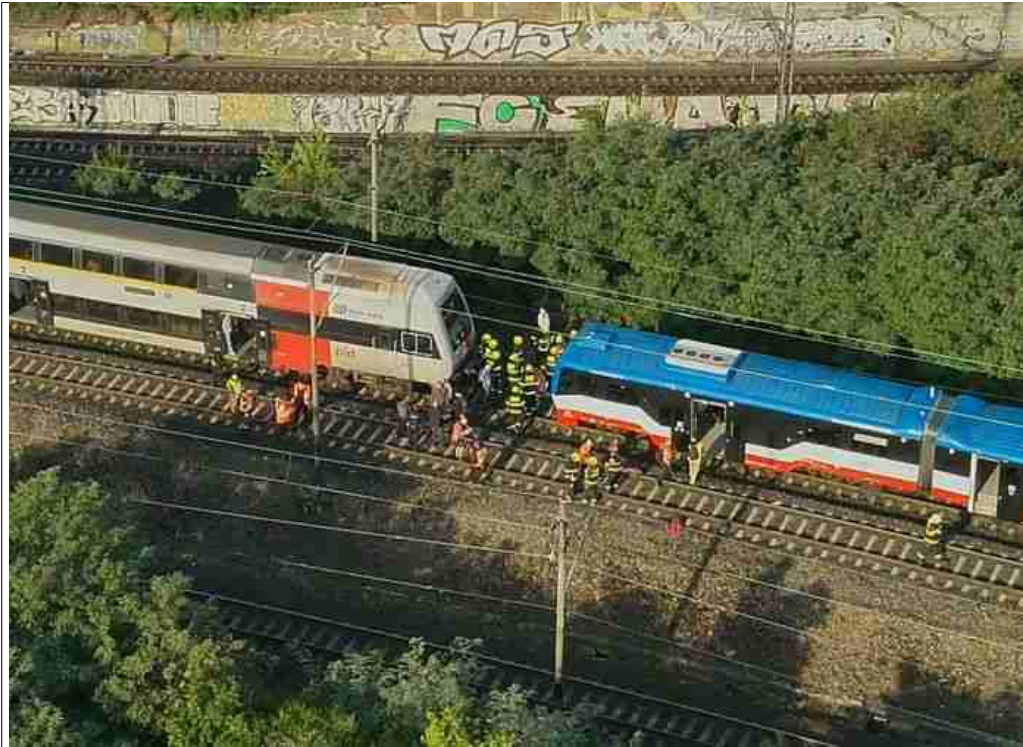
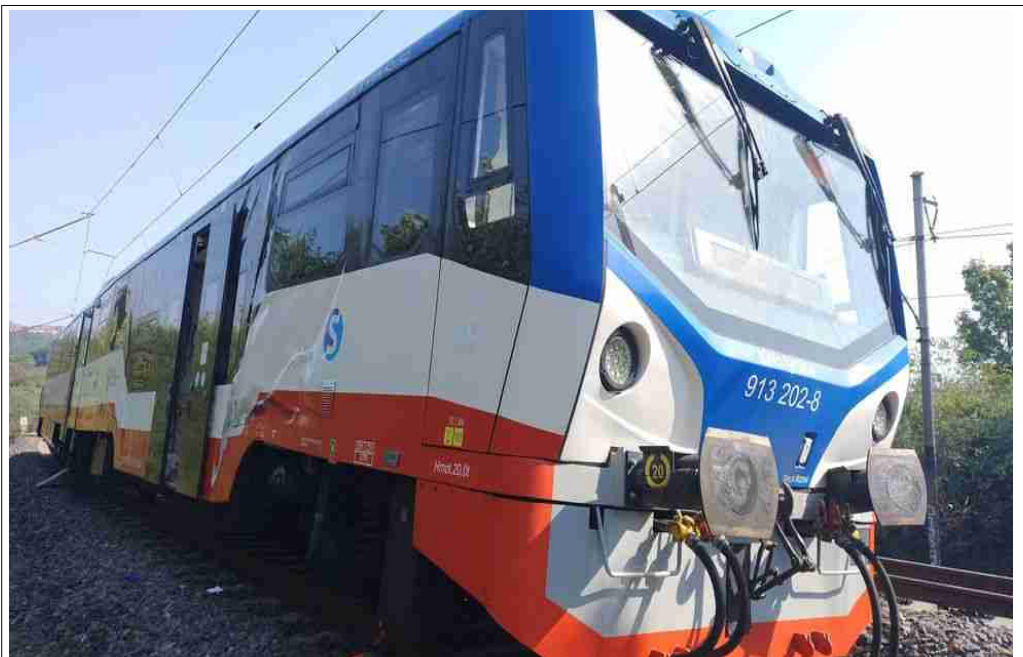
| Consequences: | 0 fatality, 37 injuries;<br>total damage CZK 31 614 162,- |

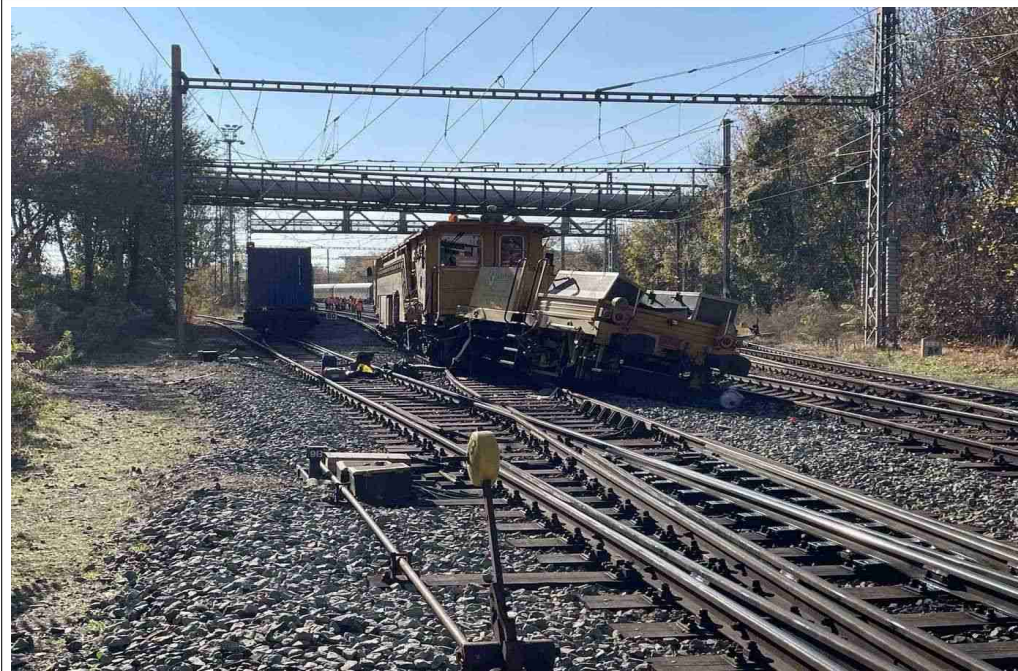
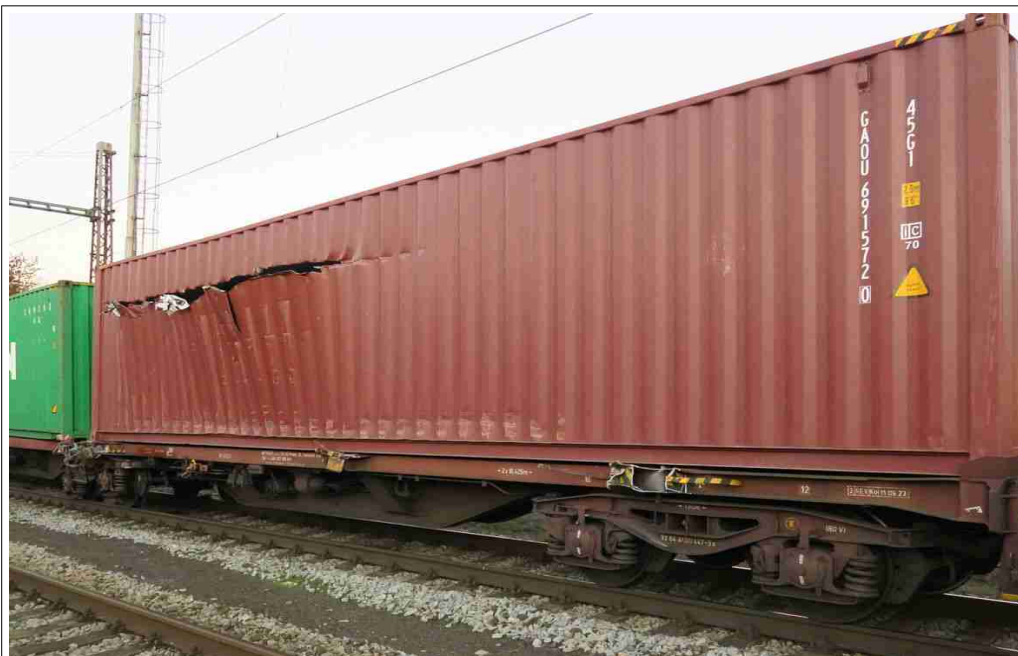
Consequences: 0 fatality, 0 injury;  
total damage CZK 8 776 026,-

- failure to respect the signal „Stop” of the main (departure) signal device S1 at Praha-Malešice station due to:
  - the train driver of the freight train No. 53051 followed signal „Continue” of the main (departure) signal device S2 at Praha-Malešice station which was not intended for this train;
  - the head guard of the freight train No. 53051 did not observe the track and signals and he did not alert the train driver of the need to stop the train.

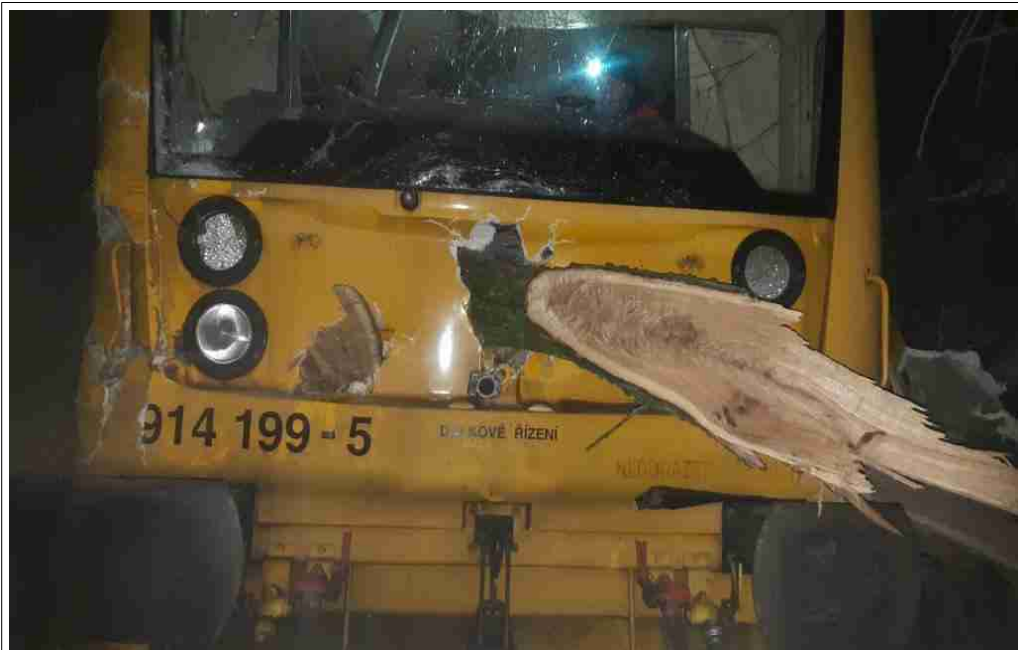
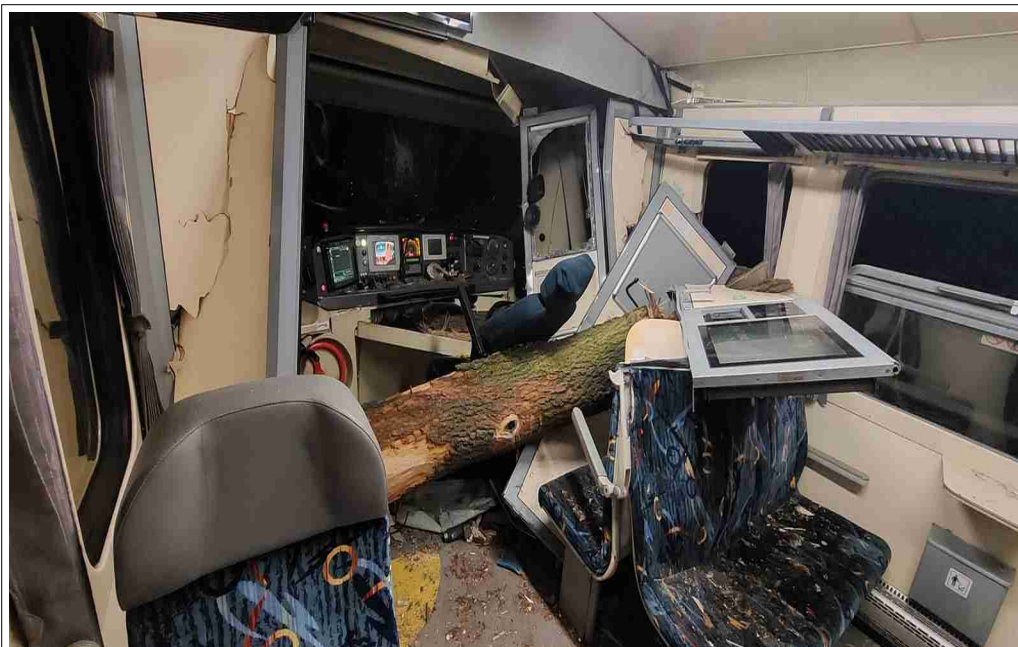
Date and time: 22<sup>nd</sup> January 2025, 16:57 (15:57 GMT).  
Occurrence type: trains collision with an obstacle.  
Description: collision of the regional passenger train No. 24836 with the obstacle (broken off part of the treetop) which fell on a track.  
Type of train: the regional passenger train No. 24836.  
Location: open line between Olbramkostel and Šumná stations, km 116,610.  
Parties: Správa železnic, státní organizace (IM);  
České dráhy, a. s. (RU of the regional passenger train No. 24836).  
Consequences: 0 fatality, 1 injury;  
total damage CZK 518 642,-  
\*) The amount of damage was not final at the date of the report publishing.  
Causal factor:

- disruption of a structure gauge of the line track between Olbramkostel and Šumná stations by the obstacle – broken off part of the treetop which grew in a railway protective area in an impact distance from the structure gauge as a result of its limited vitality and a defective growth of a skeletal branch when it was not selected to removing within checking activity to ensuring of operability of the line track and it was not removed.

- failure of stability of a weakened valley of a tree crown skeletal branch (oak) caused by the load of a thick layer of rime.
