**STATE COMMISSION ON RAILWAY ACCIDENT INVESTIGATION**

**ANNUAL REPORT 2024**

**ON THE ACTIVITIES**  
**OF THE STATE COMMISSION**  
**ON RAILWAY ACCIDENT INVESTIGATION**

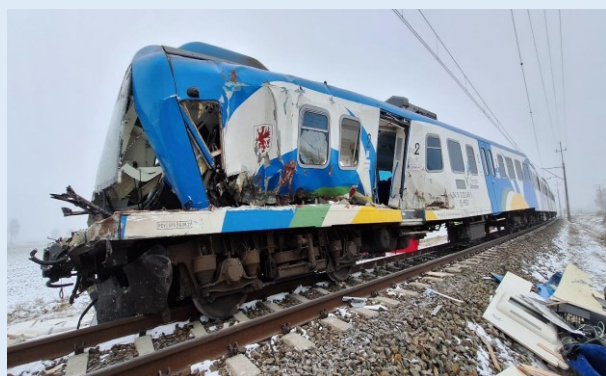
- as a result of the occurrence, the train inspector died on the spot, the train driver and the train manager were seriously injured, a passenger of the train was injured; the driver of a road vehicle did not sustain any injuries; the train driver died after 26 days in hospital as a result of the injuries sustained
- the semi-trailer of an IVECO lorry and an electric multiple unit EN57AL-1527 were destroyed; the train derailed with the first bogie to the right side in the direction of travel

Photograph 1 - Consequences of the occurrence - the damaged EMU EN57AL-1527 (source: own material of PKBWK)

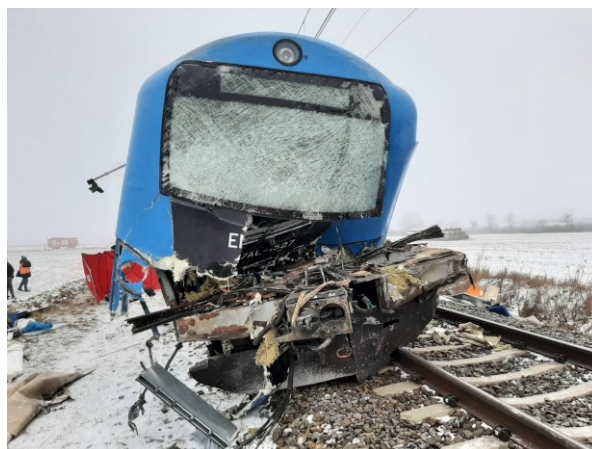
Photograph 2 - Consequences of the occurrence - the damaged EMU EN57AL-1527 (source: own material of PKBWK)

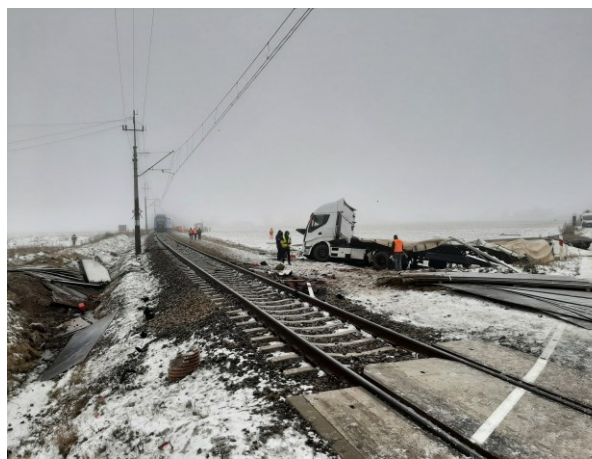
Photograph 3 - Consequences of the occurrence - the damaged lorry with semi-trailer, scattered cargo - 10 mm thick metal sheets (source: own material of PKBWK)

2. Until either of the actions specified in recommendation 1 is executed, due to the safety risk at the crossing, the railway infrastructure manager PKP PLK S.A. shall introduce the permanent speed limit of 20 km/h for the train head at the Category D level crossing at km 56.055 of railway line 354, Poznań Główny POD-Piła Główna, in both directions.

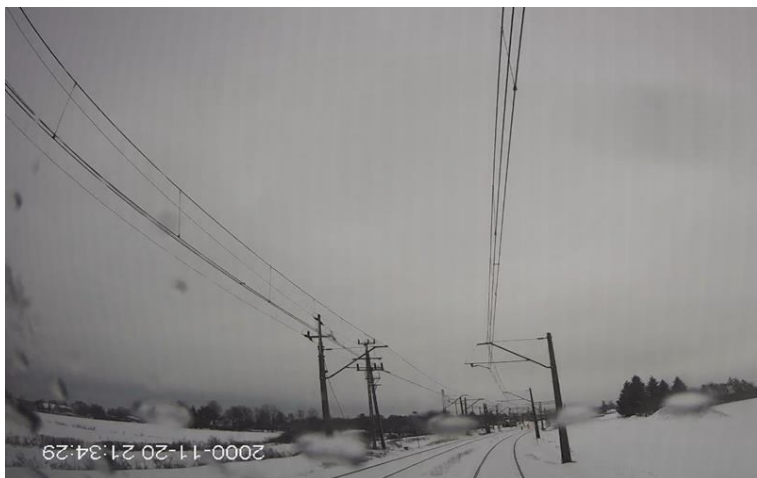
- one person died on the spot and one was seriously injured and taken to hospital where he died as a result of the injuries sustained

Photograph 4 - The SA134-019 front camera view of the working group (source: materials provided by POLREGIO S.A.).

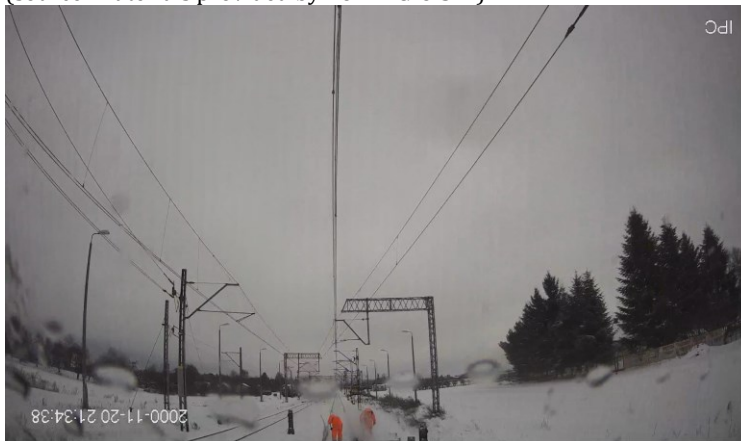
Photograph 5 - The SA134-019 front camera view of the working group immediately prior to the accident (source: materials provided by POLREGIO S.A.)

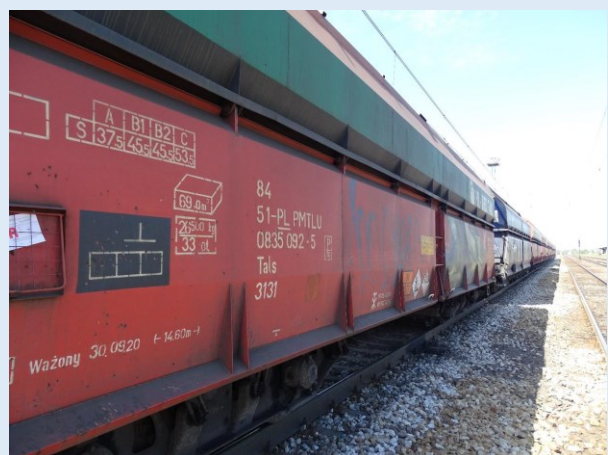
- the fractured wheelset axle led to derailment of the following wagons: 9, 10, 14, 15, 16 and 17 behind the locomotive
- furthermore, the train was torn apart between the fourteenth and fifteenth wagon behind the locomotive
- turnouts no. 3 and 7, including turnout elements and track sections in the path of the train, were damaged

| Photograph 6 - A view of the wagon with the fractured axle following the accident (source: materials provided by the railway commission) | Photograph 8 - Consequences of the occurrence - a view of the fractured axle (source: own material of PKBWK) |

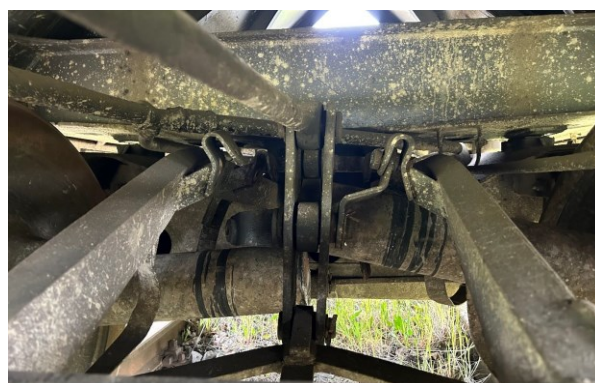
Photograph 7 - **Consequences of the occurrence** - a view of the fractured axle (source: own material of PKBWK)

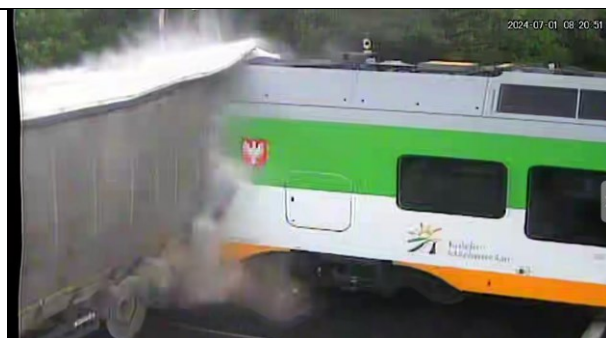
Photograph 10 - A view of the collision of the KM passenger train with the semi-trailer (source: material provided by PKP PLK S.A.)

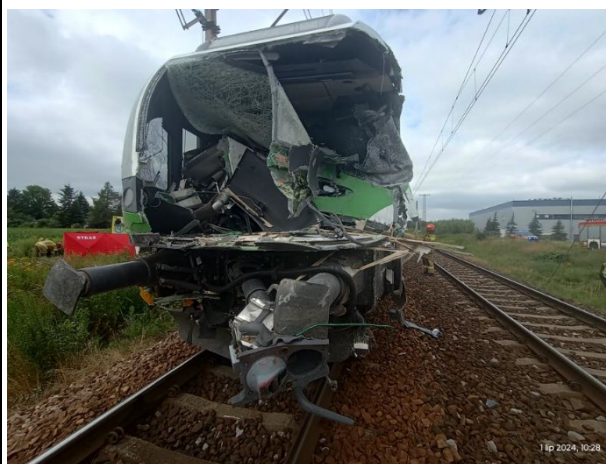
- as a result of the occurrence, the driver of passenger train ROJ 91448 died on the spot
- the driver's cab was completely destroyed, the first section of rail vehicle ER75-001 was damaged
- a KOEGEL semi-trailer of a DAF road tractor with the transported load (construction materials) was destroyed

Photograph 11 - Consequences of the occurrence - a view of the destroyed driver's cab of rail vehicle ER75-001 (source: material provided by KM)

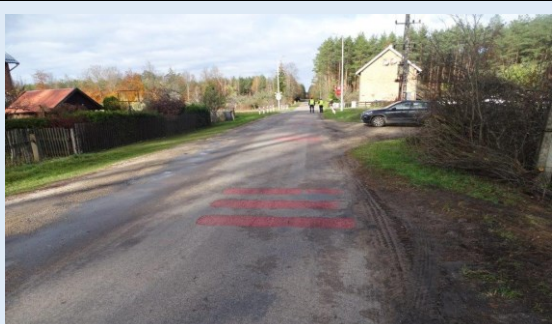
Photograph 12 - A view of the level crossing from the direction of the passenger car's travel (source: railway commission)

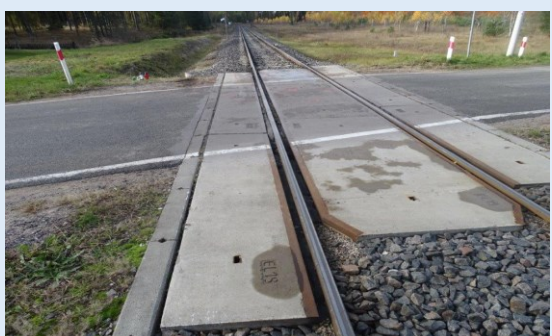
Photograph 13 - A view of the technical condition of the level crossing from the direction of passenger car's travel (source: materials provided by the railway commission)

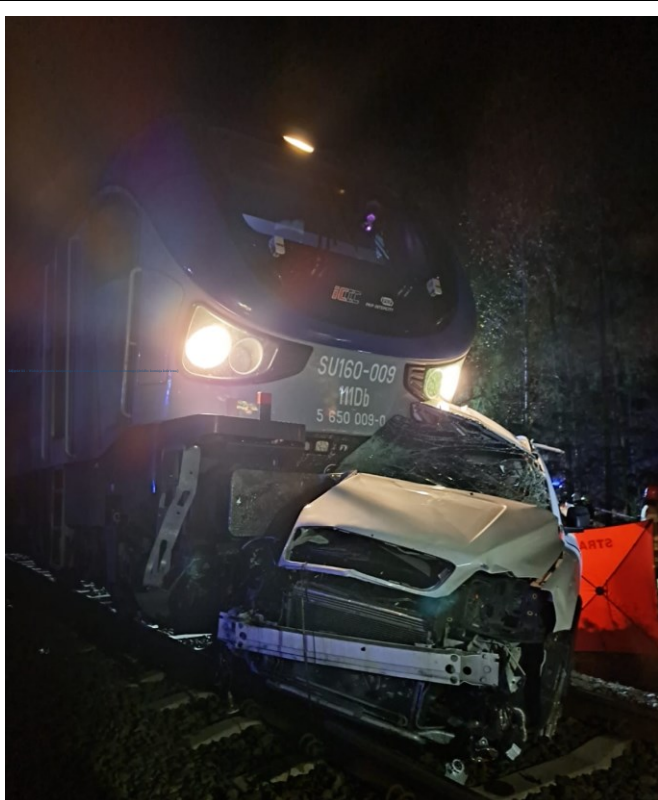
- The driver of the passenger car and four passengers died on the spot
- the passenger car (Volvo) was completely destroyed
- the locomotive leading train SU160-009 was damaged (no derailment)

Photograph 14 - Consequences of the occurrence - damaged locomotive ET22-1062 (source: materials provided by the railway commission)

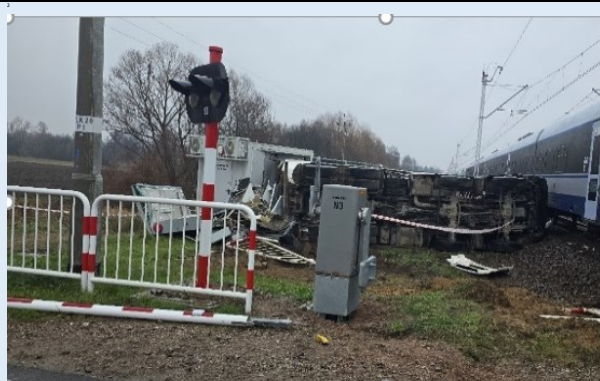
- Three passengers of train EIJ 5220 were injured as a result of the occurrence
- the first bogie the electric multiple unit ED161-004 was derailed on the right-hand side in the direction of travel, the head section of the ED161-004a cab was damaged
- a lorry (MAN) was thrown away and turned by 180° by the moving train
- U11 fencing was crushed, a container with internal crossing signalling equipment was destroyed, a power supply cabinet and container with telecommunication equipment were destroyed

Photograph 15 - Consequences of the occurrence at the level crossing (source: materials provided by the railway commission)

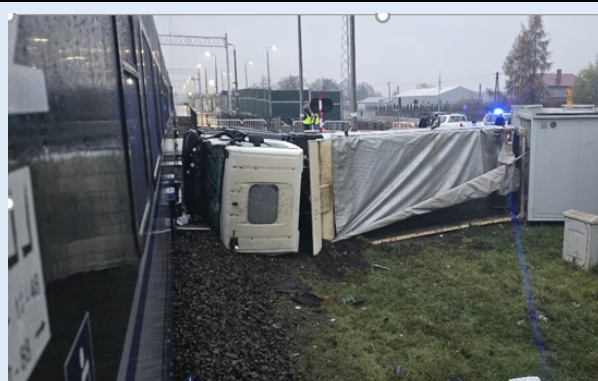
Photograph 16 - Consequences of the occurrence at the level crossing (source: materials provided by the railway commission)

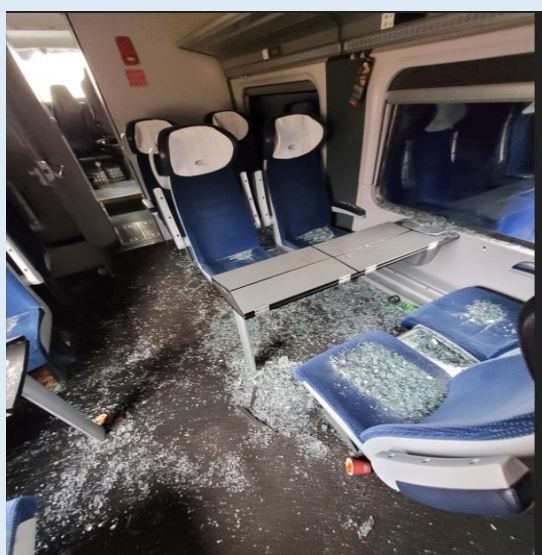
Photograph 17 - Consequences of the occurrence - the interior of ED161-004a (source: own material of PKBWK)

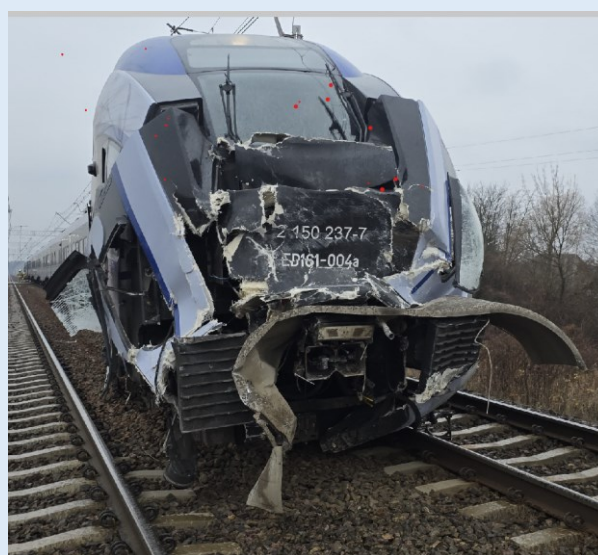
Photograph 18 - Consequences of the occurrence - the damaged ED161-004a cab (source: materials of the railway commission)
