**Management of the Federal Railway
Accident Investigation Office**

Railway Accident Investigation

ANNUAL REPORT

2012

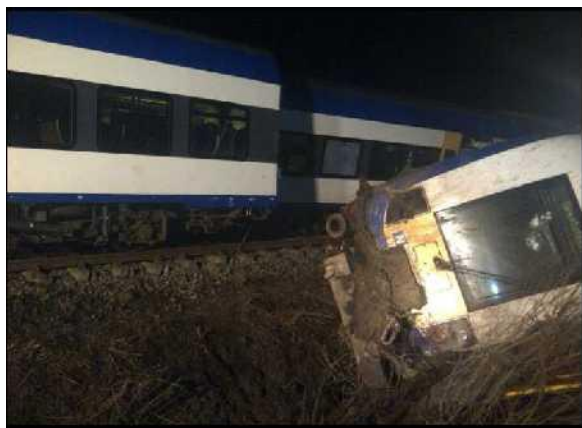
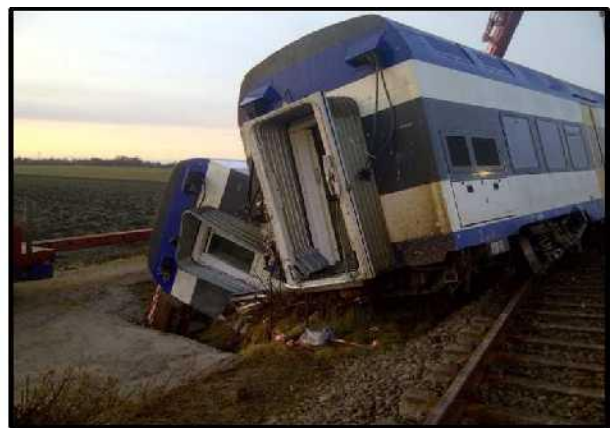
Figure 7: Collision between Stedesand and Langenhorn

In the collision 1 person was killed and 4 were slightly injured.

14 cattle were killed in the collision. The driving trailer overturned and came to rest at the side of the track, the second coach also derailed. The cost of the damage is estimated at about EUR 2 million.

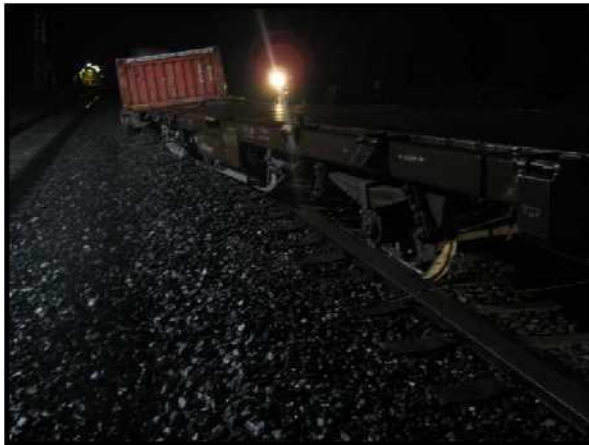
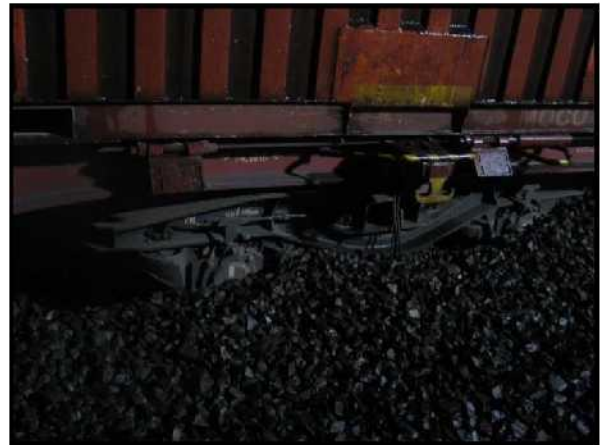
Figure 8: Train derailment between Langenselbold and Hailer-Meerholz

A loaded container (11.375 t) from the sixth wagon fell onto the track. There were no dangerous goods in the train. There was considerable damage to the vehicles, the track and the signalling equipment.

The derailment of KT 41969 occurred because of a defective axle bearing on the fourth axle of wagon number 21 81 4361 075-4.

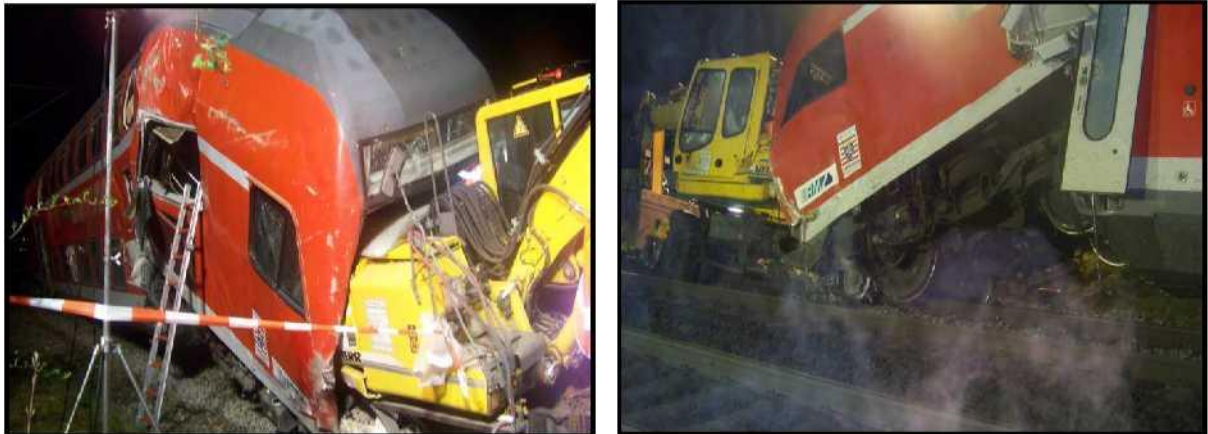
Figure 9: Train collision between Mühlheim (Main) and Hanau Central Station

The train driver of RB 15640, the driver of the road-rail vehicle and the assistant driver were fatally injured. 14 passengers in the train were slightly injured. There was considerable damage to the vehicles, track and safety equipment. Both the driving trailer and the road-rail vehicle were write-offs.

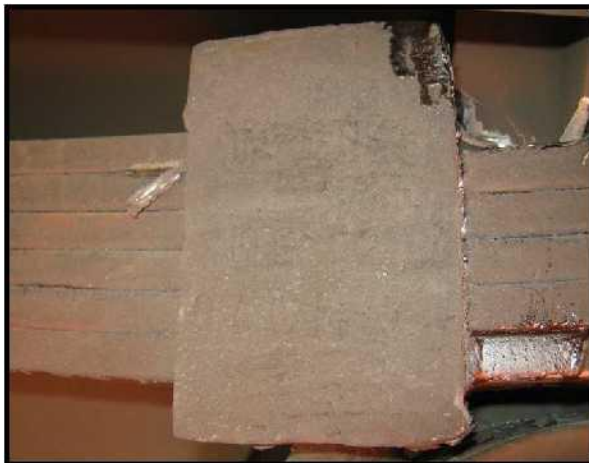
Figure 10: Train derailment at Bebra

The track, light masts and overhead lines were severely damaged by the derailment. The damage caused to the overhead lines, track, lighting and safety equipment was estimated at EUR 3 million.

The present stage of the investigation suggests that the derailment was due to the fracture of a leaf spring on the last freight wagon (wagon number 23 80 2911 925-8).

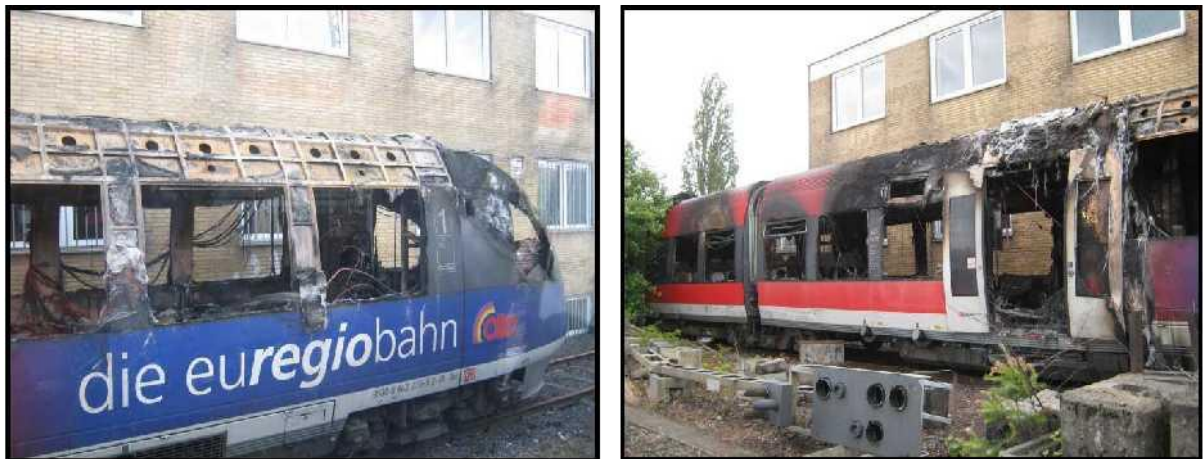
Figure 11: Fire on a vehicle at Aachen-Rothe Erde

The power car was more or less burnt out and the overhead line was also seriously damaged by the fire.

The cost of the damage was estimated at about EUR 1.2 million.

The cause of the fire was two demonstrable electrical insulation defects which had not been previously identified. The fire started in the vehicle coupling due to high currents in the components and cables which were not designed for them.

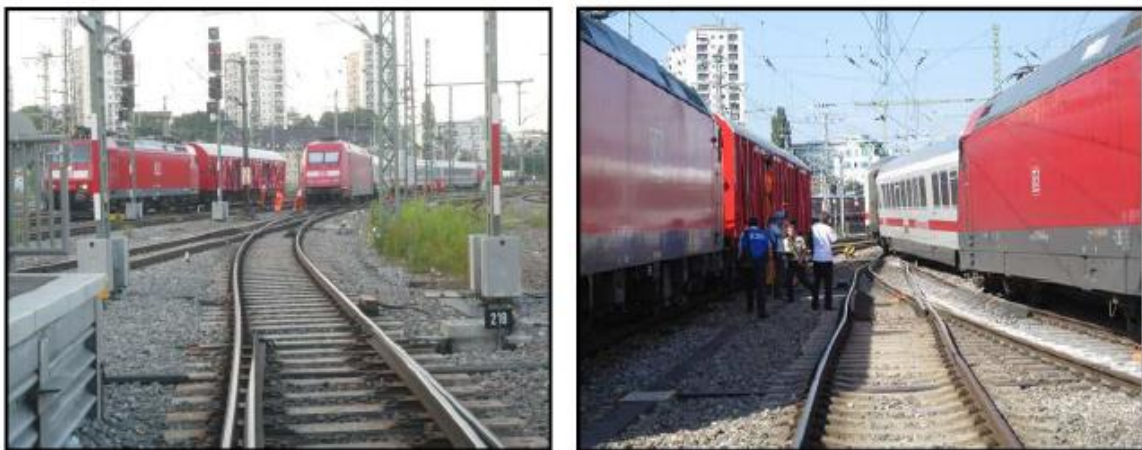
Figure 12: Train derailment in Stuttgart Central Station on 24 July 2012

Nobody was injured. The derailment caused damage to vehicles (power car and the last two wagons) and the infrastructure.

The investigations carried out initially showed that the permissible compressive forces generated in the rake of coaches, when leaving the station, was exceeded and consequently could have made a major contribution to the derailment. After a similar train derailment occurred on 29 September 2012, in which the permissible compressive forces were not exceeded, investigations were again focussed in the vehicle technology and infrastructure areas. It was found that the areas process control and safety technique could be excluded as the cause of the derailment.

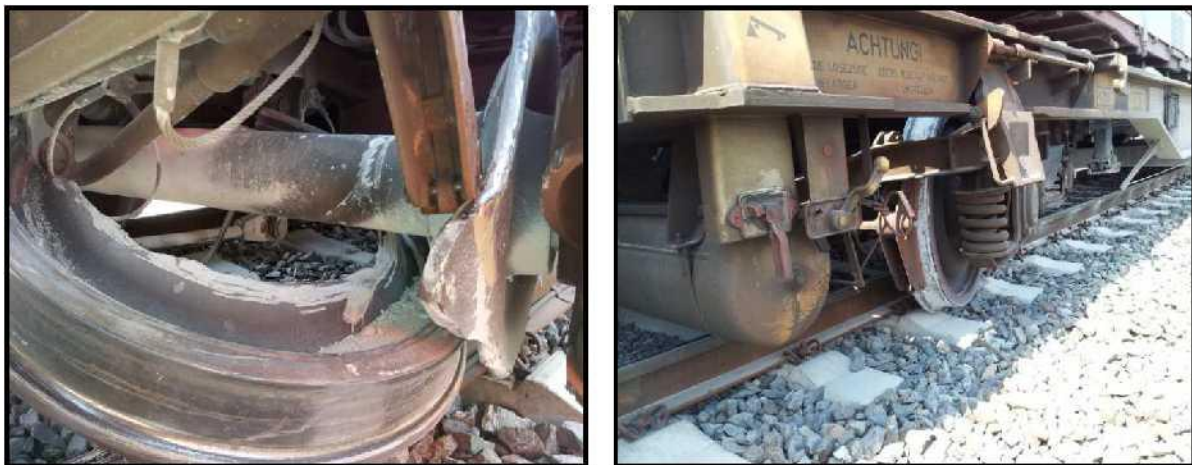
Figure 13: Train derailment at Winterhausen

The track was seriously damaged. The load of the semi-trailer transported on the derailed wagon was displaced by the transverse force set up during the derailment.

On the basis of the investigations carried out it was concluded that the derailment was the result of a wheel centre fracture on wheelset No 129 627 (AAE) of wagon 33 68 4956 309-1. The wheel centre fracture occurred at km 126.623 - the place where the larger piece of the fractured wheel centre was found immediately after the bogie derailed with both axles. The results of the material investigation carried out indicated that the production of cracks was due to thermal overloading.

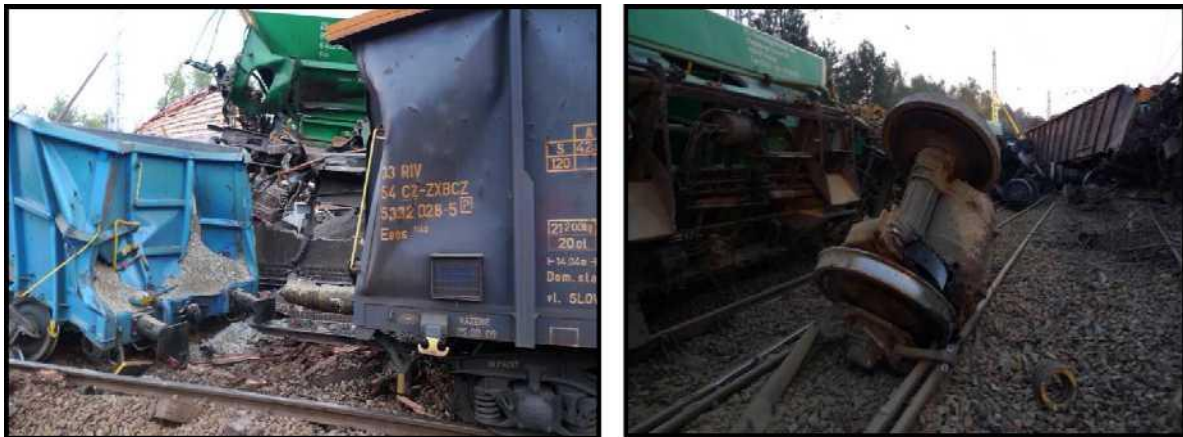
Figure 14: Train collision at Hosena

Due to the side movement of DGS 49325 several freight wagons and the locomotive DGS 49325 derailed. Some of the derailed freight wagons collided with the pointsman's signal box W3 and caused it to collapse. Several wagons piled up on the ruins of the signal box. The pointsman in signal box W3 was fatally injured. The locomotive driver of DGS 49325 was seriously injured after jumping from the moving train. The locomotive driver of DGS 92505 and the movements inspector suffered a shock.

There was considerable damage to vehicles and the infrastructure. The pointsman's signal box was destroyed.

DGS 49325 ran past the entry signal A at danger due to defective brake equipment. Previous experience suggests that the defective brake equipment was due to a closed air shut-off cock on the first freight wagon immediately behind the locomotive.

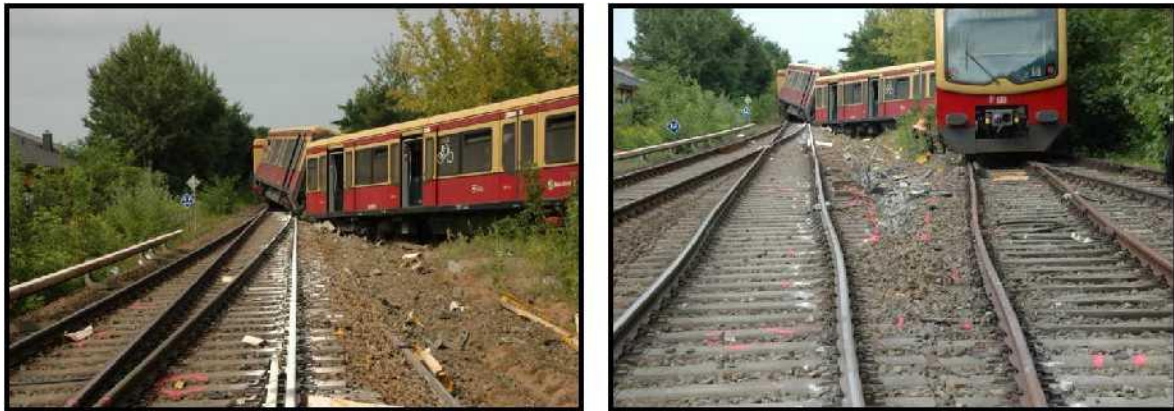
Figure 15: Train derailment in Berlin Tegel

Six people were slightly injured by the derailment and taken to hospitals for further examination.

Of the six coaches in the train, coaches 3 and 4 derailed. The track was damaged in the area around the derailment.

The cause of the derailment in track 1 of Berlin Tegel Station was the movement of the point 74 under the S Bahn train. This inopportune movement of the point was due to mishandling by the signal box staff.

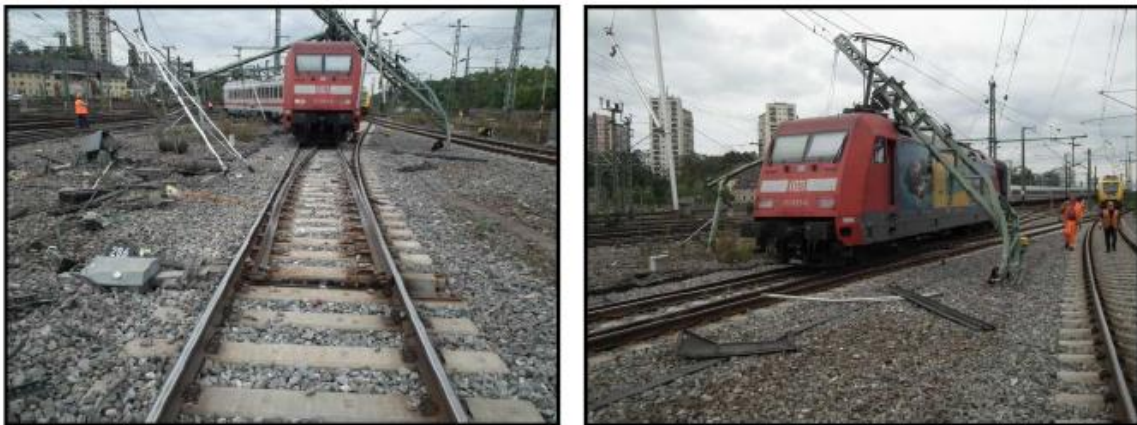
Figure 16: Train derailment in Stuttgart Hbf on 29 September 2012

All axles of the propelling power car were derailed as well as coaches 61 80 1895 413-0 and 61 80 1991 185-7 with both bogies. The rear bogie of coach 61 80 8890 510-3, running in ninth position, also derailed.

As a result of the derailment there was considerable damage to the vehicles as well as to the infrastructure.

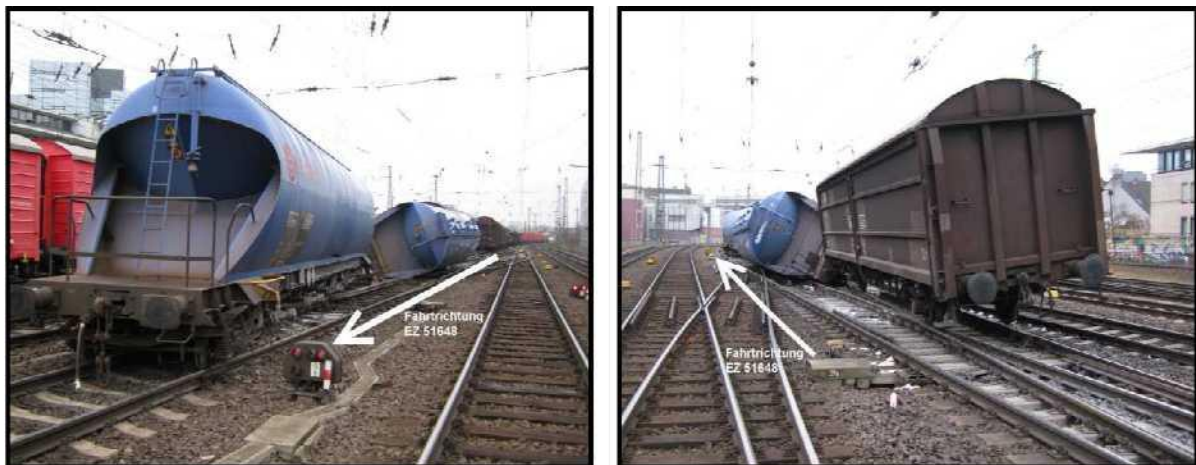
Figure 17: Train derailment in Hanover Central Station

Nobody was injured. Besides the 21st wagon the two following wagons derailed further on. There was considerable damage to the vehicles as well as to the infrastructure. The wagons in the train carrying dangerous goods were not involved in the collision.

The derailment of the 21st wagon was due to the fracture of the axle journal on the right of the first axle of the leading bogie in the direction of travel. The fracture was due to a thermal overload of the axle journal in the axle bearing (hot box).

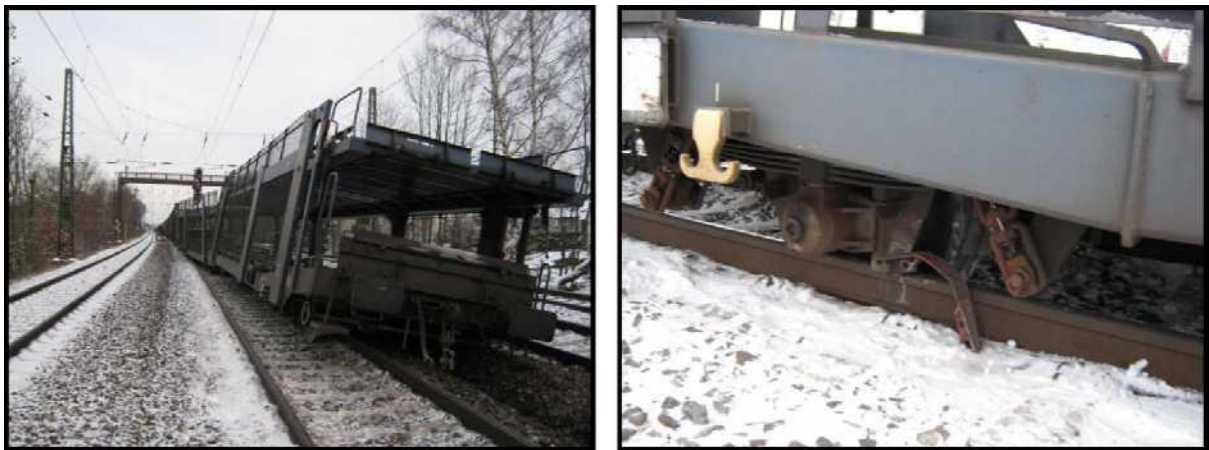
Figure 18: Train derailment at Löhne

At about 12.30 on 13 December 2012, the 22nd vehicle of EZ 51229 derailed in Löhne Station at km 85.35 (on Platform 8). The derailed wagon, an empty Laaers wagon, was pulled along beside the track to km 82.80 and damaged the track and the points. The train was brought to a stand by an automatic brake application caused by the train dividing.

Nobody was injured. All four axles of the wagon were derailed and it came to rest in an inclined position. There was considerable damage to the vehicles as well as to the infrastructure.

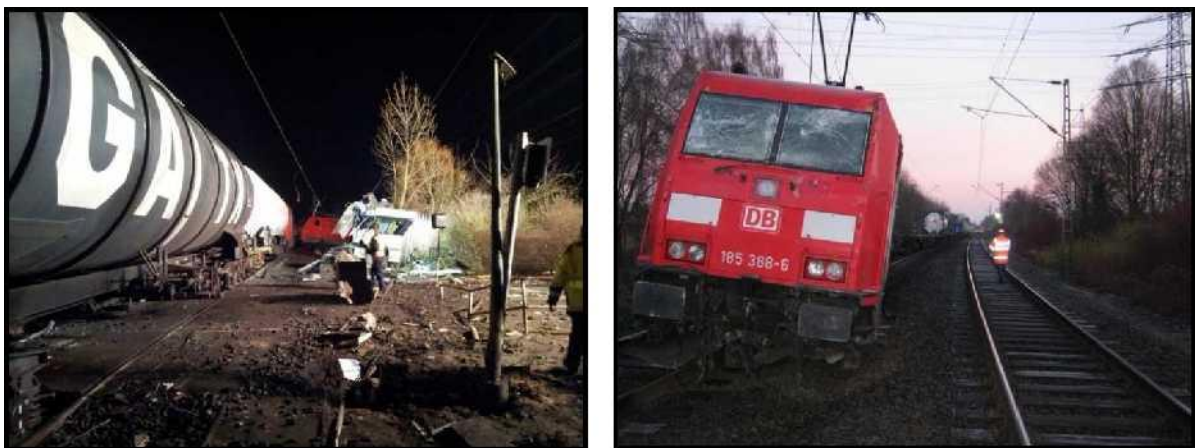
Figure 19: Railway crossing accident between Düsseldorf-Eller and Düsseldorf-Rath

At about 20.14 on 19 December 2012 freight train KT 41953 (Duisberg-Ruhrort Hafen - Wels (A)) collided on the technically protected railway crossing 'Am Hackenbruch' at km 27.754 with an empty bus. Just a few minutes later freight train EZ 45722 (Gremberg - Kijfhoek (NL)) travelling in the opposite direction also collided with the bus.

The locomotive drivers of both trains were slightly injured in the accident. Both locomotive drivers and the passengers, who were all able to get out of the bus in time, suffered from shock. The locomotive and four vehicles of train 41953 derailed. Both the locomotives of train 45722, which was double headed, derailed. There was considerable damage to railway vehicles, railway premises and a neighbouring private property. The bus was completely destroyed. The cost of the damage was estimated at about EUR 5 million.

The driver of the bus drove into the crossing area of the level crossing when the railway safety equipment [*Bahnübergangssicherungsanlage*] (BÜSA) was switched off, and because of a technical defect on his vehicle after the switching on of the BÜSA could not move out in time.
