ANNUAL REPORT 2012

On the Investigation of General Interest Rail Network Accidents and Incidents

Rail Accident Investigation Commission – CIAF

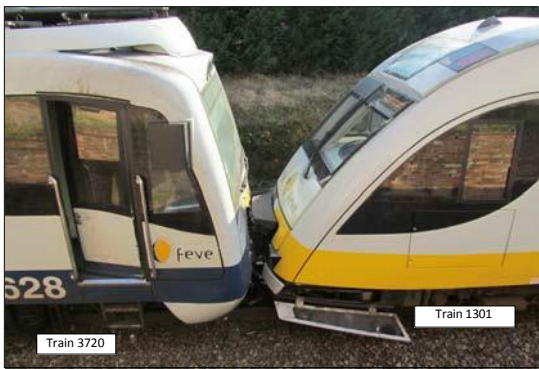
File	Date	Line	Administrator	Operator	Place	
0004/12	02/01/2012	012 Oviedo-San Esteban de Pravia	FEVE	FEVE	Station	
Summary:	<div>

</div> <p>FEVE regional passenger train 1301 from Ferrol to Oviedo was halted at the platform on track 2 of San Claudio station. After performing its commercial operations it resumed running without waiting for the crossing that had been set on the board with FEVE commuter train 3720 at this station. It started on its way without realising that exit signal S1/2 was indicating stop, improperly overrunning this signal. Emergency braking was activated by the ASFA system and switch A2 was forced open to pass over it, since it was aligned towards track 1 for commuter train 3720 from Oviedo to Trubia, which had an entry route set for the station.</p> <p>A head-on collision took place between the two trains, leading to the derailment of the two axles of the second bogie of the head unit of train 3720.</p> <p>As a result of the accident nine people were slightly injured, eight of them passengers plus the driver of train 3720.</p>

Conclusion:	The accident was caused by passenger train 1301 improperly overrunning exit signal S1/2, indicating stop, due to failure to comply with the orders given by the signals to the driving staff.				
	Recommendations					
Recommendation	04/12-1 To stress regulatory compliance by driving personnel, especially with article 2.27.00 Chapter II "Train Traffic" of the Rail Traffic Regulations (RCT).					
Final recipient	FEVE

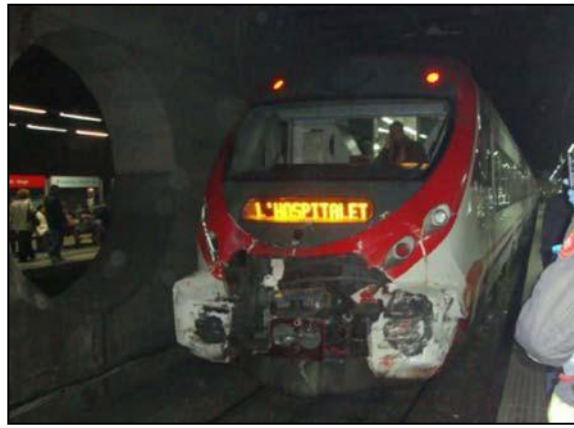
Conclusion:	<p>The accident was due to human error by the driving staff not complying with running on sight as laid down in the regulations.</p>				
Recommendations					
Recommendation	<p>07/12-1 To examine the feasibility of preventing speed being pre-set when running on sight.</p>				
Final recipient	Renfe Operadora				
Recommendation	<p>07/12-2 To examine the feasibility of those advanced signals in a state of stop and proceed changing to absolute in similar cases to this event.</p>				
Final recipient	ADIF

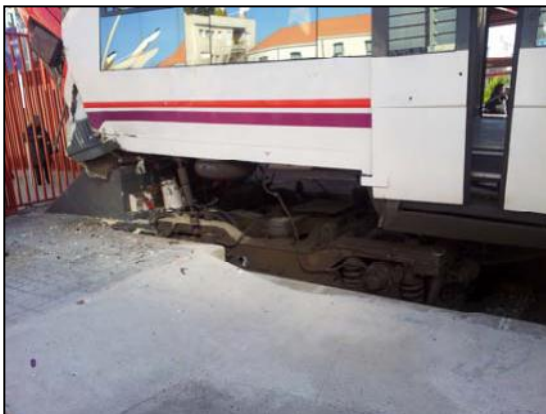
File	Date	Line	Administrator	Operator	Place
0010/12	09/02/2012	276 Maçanet-Massanes–Barcelona-Sagrera	ADIF	Renfe Operadora	Station
Summary:

<p>Passenger (commuter) train 28867, belonging to the railway undertaking Renfe Operadora, proceeding from Molins de Rei and ending its run in the station of Mataró, collided with the buffer of track four.</p> <p>The train passed through crossover points 1-3 and 5-7 giving access to track 4A at a speed of 40 kph, more than the maximum 30 kph speed limit laid down for advanced warning signal 255 which was indicating caution (yellow-green). The train continued its progress and collided with the track 4 buffer at a speed of 23 kph, without using the brake over the last few metres.</p> <p>After the collision, the head railcar had overridden the buffer, the first carriage was completely derailed, the body had mounted the buffer and the first bogie was embedded in it. The first bogie of the second carriage was derailed in the direction of travel.</p> <p>This resulted in serious injury to the driver of the train and minor injuries to ten passengers.</p>

Conclusion:	The accident was due to human error by the driving staff, through failure to comply with the orders given by the signals and not paying due attention while driving.				
Recommendations					
Recommendation	10/12-1 To study the possibility of installing ASFA beacons with an L7 fixed base (speed control) on tracks with a buffer and a high number of passenger train entries.				
Final recipient	ADIF				
Recommendation	10/12-2 To study the possibility of installing buffers that absorb and cushion the impact of trains on those lines where a large number of passenger trains end their journey.				
Final recipient	ADIF

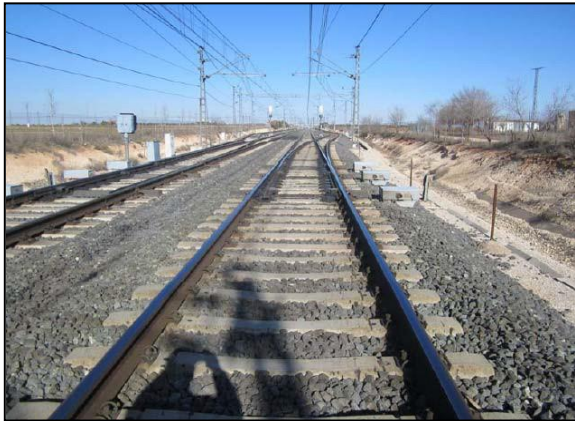
Conclusion:	<p>The accident was due to human error by the traffic staff, by setting a route via track 2 for train 222 when work was being carried out on this track, and by the person in charge of the work not taking appropriate safety measures.</p>				
Recommendations					
Recommendation	<p>22/12-1 To convey, to both those responsible for train traffic and those responsible for track work, the need for strictly enforcing the relevant provisions of the General Traffic Regulations.</p>

Final recipient	ADIF				
Recommendation	<p>22/12-2 To set up a programme for the prevention of human error in matters related to track work, intended for traffic staff (including the control centre) and infrastructure staff (in-house and external).</p>				
Final recipient	ADIF

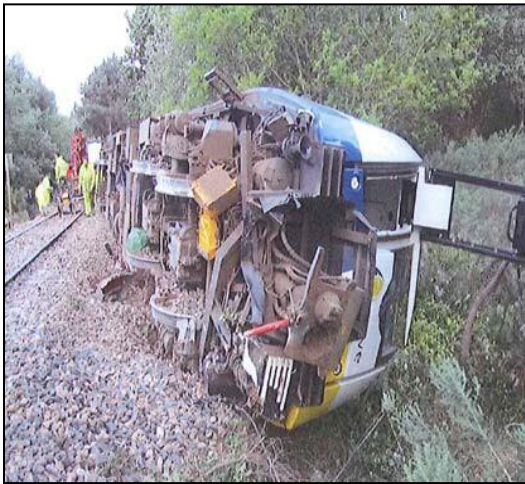
File	Date	Line	Administrator	Operator	Place
0035/12	11/05/2012	011 Ferrol-Gijón	FEVE	FEVE	Open track
Summary:	<div>

</div> <p>FEVE commuter train 1903, with seven passengers and the driver, was running normally and on schedule from Ferrol to Cerdido. Coming out of a curve to the right in the direction of travel, the driver realised that the track width was occupied by a large tree that had fallen on it (brought down by the strong gusts of wind prevailing at the time and by the state of decay of the roots and trunk).</p> <p>The driver of the train used the emergency brake without being able to avoid a collision, which caused the derailment of the first bogie of the UTDH forming train 1903, and when this had almost stopped, caused the UTDH to overturn towards the left-hand side of the track in the direction of travel.</p> <p>There were no fatalities or injuries as a result of the accident.</p>

Conclusion:	<p>The accident was due to train 1903 colliding with an obstacle – a large pine that had fallen across the width of the track.</p>				
Recommendations					
Recommendation	<p>Since the existing measures and those taken were considered adequate, no recommendations were made.</p>

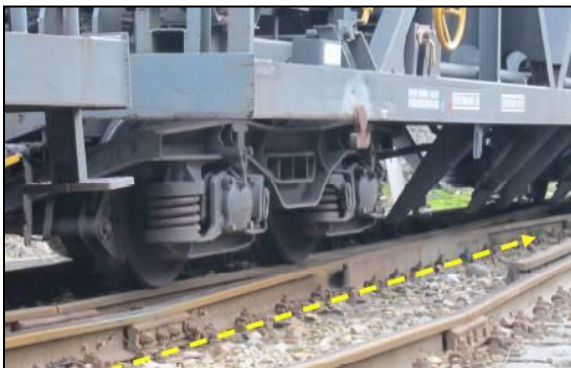
File	Date	Line	Administrator	Operator	Place
0005/12	15/01/2012	012 Oviedo-San Esteban de Pravia	FEVE	FEVE	Station
Summary:	<div>

</div> <p>FEVE special freight train EB904 from Aboño to the Soto de Ribera thermal power station, consisting of 2 locomotives and 16 wagons (16 hoppers loaded with coal), was derailed at KP 298+108 two metres after switch A4 and 11 metres before the level crossing at the station of Trubia.</p> <p>The train was running normally when, after passing through switch A4, the second bogie of the fourth carriage of the train set in the direction of travel was derailed, stopping 90 metres after the point of derailment.</p> <p>The wagon was derailed towards the right-hand side in the direction of travel of the train (high rail).</p> <p>No personal injuries occurred.</p>				
Conclusion:	<p>The accident was caused by the technical failure of the infrastructure since, in the area where the train was derailed, there was deficient track alignment and levelling, as well as significant potholes and ballast contamination.</p>

Recommendations					
Recommendation	<p>05/12-1 To restore the values of the geometric parameters of the track in the section where the accident occurred in accordance with those of track standard NFI 001 for safe train travel.</p>				
Final recipient	FEVE				
Recommendation	<p>05/12-2 To examine the feasibility of cleaning and improving the superstructure of the track in the area of the derailment, in order to prevent premature deformations.</p>				
Final recipient	FEVE				
Recommendation	<p>05/12-3 When track inspection (auscultation) is performed and areas are detected with out-of-tolerance parameter values, this being significant, to take action immediately in these areas of the layout by carrying out maintenance work.</p>				
Final recipient	FEVE

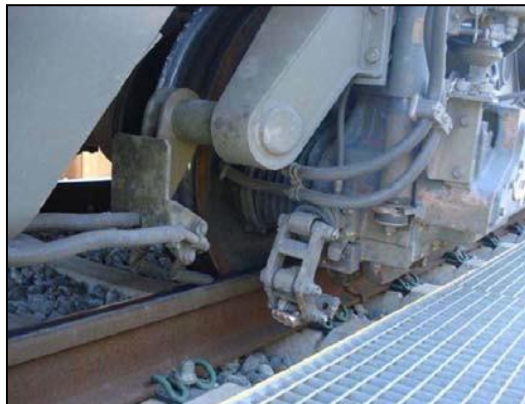
</div></div>				
Conclusion:	<p>The derailment occurred due to a failure in the gauge changing system of the left wheel of the ninth axle, corresponding to the first axle of the first bogie of the third carriage of the train set, in the direction of travel, due to the support fastening screws of the safety device lever breaking. This breakage caused the lever to become loose, so that in the gauge change operation it did not act and did not lead to unlocking so that the gauge change did not take place, leaving the wheel set in UIC gauge.</p>

Recommendations					
Recommendation	<p>The measures adopted being considered adequate, no recommendations were made.</p>

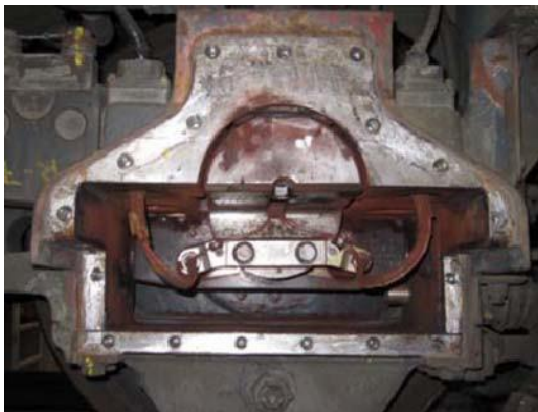
File	Date	Line	Administrator	Operator	Place
0050/12	21/06/2012	052 Plasencia de Jalón Changer Jct. – Plasencia de Jalón Changer	ADIF	Renfe Operadora	Station (gauge changer)
Summary:	<div>

</div> <p>Renfe Operadora passenger train 601, from Madrid - Puerta de Atocha to Pamplona, was running normally on UIC gauge and had to change to Iberian gauge when passing through the Plasencia de Jalón changer. When this gauge change was taking place, the train was halted when the staff of the changer facility alerted the driver. It was found that the 8th axle was derailed when the left-hand wheel in the direction of travel did not make the gauge change.</p> <p>Outwardly the train set seemed completely normal. Then, once the axle box of the derailed wheel was uncovered, it was found that there were no cracks in the gauge change devices. However, the appearance inside displayed evidence of a lack of lubrication of the components that make up the gauge change locking mechanism. As a result, the pin locking the wheel in position was stuck in UIC gauge, so that the guide rails of the platform could not pull the wheel over to the Iberian gauge.</p>

Conclusion:	<p>The derailment was caused by a fault in the axle gauge change system of the left-hand wheel of the train set's eighth axle in the direction of travel, due to the wheel's gauge change locking mechanism not working properly, as a result of lack of lubrication.</p>				
Recommendations					
Recommendation	<p>50/12-1 To specify in the maintenance instructions how the operation of lubricating the locking pins should be carried out in order to be effective. To ensure that the maintenance operation is properly carried out, the operatives who will perform it will be trained and random checks made to see that it is done correctly.</p>				
Final recipient	Renfe Operadora				
Recommendation	<p>50/12-2 To ask the technologist to study using types of fittings other than the pin and bushing to reduce wear and lubrication requirements.</p>				
Final recipient	Renfe Operadora

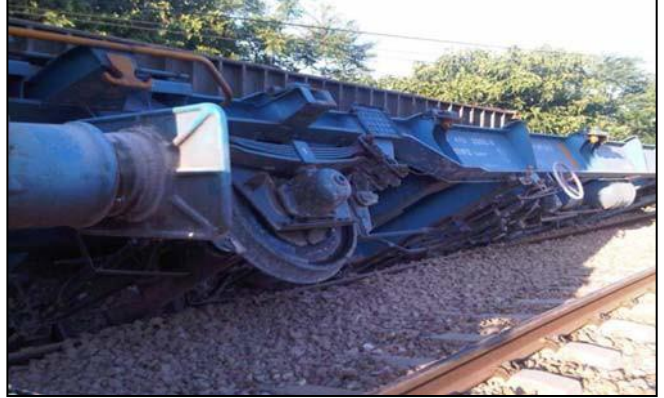
<p>Just over three minutes after the alarm, and as the train was passing through the exit signal of Villa del Río (KP 387+625), the head of CTC managed to notify the driver by mobile phone regarding the incident, informing him that the train would be placed aside at the next station (Montoro, KP 397+720) for checking the axle concerned.</p> <p>Subsequently, at KP 393+525 the left-hand wheel of axle 39 was derailed and after travelling derailed for some 3 300 metres the train came to a stop.</p> <p>The driver notified the head of CTC that the train had stopped at KP 397+055, between the advanced warning signal and the entry signal to Montoro station, after he had applied the emergency brake, on noticing that the catenary contact wire had fallen onto the locomotive.</p> <p>After the driver had checked the train, he reported that the wagon with the overheating had been derailed, affecting its cargo (a container), which had overturned. He also reported that overhead contact and catenary line posts had fallen down.</p>

<p>Conclusion:</p> <p>The derailment was caused by a technical failure of the equipment, when the left-hand stub shaft of the first axle of the eighteenth wagon of the train set, in the direction of travel, had broken as a result of overheating of the axle box, together with some mishandling of the incident by the traffic staff. As a contributory cause it should be pointed out that the derailed train was running outside the assigned train-ground channel.</p>

Recommendations	
Recommendation	51/12-1 To draw up specific regulations for acting in the case of entering to repair a wheelset without the axle box cover, specifying the checks and measurements to be made on bearings and axle, together with an inspection sheet for entering the operations carried out in the light of the results. These regulations could be incorporated into the current Technical Standard for Maintaining Wheelsets.
Final recipient	Renfe Operadora
Recommendation	51/12-2 To stress to driving staff on refresher courses the desirability of checking that the train-ground settings and channel when travelling match those assigned.
Final recipient	Renfe Operadora
Recommendation	51/12-3 Recommendation No 4 made in file 63/2010 is repeated: To study the suitability of making changes to the existing regulations on the management of alarms that occur in hot axle detector equipment.
Final recipient	Department of Railways (DGF)

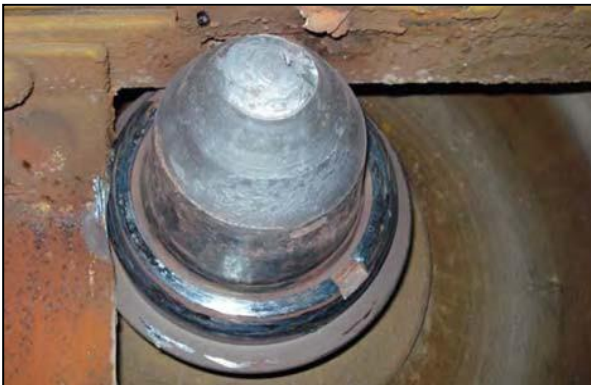
<p>This train had given an alarm regarding the overheating of axle No 33 (2nd axle of wagon 14) when it passed through the hot axle detectors (HABD) of Olite, Tudela and Casetas. After passing through the detectors of Tudela and Casetas, the control centre stopped the train on the two occasions for the driver to check the axle box of axle 33. After checking the driver did not see any anomaly and continued travelling until reaching Casetas station, where he stopped to be relieved as scheduled. Subsequently, the train continued on its way and on passing through the HABD of Casetas it repeated the overheating alarm. Due to a malfunction of the numbering system of the Casetas HABD, it assigned the overheating alarm to train 81050 (which was travelling behind train 82658), so that the Saragossa Control Centre halted the 81050 and train 82658 (which was the one that had been reporting overheating alarms) continued on its way. As train 82658 was moving between Almudévar and Tardienta, the driver noticed a fall in pressure of the automatic brake hose (caused by the rupture of the hose on running derailed for the last 8 kilometres), stopping the train at KP 51+800, when he discovered that the fourteenth wagon of the train set was derailed on both axles, and that the second axle (No 33) of the wagon was missing the right-hand axle box.</p>

Conclusion:	<p>The accident was caused by the failure of the rolling stock due to the rupture of the right-hand hose of the second axle of the wagon occupying the fourteenth place in the train set, in the direction of travel, as a result of a temperature increase in the axle box due to seizure of the axle end bearing, having exceeded the maintenance deadline; together with a fault in the Casetas hot axle detector (HABD) which wrongly assigned the overheating alarm to another train.</p>

Recommendations	
Recommendation	61/12-1 To update the maintenance manuals for Transfesa Leks type car-carrier wagons for mainland transport, to match the period of the axle maintenance cycle with type R wagon maintenance operation.
Final recipient	Transfesa
Recommendation	61/12-2 In agreement with Transfesa to set up the plan for adapting and installing type 65 axles on Leks type wagons with type 66 axles, monitoring its implementation as well as its result.
Final recipient	ADIF
Recommendation	61/12-3 To study the feasibility of the stock data sheets of trains incorporating the number of axles for each wagon so that it is easy to identify the wagon with an axle with signs of overheating.
Final recipient	ADIF
Recommendation	61/12-4 For the staff of the Miranda Control Centre involved in handling the overheating alarms covered in this report to undergo a refresher course in the management of hot axle alarms.

Final recipient	ADIF
Recommendation	61/12-5 To review the operational functioning of the HABDs installed on the RFIG in order to prevent a possible misallocation of train numbers.
Final recipient	ADIF
Recommendation	61/12-6 Recommendation No 1 of file 51/2012 is repeated: To study the suitability of making changes to the existing regulations on the management of alarms that occur in hot axle detector equipment.
Final recipient	Department of Railways (DGF)

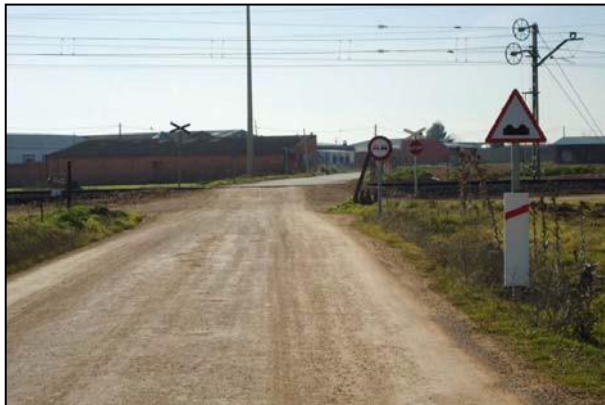
Conclusion:	<p>The accident arose from incursion onto the rail track by the road vehicle crossing the level crossing when train 18081 was passing.</p>				
Recommendations					
Recommendation	<p>71/12-1 As soon as possible, ask the road owner (Miguelturra Town Council) for the current figure for average daily traffic (ADT).</p>

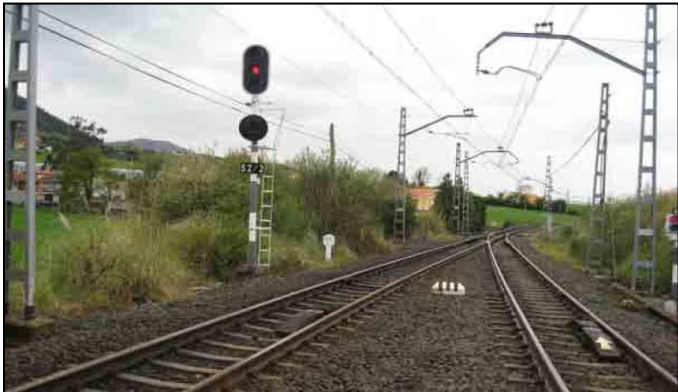
File	Date	Line	Administrator	Operator	Place
0028/12	18/04/2012	024 Santander-Bilbao	FEVE	FEVE	Station
Summary:

Freight train 9860, travelling from Aranguren to Santander, and special service train SR507, from Santander to Gama, were running under normal conditions towards Heras station, where both trains were due to cross.		
	entry signal E1 (Santander side) for train SR507 and an entry route up to signal S2/2 for train 9860 (Bilbao side).		For this, the CTC in Heras station provided a stop before		
	Train SR507 halted before entry signal E1 (Santander side) which indicated stop.		station provided a stop before		
	For its part, freight train 9860 headed towards track 2 of the station, encountering advanced warning signal E'2 showing caution, and entry signal E2 showing a stop warning, passing through this at a speed of 40 kph.				
	Train SR507 remained halted before signal E1. Train 9860 made its entrance into Heras station via track 2 and, at a distance less than that of exit signal S2/2 being in sight, the driver applied the emergency brake, without managing to avoid improperly overrunning the signal, or the first bogie forcing open switch A1, towards track 1 for the entry of train SR507. This caused a near collision between the two trains. There were no fatalities or injuries as a result of the incident.

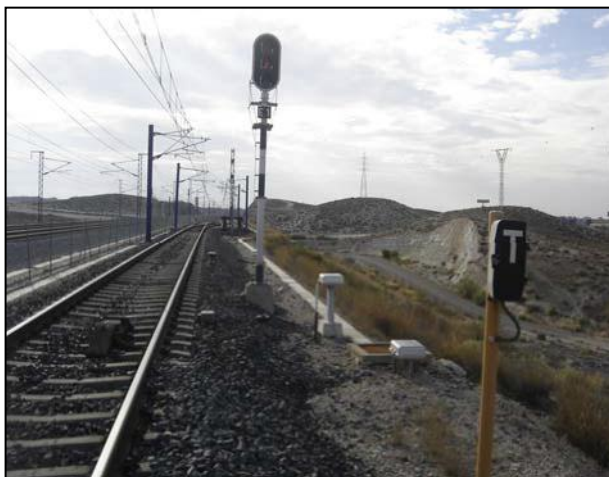
<p>Consequently, train 99561 heading towards the station found advanced warning signal E'1 showing caution and entry signal E1 showing stop. It continued its progress on track 3, but the driver did not notice in time that the next signal S1/3 was set to stop, and, although he used the emergency brake, he overran this, activating the emergency braking system to no avail. The train came to a stop 18 m after this signal, without managing to force open the access points to the main line.</p> <p>For its part, travelling in the opposite direction, train 91182 passed the Río Huerva station's advanced warning signal E'2, indicating stop, and before it reached signal E2, indicating stop, signal S1/3 was overrun by train 99561, giving rise to a near collision.</p> <p>Train 99561 reported to the CTC what had happened and the latter authorised it to back up along track 3 to release the points circuit and park there, not having forced the point open.</p>

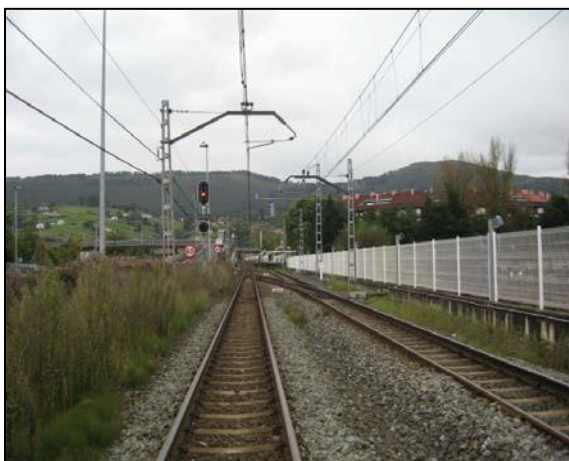
File	Date	Line	Administrator	Operator	Place
0034/12	09/05/2012	024 Santander-Bilbao	FEVE	FEVE	Station
Summary:	<div>

</div> <p>FEVE regional passenger train 6803 from Santander to Bilbao was travelling eight minutes late. That day, due to the delay of train 6803, it was decided to transfer its crossing with train 6414 to the station of Astillero. The daily crossing between the two was set in their timetables at Heras station.</p> <p>Train 6803 was parked on Astillero's track 2, and after completing its commercial operations and the light signal was displaying the acronym OT (operations terminated), it started up, passing signal S1/2 (KP 540+178) indicating a stop warning (yellow), although this was interpreted by the driver in the cab as a caution signal (yellow-green). Next the driver increased the speed limit from 60 kph, set by acknowledgement of signal S1/2, to 80 kph.</p> <p>Then the train entered a cut-and-cover tunnel, reaching a speed of 65 kph, and after the driver realised the state of signal S1/1L (KP 540+782) indicating stop (red) he pressed the emergency stop button, overrunning the signal by 17 metres.</p>

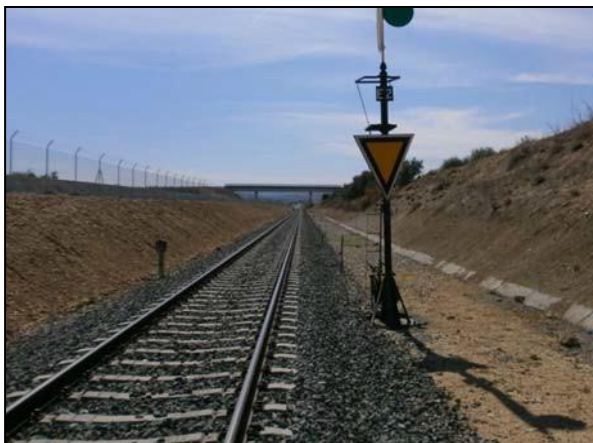
Conclusion:	<p>The incident was caused by freight train 99561 improperly overrunning exit signal S1/3, indicating stop, due to failure to comply with the order given by the signal to the driving staff.</p>				
Recommendations					
Recommendation	<p>40/12-1 To examine the feasibility of providing the mechanical signals of this station with ASFA beacons in order to mitigate traffic risks. In such an event, to have this measure applied to other similar premises.</p>				
Final recipient	ADIF

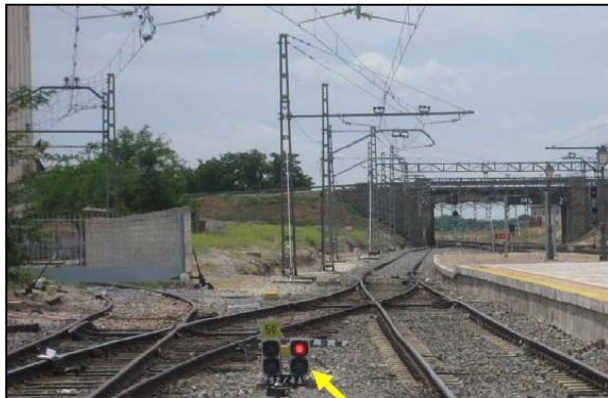
File	Date	Line	Administrator	Operator	Place
0045/12	15/06/2012	100 Madrid-Hendaye	ADIF	Renfe Operadora	Station
Summary:	<div><div>

</div><div><p>Between the stations of Arévalo and Sanchidrián, with supplementary telephone blocking (BTS) being established for work on safety facilities, freight train 90602, travelling from Irún to Vicálvaro, belonging to the railway undertaking Renfe Operadora, had its entry set for Arévalo's track 4, in order to be overtaken by passenger train 18000, also belonging to Renfe Operadora, for which signal E'2 was displaying caution and signal E2 was indicating stop. The train headed towards track 4 to park there and halted in front of signal S2/4A. The traffic manager sent the driver a signal passing permit (BAR), to be able to pass this signal and move up to signal S2/4, since due to the length of the train its tail end would not be free of switch circuits numbers 2, 12 and 18. The traffic manager returned to his office and drew up the order and information bulletin (BOI) with the traffic conditions for supplementary telephone blocking on the Arévalo-Sanchidrián route. Then he sent the BOI to the driver of train 90602. Following this, train 90602 started up without having an exit route set and without receiving the order to go (start train) from the traffic manager. The Arévalo traffic manager immediately called the Control Centre (PM) in Madrid to stop train 90602, since freight train 82202, from As Gándaras to Pinto, was travelling under supplementary telephone blocking on its way between Arévalo and Sanchidrián, the same section that train 90602 had entered, both in the same direction of travel.</p><p>This caused a near front-to-end collision situation between the two trains. However, when train 90602 was stopped by the Control Centre, it was at a distance of 15 090 metres behind train 82202. The Control Centre halted train 90602 at KP 169+839, 798 metres from signal S2/4, and then authorised it to back up to Arévalo, when it finally came to a stop on track 4 in front of exit signal S2/4.</p></div></div>

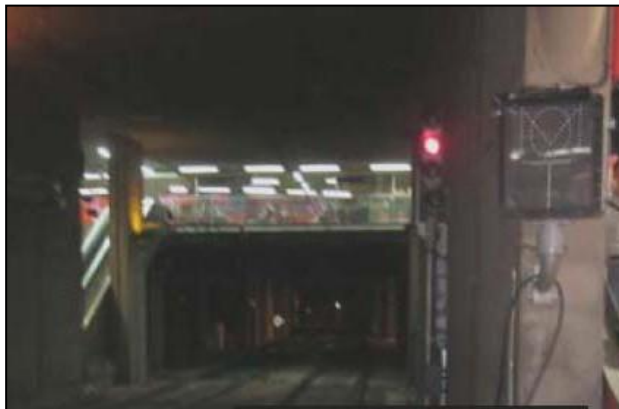
<p>At the time of the events, track circuit A6 was occupied due to a fault in the insulating joint, which prevented the exit signals towards the Recoletos side from opening. The trains were issued with the corresponding signal passing permit.</p>				
	<p>Thus, train 4141 was headed towards the station of Atocha-Cercanías without a stop being specified there, and was parked on track 4C with exit signal S1/4C, indicating stop. After the traffic official had sent the signal passing permit (BAR) to the driver of the train with a route along track I, the train started up and, as it passed exit signal S1/4C, train 21232, travelling in the opposite direction, passed the station's advanced warning signal E'2-2, indicating stop.</p> <p>Train 4141 continuing on its way passed through crossing T10b, opening it up with the points being aligned towards track 2. Then it stopped, being confronted by train 21232 which was situated in front of entry signal E2-2 indicating stop.</p> <p>There occurred a near collision between the two trains, facing each other at a distance of some 50 metres.</p>

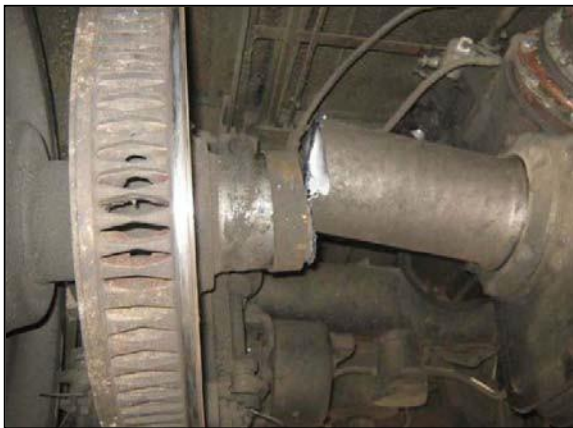
File	Date	Line	Administrator	Operator	Place
0064/12	08/10/2012	200 Madrid-Barcelona	ADIF	Renfe Operadora	Open track
Summary:	<div>

<p>Renfe Operadora train 15640, from Zaragoza Delicias to Canfranc, when travelling normally at a speed of 90 kph between the stations of Villanueva de Gállego and Zuera, came to a stop through the driver applying the service brake, on noticing that the vehicle was behaving abnormally and on looking through the rear-view mirror seeing that sparks were flying from the first bogie.</p><p>The driver informed the CTC and proceeded to reconnoitre the train, noting that the wheels of the second axle of the first bogie in the direction of travel were resting at an angle on the rail, since the body of the axle was broken.</p></div>				
Conclusion:	<p>The incident stemmed from equipment failure, due to the second (driving) axle of the first bogie, in the direction of travel, being broken. The breakage occurred from an old surface crack caused by the axle having been in sporadic contact with an electrical element, which produced a series of electric arcs. Ruling out possible contact with a cable of the vehicle itself, the most reliable assumption is that the crack was caused by contact of the axle with a welding machine. This initial crack increased with fatigue until it caused catastrophic failure of the axle body.</p>

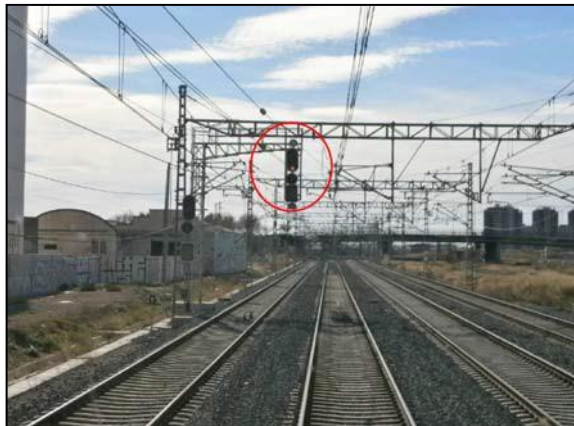
File	Date	Line	Administrator	Operator	Place
0076/12	21/12/2012	600 Valencia-San Vicente de Calders	ADIF	Renfe Operadora	Station
Summary:

<p>Renfe Operadora passenger train 1112 travelling from Valencia-Joaquin Sorolla to Barcelona-Sants started off from track 9 with exit signal S1/9PA indicating stop and the driver acknowledged this by pressing [or acting upon] the ASFA push-button. Then he passed through switches 110, 108, T106 and T104 until reaching track II leading to the station of Valencia-Font de Sant Lluís, and upon seeing a fault appear on the cab's diagnostic screen (IDU), was trying to identify this.</p> <p>Arriving at the warning beacon for signal E2B without altering speed he then overran the beacon for this signal which was indicating stop. The ASFA system emergency braking then came into operation, with the train crossing into the next blocking section occupied by train 10596, travelling in the same direction and with an entry route set for track 6 of the station of Valencia-Font de Sant Lluís. This caused a near collision between the two trains.</p>
