NIB ANNUAL REPORT 2024

Safety Investigation Authority

FINLAND

This is the annual report of railway sector of the Safety Investigation Authority, Finland (SIAF) for the calendar year 2024.

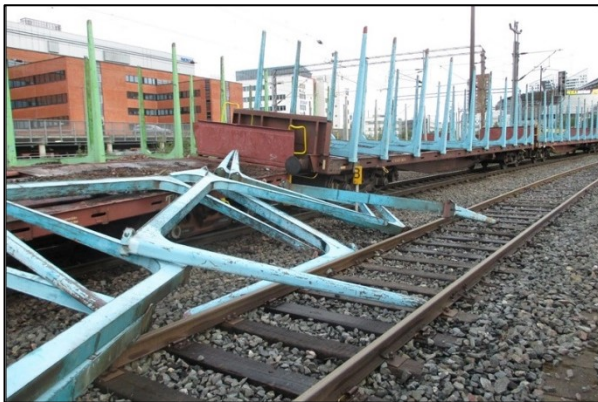
R2023-01

Collision of two goods trains in Tampere on 20 September 2023

Two empty timber trains collided with each other at a set of points in the Viinikka marshalling yard in Tampere on 20th of September 2023. The accident occurred as train T3321, which was headed to Orivesi, was being reversed back into the marshalling yard. The train was too long to fit onto the section of track that had been assigned for it, as a result of which its wagons overran the main signal that marked the end of the movement authority and collided with the side of a train that was going through the points on its way to Parkano. No personal or environmental damage was caused by the accident. Eight wagons designed for carrying timber were damaged in the collision. The track also sustained damage over a distance of 50 metres. In addition, the accident caused widespread disruption to rail services.

The actors within rail industry have failed to recognise all the risks associated with reversing. Reversing is generally seen more as a disruptive inconvenience than a high-risk special manoeuvre. The investigation also revealed that there are no technological systems in place for reversing that would safeguard against the risk of human error.

1. *The Finnish Transport Infrastructure Agency and Fintraffic Railway Ltd join forces to improve the safety of reversing and other degraded operations by putting into place an array of technological systems to safeguard against an accident in the event of human error. [2024-S27]*

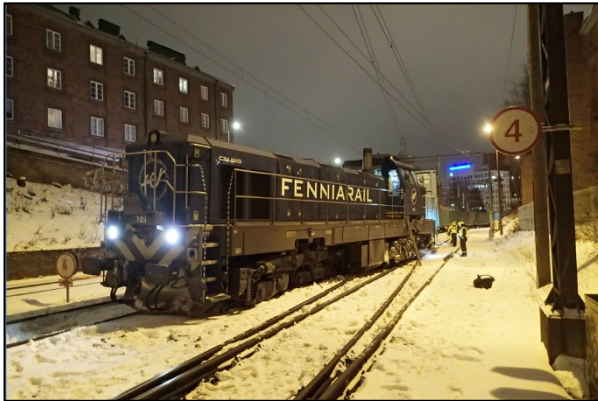
R2023-02

Derailment of a freight train in Tampere on 30 November 2023

On 30th of November 2023, the locomotive of freight train T7121 and the front bogie of its first wagon became derailed at the switch V171 to the north of Tampere station. No personal or environmental damage was caused by the accident. As a result of the derailment, the switch V171 was severely damaged and only one track between Tampere and Lielähti remained in use until 3 December 2023. The derailment and prolonged track clearance caused significant traffic disruptions, and some trains had to be cancelled.

The accident was caused by the combined effect of various factors, which included the worn heel of the switch, the high lateral force on the rails characteristic of the locomotive type, and the worn wheelset of the locomotive.

At the time of the incident, the switch V171 had worn down to its critical operational and maintenance threshold. The switch also had an abnormal wear profile, which contributed to the rising of the wheel of the locomotive and its staying on the tongue of the switch. The track maintenance operator had noticed that the switch was worn out but did not present a repair plan to the client, while the client also did not require the plan.

1. *The Finnish Transport Infrastructure Agency ensure the uniformity of the guidelines and improve their accessibility, unambiguously define the method of measuring the maintenance needs of the heel of the switch and specify accurate wear profiles for the heels of the switch. [2024-S33]*

3. *Railway operators and rolling stock maintenance operators draw up instructions for inspecting the shape of the wheel flange and include a guided inspection as part of the maintenance of wheelsets. In addition, a procedure must be introduced for monitoring the wear of rolling stock wheelsets to identify and anticipate wear on the wheels between maintenance. [2024-S35]*

5. *Infrastructure managers and railway operators using six-axle locomotives jointly define safety margins for the wear of the track and the wheelsets of rolling stock that ensure safe operation, taking into account the combined effect of different factors. [2024-S37]*

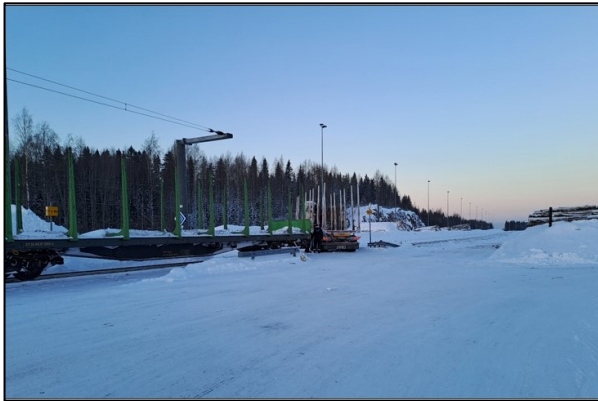
R2024-01

Level crossing accident at Kurkimäki timber loading site on 6 February 2024 resulting in the death of the shunting foreman

A shunting unit pushing empty timber transport wagons collided with the trailer of a vehicle combination for timber transport at Kurkimäki timber loading site on 6th of February 2024. The vehicle combination was crossing a level crossing. The shunting foreman directing the shunting unit was killed in the accident. The material damage caused by the accident was minor.

The accident was typical for an unguarded level crossing, and the failure of the vehicle combination driver to notice the approaching shunting unit and the manner in which the shunting foreman interpreted the driver's intentions both contributed to the course of events.
