MINISTERUL TRANSPORTURILOR ȘI INFRASTRUCTURII  
AGENȚIA DE INVESTIGARE FERROVIARĂ ROMÂNĂ - AGIFER

## ROMANIAN RAILWAY INVESTIGATION AGENCY - AGIFER -

## ANNUAL REPORT 2025

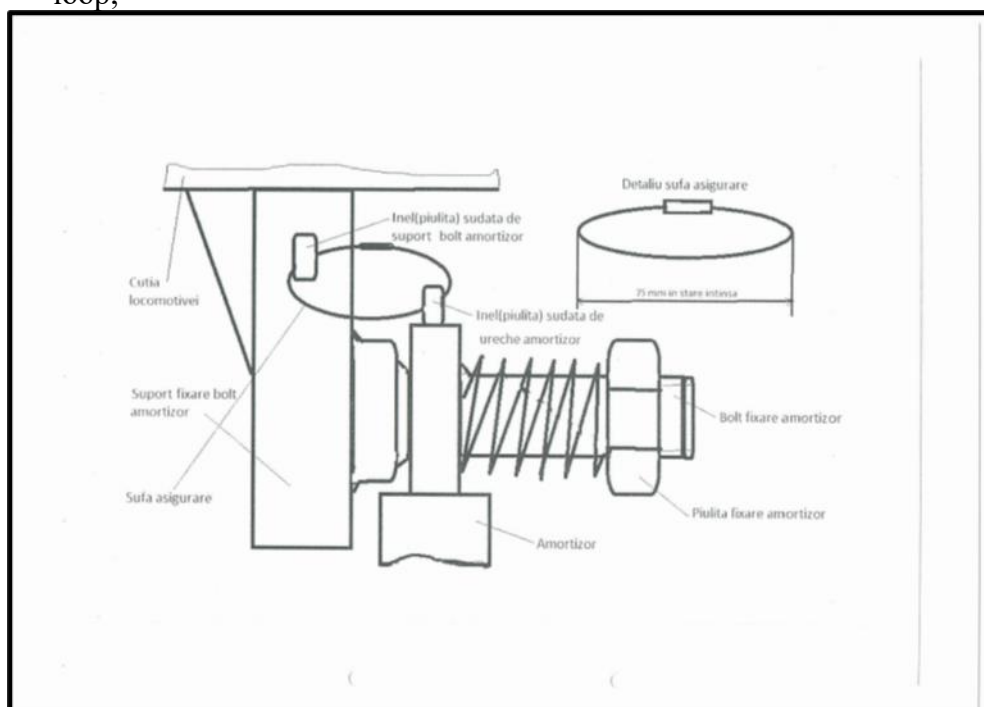
- On 9<sup>th</sup> October 2024, from the SC Service of SNTFC “CFR Călători” SA, the technical proposal by which the securing against falling of the dampers could be achieved following the breaking of their upper fastenings was transmitted to the Rolling Stock Headquarters of the same operator, as follows:

- Mounting by welding, on each upper support (on the locomotive body) for fixing the pin of the vertical dampers, of one metal ring (nut);
- Mounting by welding, on the upper part, on each fixing lug of the vertical damper, of one metal ring (nut);
- Mounting between the two metal rings (nuts) of a securing cable in the form of a loop;

This technical proposal was taken into consideration and, after the date of issue, put into practice as follows:

- On 13th November 2024, from the Rolling Stock Headquarters of SNTFC “CFR Călători” SA, document no. SIRM/8/833/13.11.2024 regarding the technical solution for securing the dampers on Co-Co type electric locomotives, proposed by the SC Service, was transmitted to all Passenger Railway Transport Regional Branches 1-8, including SCRL Brașov, for implementation;
- On 28th April 2025, from the Rolling Stock Headquarters – Rolling Stock Maintenance and Repair Service of SNTFC “CFR Călători” SA, the document without number regarding the technical solution for securing the dampers on Bo-Bo type electric locomotives, proposed by the SC Service, was transmitted to the Passenger Railway Transport Regional Branches Craiova, Timișoara, Iași and Galați, including SCRL Brașov, for implementation.
