Swiss Transportation Safety Investigation Board STSB Annual Report 2023

Swiss Transportation Safety Investigation Board STSB

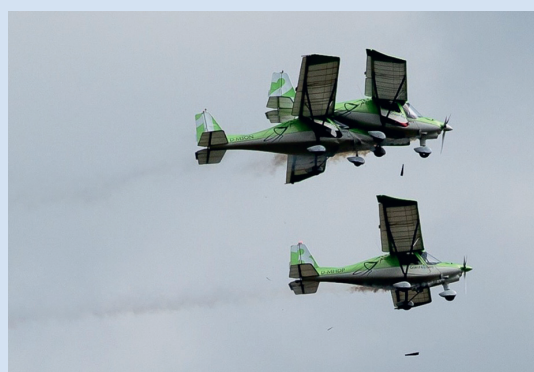
Collision over Dittingen (BL), 23.08.2015

Two microlight aircraft in a formation of three collided north-east of Dittingen airfield (LSPD) during a public flying display.

The European Aviation Safety Agency (EASA) does not stipulate that specific authorisation is required to perform formation flights, as it does for aerobatic flights. There are no binding guidelines or syllabuses for theoretical and practical training in formation flying.

The European Aviation Safety Agency (EASA) should take appropriate measures to ensure that internationally standardised guidelines for public flight displays are applied in all member states. These guidelines should set out the conditions for obtaining display authorisation, describe the theoretical and practical training and check pilots' knowledge and flying skills. They should also define the requirements for granting special formation display authorisations.

The Federal Office of Civil Aviation (FOCA) should ensure the assessment of hazards and the evaluation of risks to third parties during public air shows and require the organiser to take precautionary measures to ensure safety.

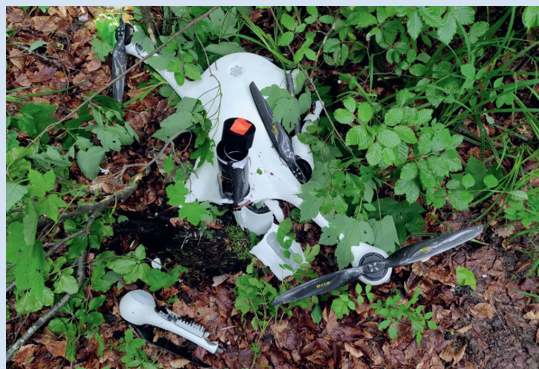
Accident involving a drone, Irchel (ZH), 09.05.2019

Approximately two minutes after take-off from the University of Zurich premises in Irchel, the M2 V9 drone's flight termination system was automatically activated, the parachute released and the drone made an emergency landing. After the parachute was released, the canopy suspension line ruptured and the drone fell unchecked to the ground in the wood and was destroyed.

As the investigation showed, the flight controller firmware, based on ArduCopter 3.5.0-rc5 software, was only able to use two of the three available inertial measurement units (IMUs) to control the drone. As a result, the flight controller software lacked resilience, i.e. the ability not to fail completely in the event of malfunctions or failures of individual components, and was unable to maintain control of the drone.

In practice, flight-critical parameters such as the ambient temperature and humidity are not taken into account when operating under extreme weather conditions. If this were the case, a flight mission could be cancelled early or might not be carried out at all under certain conditions.

In the case of a conventional quadcopter with four rotors, such as the M2 V9 drone investigated here, the failure of one rotor inevitably leads to the drone crashing or to the triggering of the automatic flight abort system. Drones with six or more rotors have a significantly lower likelihood of failure.

The Federal Office of Civil Aviation (FOCA), together with the operator or manufacturer, should take appropriate organisational or technical measures to ensure that drones do not take off in unsuitable weather conditions that could lead to problems such as condensation or ice.

The Federal Office of Civil Aviation (FOCA) should ensure that the manufacturer strives to introduce a back-up propulsion concept, especially for flights over populated areas, in order to reduce the likelihood of propulsion-related failure due to material wear or exogenous factors such as bird strikes.

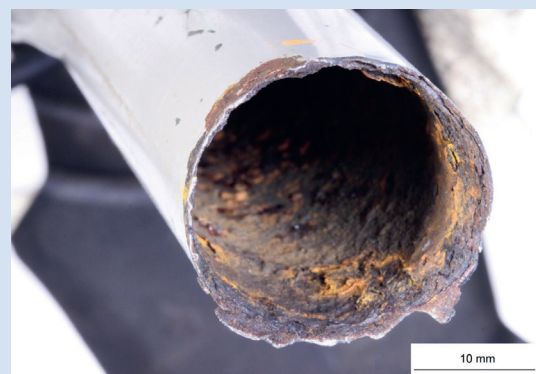
On an SF 25C motor glider the right control stick broke directly above the weld seam at the transmission joint so that it could no longer be used to control the aileron and elevator. The design was such that the aileron, but not the elevator, could still be controlled with the left stick. The crew, who were unaware that the control stick was broken, therefore lost control of the motor glider during the take-off run. The aircraft hit the ground hard, collided with a tree and came to a halt heavily damaged.

The motor glider was manufactured in 1977. The investigation revealed that the broken steel rod was heavily corroded on the inside and therefore weakened.

Other glider models of comparable design and manufactured during the same time period also experienced structural failure due to material fatigue or other signs of ageing. In older aircraft of similar design, the maintenance manuals usually do not contain any maintenance specifications

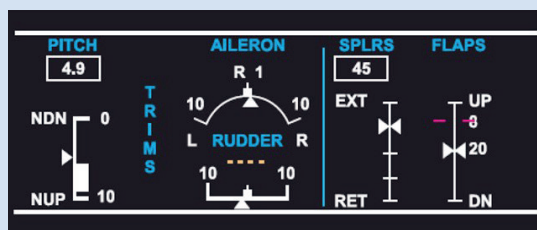
The investigation revealed that the reversal of the spoileron function caused by a maintenance error had not been recognised by any of the flight crews flying the aircraft before the serious incident occurred. In the synoptic display on the flight control page, the position indices of the left and right spoilerons are grouped around a single vertical axis and can easily be confused. When checking the spoilerons before take-off, pilots are therefore likely to 'fall victim' to a confirmation bias, confusing the indices and confirming the deployment sequence that they believe to be true.

The US Federal Aviation Administration (FAA) should ensure that the manufacturer modifies the flight control display to minimise the possibility of confusion between the left and right spoilerons; this recommendation should apply to all aircraft equipped with similar displays.

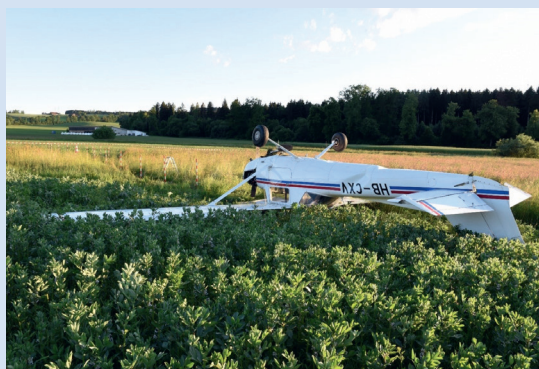
Take-off accident involving a powered aircraft at Beromünster aerodrome (LU), 12.06.2020

The aircraft took off at too low a speed, whereupon the available take-off power was insufficient to accelerate it or bring it into a climb. An emergency landing was unavoidable; the aircraft overturned in a field of tall grass.

Incidents may occur during take-off particularly on aerodromes with challenging conditions and relatively short runways on which the available take-off distance is insufficient to ensure a safe take-off. Similarly, landings on short

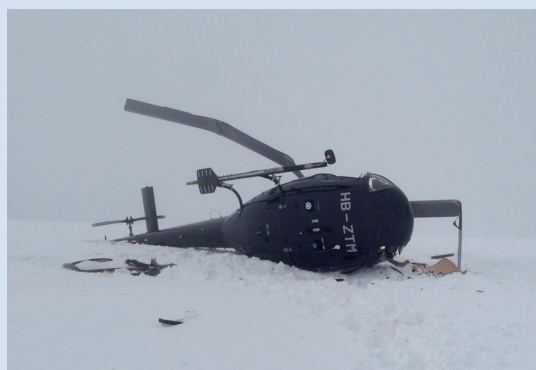
Helicopter landing accident on the Petersgrat mountain landing site (VS), 13.05.2017

While attempting to land a helicopter in murky and low-contrast light conditions in the high mountains on an area of snow with no points of reference, the pilot lost control of the flight attitude and the helicopter tipped onto its left side. The rotor blades hit the cabin roof and practically tore it away completely at the front. The pilot was fatally injured on the head. The passengers sustained minor or no injuries and were able to free themselves from the wreckage.

The main switch of the emergency locator transmitter (ELT) was in the OFF position. The ELT was therefore unable to transmit any signals.

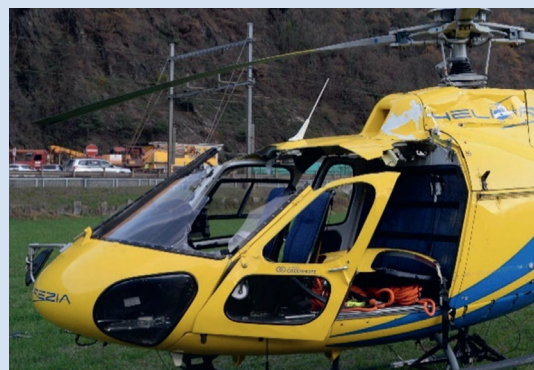
Collision with a high-voltage power line near Prati della Gerra, Arbedo-Castione (TI), 03.12.2018

A helicopter collided with the earth cable of a high-voltage power line after take-off, was severely damaged and had to make an emergency landing.

The pilot was fundamentally aware of the high-voltage power line but had not noticed the obstacle due to restricted situational awareness.

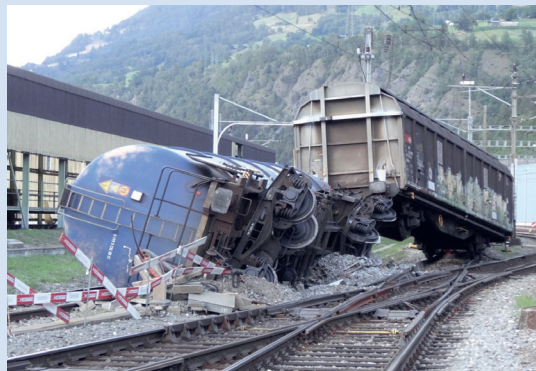
- In practice, the information provided by the radio track transmitter is hardly ever used.
- When closed, the hinged panel on the derailed tank wagon indicating dangerous goods – which in this case was incorrect – did not have a suitable securing device to prevent it from opening unintentionally.

In this accident, no use was made of the option of using the transmitter in the LISA device¹ to inform the driver that only a partial route had been set. During the investigation, it was found that this option is rarely used.

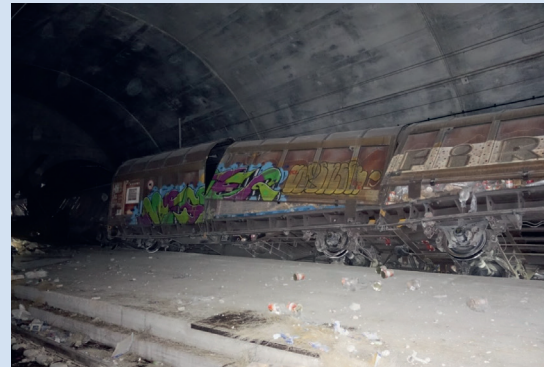
Derailement of a goods train in the Gotthard Base Tunnel in Faido (TI), 10.08.2023 (interim report)

On 10 August 2023, several goods wagons in a north-bound goods train derailed in the Gotthard Base Tunnel near the Faido multifunction station. Very extensive damage was caused to the infrastructure and rolling stock. Several fragments of a wheel disc belonging to one of the derailed freight wagons were found some way ahead of the derailment site.

Wheel discs are safety-critical components, the failure of which can directly give rise to a serious accident.

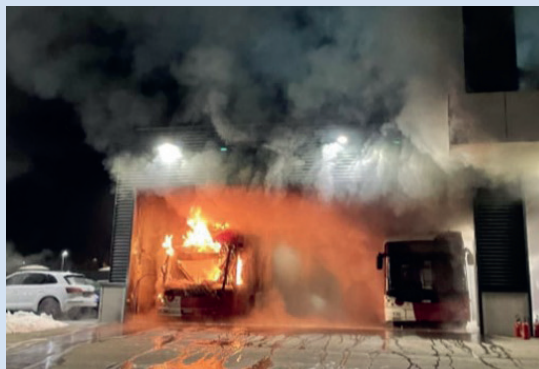
- The lack of insulation between the negative terminal of the 24V battery system and the chassis.
- The lack of protection for the power cables, which run over various metal parts with sharp edges.
- The fact that some cables in the secondary circuits were not suitable for containing the flames.

The chassis and bodywork of trolleybuses consist of various interconnected metal parts. Some of these have sharp edges which, over time, due to the vibrations caused by the movement of the vehicle, damage the electrical wiring and lead to a faulty electrical connection, which may result in a fire.
