**The Rail Safety
Inspection Office**

NIB ANNUAL REPORT 2024

The Rail Safety Inspection Office

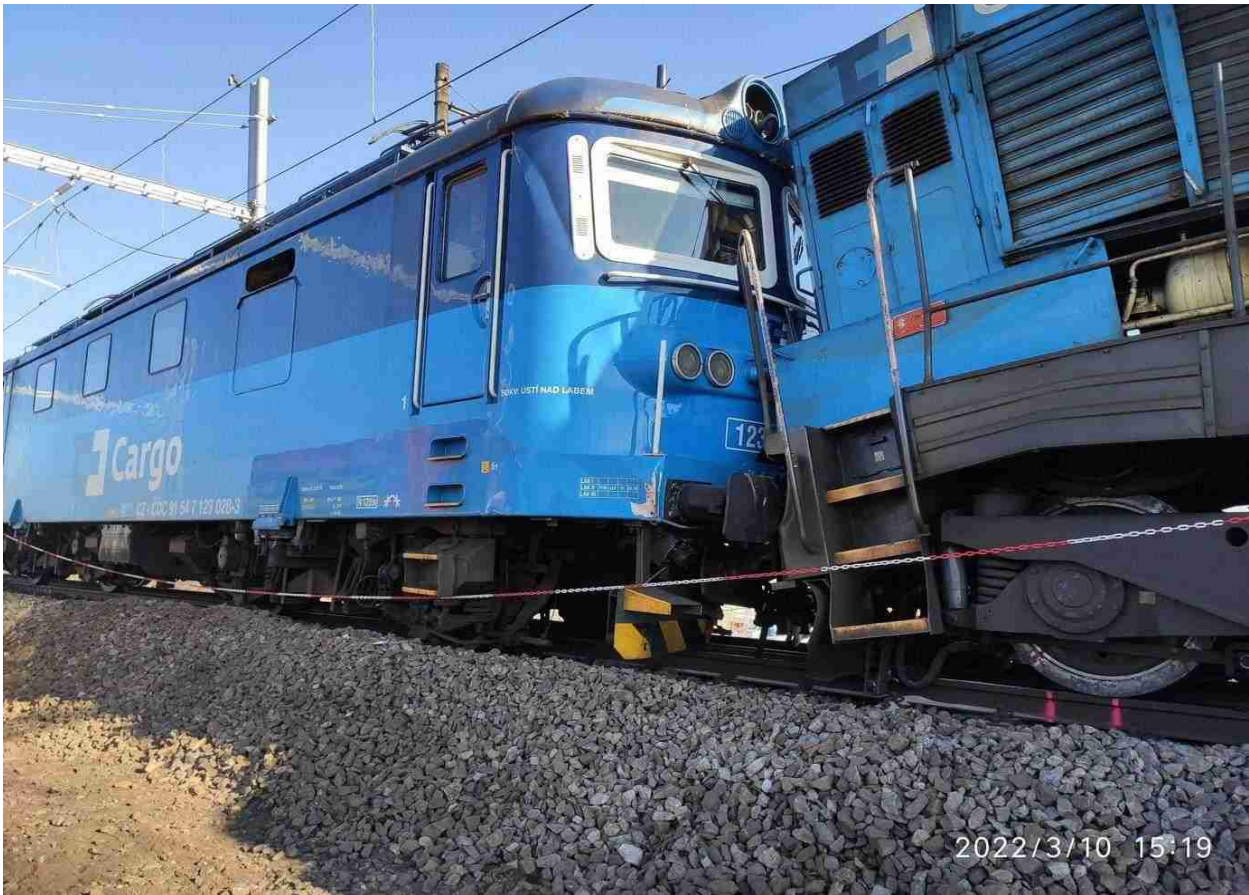
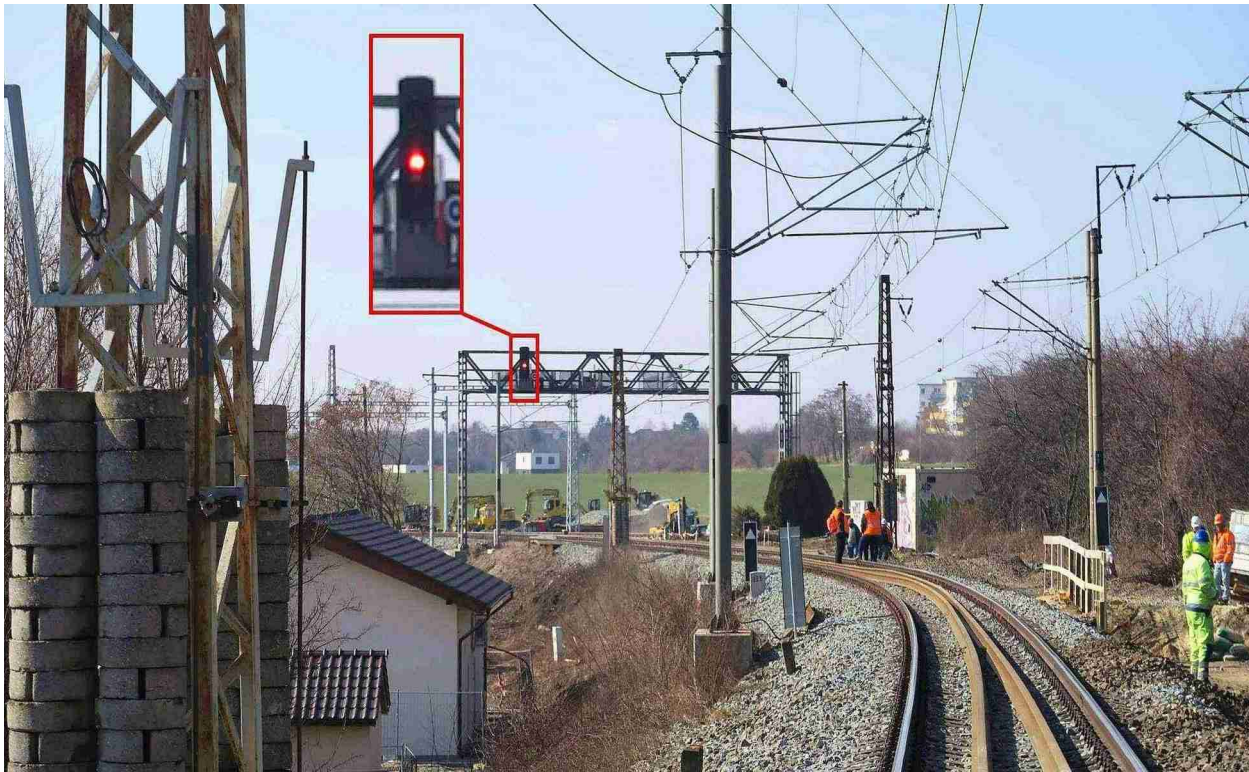
Date and time: 10th October 2022, 17:06 (15:06 GMT).

Consequences: 2 injuries;
total damage CZK 32 959 867,-

- failure to respect the signal „Stop” of the main (departure) signal device L4 by the train driver of the freight train No. 55098 due to fallacious perception of previous signal of the main (entry) signal device 2L and not stop in front of the main (departure) signal device L4 with signal „Stop”.

within the framework of own activity as a national safety authority, to take own measures, which will ensure at infrastructure managers of railway (with the exception of special railways):

- to reassess (taking into account the local conditions) the installation of fixed buffer stops in safety tracks and in the future to use of such types of buffer stops, which, in the event of a collision with a rolling stock, have a lower risk of endangering the structure gauge of traffic tracks due to the consequences of this collision.

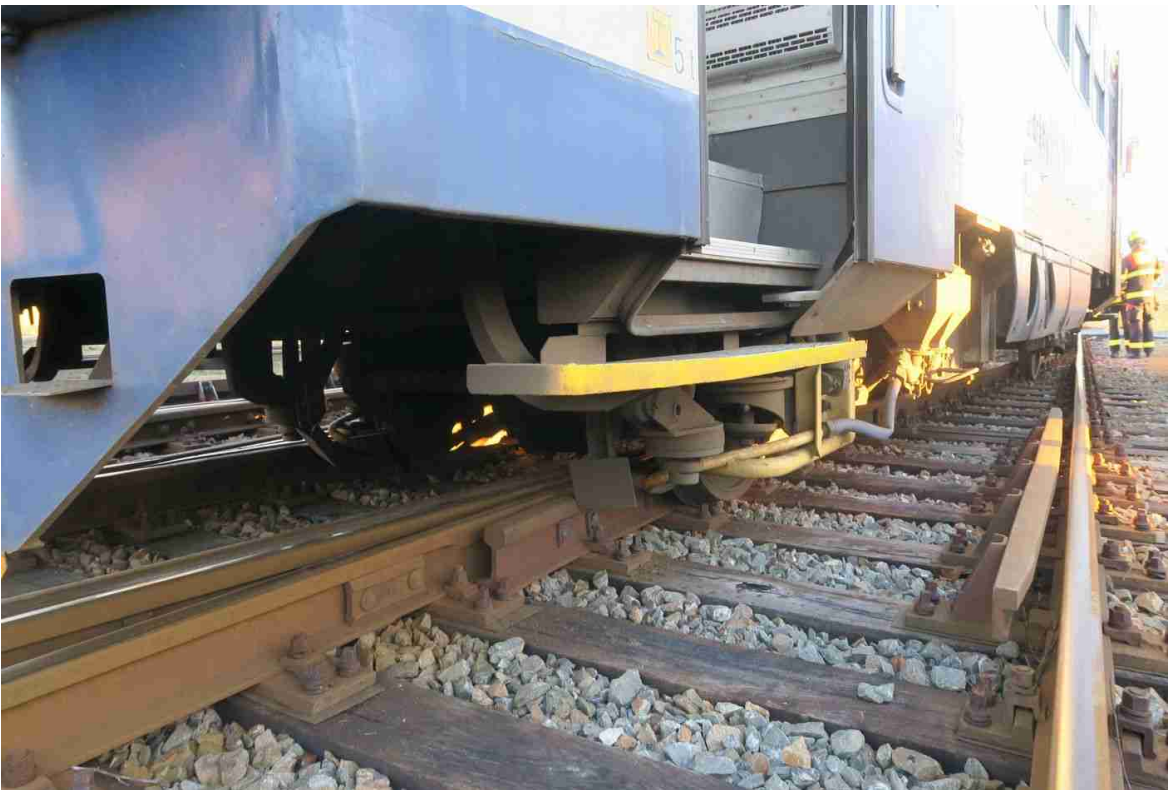
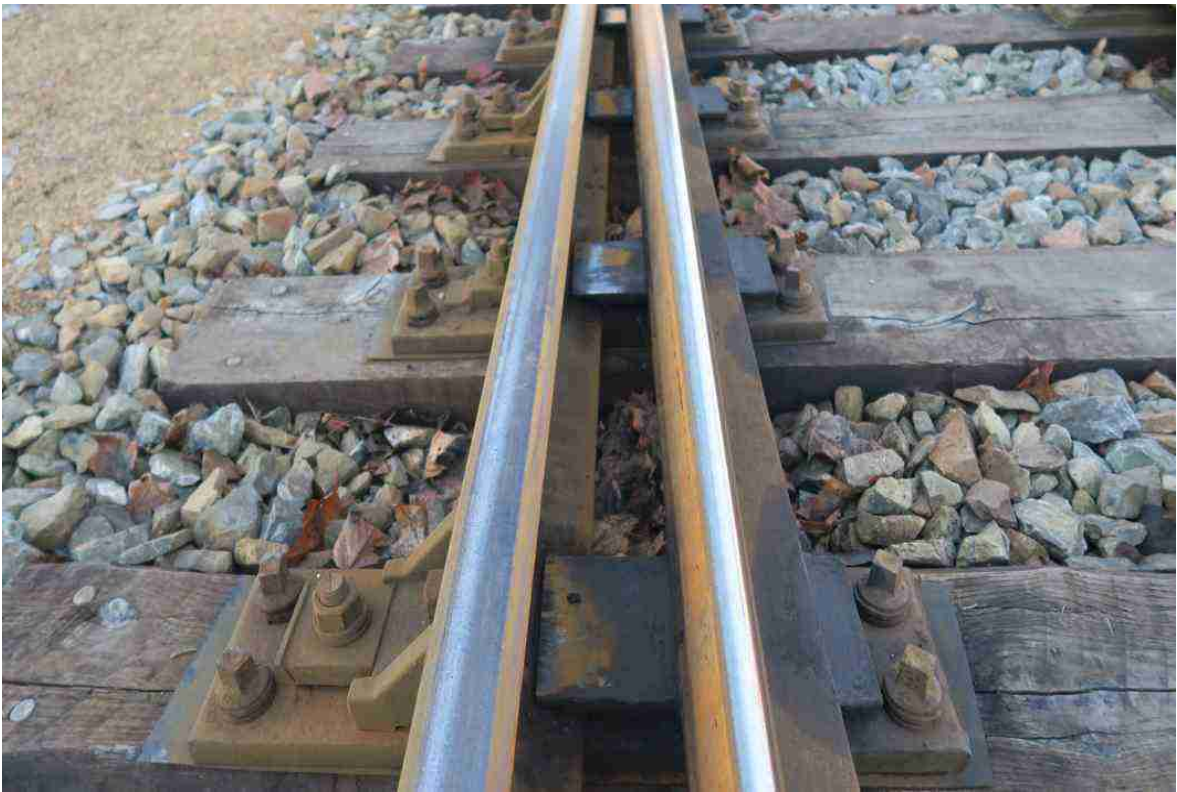
Date and time: 16th January 2024, 18:55 (17:55 GMT).
Occurrence type: unauthorized movement.
Description: unauthorized movement of the long distance passenger train No. 1334 behind the single-aspect signal (fouling point indicator) with signal „End of the train route“ (and boundary of track) with consequent ride to preparing train route for the oncoming long distance passenger train No. 1333 and trailing of the switch No. 2.
Type of train: the long distance passenger trains No. 1334 and No. 1333.
Location: Rynoltice station, the single-aspect signal (fouling point indicator) with signal „End of the train route“ (and boundary of track) valid for station tracks No. 1 and 3, km 119,934.
Place of the trailing of the switch No. 2 was at station head in direction to Jablonné v Podještědí station.
Parties: Správa železnic, státní organizace (IM);
ARRIVA vlaky, s. r. o. (RU of the long distance passenger trains No. 1334 and No. 1333).

- minimum range and way of perform familiarization with line conditions at railway lines and stations where train driver will be drive rolling stocks, e.g. determination of minimum numbers of travel on specified railway line or its part both directions during the day and at night;
- requirements on records and archiving documentations which prove real execution component parts of familiarization with line conditions at railway lines and stations where train driver will be drive rolling stocks,

so that was completely satisfy of requirement certainty, including legal assurance, and recipients this legal duty it was not hamper in practice in its consistent application for application duty from Article 35(1) of Decree No 173/1995 Coll., so that train drivers were demonstrably familiarization with line conditions at railway lines and stations where train drivers will be drive rolling stocks.
