Joint Network Secretariat Urgent Procedure Task Force “Extreme effects of thermal overload in special cases of freight operation

**Final report –**

**Part 3: Detailed information on the work of the  
JNS task force**

02. February 2022

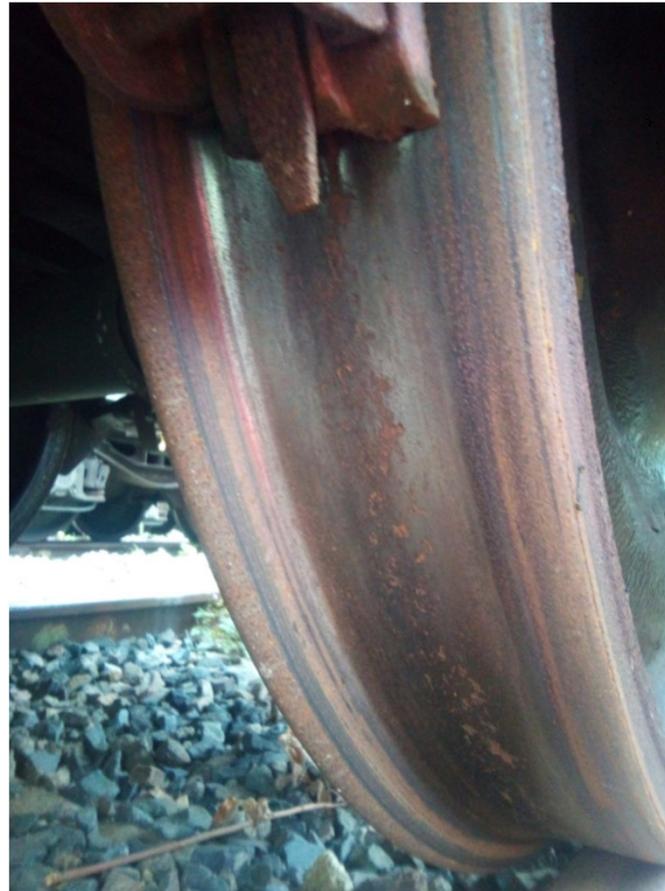
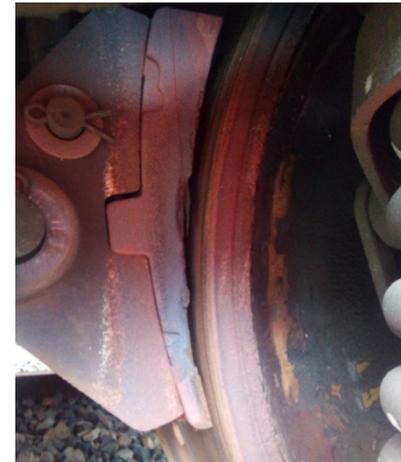
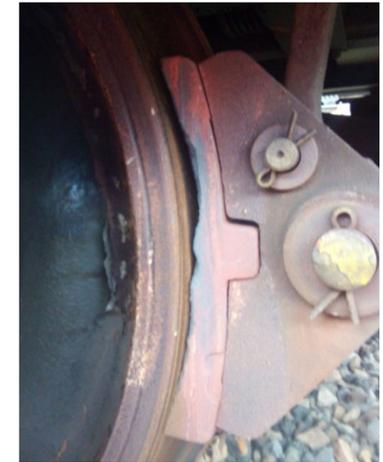
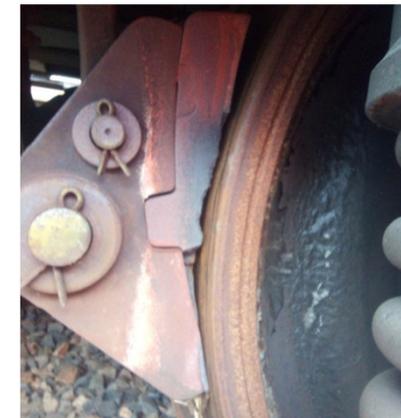
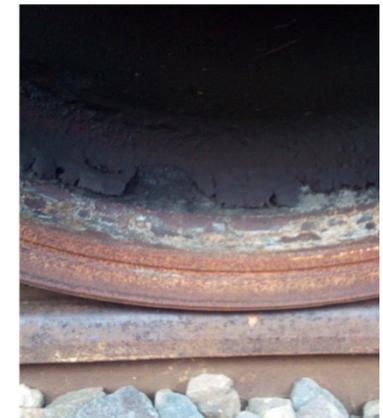
EXAMPLE: CAST-IRON #1

- Significant thermal overload
- Impact on the blocks
- Impact on the wheels (web and treads)

This incident has generated **sparkling + smoke + fire along the track**

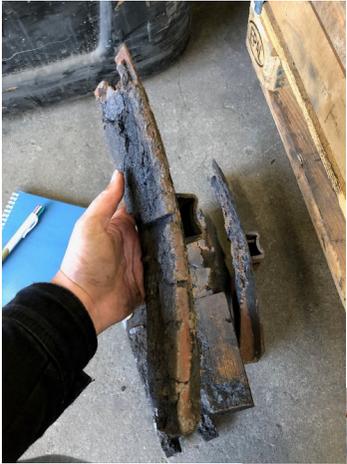
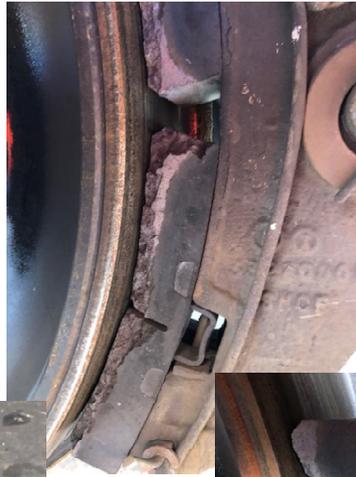
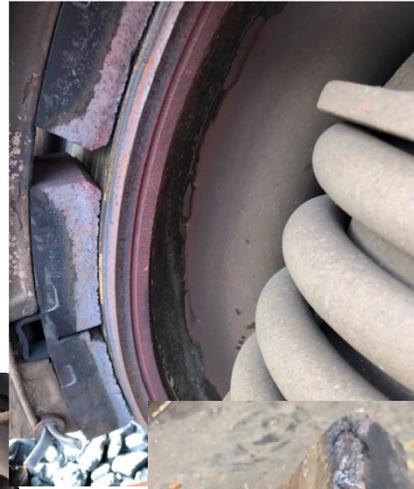
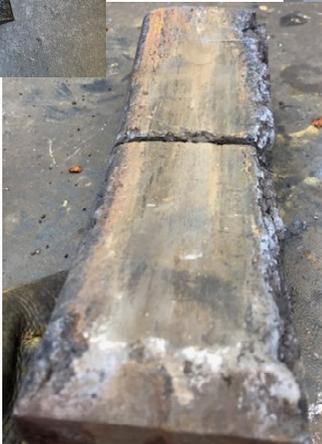
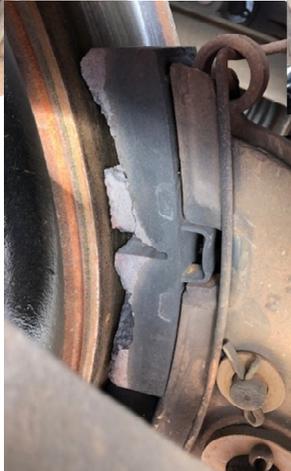
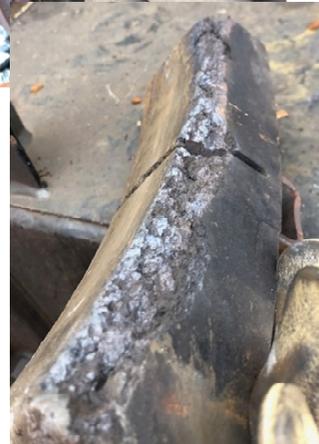
All IB116\*  
after  
unintended  
brake  
applications

- Behavior was analyzed
- To be kept in mind that the block has to destroy itself during the fixed brake
- Seems unusual (does not “only” wear)
- Damages on the brake block and signs of thermal overload on the wheel

**Needs to be further investigated  
(normal procedure)**

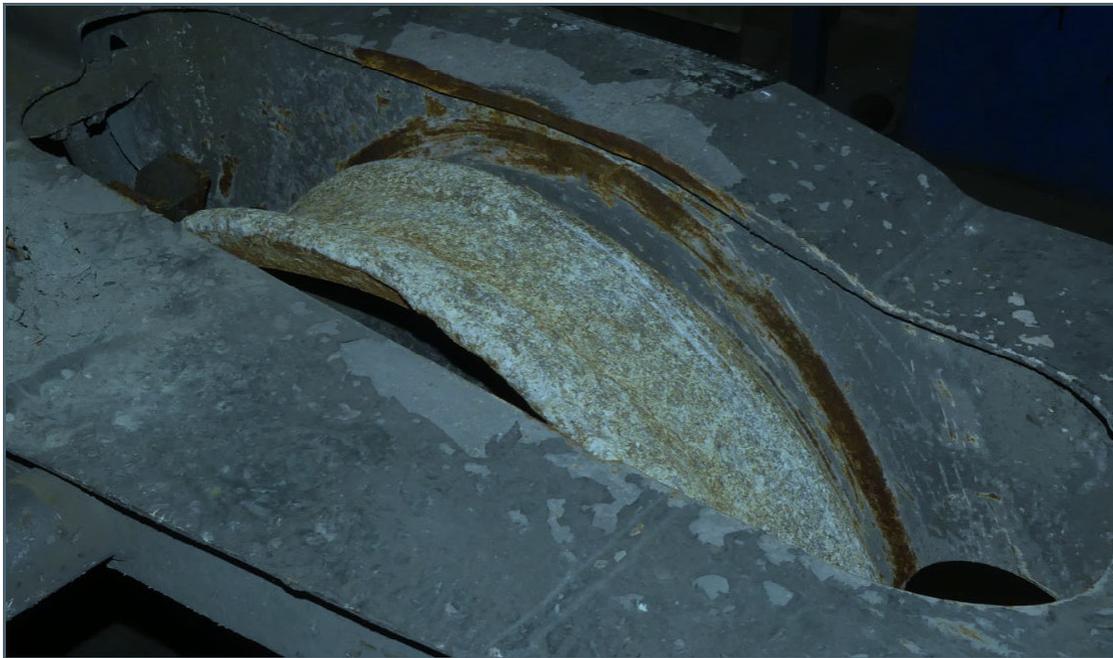
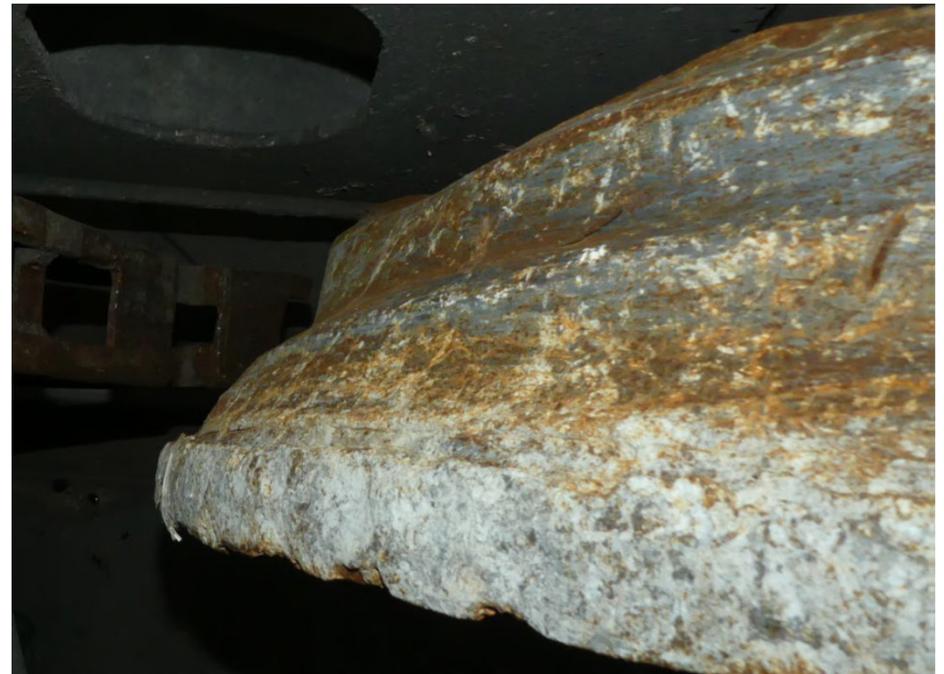
CASE 7 “2020-05-17\_66583\_PM PANICALE\_DB”

- Keeper : DB Cargo Germany
- Derailment case.
- Yes, to categorize as “2” as the wheel is highly damaged.

Data analysed	Evidence collected	Evaluation
Brake system operation	Brake test report available	No abnormalities were found.
Bake system technic	Brake calculation available	No abnormalities were found.
Wheel investigation after incident	Special investigation report of the wheelsets available. 20-61015-TT.TVE33.2-14-001-Entgleisung It.	Thermal overload of the wheel Extraordinary wheel tread deformation with finally derailment
Running of the train	Automatic traction/braking system used for this event. <i>(the automatic system uses both electric and pneumatic braking).</i>	Strange behavior for example regarding the BP pressure evolution. Does not correspond to the normal behavior of a loco driver. Chaotic brake application and release orders.
Maintenance History	Maintenance data	No abnormalities were found.
Infrastructure (IS) detection systems	Data of the wheel detector systems	the last hot wheel detector met by the train before the derailment occurred registered a temperature of the wheel between 296° and 318° C. (see short-term risk control measure 2.2.1)

- ➔ Interaction Wheel / brake block needs to understand what exactly leads to such a picture of damage.
- ➔ By the elements collected on the event, there is no evidence that the case is directly related to IB116\* issue and could occur with different brake blocks.

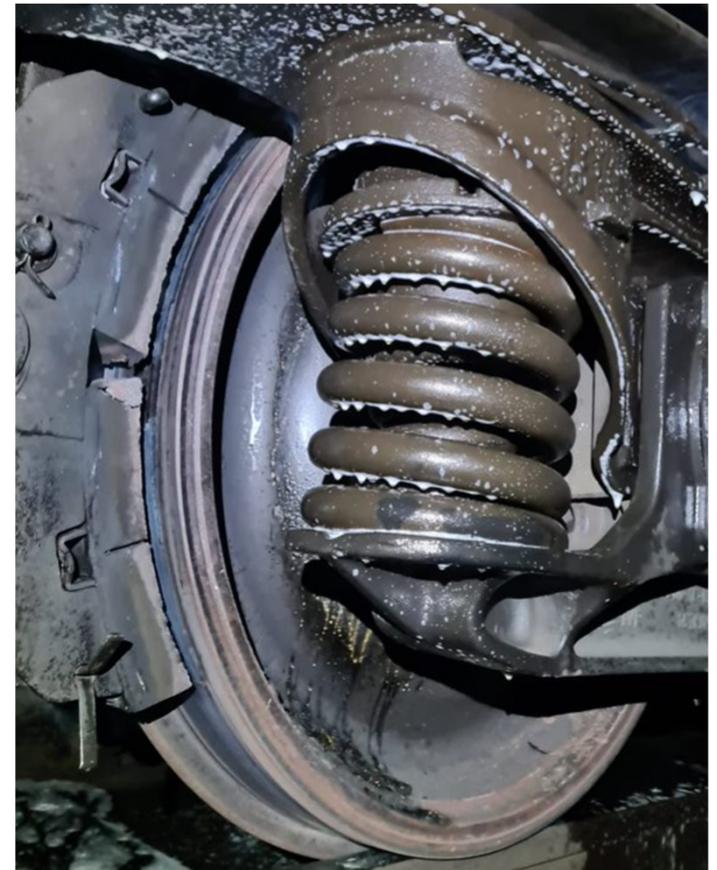
CASE 10 “2020-09-25\_47227\_GEMONA\_MIR”

- Keeper : Rail Cargo Austria
- Fire case.
- Update after Meeting 11th January, categorization 1

data analyzed	Evidence collected	Evaluation
Brake system operation	Brake test report available	No abnormalities were found.
Brake system technic	Brake calculation available	Max. braked weight 62 t
Wheel investigation after incidence	Only based on pictures	Categorized „1“
Running of the train	Template LL Analysis	Automatic traction/braking system used for this event.
Maintenance History	n. a.	
IS detection systems	n. a.

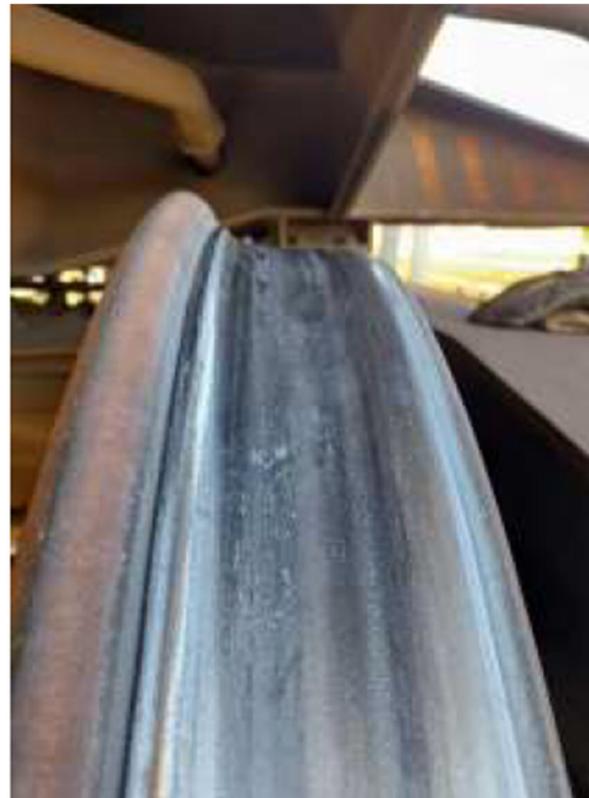
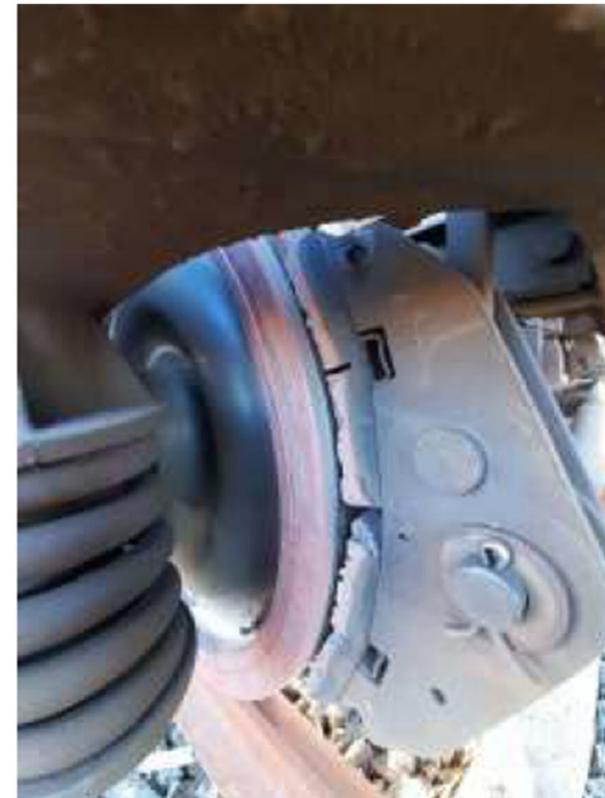
CASE 17 “2021-04-02\_56440\_SARZANA\_MIR”

- Keeper : VTG Rail Europe
- wheel damage is categorized as “2” after evaluation based on the photos in part 2 about the extraordinary deformations
- Extraordinary wheel tread deformation near the flange

data analyzed	Evidence collected	Evaluation
Brake system operation	Brake test report available	No abnormalities were found.
Bake system technic	Brake calculation available	No abnormalities were found.
Wheel investigation after incidence	Wheelset maintenance report available	Effects of thermal overload: Increased residual stress insight the limits (max 299 MPa) Strong deviation in sd between left/right wheel (30,3 – 36,8 mm)
Running of the train	Template LL Analysis	Automatic traction/braking system used for this event.
Maintenance History	n. a.	
IS detection systems	Data of the wheel detector systems	Case detected by a HABD absolute alarm (temperature of the axle box was 102°C). (See short-term risk control measure 2.2.2)

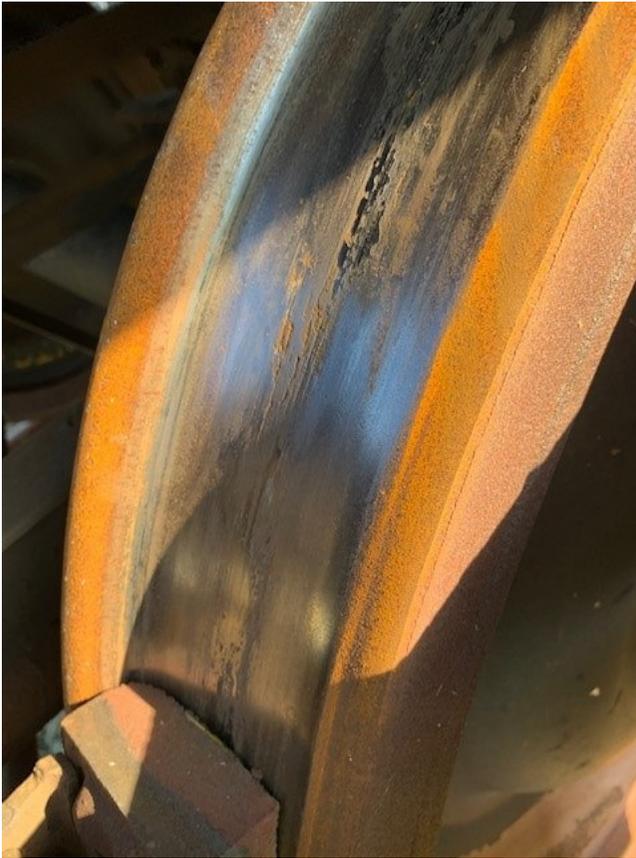
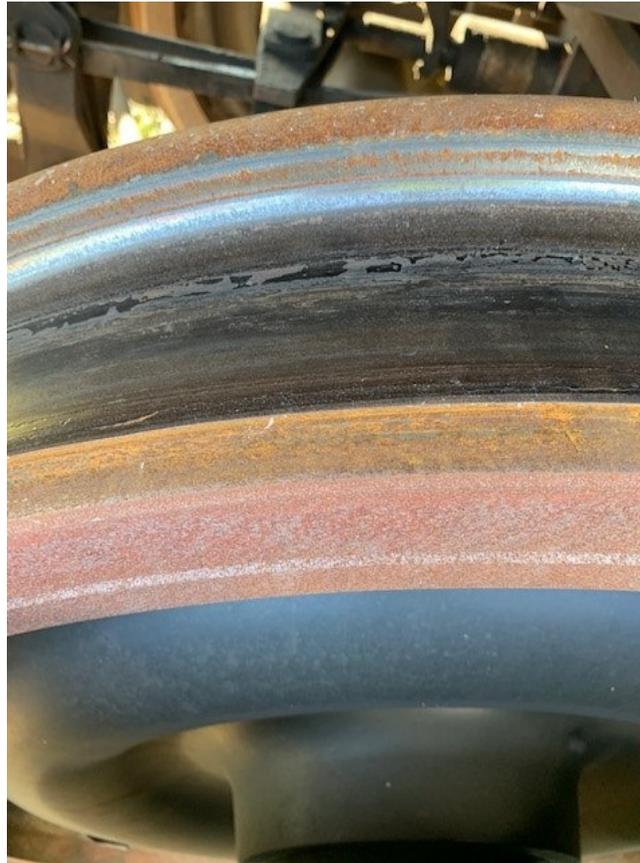
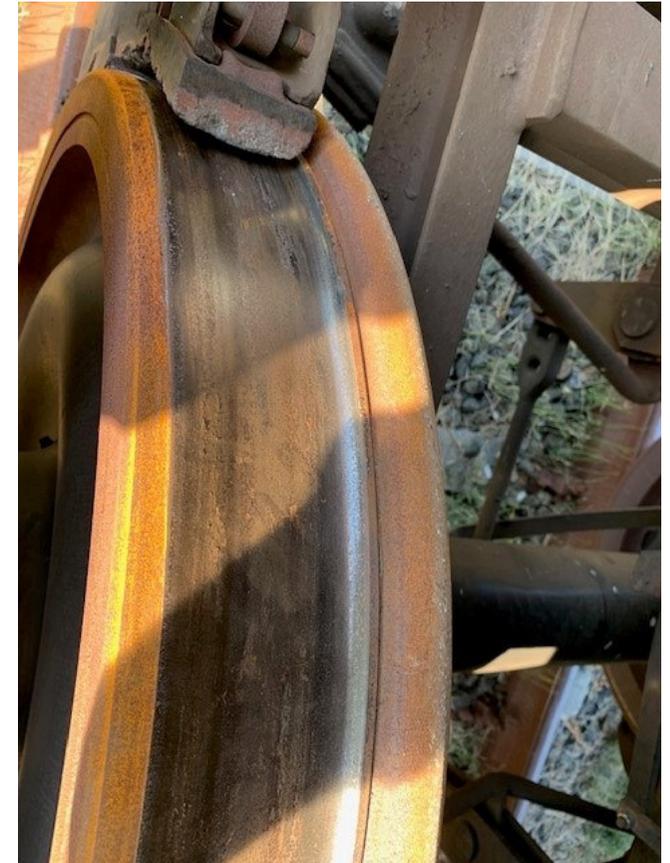
Wheelset without extraordinary wheel tread deformation

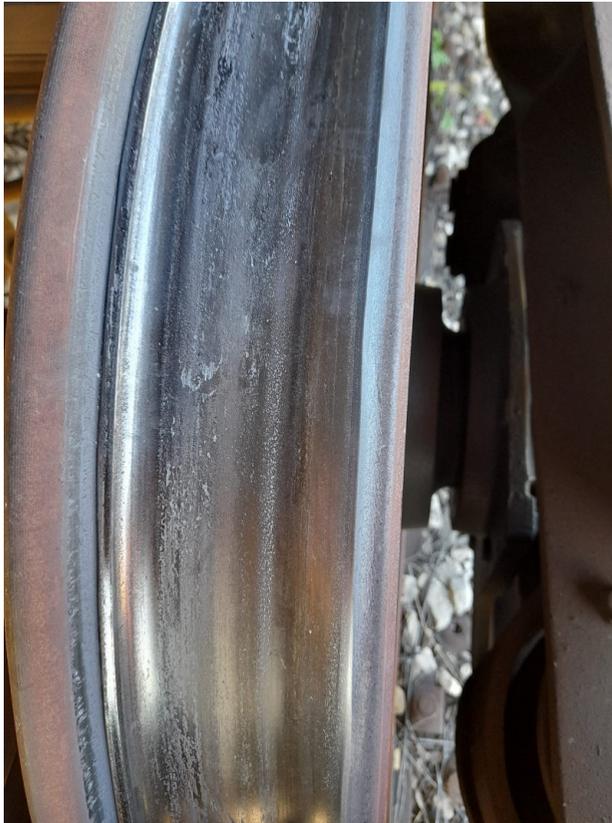
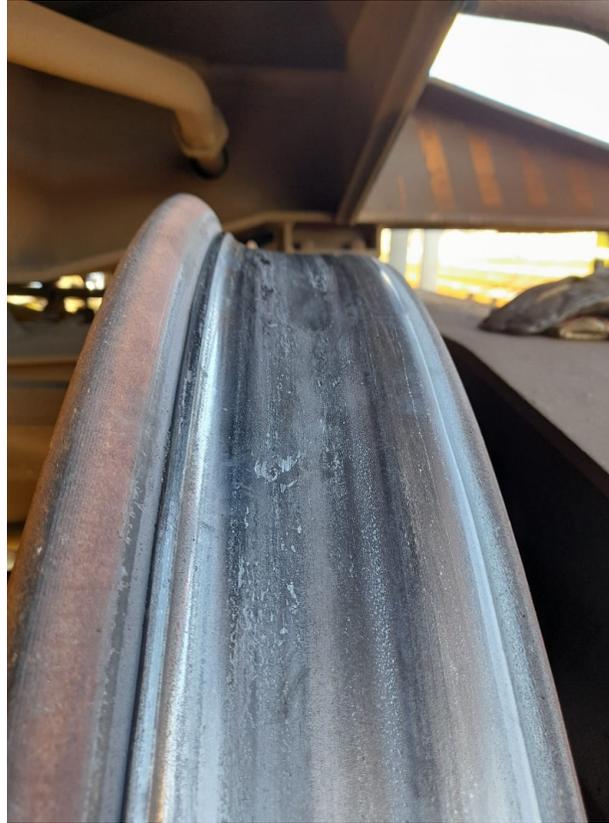
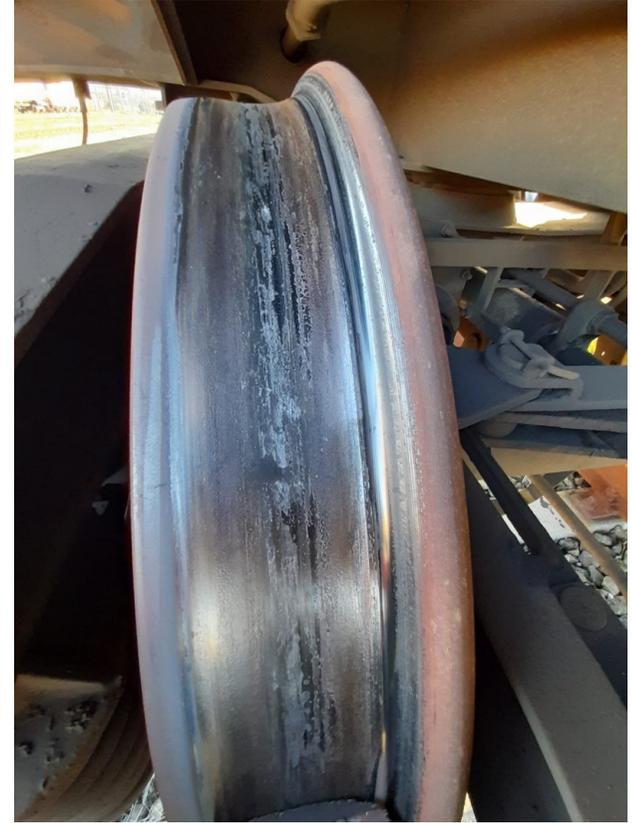
Wheelset with extraordinary wheel tread deformation

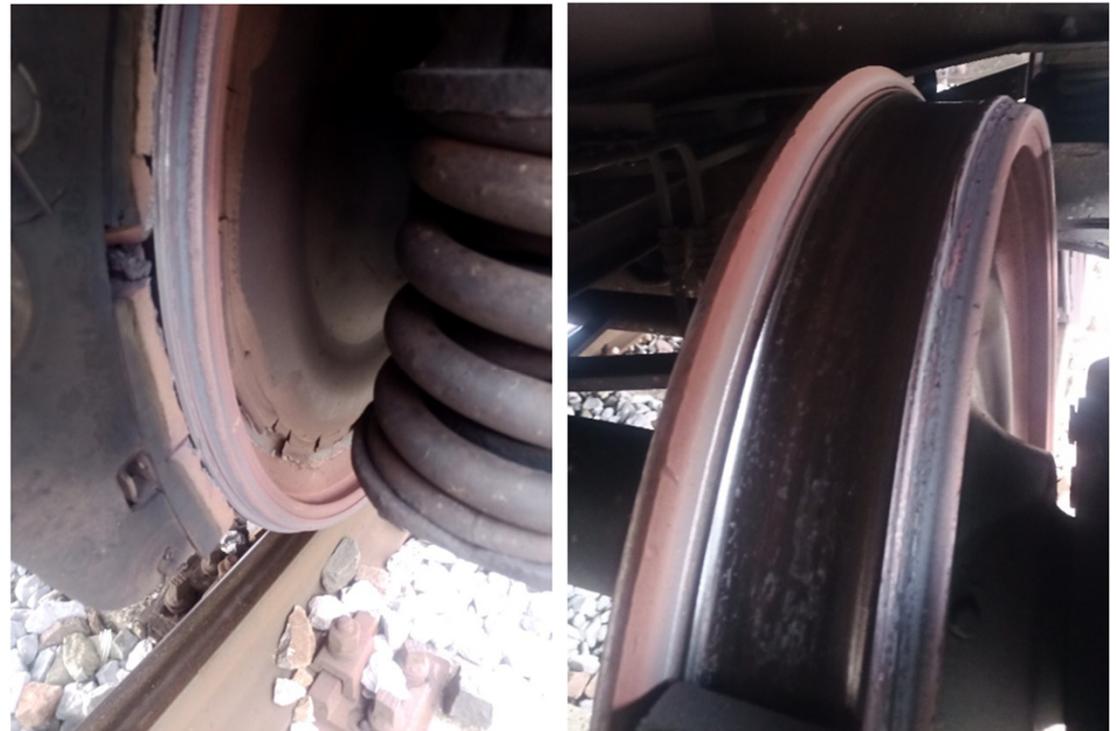
CASE 23 “2021-06-07\_44235\_CARNIA\_MIR

- Keeper : Železničná spoločnosť Cargo Slovakia, a.s.
- Yes, wheel damage is to be categorized as “2” after evaluation based on the photos in part 2 about the extraordinary deformations
- Extraordinary wheel tread deformation near the flange and on the outer side of the tread

data analyzed	Evidence collected	Evaluation
Brake system operation	Brake test report available	Abnormalities detected. (A-Chamber, leakage)
Bake system technic	Brake calculation available	Max. braked weight 64 t
Wheel investigation after incidence	Only based on pictures	Categorized „2“
Running of the train	Template LL Analysis	Automatic traction/braking system used for this event.
Maintenance History	n. a.	
IS detection systems	Data of the wheel detector systems	Case detected by a HFB alarm (temperatures of the right wheels: 506 °C, 637 °C, 651 °C, 651 °C). The HABD recorded 85 °C (See short-term risk control measure 2.2.2)

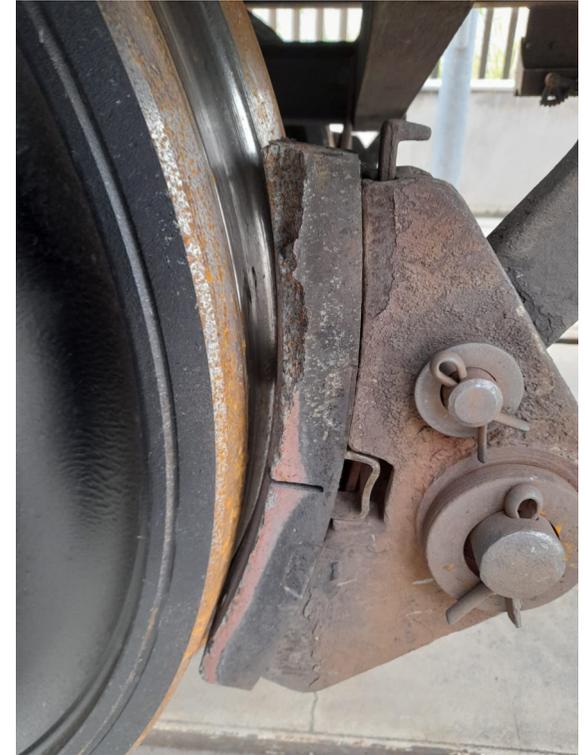
CASE 28 “2021-0729\_63842\_SPRESIANO\_CAPTRAIN”

- Keeper :Petrociterne (SA)
- Fire case.
- From data available, the wagon was able to run at lower speed without replacement of the wheelsets.
- After meeting 11th January, Categorized “1”

- Picture with changed wheelsets after incident
- Picture with signs of thermal overload on the brake blocks,, see short-term risk control measure 2.1.5

data analyzed	Evidence collected	Evaluation
Brake system operation	Brake test report available	Abnormalities detected. (Release function)
Bake system technic	Brake calculation available	No abnormalities were found.
Wheel investigation after incidence	Only based on pictures	Categorized „1“
Running of the train	Template LL Analysis	No automatic traction/braking system used for this event.
Maintenance History	n. a.	
IS detection systems	n. a.
